# **SENECA RESOURCES COMPANY, LLC**

## **2018 ANNUAL SEISMIC MONITORING SYSTEM ACTIVITIES REPORT FOR THE FEE SENECA RESOURCES WARRANT 3771 #38268 (API NO. 37- 047-23835-00-01) CLASS II DISPOSAL WELL**

**February 2019**

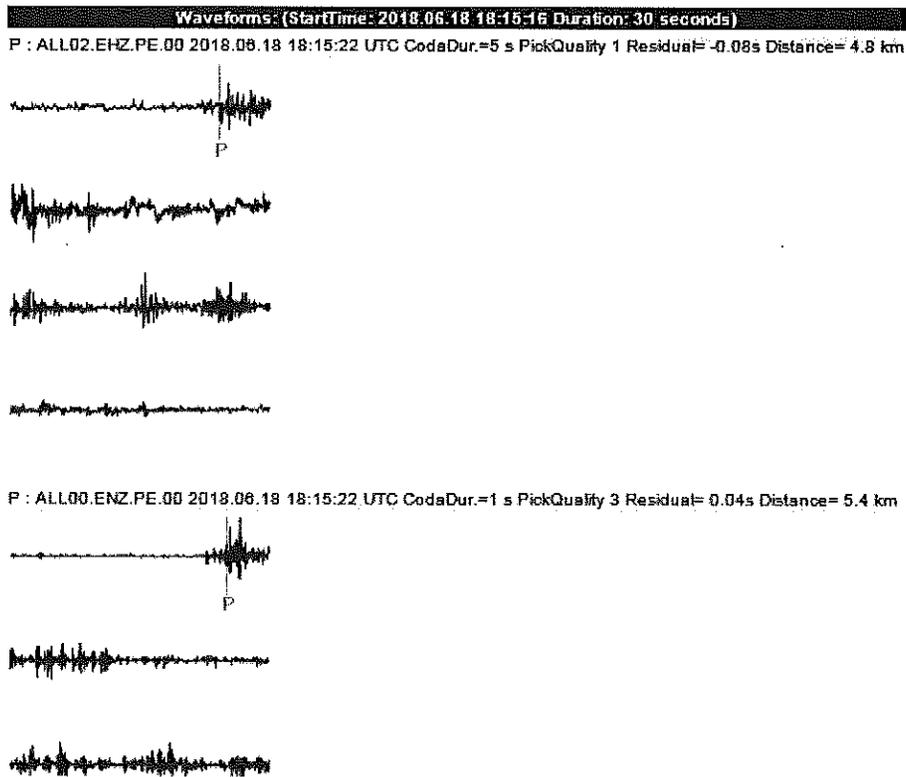
- 06/18/2018 – The seismic network was initially triggered with false detection due to a thunderstorm. **Figure 1** is seismic waveforms of the event detected on ALL02 seismic station and the accelerometer.
- 09/03/2018 – Thunderstorm triggered event and false detection. **Figure 2** is a weather map shown a thunderstorm that triggered a false detection on the seismic network.

**Figure 1. Thunderstorm-induced Trigger Event Detected on the ALL Seismic Monitoring Network in Pennsylvania**

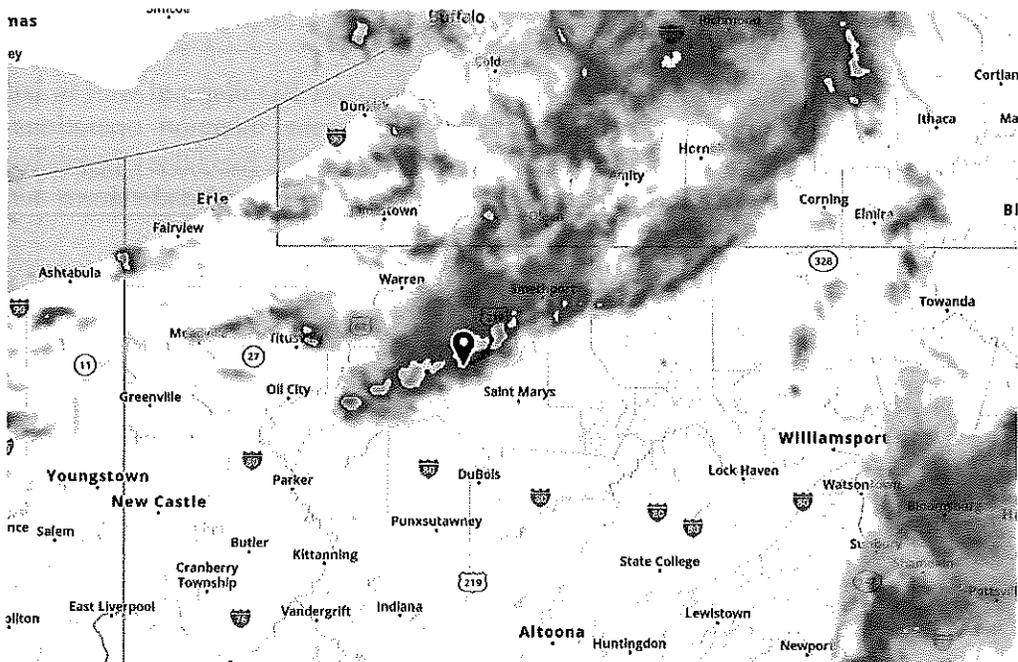
**Figure 2. Weather Map Showing Location of Seneca Resources Disposal Well and Thunderstorm that Triggered a False Detection on the ALL Monitoring Network**
