New Hope Crushed Stone

Monthly Update Solebury Communications Group August 2017

August 2017 Project Status

STATUS AS OF:	September 7, 2017					
PROJECT	New Hope Crushed Stone (NHCS) Quarry Reclamation and Stream Restoration					
START DATE	Reclamation: January 29, 2016 Stream Restoration: January 29, 2016					
ANTICIPATED COMPLETION DATE	Reclamation: March 2019 Stream Restoration: March 2019					
CURRENT STATUS	Quarry Reclamation On Schedule Stream Restoration On Schedule

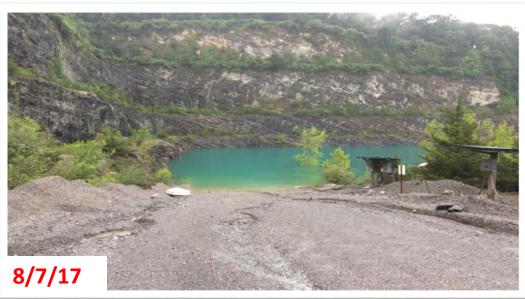
Rise in water level.

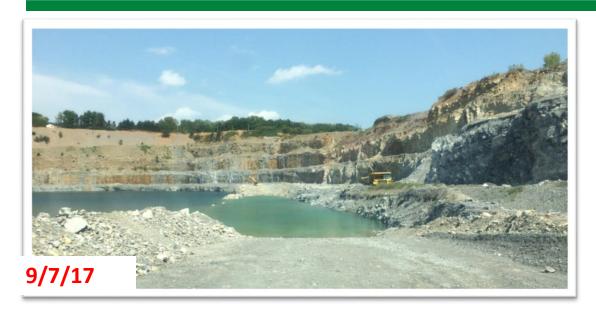
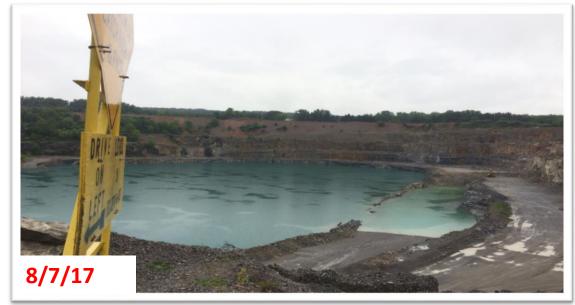
North and East Wall

- Reclamation work included pushing material over the SE wall. On the north side boulders were removed and the slopes were smoothed. North and West side access was improved for the top wall due to rain events.

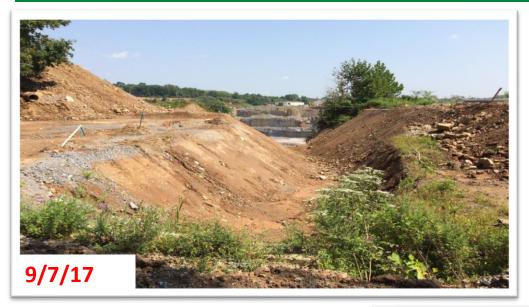
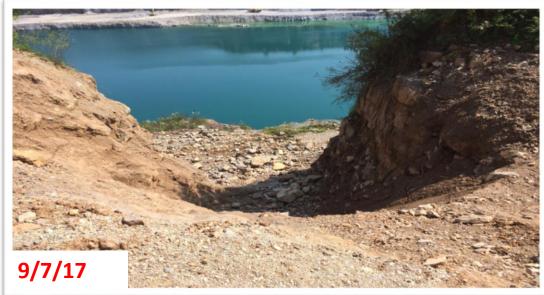
Stream Inlet to Quarry

- Stream work was done on 22.5 days.
 - Excavation of the remaining stream channel from the crossing to the quarry and steam grading was completed.
 - The stream is ready for matting which will be a priority for September.
