# **THE KALP AND MELCROFT AMD ABATEMENT PROJECTS**

Problem Areas PA 2767 and PA 0429  
Saltlick Township  
Fayette County, Pennsylvania

Roderick Fletcher, P.E.  
Director, PA-DEP Bureau of Abandoned Mine Reclamation  
Harrisburg, PA 717-783-2267 (rfletcher@state.pa.us)  
and  
Richard Beam, P.G.  
Environmental Services Section, Cambria District Office  
Ebensburg, PA 814-472-1800 (ribeam@state.pa.us)

March 27, 2007

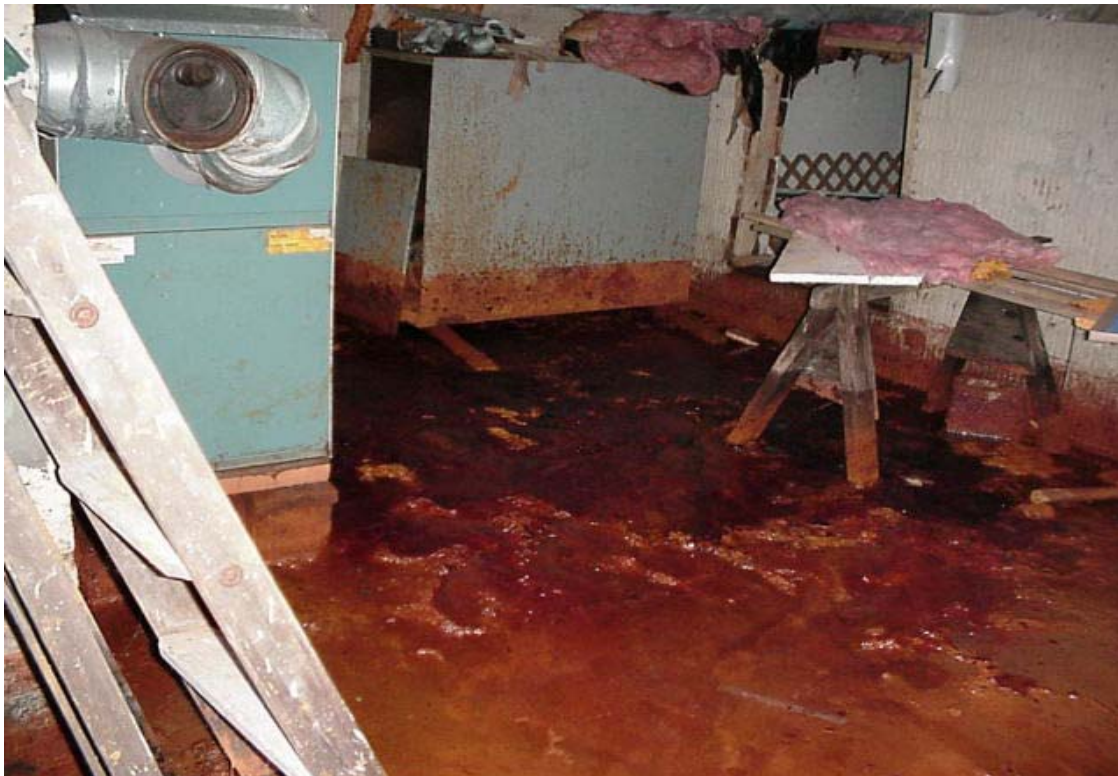
**Figure 1: AMD in home basement Village of Melcroft**

Both mine pools were causing considerable property damage to a number of nearby residences. Mine drainage was partially flooding basements, inundating yards and damaging public highways. In 1984, both OSM and the PA-DEP BAMR identified the mine pool at the Kalp site as a significant priority 2 health and safety hazard because of its impact to adjacent homes, properties and public highways and the potential for a mine pool blowout.

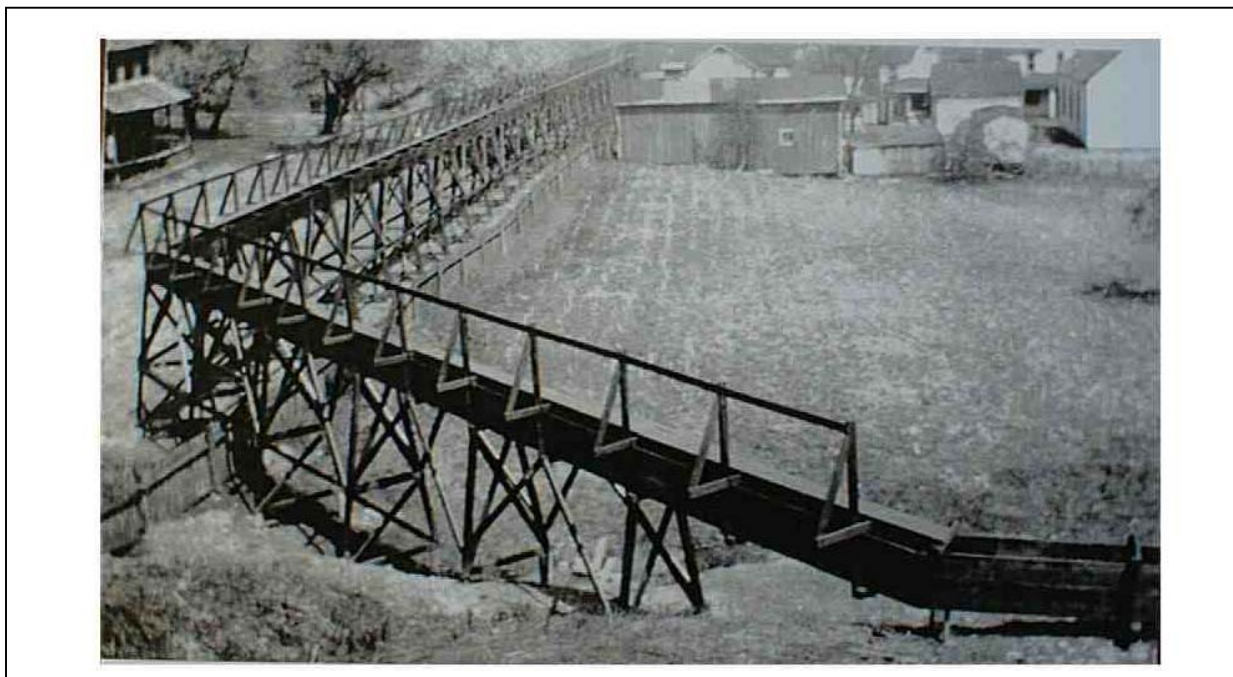
**Figure 2: Historic photo of a portion of the mine drainage flume**

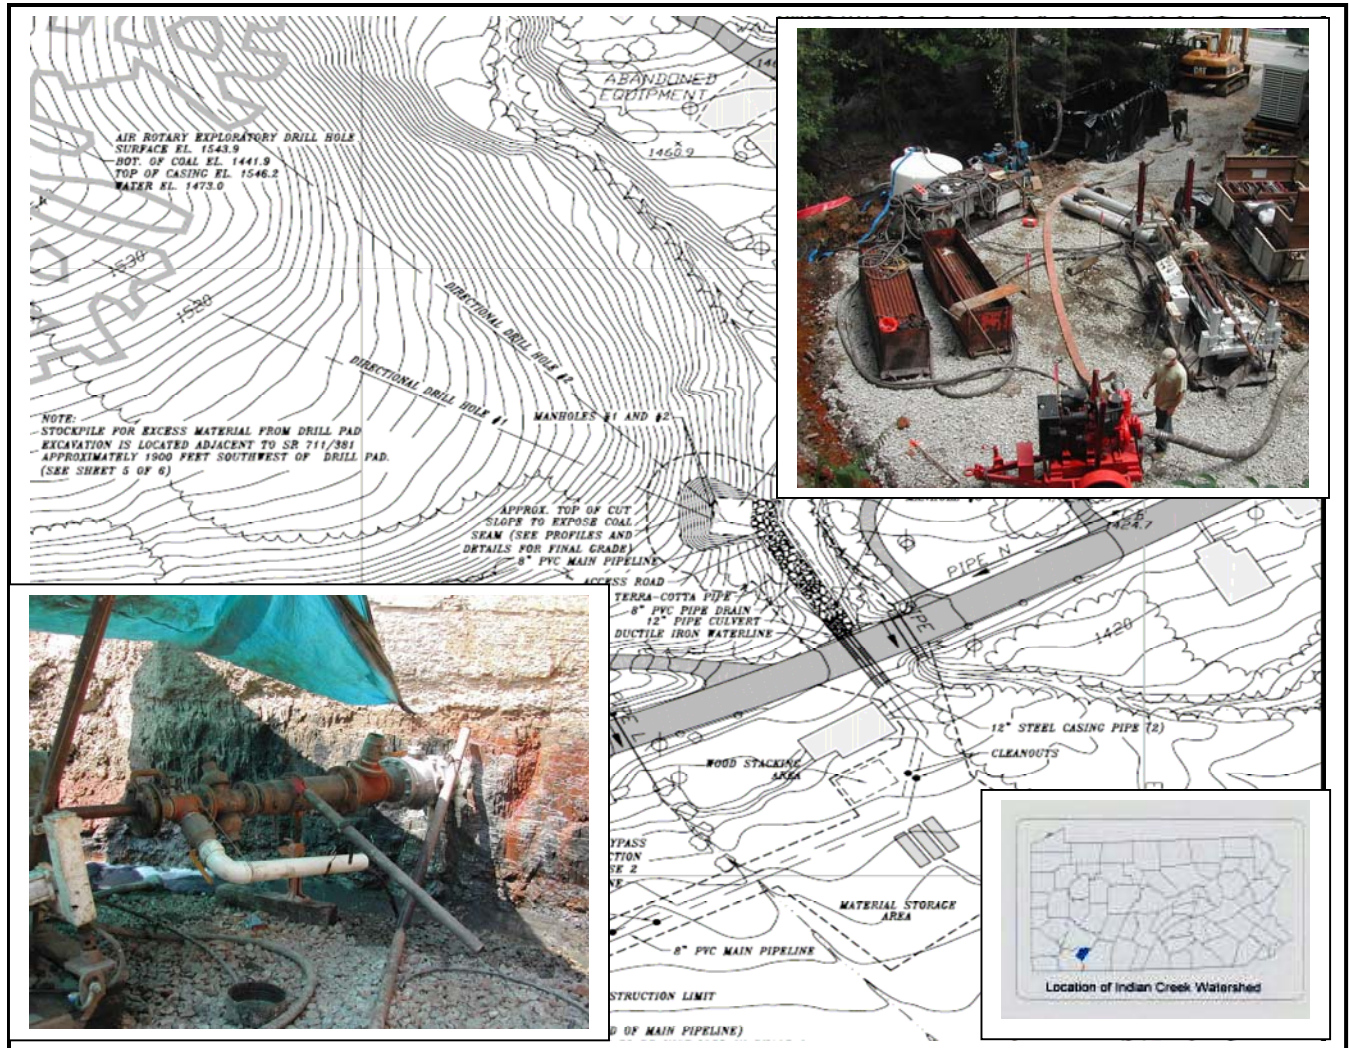
pool. This resulted in a significant cost savings for the project in that treatment of a discharge during drilling operations was not needed. Figure 3 shows the Kalp site drilling area. Given the space limitations at this site, injection of the drilling water into the pool also minimized the construction footprint.

**Figure 3: Directional drilling at the Kalp project site**

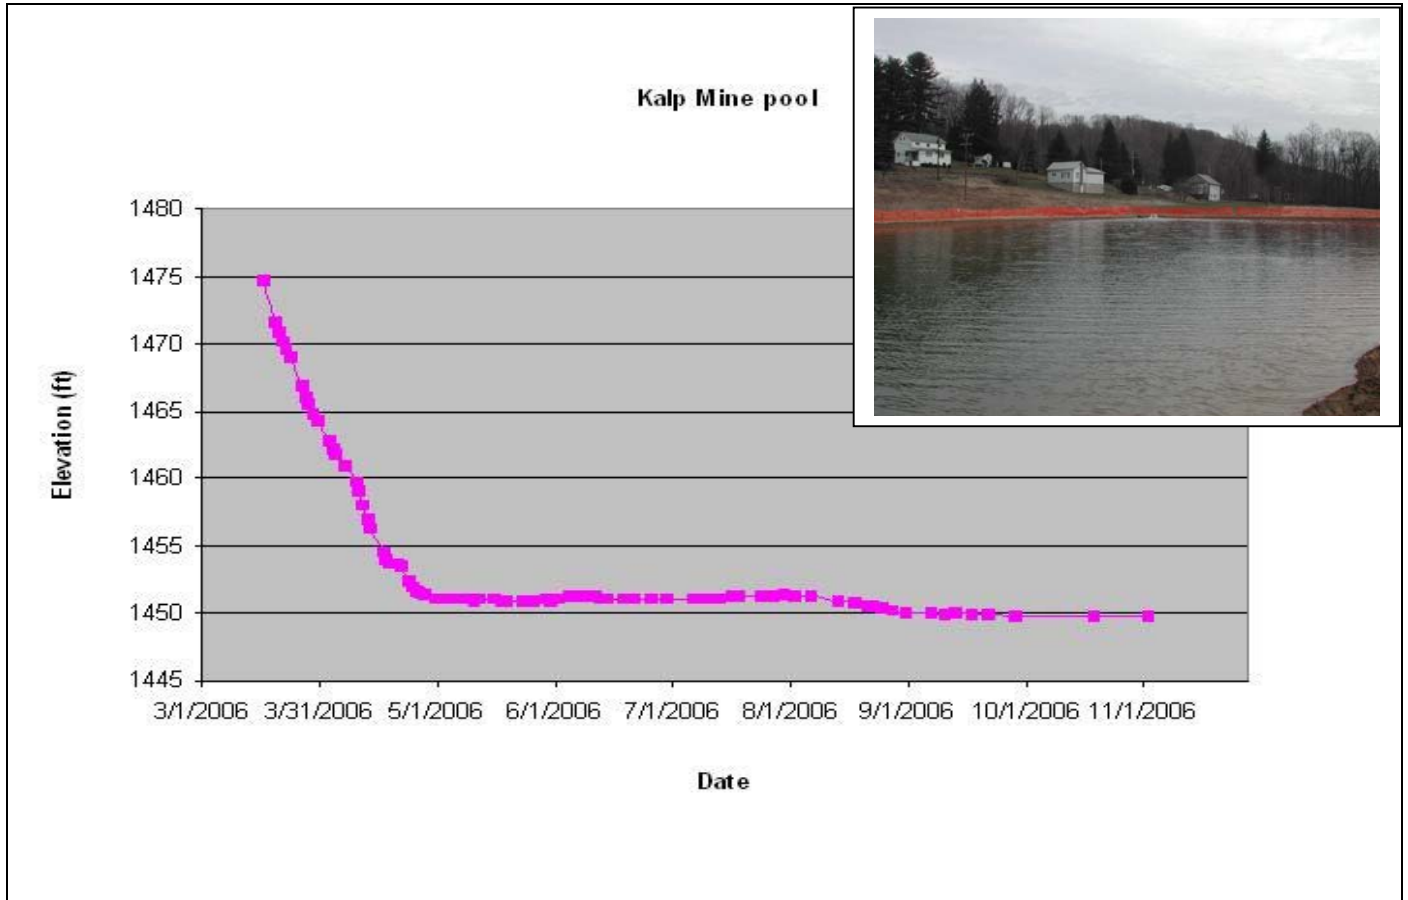
**Figure 4: Dewatering and chemical treatment of the Kalp Mine pool**

aforementioned health and safety concerns and to aid in the design and construction of the pending phase 2 treatment projects. At the Kalp site a total of 80,655,000 gallons of mine pool water has been removed and chemically treated. At the Melcroft site a total of 48,630,000 gallons of mine pool water was removed and chemically treated. The directional boreholes functioned flawlessly in dewatering and controlling the mine pool discharges.

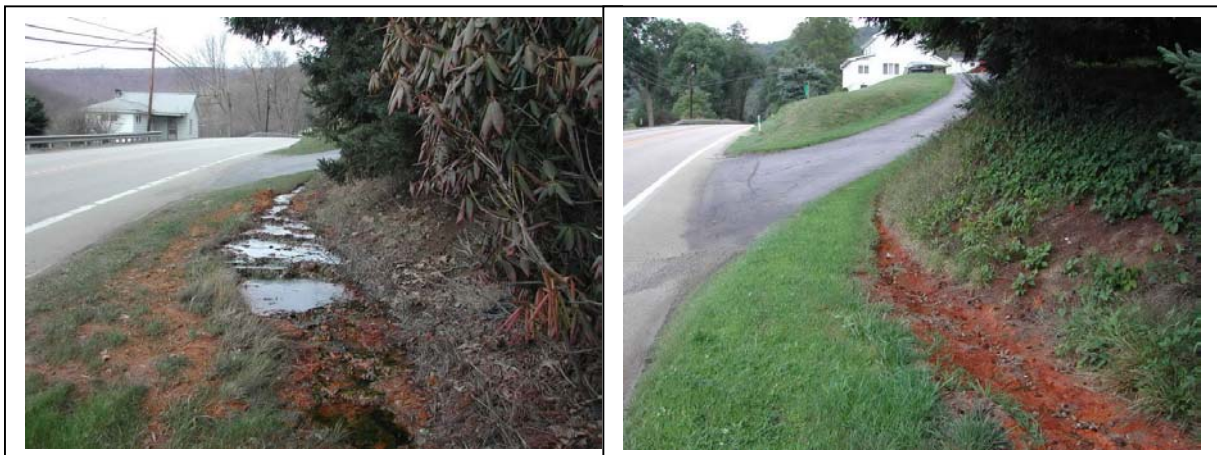
**Figure 5: Typical cropline discharge area before and after dewatering**

At the Kalp site crop line seeps and discharges, including the original discharge point for the mine (Kalp discharge), have been eliminated. The potential for a mine pool blowout has been significantly reduced and homeowners who had been experiencing problems with mine drainage in their yards and basements no longer are subject to these problems. Figure 5 is a before and after photo showing one of the crop area discharges. The mine is currently discharging from the directional boreholes at its baseflow condition.

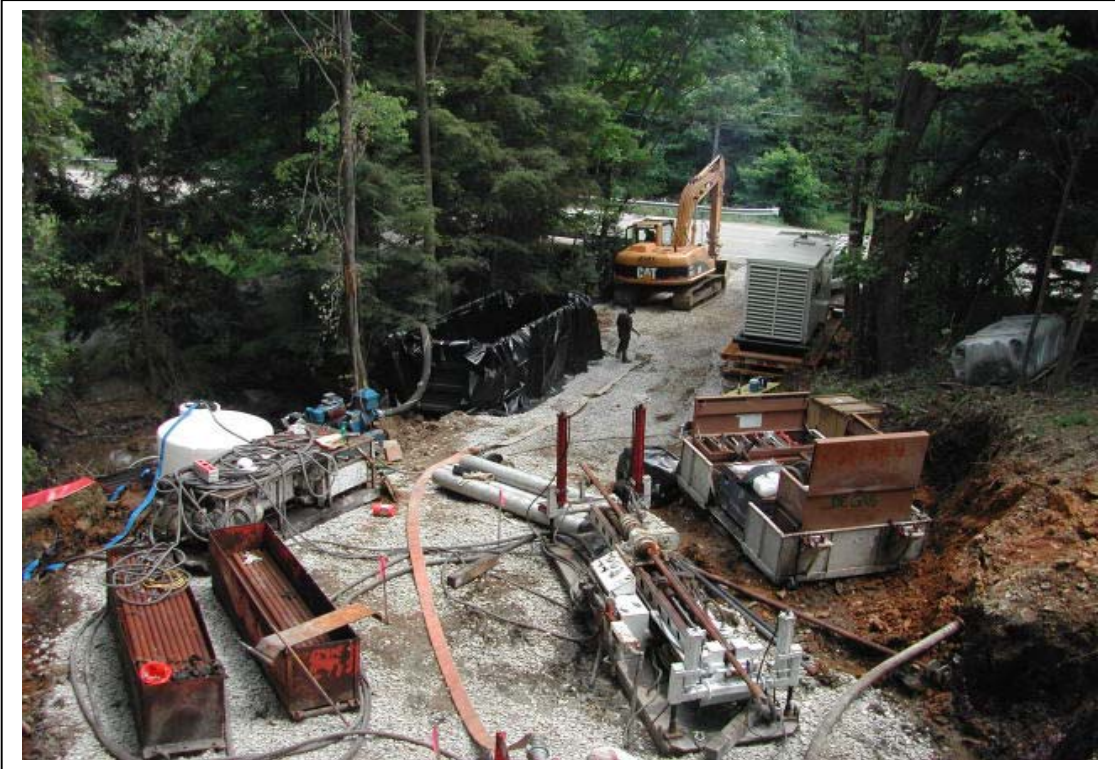
**Directional drilling at Melcroft #1 Mine (Kalp site)**

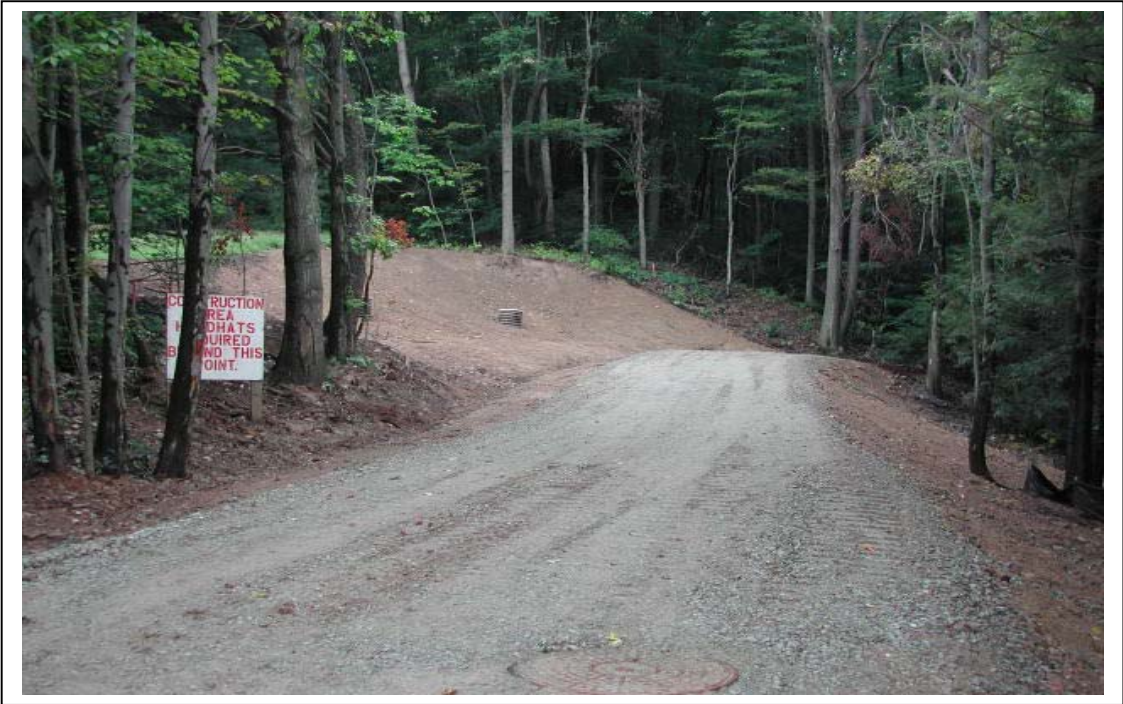
**Reclaimed drill site at Melcroft #1 Mine (Kalp site)**

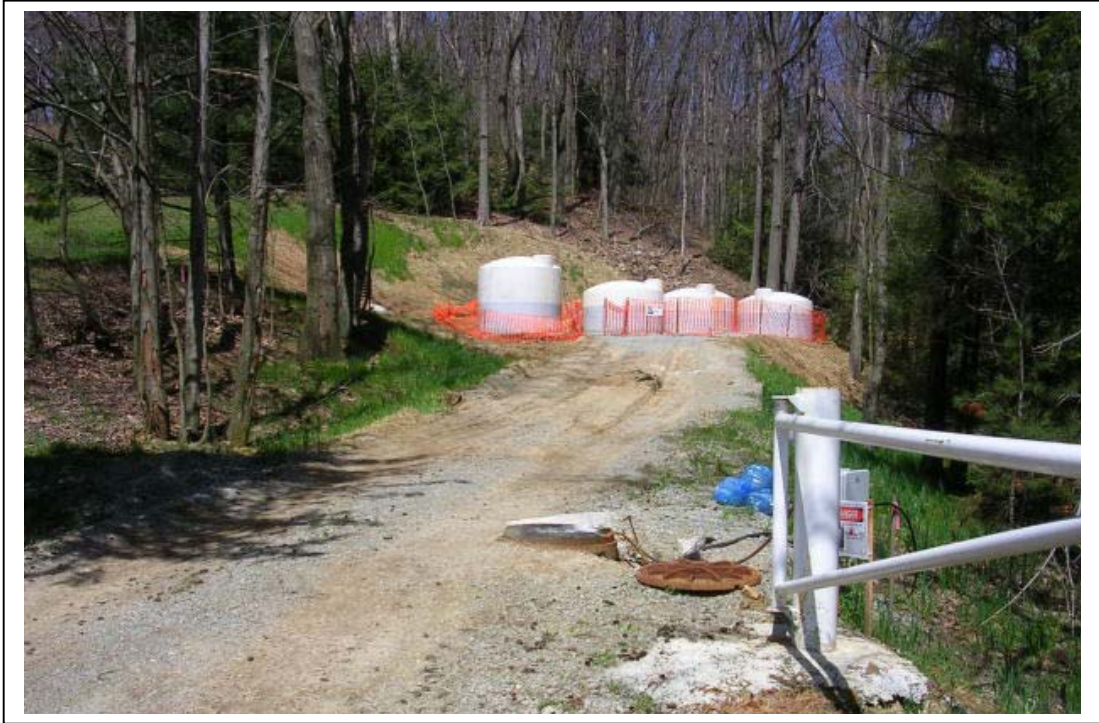
**Mine pool dewatering and chemical treatment at Melcroft #1 Mine (Kalp site)**

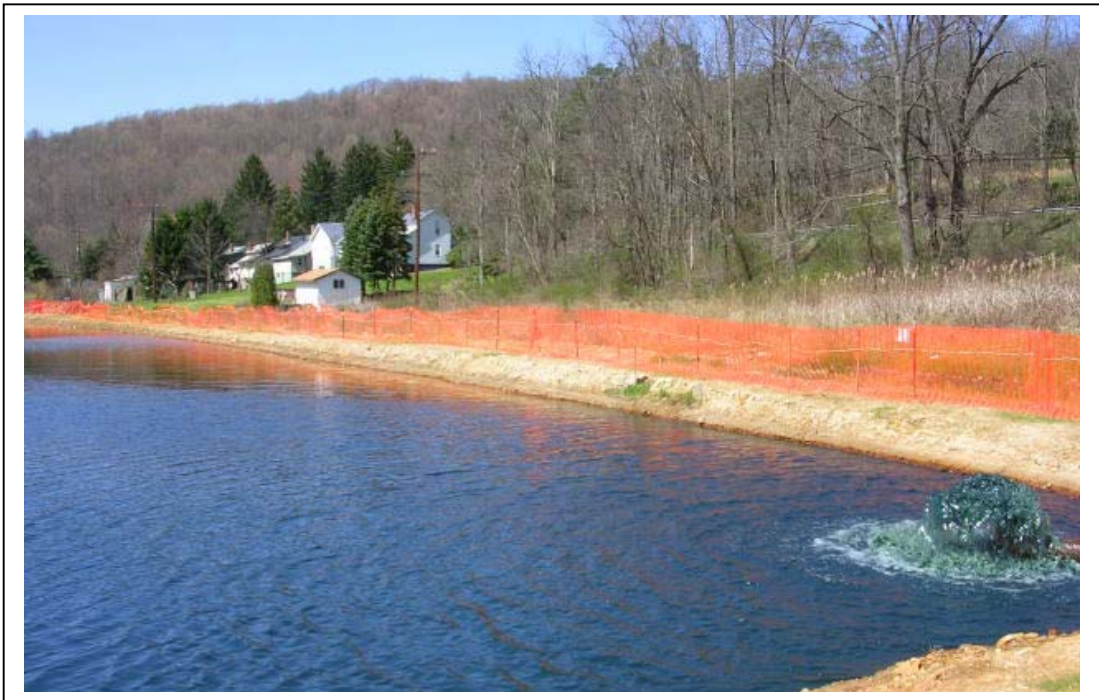
**Mine pool dewatering and chemical treatment at Melcroft #1 Mine (Kalp site)**

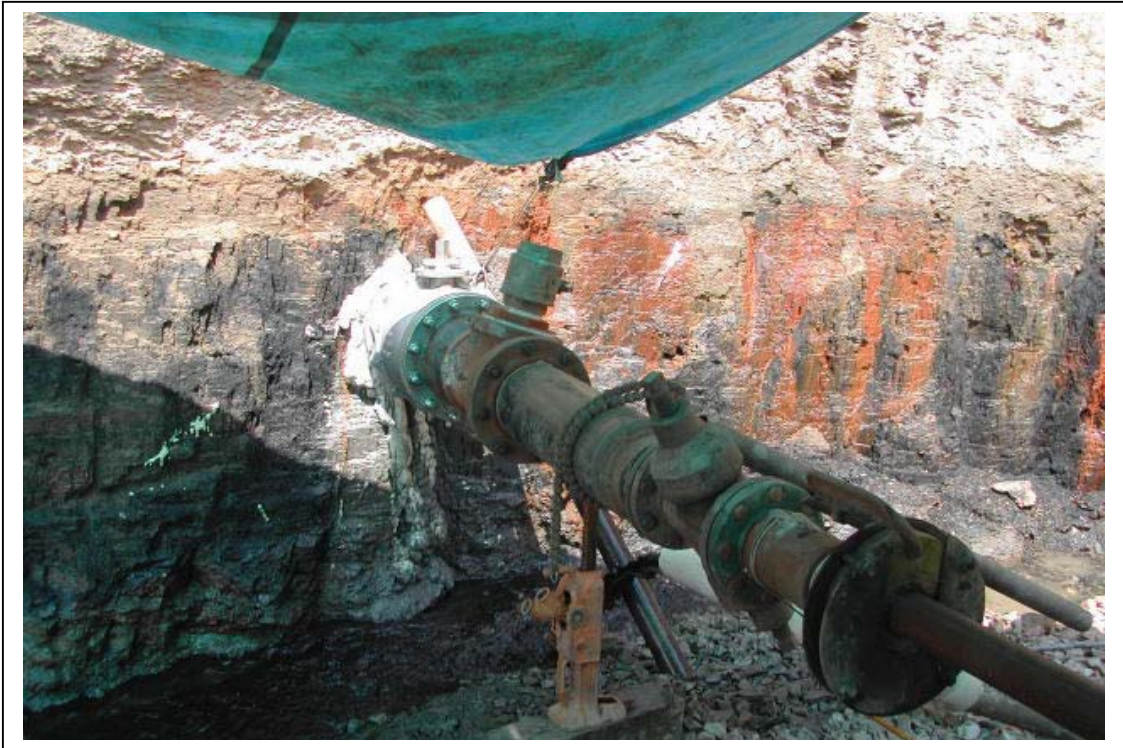
**Directional Drilling at Melcroft #3 Mine (Melcroft site)**

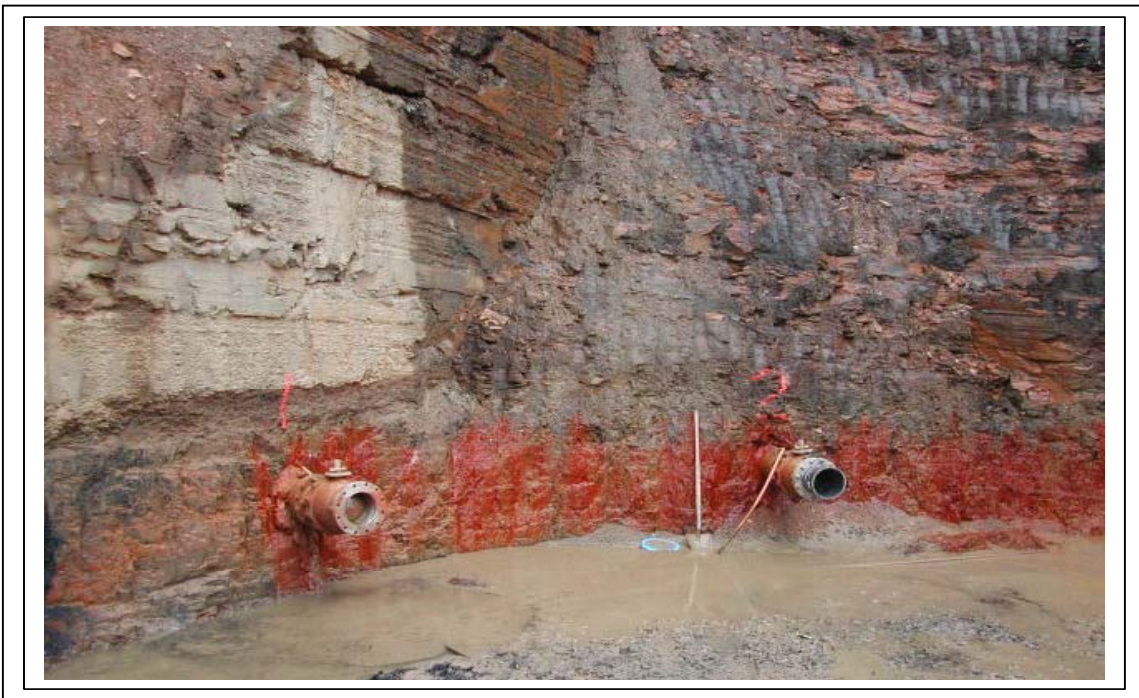
**Completed Directional boreholes at Melcroft #3 Mine (Melcroft site)**

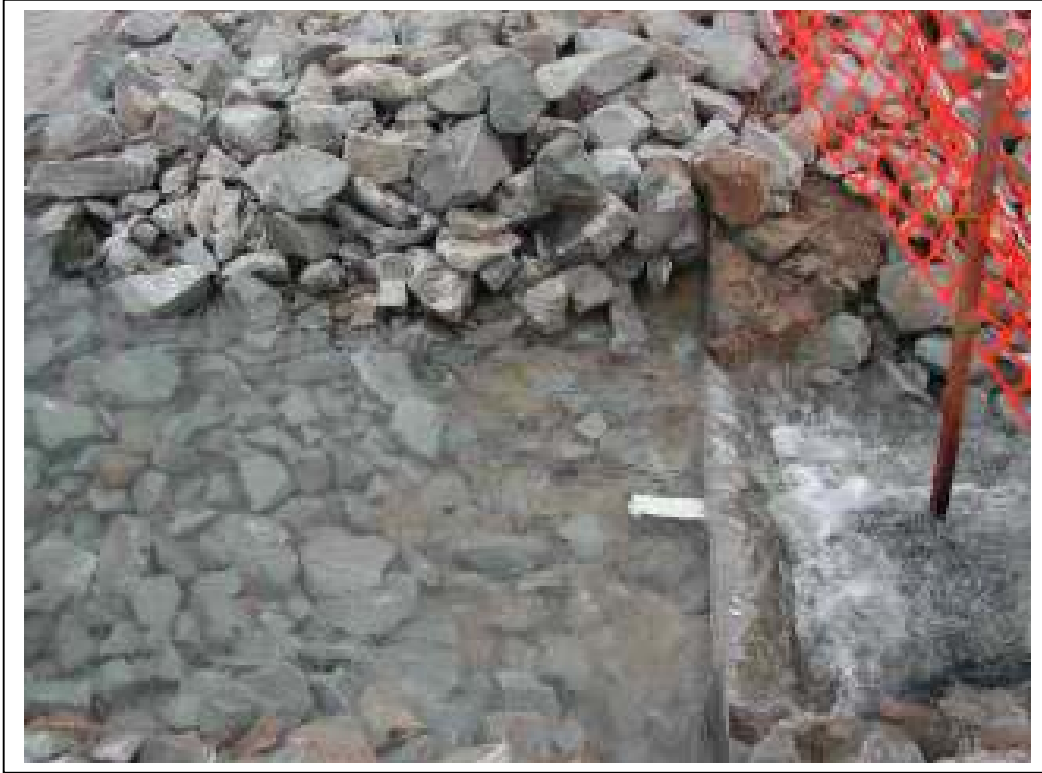
**Treated discharge during mine pool dewatering**

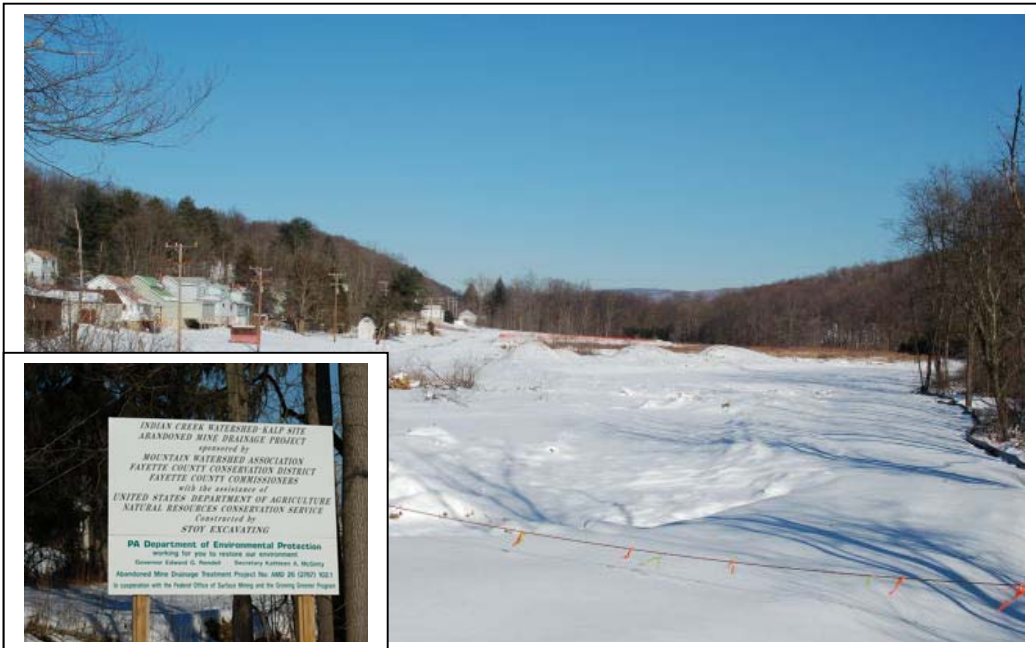
**Passive treatment construction area at the Kalp site**
