Carbon Monoxide Poisoning at a Surface Coal Mine A Case Study

Kenneth K. Eltschlager
Office of Surface Mining Reclamation and Enforcement
Pittsburgh, Pennsylvania

William Shuss and Thomas E. Kovalchuk
Pennsylvania Department of Environmental Protection
Greensburg, Pennsylvania

Abstract: In April of 2000, two adults and their newborn infant, were poisoned by carbon monoxide in their home and received medical treatment at a Pennsylvania hospital. Carboxyhemoglobin levels were; child - 31%, father - 28%, and mother - 17%. Initially the furnace was blamed but after further review, blasting at a nearby coal mine was determined to be the source. All other sources of carbon monoxide were ruled out. The blasting was about 400 feet from the house. The conditions that led to the migration of gas include: the blasts were highly confined, the geologic structure contained fractures that served as conduits for the carbon monoxide to reach a hand-dug well outside the house, and the well was atmospherically connected to the basement floor drains.

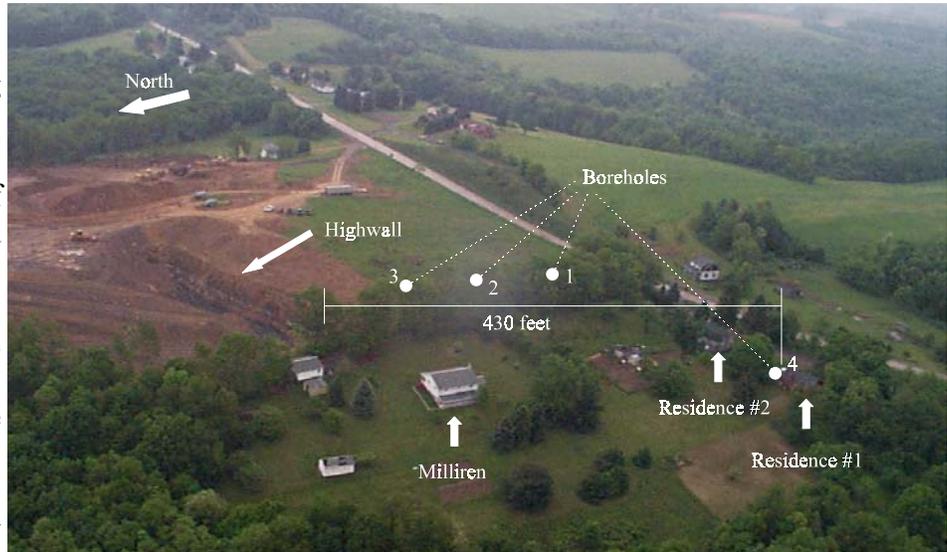
Figure 1 Mine site and nearby structures.

State Industries, Inc. began mining the Upper Freeport coalbed at the Milliren Mine, SMP 03910107 in Armstrong County, Pennsylvania in February 2000. The mine property is owned by Mr. and Mrs. Milliren and their garage is within 50 feet of the nearest blast site. Figure 1 shows the mine and nearby structures.

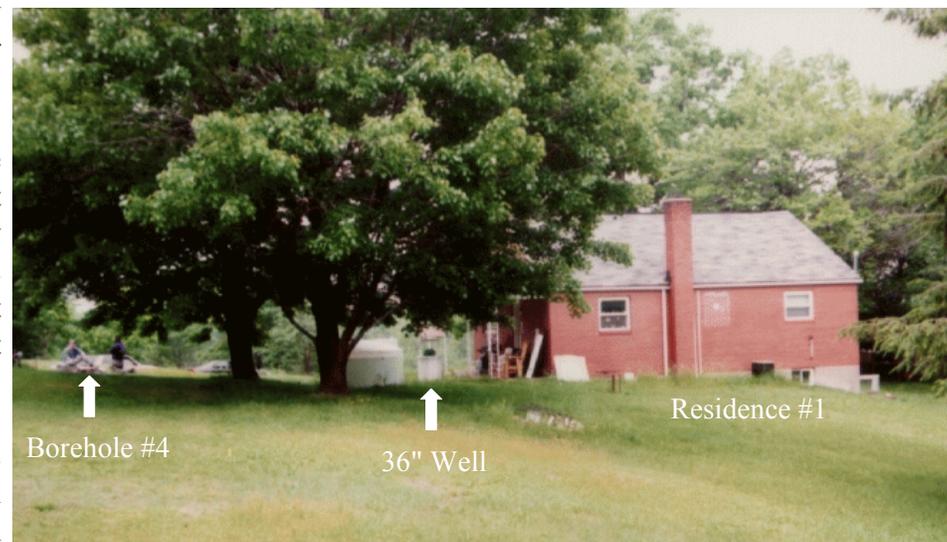
Figure 2 Residence #1 setting.

Residence #1 is about 430 feet from the nearest blast and topographically sits at an elevation of 1370'. A hand-dug 36-inch diameter, cobble lined, well that is about 28 feet deep serves as the primary source of water. The well is located on the east side of the house nearest the mine (Figure 2). The Millirens and residence #2 have drilled wells.

Four boreholes were drilled on May 31, 2000, five weeks after the last CO recording (Figure 1 and 4). The fourth was adjacent to residence #1 (Figure 2). Drill hole 4 confirmed that the coal cropped below the house and that the stratigraphy between the mine and house were the same. Drill hole 2 lost air circulation when a fracture was encountered at the depth of the sandstone.

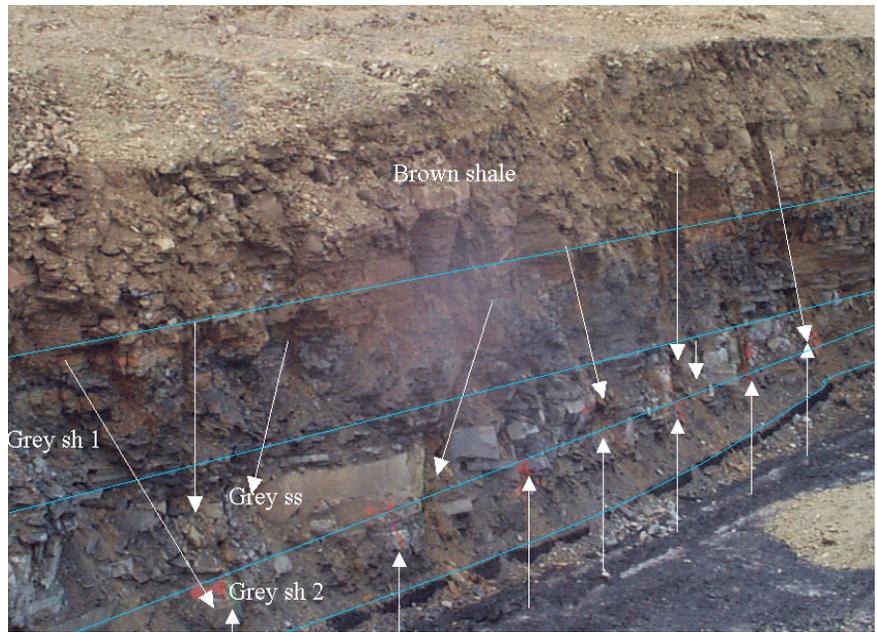
Figure 3 Milliren mine highwall, fracture traces and blasthole locations.

Twenty blasts were detonated from March 7, 2000 to April 20, 2000. The overburden above the coal (12-36") is predominately shale with a 4 to 6-foot thick sandstone two or three feet above the coal. A typical blast hole would penetrate about 20 feet of shale, 6 feet of sandstone and 3 feet of shale before reaching the coal. The shale is ripable with a dozer. The sandstone needs to be explosively broken before it can be removed (Figure 3).

The stratigraphy could also be viewed in the highwall (Figure 3). Mineralization and staining is obvious on the rocks and is physical evidence of groundwater flow paths. The downward arrows of figure 3 are the defined flow paths based on rock weathering. The joints measured and documented in the highwall and encountered during drilling were both prominent, numerous and open. Clearly, most of the blast holes (the upward arrows of Figure 3) were in or immediately adjacent to the sandstone joints.

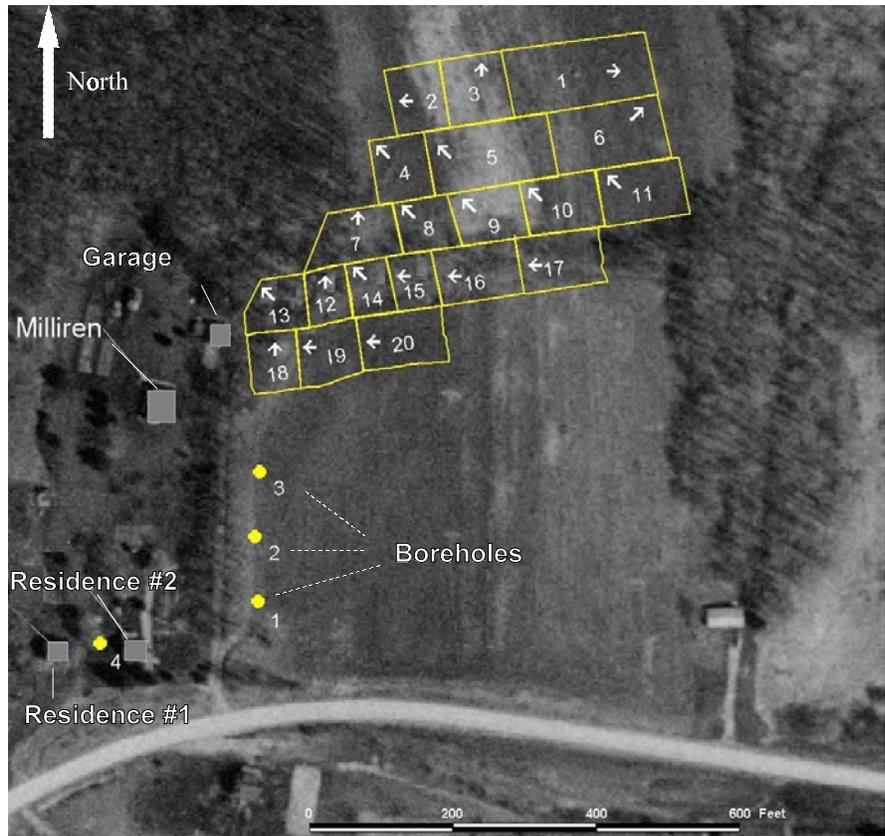
Figure 4 Areal photograph with blast locations in sequence.

Blast Sequencing: Mining operations were advancing toward the Milliren property and, by mid-April, were within 200 feet. On the last two cuts, the blaster generally directed relief away from the Milliren garage to protect the structure. The arrows in each blast on Figure 4 show where the first hole was initiated. Blast #12 was initiated in the center as a typical box cut. Blast #13 was corner initiated prior to excavation of the blast #12 and was the first blast confined with a low-wall to the west. Blast #18 was initiated in the center as a typical box cut. Blast #19 was initiated on the west side adjacent to blast #18 in the center and progressed in a zig-zag pattern to the east (lift shot). Blast #20 was similar. Both #19 and #20 would have a tendency to generate higher internal gas pressures within

the muck pile due to lack of face movement and subsequently force gases into the bedrock. Blasts #15, #16 and #17 were center initiated and also had a potential to contain the fumes. The mine superintendent remarked that most blasts heaved about 8 feet.

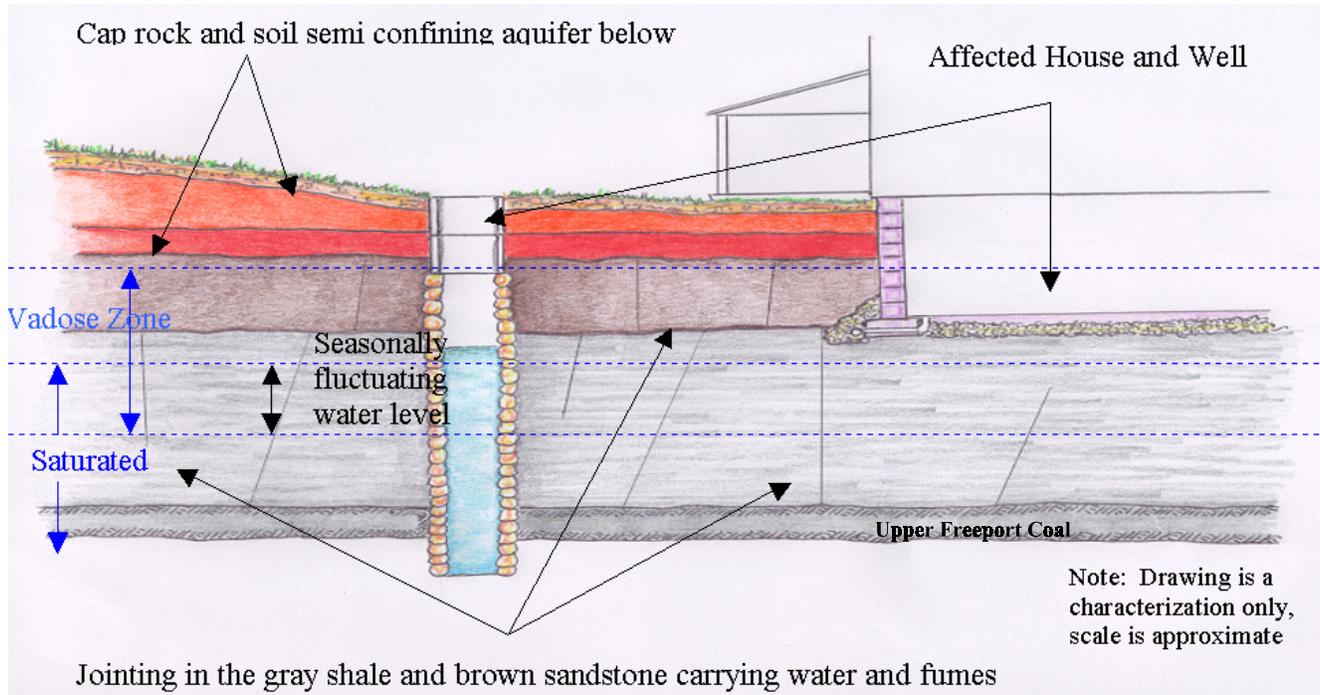
Figure 5 Residence #1 well and basement.

Topographically, the Upper Freeport coalbed truncates the hilltop or crops out around the perimeter of the hilltop. This defines the areal extent of the perched aquifer that feeds the residence #1 well (Figure 5). The aquitard below is the underclay of the coal seam. The sandstone and gray shale immediately above the coal is the saturated zone. The vadose zone (area above the water table through which water percolates from the surface) consists of gray fractured shale and sandstone. From the mineralization evident in the joints of the highwall, the fractured gray shale and sandstone units act as the conduits draining the surface water to the water table. These joints are discontinuous in the brown shale and are poorly developed or partially healed in the weathered rocks in the near surface. Sandstone and shale layers owe much of their permeability and water-bearing capacities to the presence of developed joint sets. Joints generally become less open with depth, this being a low cover site, joints are open.

Figure 5 illustrates how the well relates to the aquifer and residence #1. The well is a sump that collects water and can do the same for gases. The drawing does not show the well cap that covered the well and

prohibited it from venting to the atmosphere. Based on the ER observations the floor drains, through the under drain system of the home, are connected to the well.
