BLAST VIBRATION DAMAGE ASSESSMENT STUDY AND REPORT

**PREPARED FOR:
THE MIAMI-DADE COUNTY BLASTING TASK FORCE**

ASSESSMENT OF BLAST VIBRATION IMPACTS FROM QUARRY BLASTING IN DADE COUNTY

David E. Siskind & Mark S. Stagg

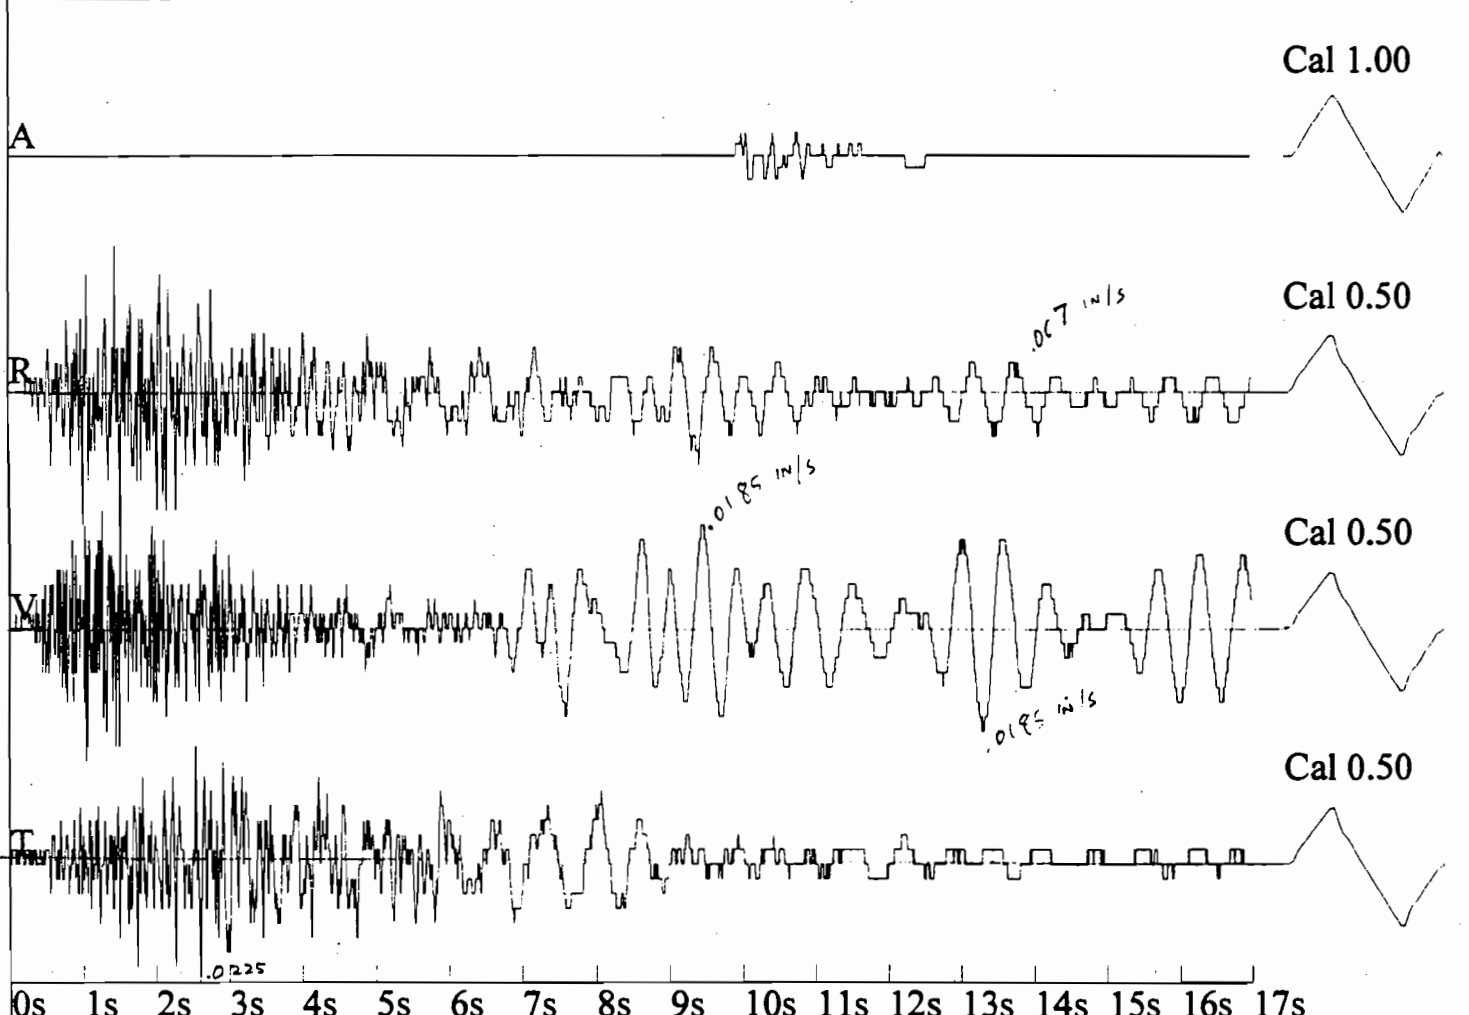
Figure 10 shows the long duration of recordings made at large distances. The amplitude here is low in terms of possible structure cracking but still within the range of producing noticeable structure rattling. The complexity of these waveforms indicates the significant and unpredictable influence of the layered geology and a possible but lesser role for the source function of design and geometry. The frequency complexity is evident by casual inspection. This waveforms start out at relatively high frequencies of 17 to 30 Hz. An 8-Hz

Figure 10.- Long duration vibration waveform record with both high and low frequencies. WRQ Section 7 blast at about 12,700 ft. Palm Springs North.

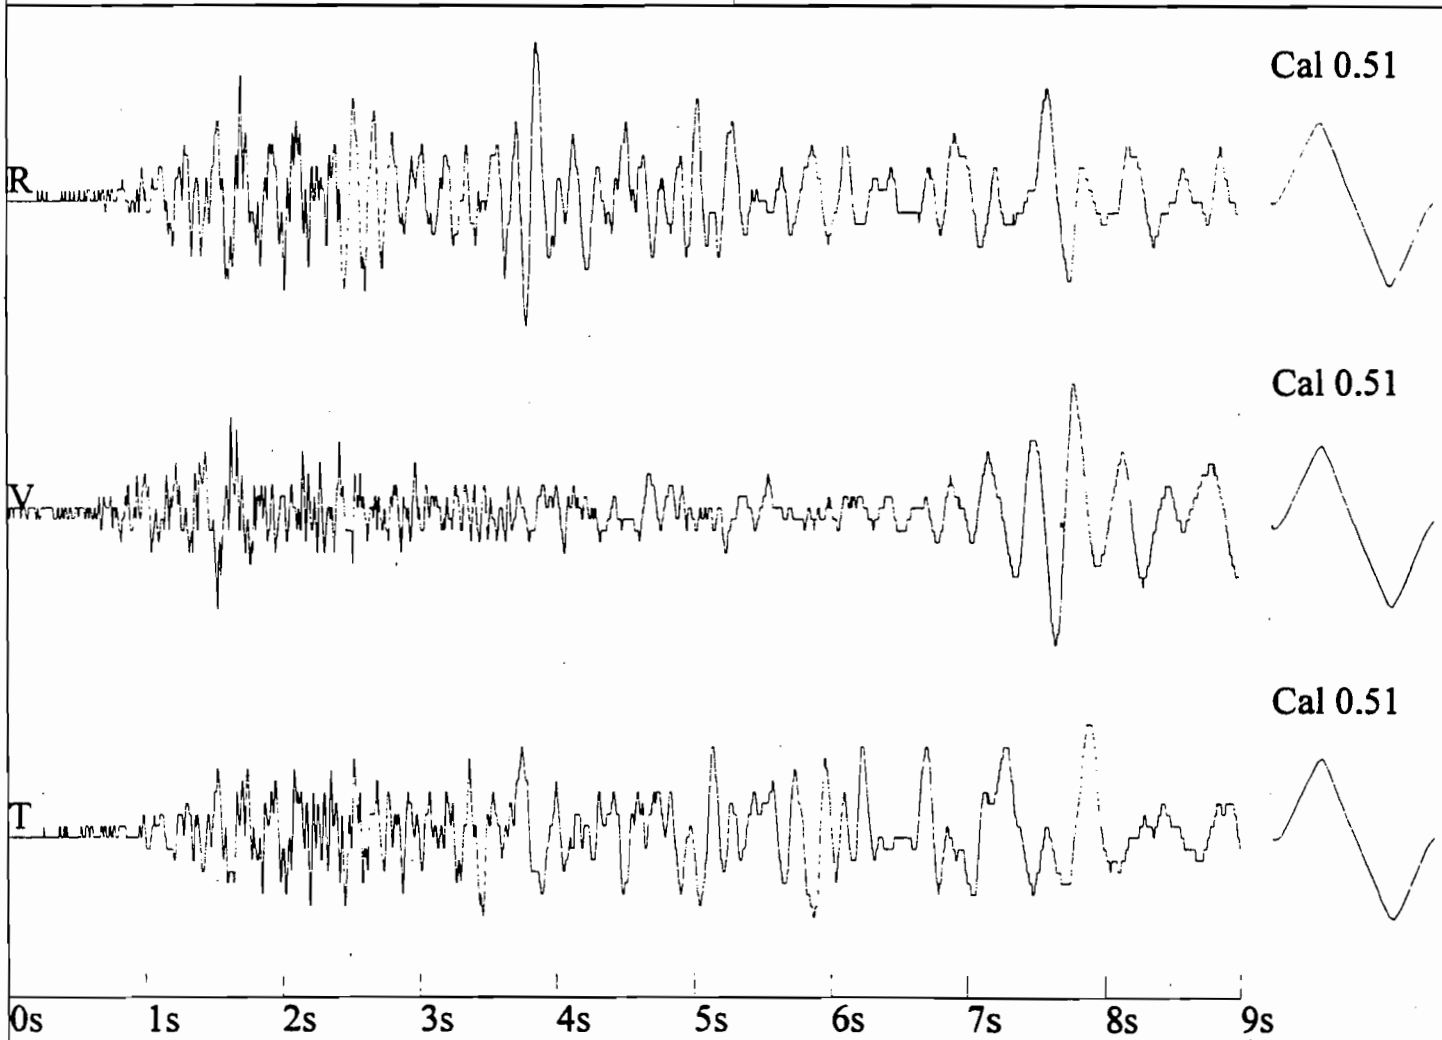
Figure 11.- Ground vibration record from WRQ Section 7 blast 15,500 ft from House 15.

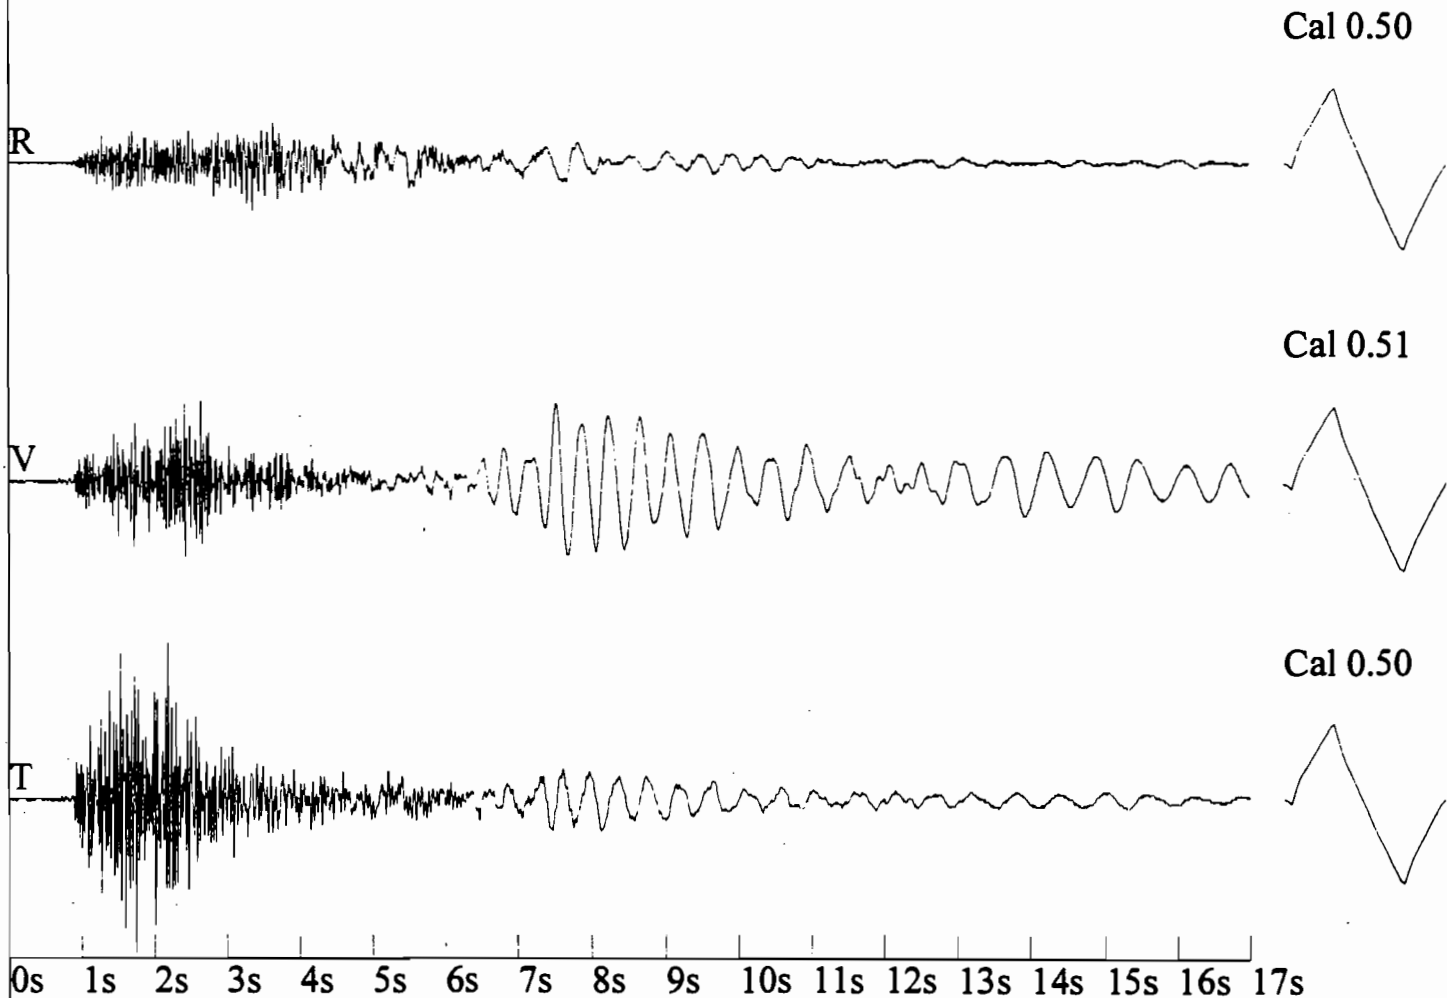
Figure 12.- Long-duration vibration waveform record with both high and low frequencies. Florida rock blast at about 10,900 ft. Shoma Homes area.

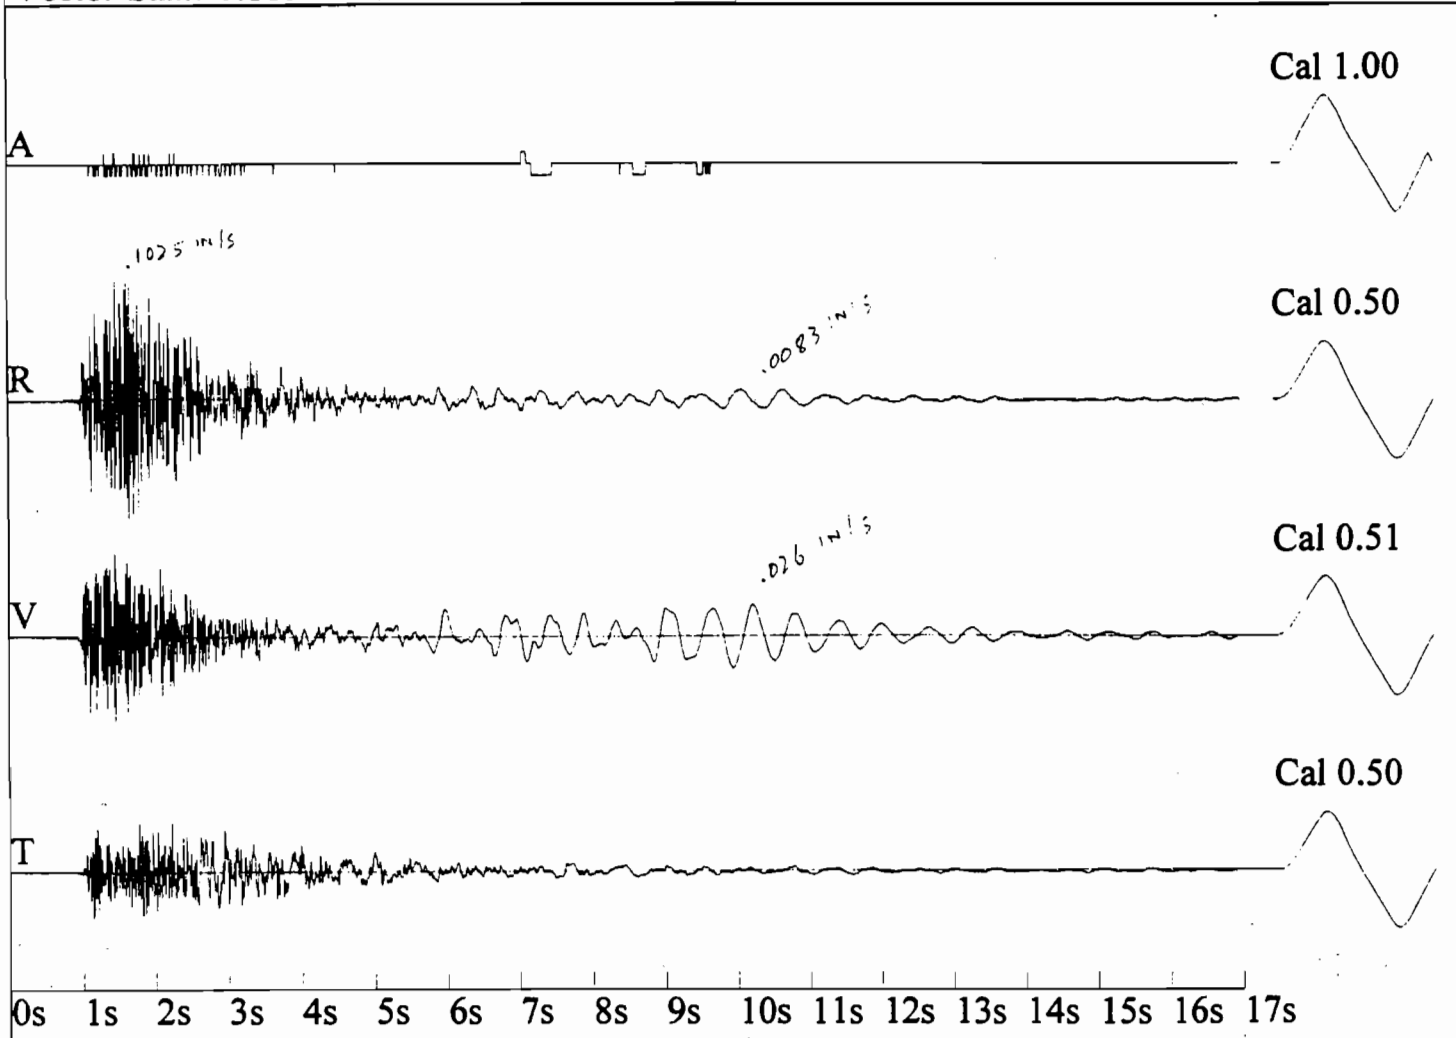
Figure 13.- Highest vibration record from monitoring at House 42. This is a Miami crushed Rock blast at 8,100 ft.

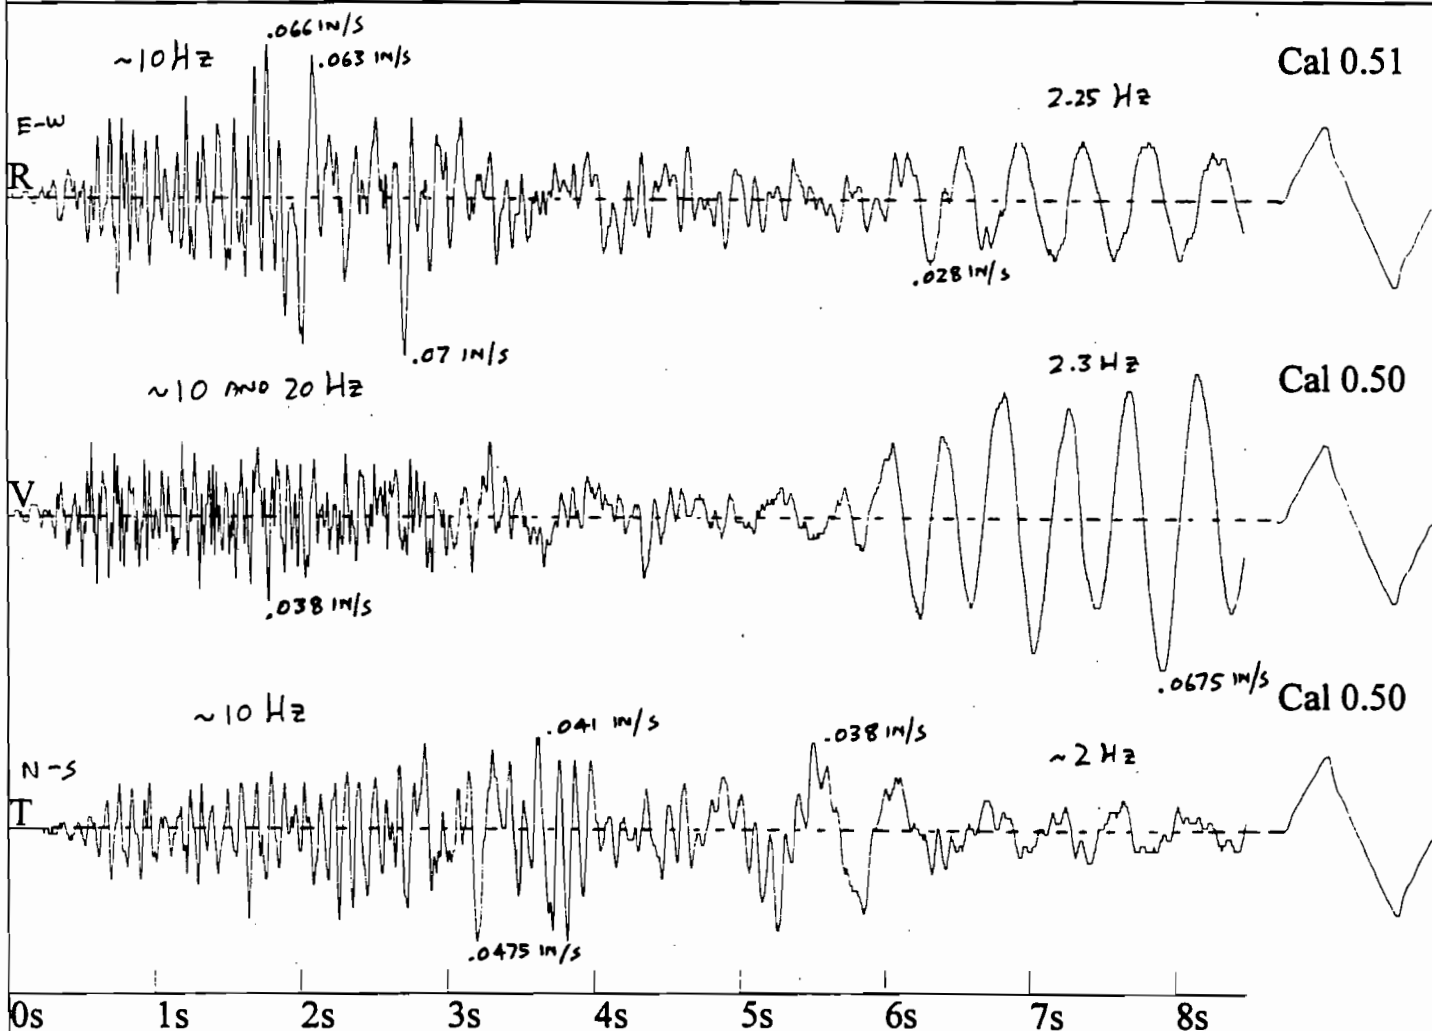
Figure 14.- Highest vibration record from monitoring at House 6. WRQ
Section 7 blast at about 12,600 ft.

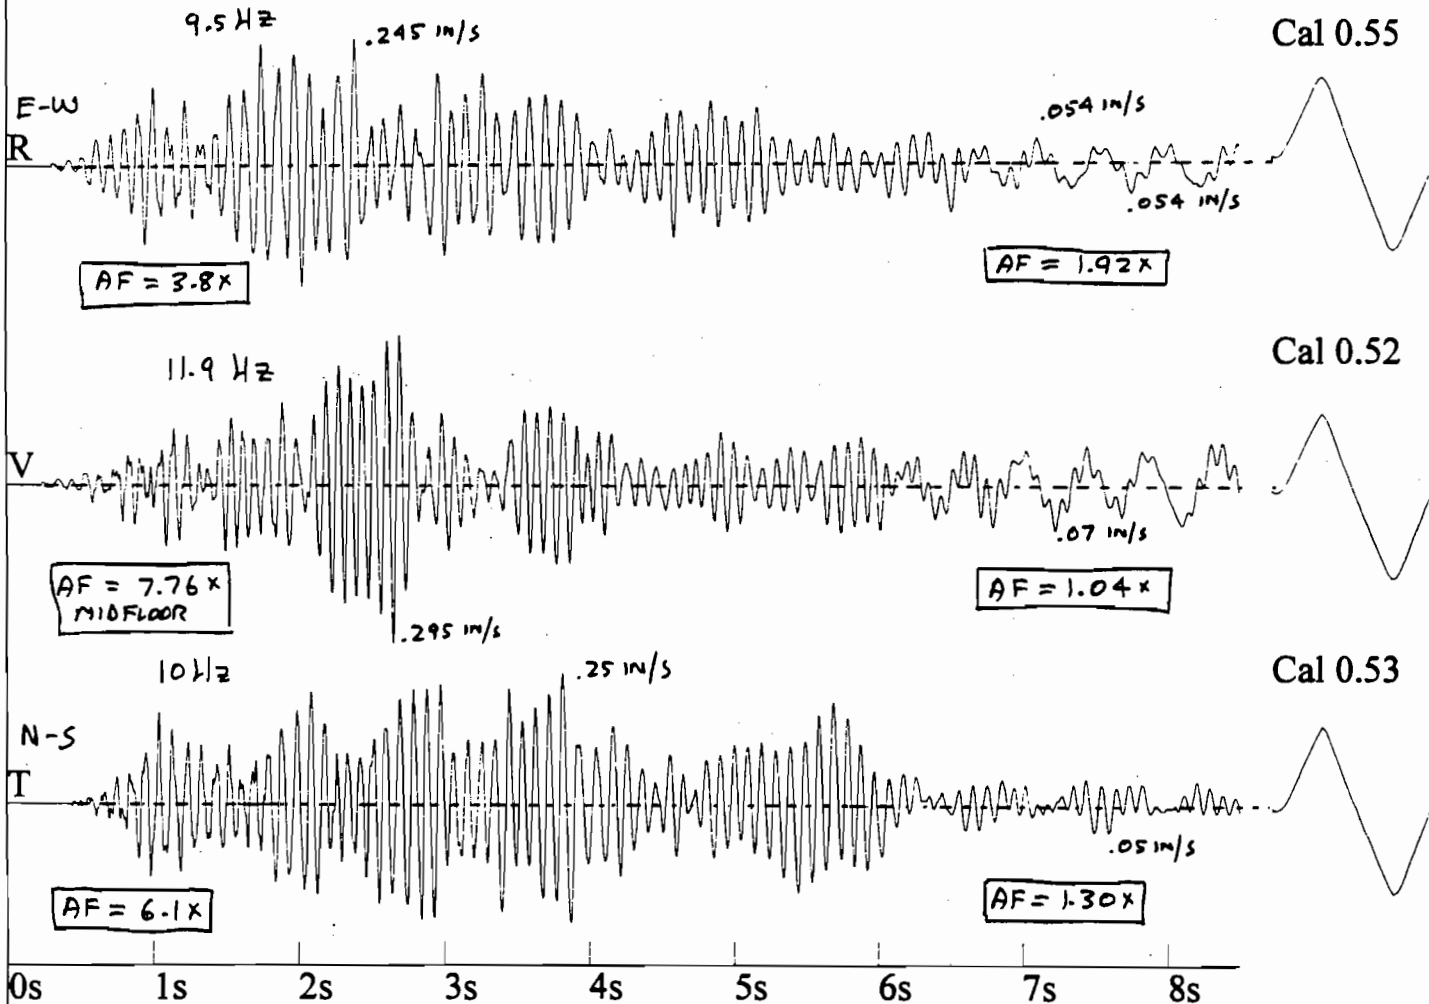
Figure 15.- Structure response record for House 6 from the same blast shown in Figure 14.

House 6: Most significant for two-story house were the large dynamic amplifications of horizontal vibrations 3.8x (E-W) and 6.1x (N-S) at the "higher" frequencies of 9 to 10 Hz. Previous non-Florida USBM data for amplifications found averages of about 2x and maximums of 4.3x. These responses are high, even without even knowing if the exact resonant frequencies were experienced and if these are the highest responses possible.

Approximating the $\sin\phi\cos\phi$ function as 0.5, the high frequency and low frequency responses are 31 and 42 $\mu\varepsilon$, respectively for House 6. These are sufficiently below the minimum masonry cracking thresholds of 100 $\mu\varepsilon$ to not be a possibility. Higher vibrations and/or higher responses could, however, be a problem. House 13 has lower amplifications, less displacement and hence less strain.

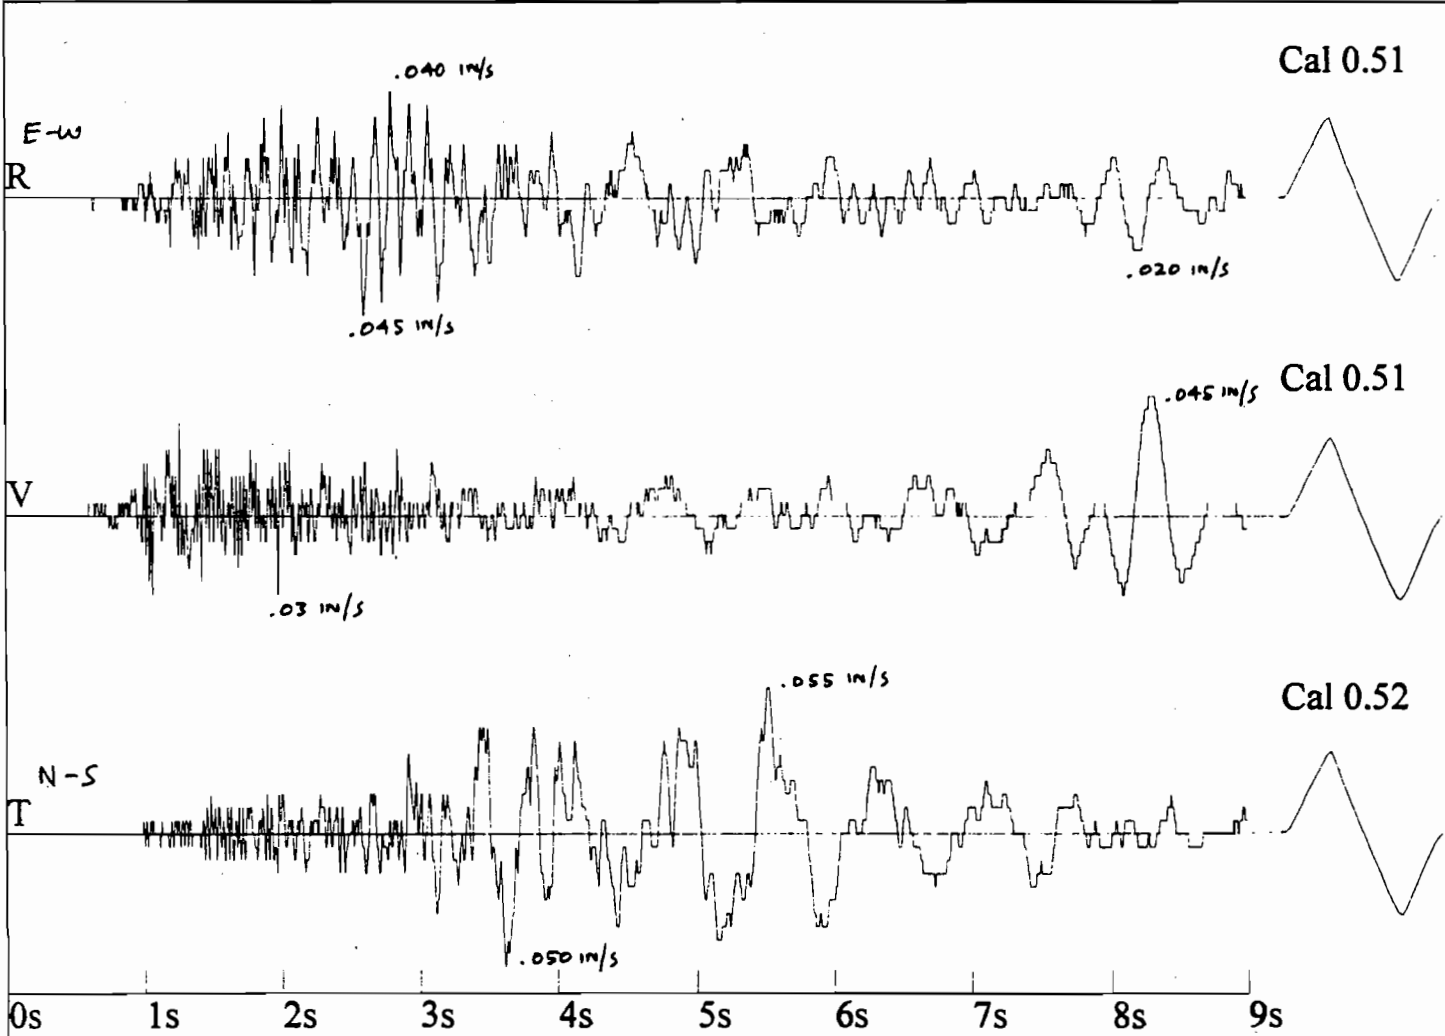
Figure 16.- Vibration record from monitoring at House 13 when structure response was also recorded (Figure 17). WRQ Section 7 blast at about 13,900 ft.

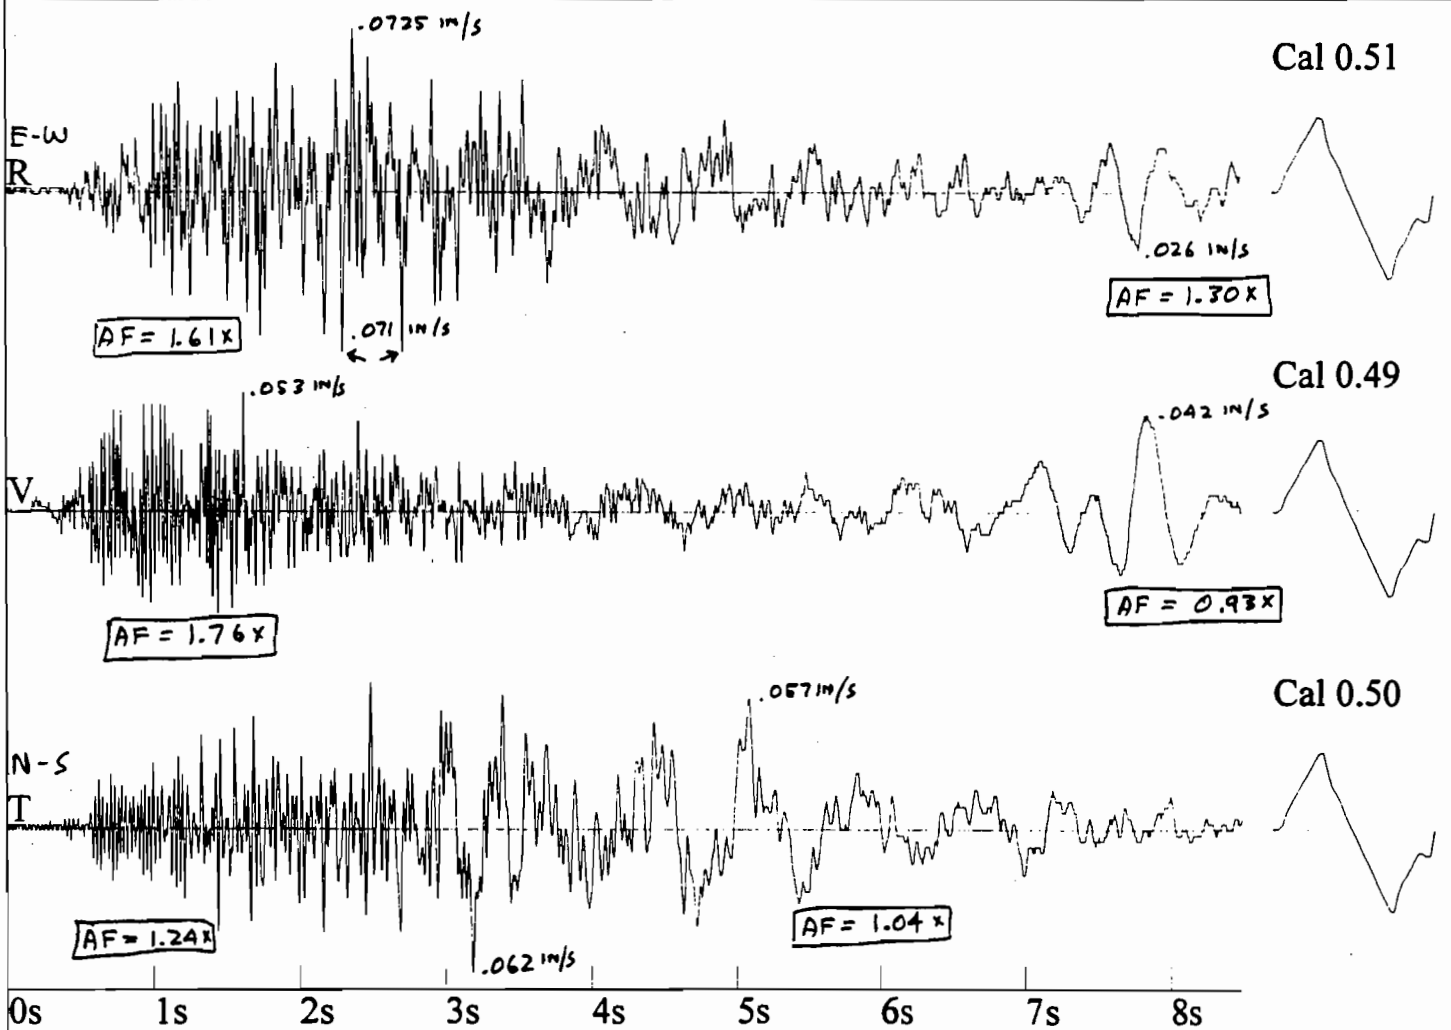
Figure 17.- Structure response record for House #13 from the same blast shown in Figure 16.

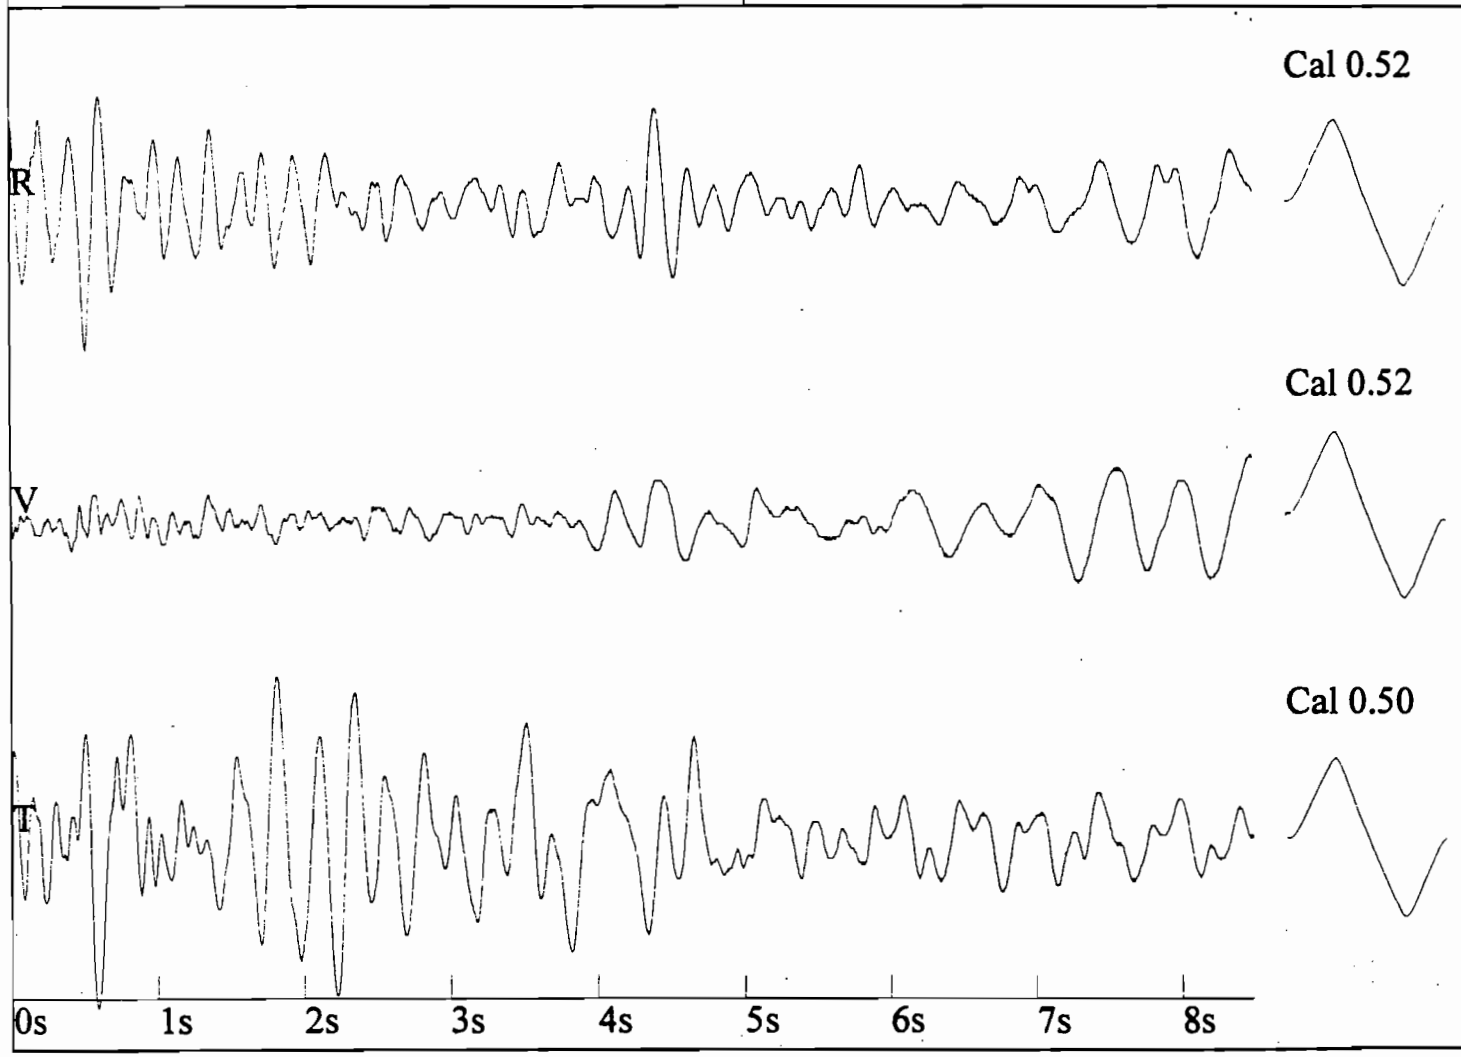
Figure 18.- Highest structure response record from House 11.

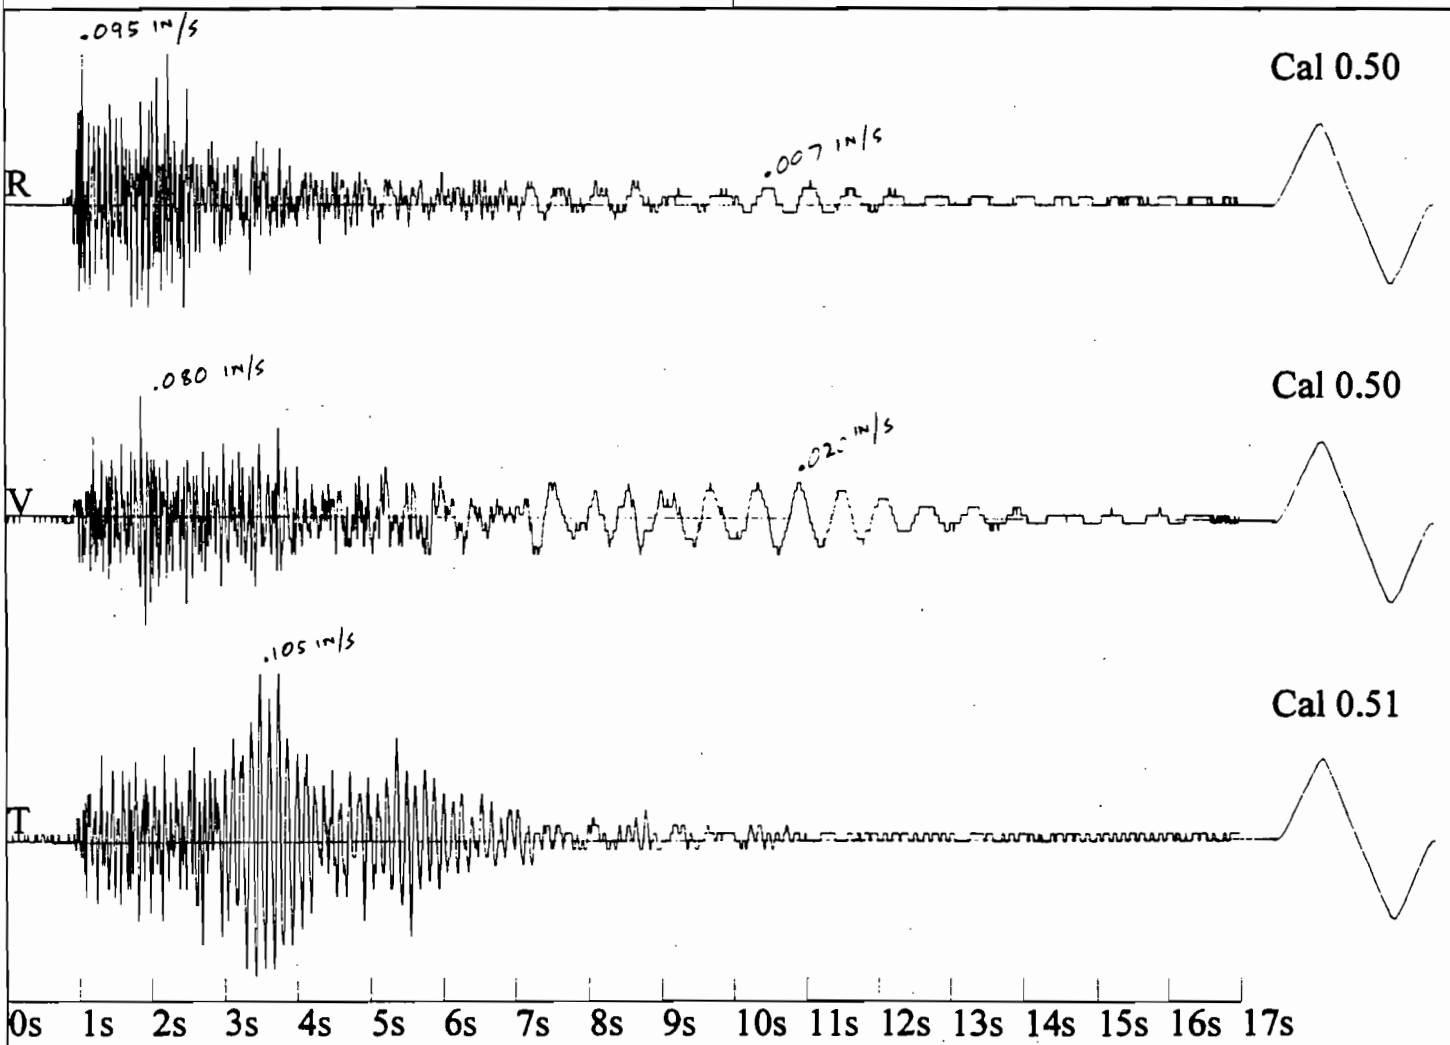
Figure 19.- Structure response waveforms corresponding to the ground vibration in Figure 13.

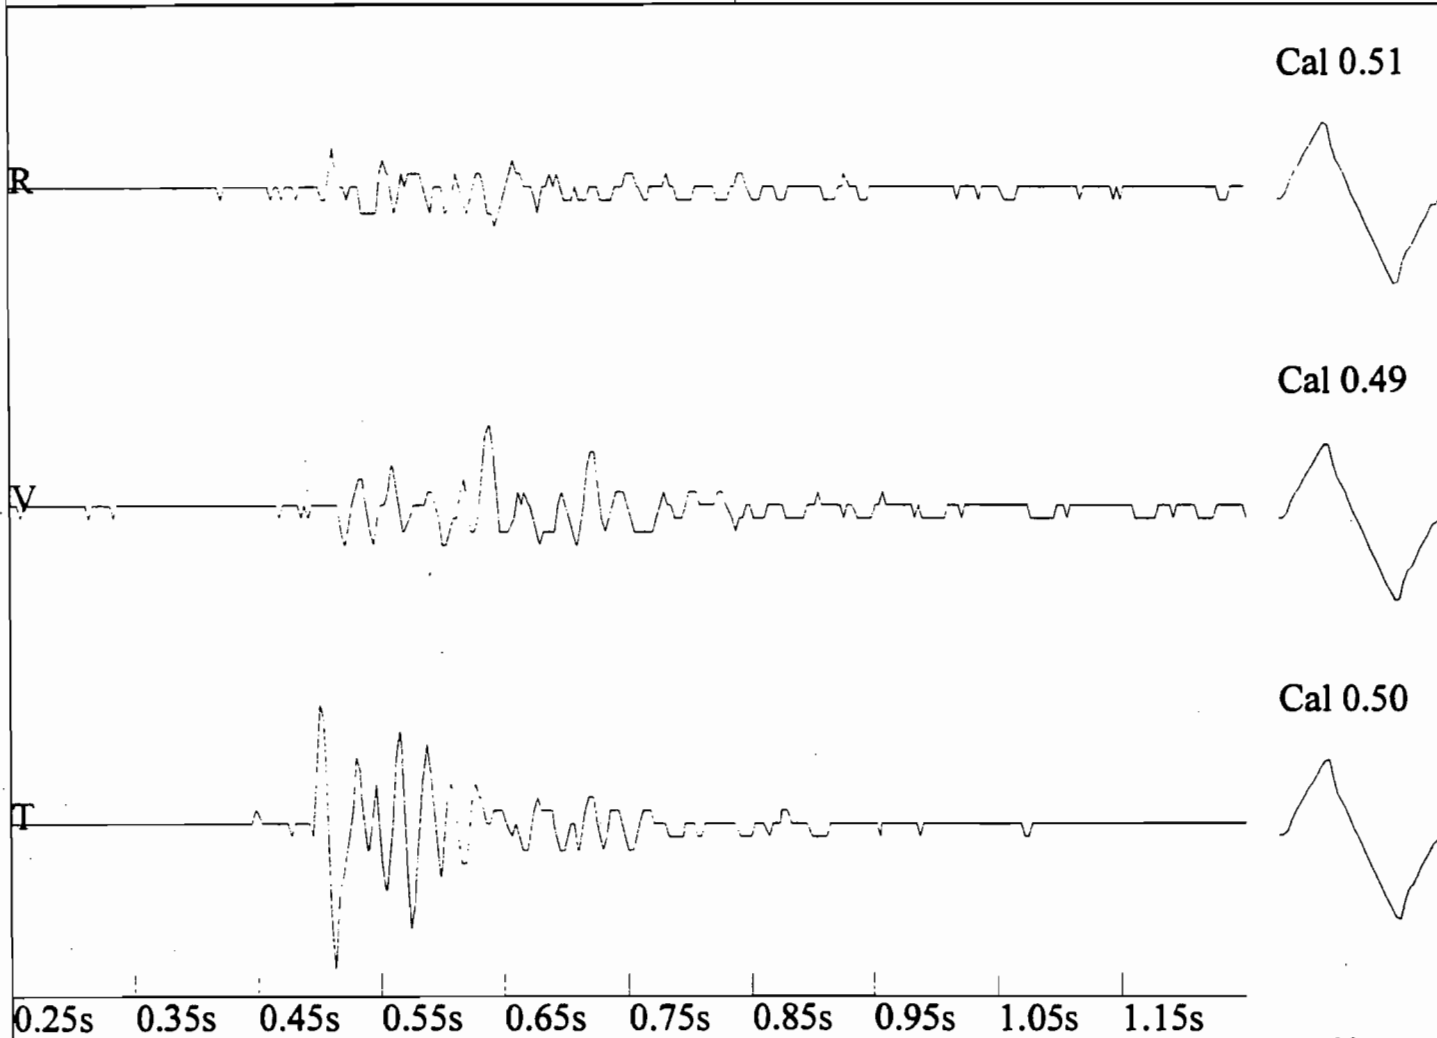
Figure 20.- Non-blast structure response event recorded at House 13. Note that the time scale has been expanded and that frequencies are relatively high.

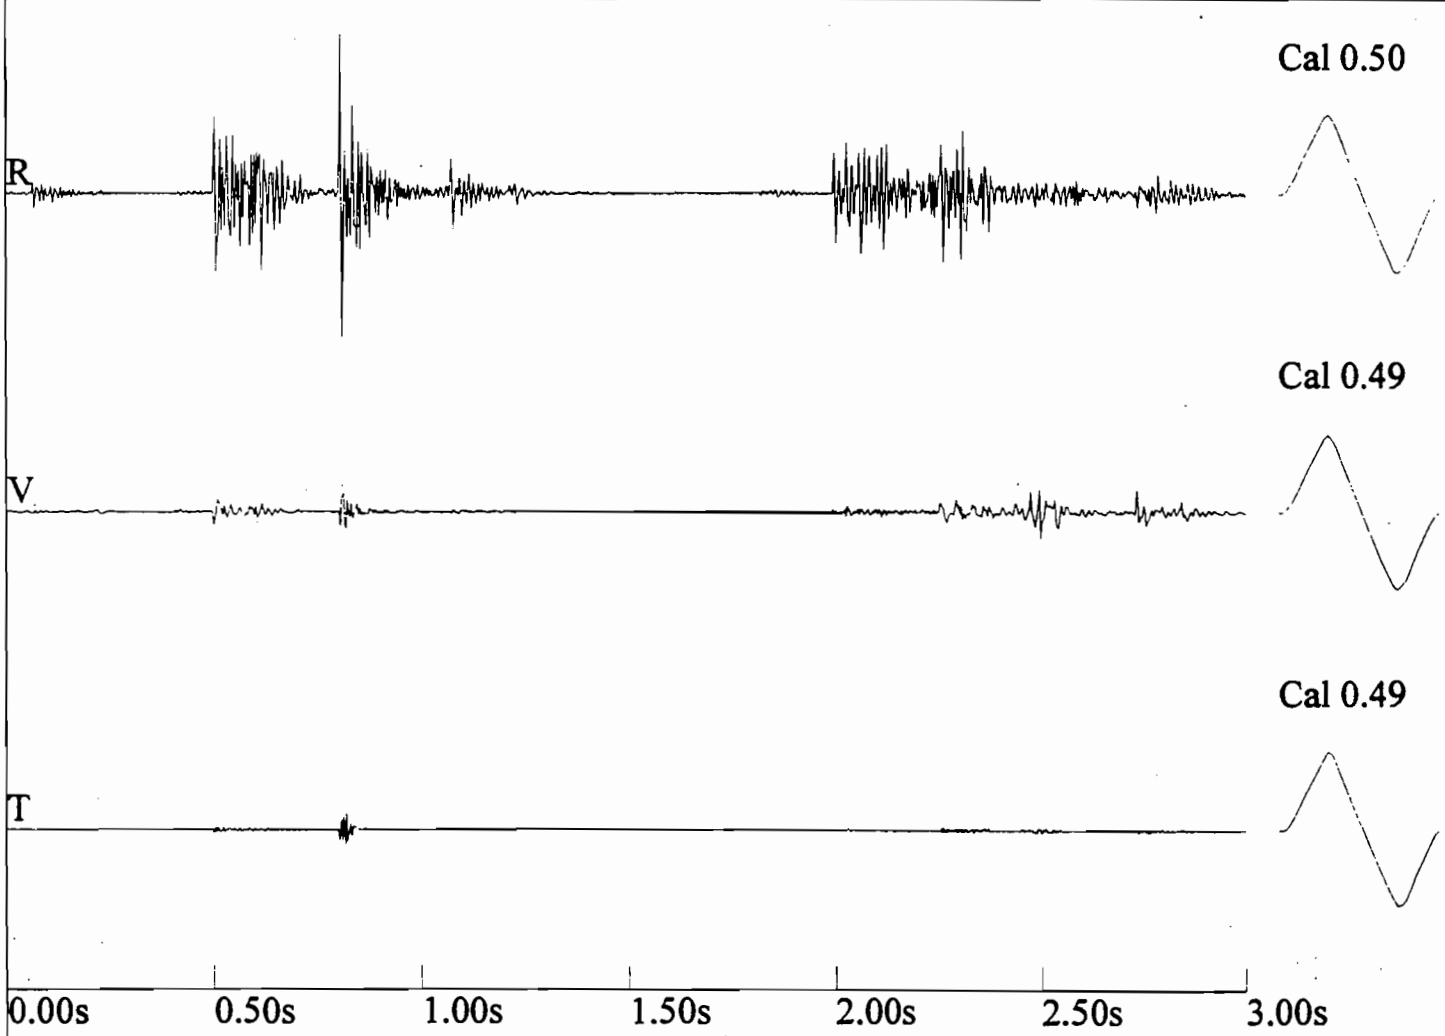
Figure 21.- Non-blast structure response event recorded at House 12. Note that the time scale has been expanded and that frequencies are relatively high.

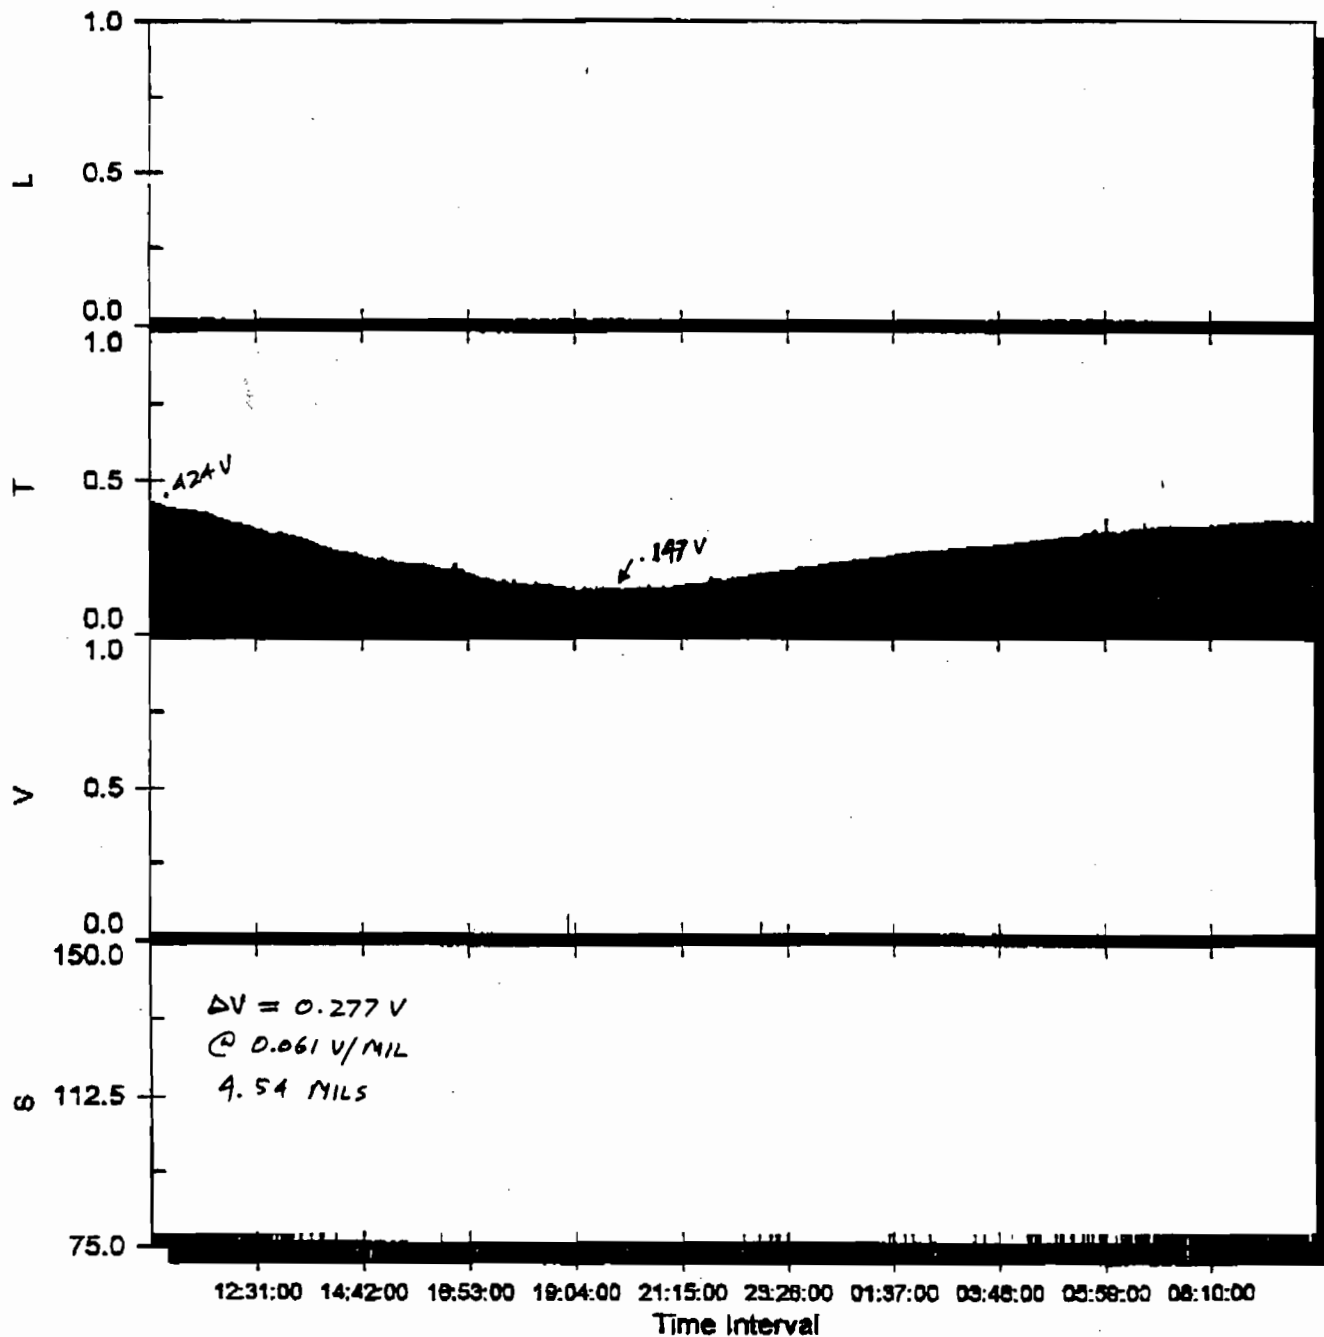
Figure 22.- Thermal response of garage wall crack in House 4. All the long-term measurements had 24-hour cycles. The difference between high and low of 0.277 volts corresponds to a crack width change of 4.54 mils.
