MEMORANDUM

TO:	Monica McQuillan, REP, Energy Transfer		
FROM:	Timothy D. Bechtel, PhD, PG, RETTEW Associates, Inc.		
DATE:	March 23, 2022		
PROJECT NAME:	Energy Transfer Mariner East 2	PROJECT NO.:	096303002
SUBJECT:	W-B71 (Library Bore) Summary of Geophysical and Geotechnical Investigations and Results

TO:	Monica Styles, REP, Energy Transfer		
FROM:	David M. Anderson, PG and Timothy D. Bechtel, PhD, PG, RETTEW Associates, Inc.		
DATE:	September 22, 2021, Revised January 20, 2022		
PROJECT NAME:	Energy Transfer Mariner East 2	PROJECT NO.:	096303002
SUBJECT:	W-B71 (Library Bore) Response to PA DEP NOV's Item 2

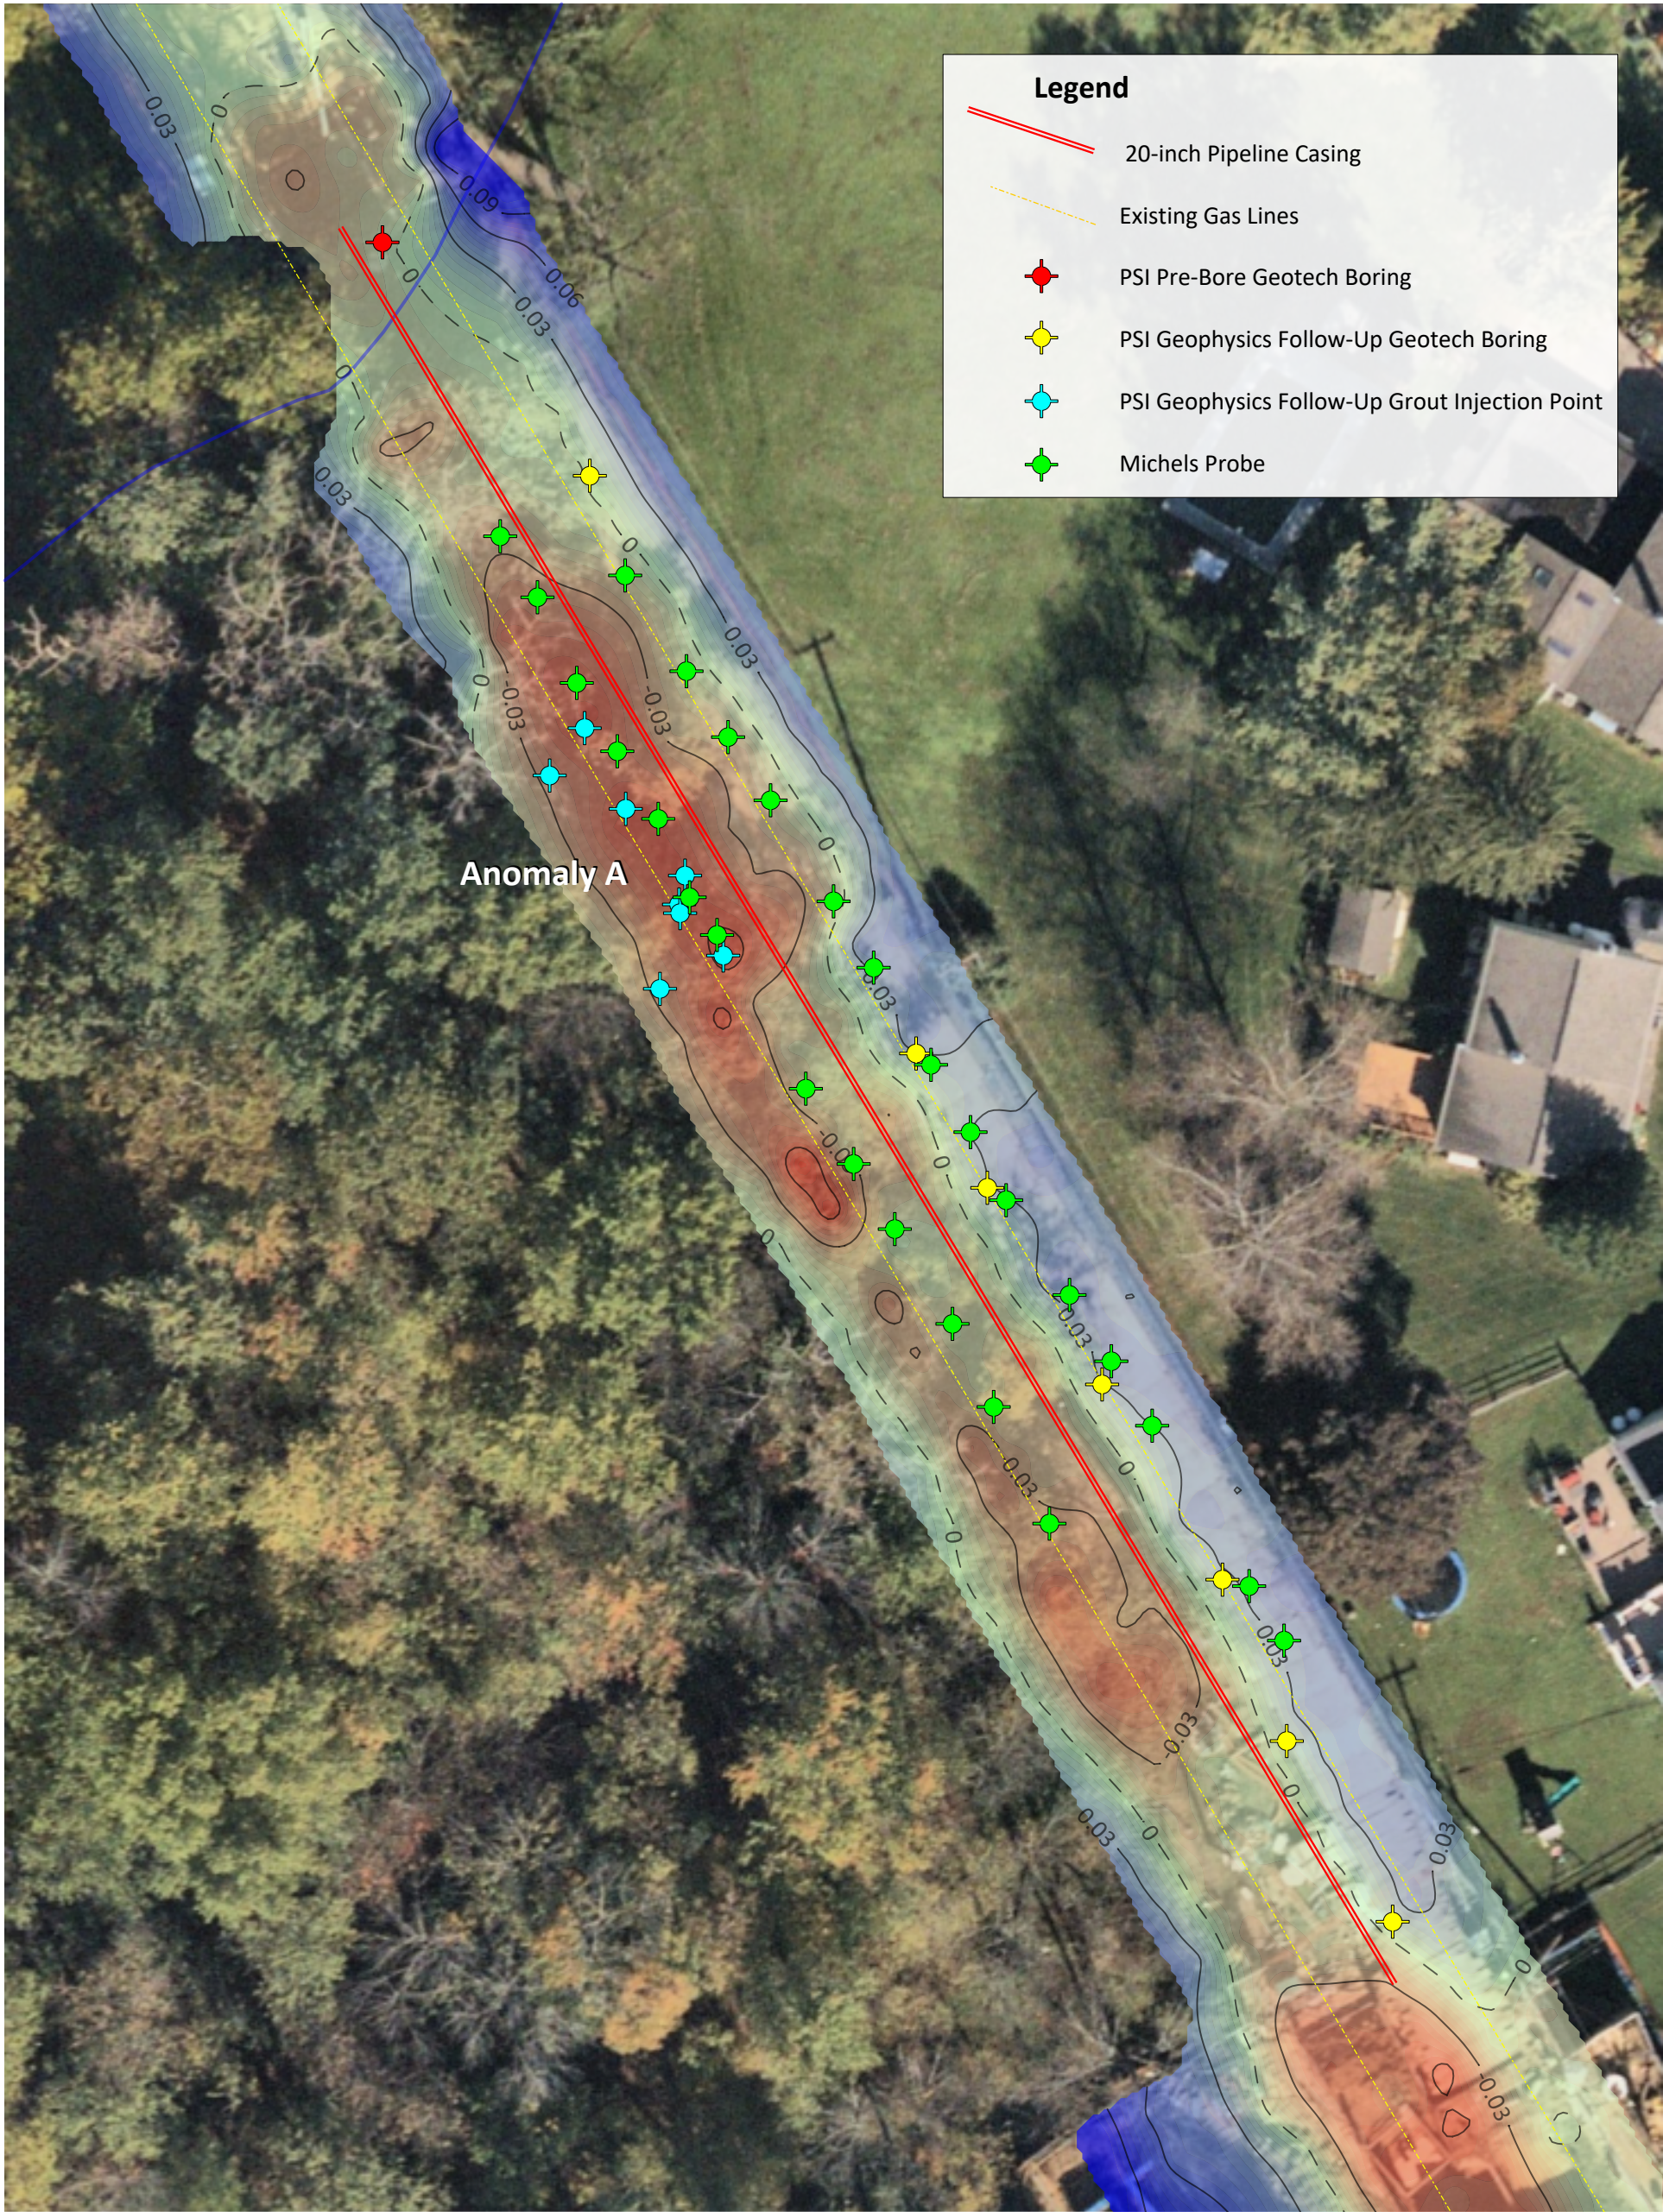
Figure 1: Boring Locations

The mapped geology and karstic conditions were confirmed prior to commencement of the bore by four geotechnical borings by Professional Service Industries, Inc. (PSI) in February 2020 and Geostructures (commissioned by Chester County) in December 2020 (see **Appendix A** timeline) and 27 top-of-rock probes by Michels (the boring contractor) – see **Figure 1**. The borings in these investigations revealed an irregular (pinnacled) top-of-rock, locally highly fractured dolomite, and a few soil- or water-filled voids with vertical dimensions up to two feet. No open (air-filled) voids were reported. RETTEW also performed a pre-bore geophysical survey in July 2020, and a follow-up re-survey in August 2020. The July 2020 survey detected a low-gravity zone, with an associated low-resistivity feature at depth (below the water table) which was labeled as Anomaly A. The August 2020 survey was performed to confirm the presence of this anomaly and check for any changing conditions. The anomaly was confirmed and no significant changes were observed. As a precaution, RETTEW recommended geotechnical investigation of this anomaly, with pressure grouting to treat karstic conditions. PSI performed 15 geotechnical borings in December 2020 with 8 (in the footprint of Anomaly A) used as grout injection points. Grouting was performed in these at 2-foot intervals and a pressure of 50 PSI. Total grout takes ranged from 0.09 to 0.5 cubic yards, with an average for the eight borings of 0.27 cubic yards. The boring locations (that fall within the bore path construction window) are shown on **Figure 1**.

The earth features were all remediated by excavating and filling with flowable fill following the guidance in the “Void Mitigation Plan for Karst Terrain”. In addition, a series of borings was completed in and around anomalies identified by the geophysical surveys. Grout was injected into the borings within Anomaly A to remediate these potential areas where subsidence might occur. The locations of these borings are shown on **Figure 1**.

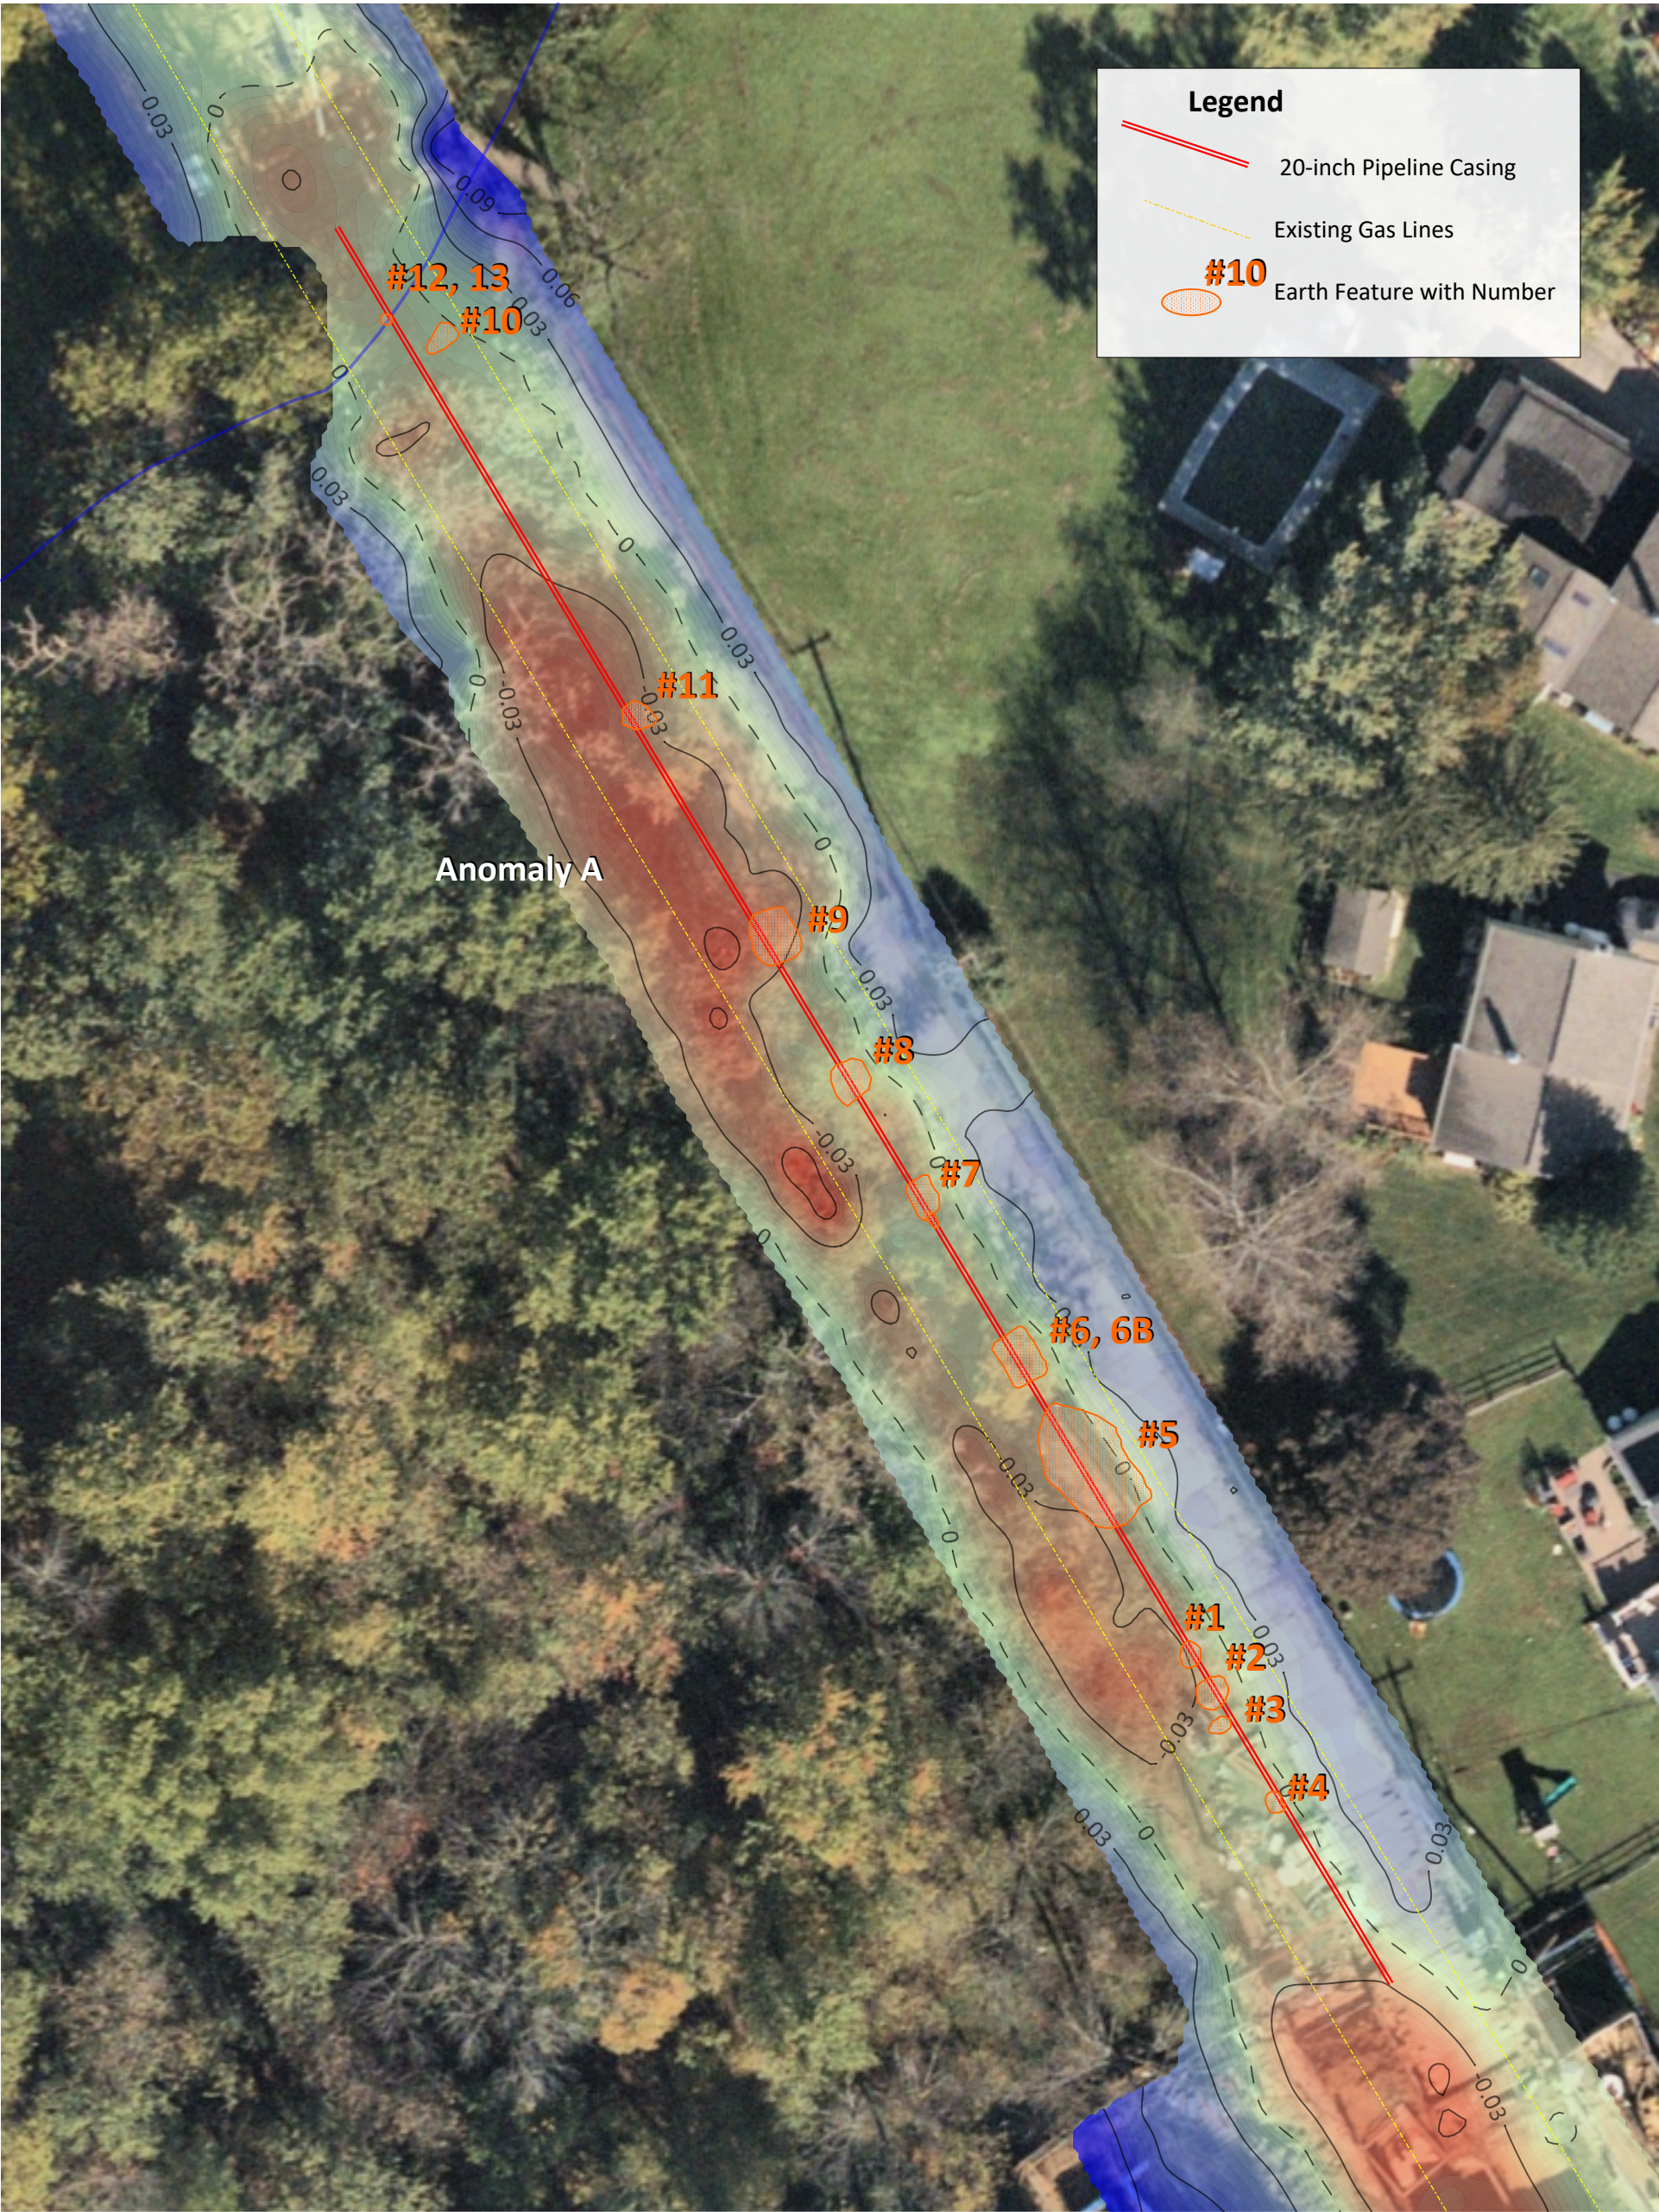
Figure 2: Earth Feature Locations and Numbers

During boring, 14 subsidence features developed (see **Figure 2** and the timeline in **Appendix A**). These features were also described in a memo dated (revised) January 20, 2022 (see **Appendix B**). As detailed in the **Appendix B** memo, a review of these events indicates ongoing boring activity itself is not an accurate predictor or indicator of a potential subsidence event

Following completion of the W-B71 bore, RETTEW completed a multi-technique geophysical survey at the site. The purpose of the survey was to detect changes in the shallow subsurface that could precede development of potential earth features at the site. The fieldwork was completed in November 2021 and the final report is dated December 14, 2021. The survey area extended from the north/upstream entry to the south/downstream entry and included the area of the late August/early September subsidence events. The flow in the Valley Creek tributary was low enough that measurements ran across the streambed. The geophysics survey did not detect or identify any significant issues in the streambed. The results of the microgravity survey are shown on the **Figure 1** Boring Map and the **Figure 2** Earth Features Map.

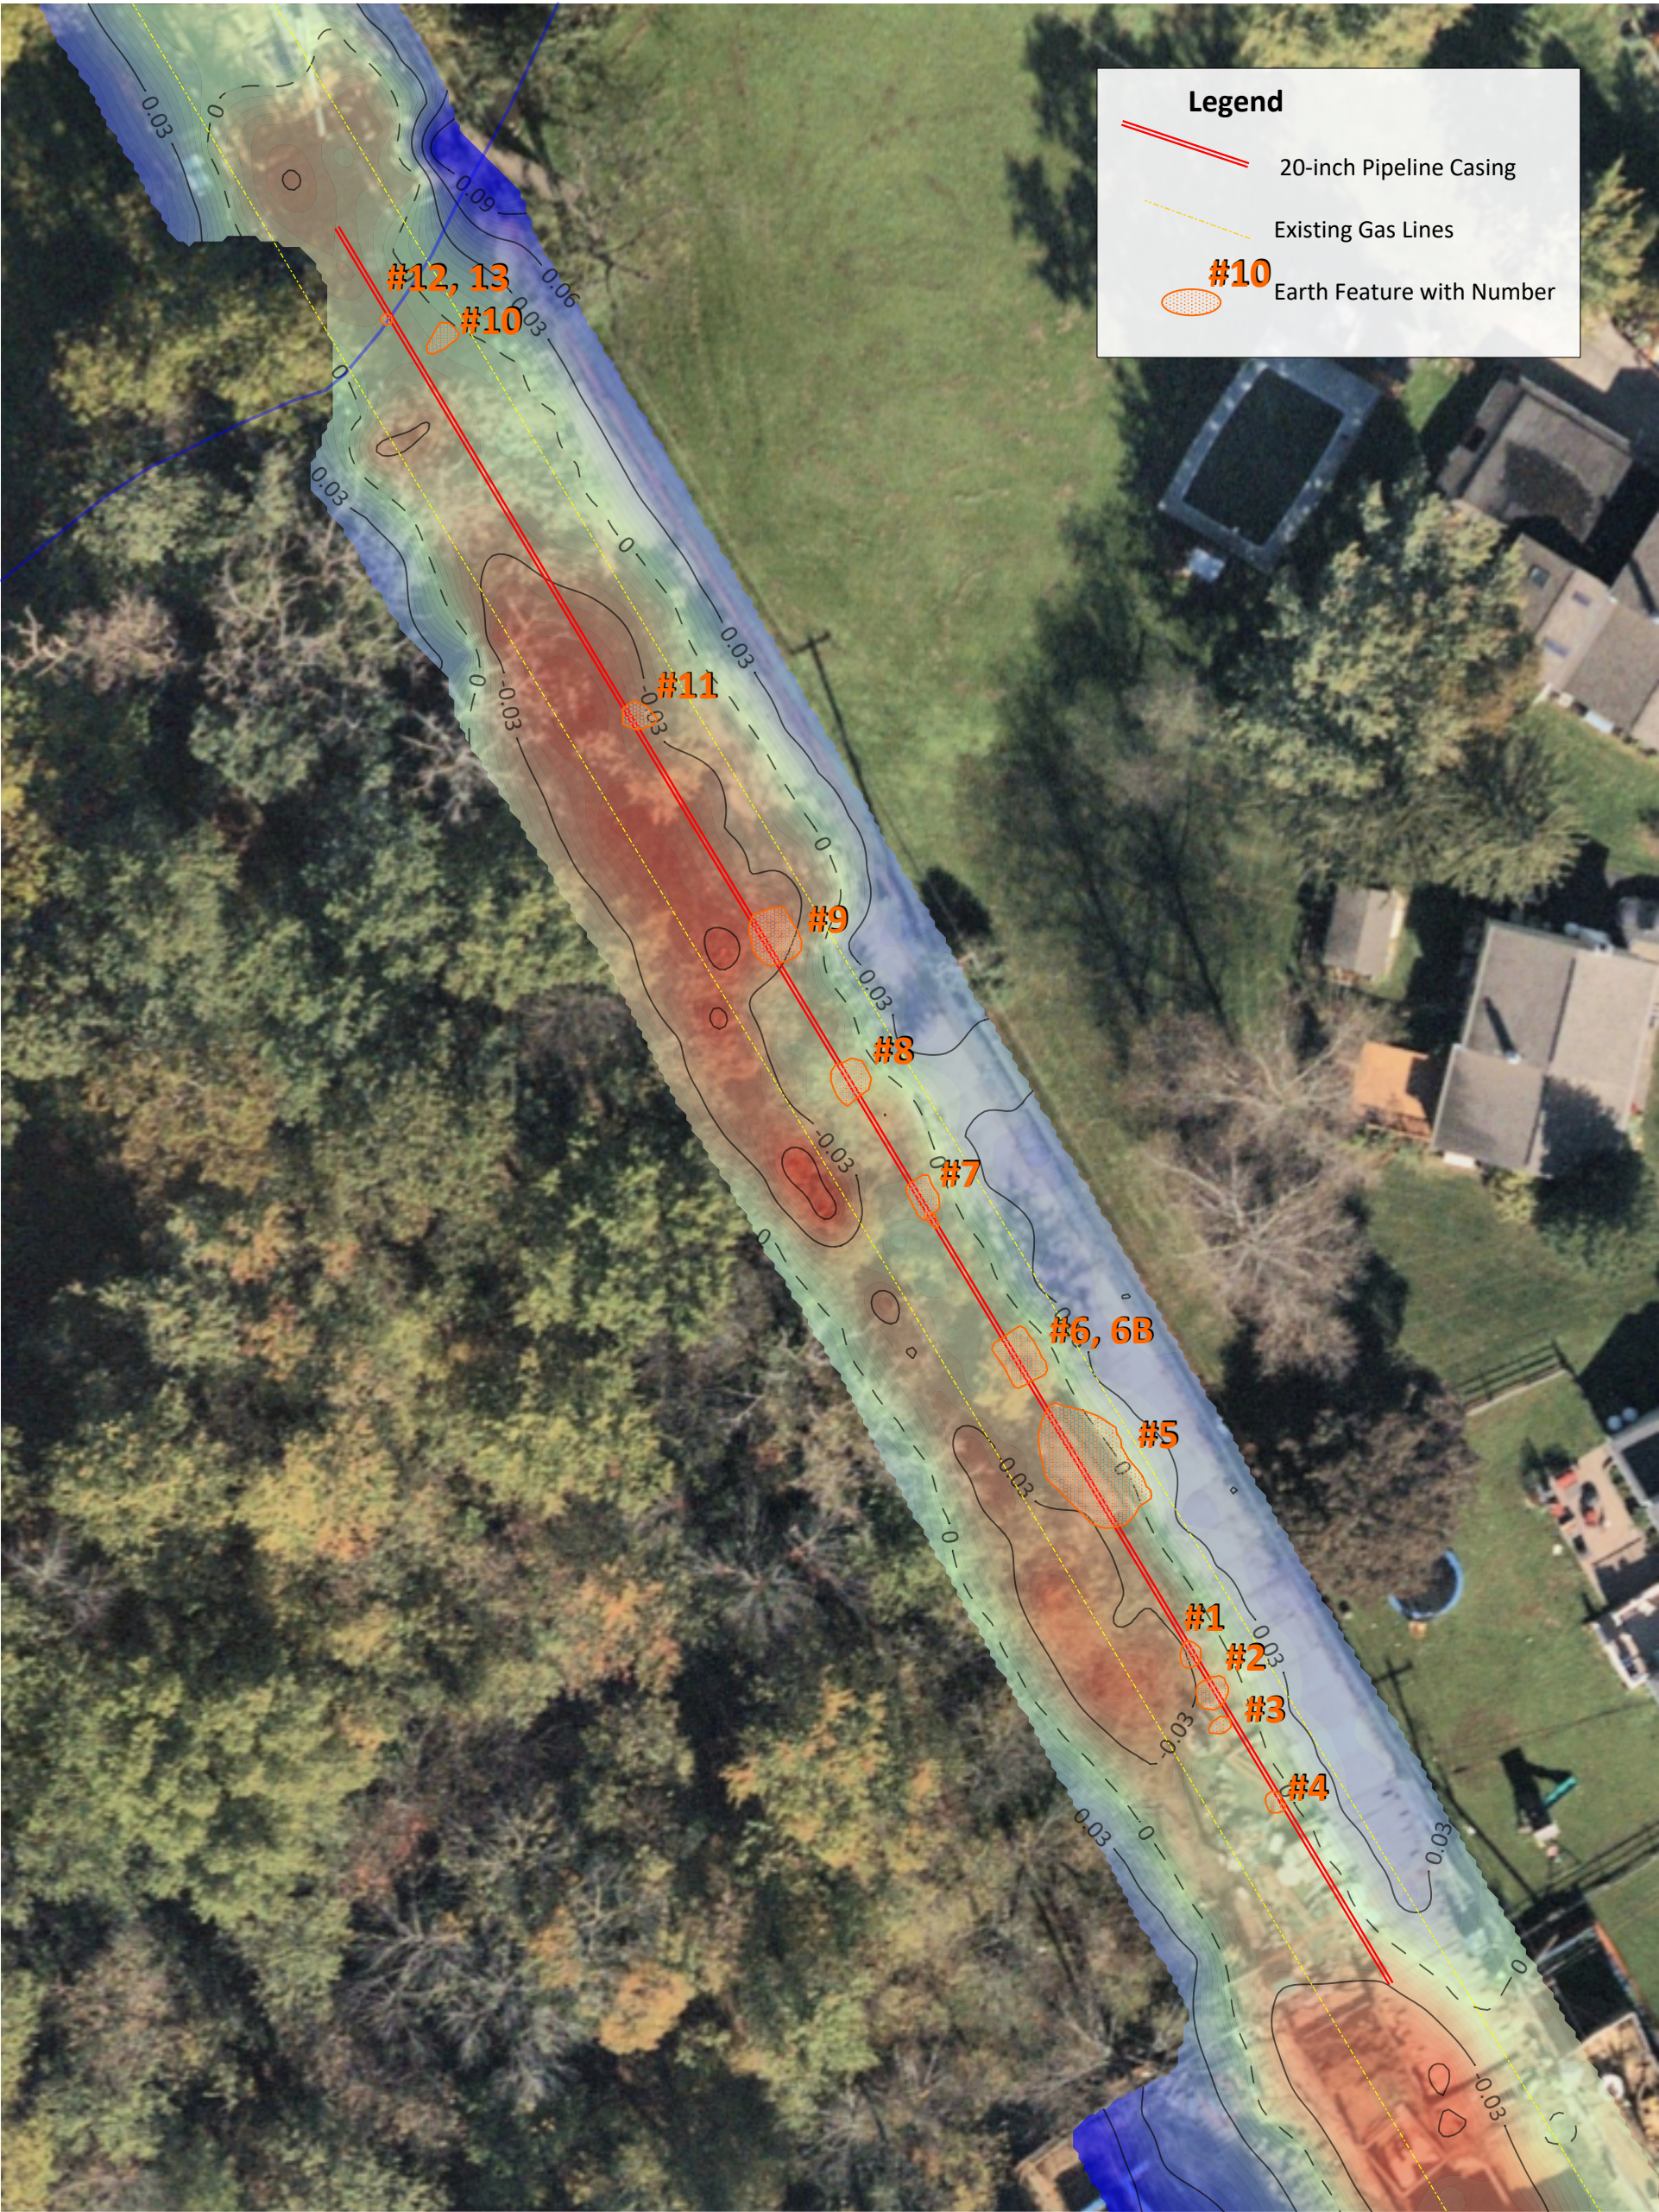
Figure 1: Earth Feature Locations and Numbers

There have been fourteen subsidence features develop at the Library Bore site since February 2021 (see **Figure 1** and **Table 1**). A review of these events indicates ongoing boring activity itself is not an accurate predictor or indicator of a potential subsidence event. The following is a summary of the site activity at the time a subsidence event occurred:

Following completion of the W-B71 bore, RETTEW completed a multi-technique geophysical survey at the site. The purpose of the survey was to detect changes in the shallow subsurface that could precede development of potential earth features at the site. The fieldwork was completed in November 2021 and the final report is dated December 14, 2021. The survey area extended from the north/upstream entry to the south/downstream entry and included the area of the late August/early September subsidence events. The flow in the Valley Creek tributary was low enough that measurements ran across the streambed. The geophysics survey did not detect or identify any significant issues in the streambed. The results of the microgravity survey are shown on the **Figure 1** Earth Features map.

The earth features were all remediated by excavating and filling with flowable fill following the guidance in the "Void Mitigation Plan for Karst Terrain". In addition, a series of boring were completed in and around anomalies identified by a geophysical survey. Grout was injected into the boring to remediate these potential areas where subsidence might occur. The locations of these boring are show on the Figure 1 map.

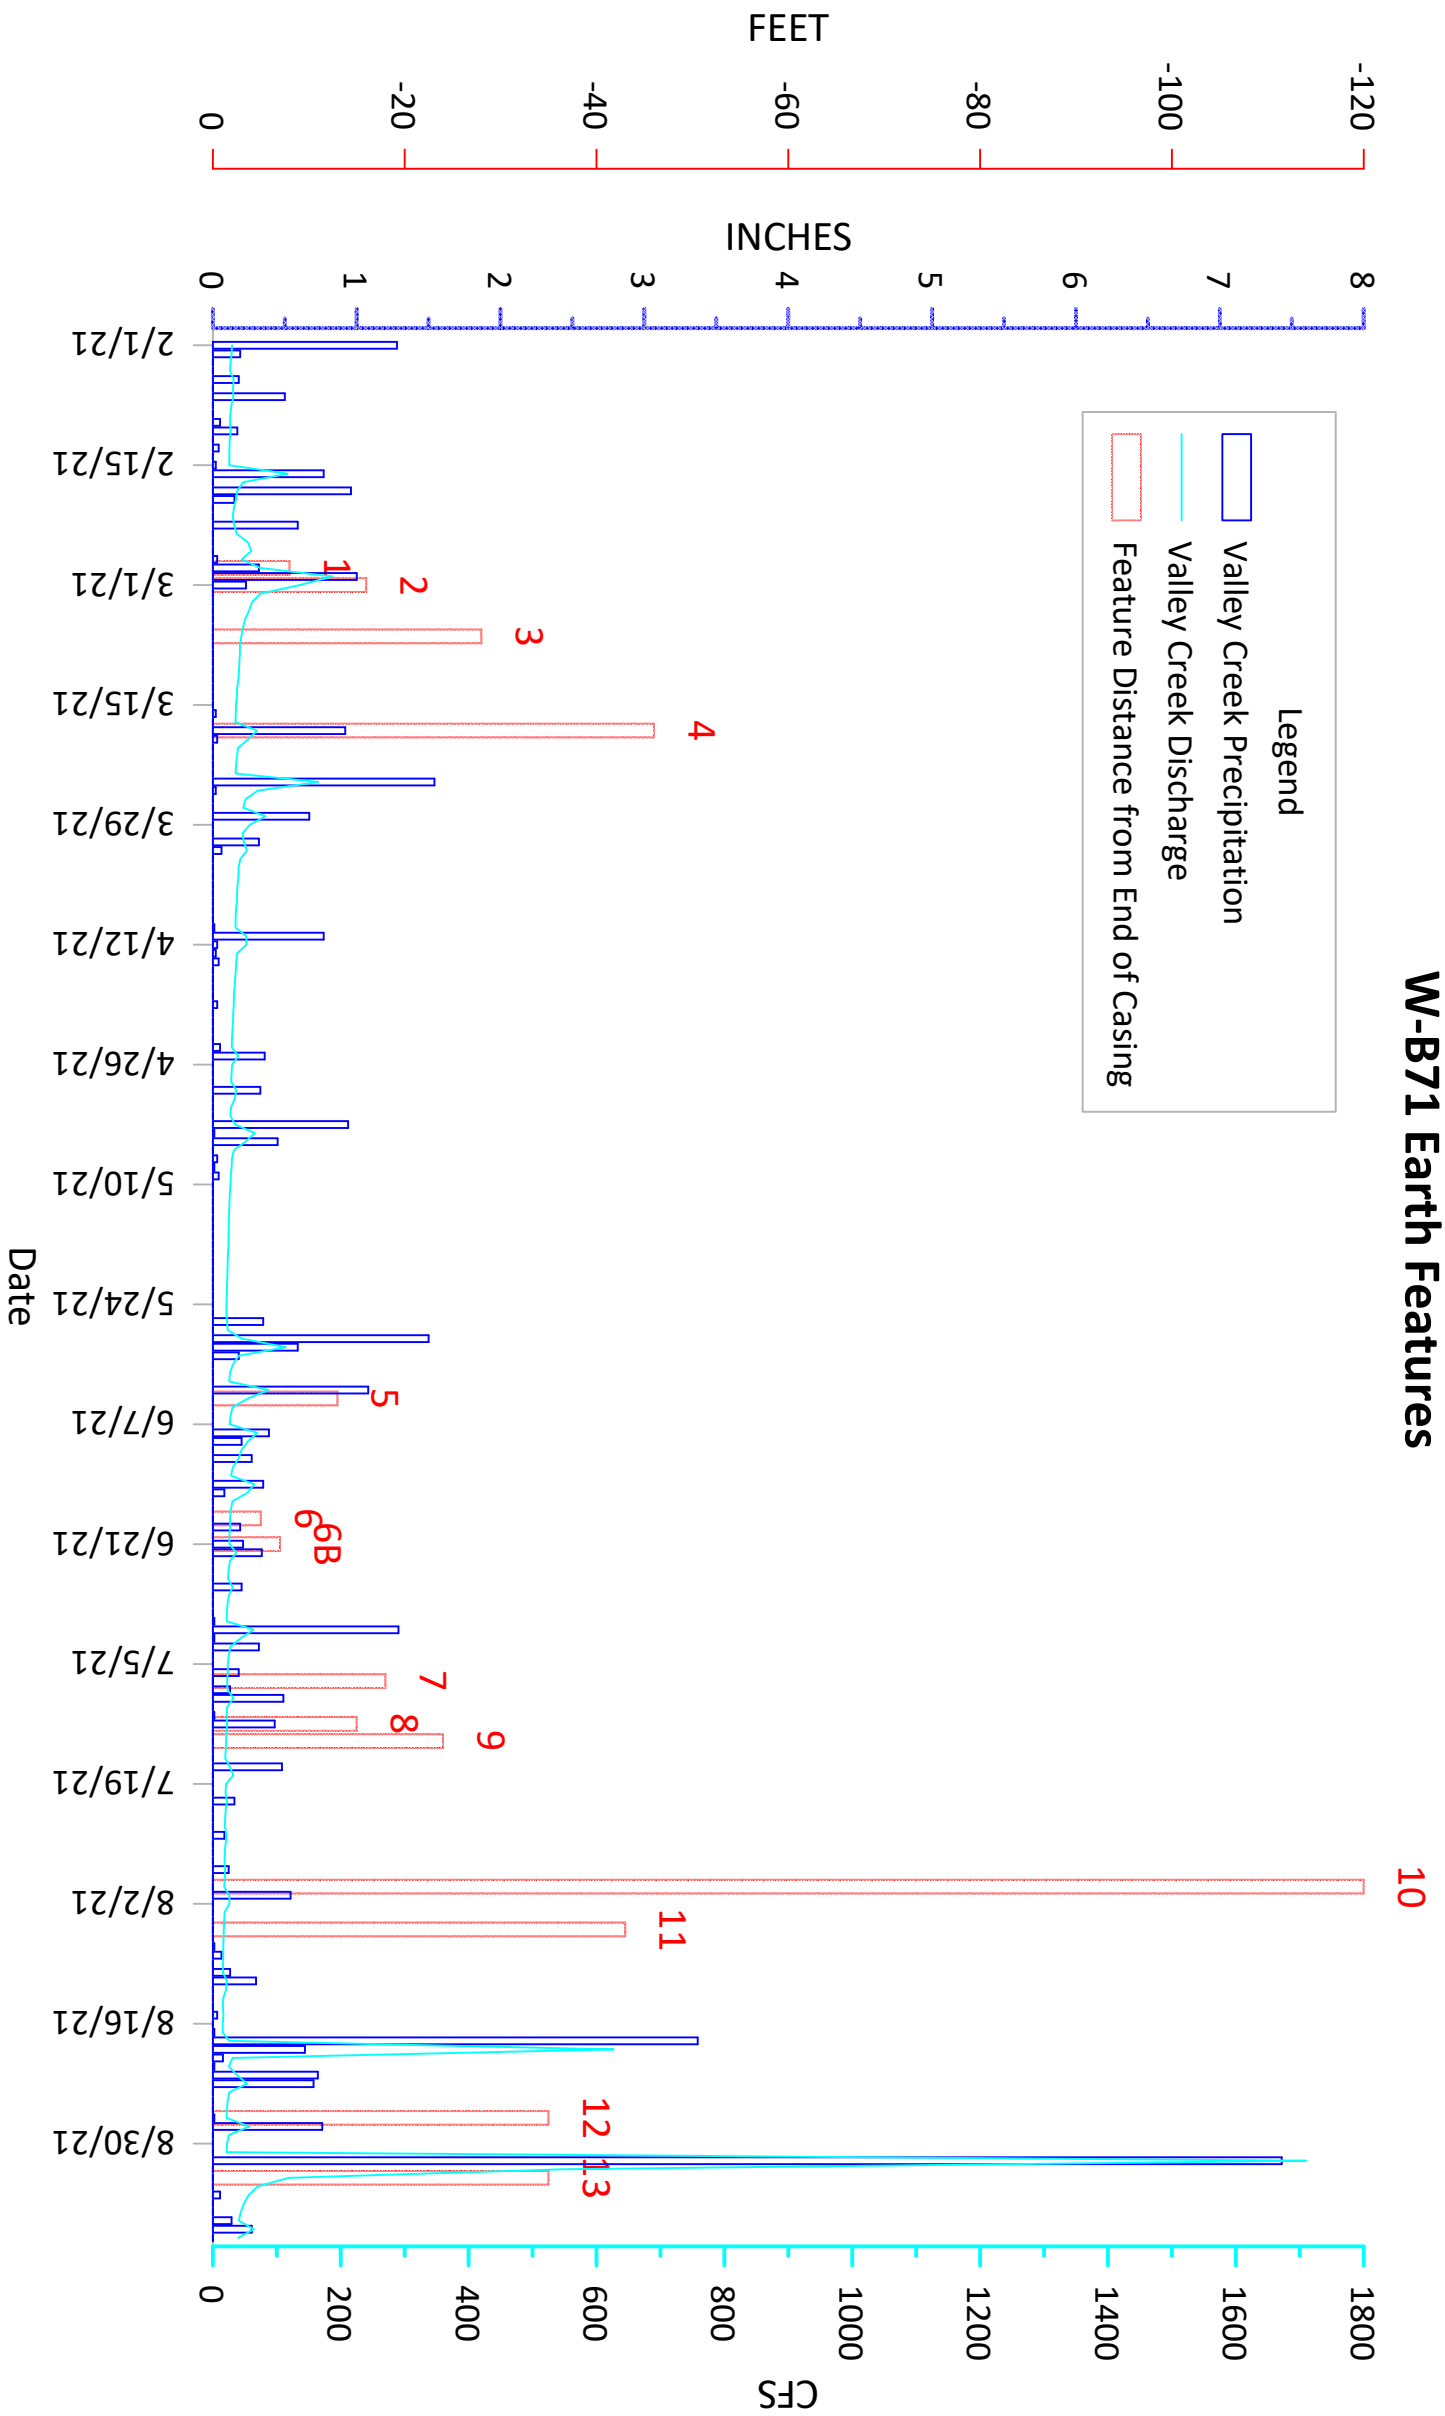
Figure 2: Precipitation, Stream Discharge, and Earth Features

The events appear to have two characteristics in common. The subsidence occurred behind the leading end of the casing (see red bars on **Figure 2** – note that negative distances indicate that the feature is behind the leading end of the casing). In addition, many of the events, particularly the last two in the creek, were associated with heavy precipitation (dark blue bars on **Figure 2**) and enhanced flow in the stream (light blue hydrograph on **Figure 2**).
