Brunner Island, LLC REGULATORY DELIVERABLE SUBMITTAL COVER SHEET

BRUNNER ISLAND, LLC – DISCHARGE CHANNEL 6 DEGREE RATE OF CHANGE NOTIFICATION [NPDES PERMIT NO. PA0008281, PART C, SECTION VI]

PA DEP – EMERGENCY RESPONSE INCIDENT REPORT

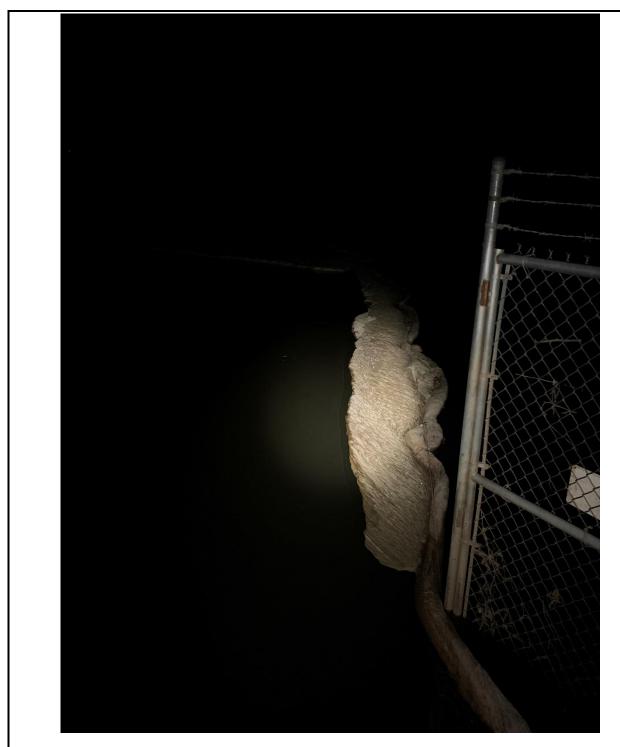
Photo #2 - Oil Boom Across the Mouth of the Channel
