**Brunner Island, LLC
REGULATORY DELIVERABLE
SUBMITTAL COVER SHEET**

**BRUNNER ISLAND, LLC – DISCHARGE CHANNEL 6 DEGREE RATE OF CHANGE
NOTIFICATION [NPDES PERMIT NO. PA0008281, PART C, SECTION VI]**

**NORMANDEAU ASSOCIATES (NAI) REPORT OF SITE INSPECTION
conducted 01/30/2026**

Re: Inspection report for Brunner Island Unit 3 Trip- Fish Observations: January 30, 2026

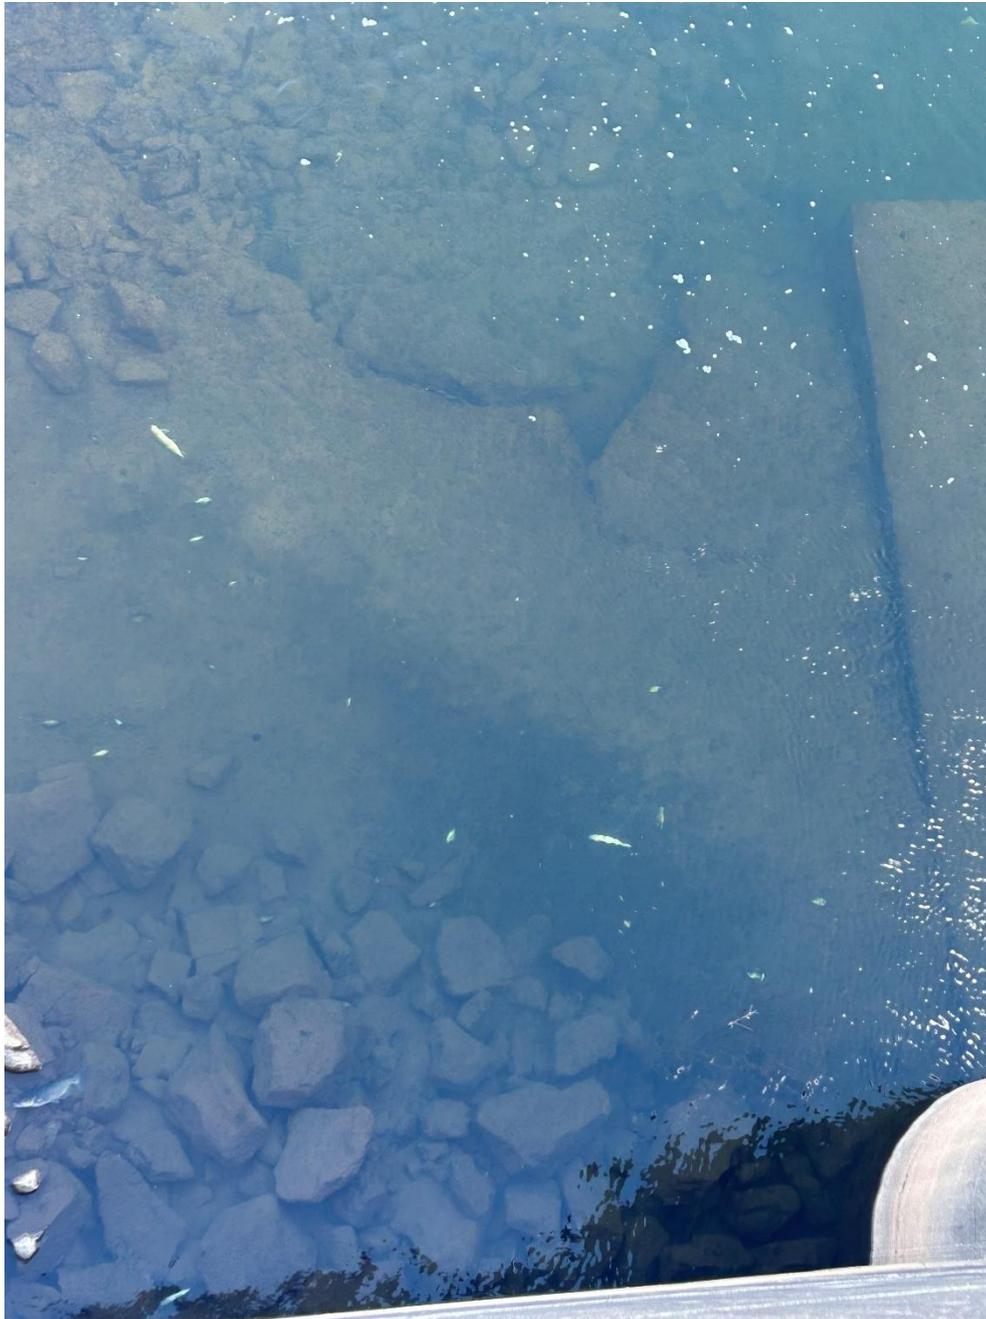
NAI then moved onward with the remainder (west side) of the discharge canal around 11:56 am. Arriving at the cooling tower (CT) intake screens on the west side of the discharge channel, NAI observed numerous deceased and/or stressed fish (*figures 1-3*). An approximate count of 70 fish was observed and recorded. Fish were not retrievable due to access and safety. Fish were not always easily identifiable due to distance. Among the observed fish, approximately 20 fish were sunfish (various *Lepomis* spp.) and Rock Bass (*Ambloplites rupestris*), 20 fish were Smallmouth Bass (*Micropterus dolomieu*), 20 fish were various shiner/minnow species and the remaining fish were Channel Catfish (*Ictalurus punctatus*). It was not clearly evident if all fish were recently affected or if any may have been residual fish from a prior inspection conducted on January 26, 2026. Fish were also observed immediately downstream of the cooling tower discharge, on the west side of the

Figure 1- Various dead fish near the BISES cooling tower (CT) intake screens.

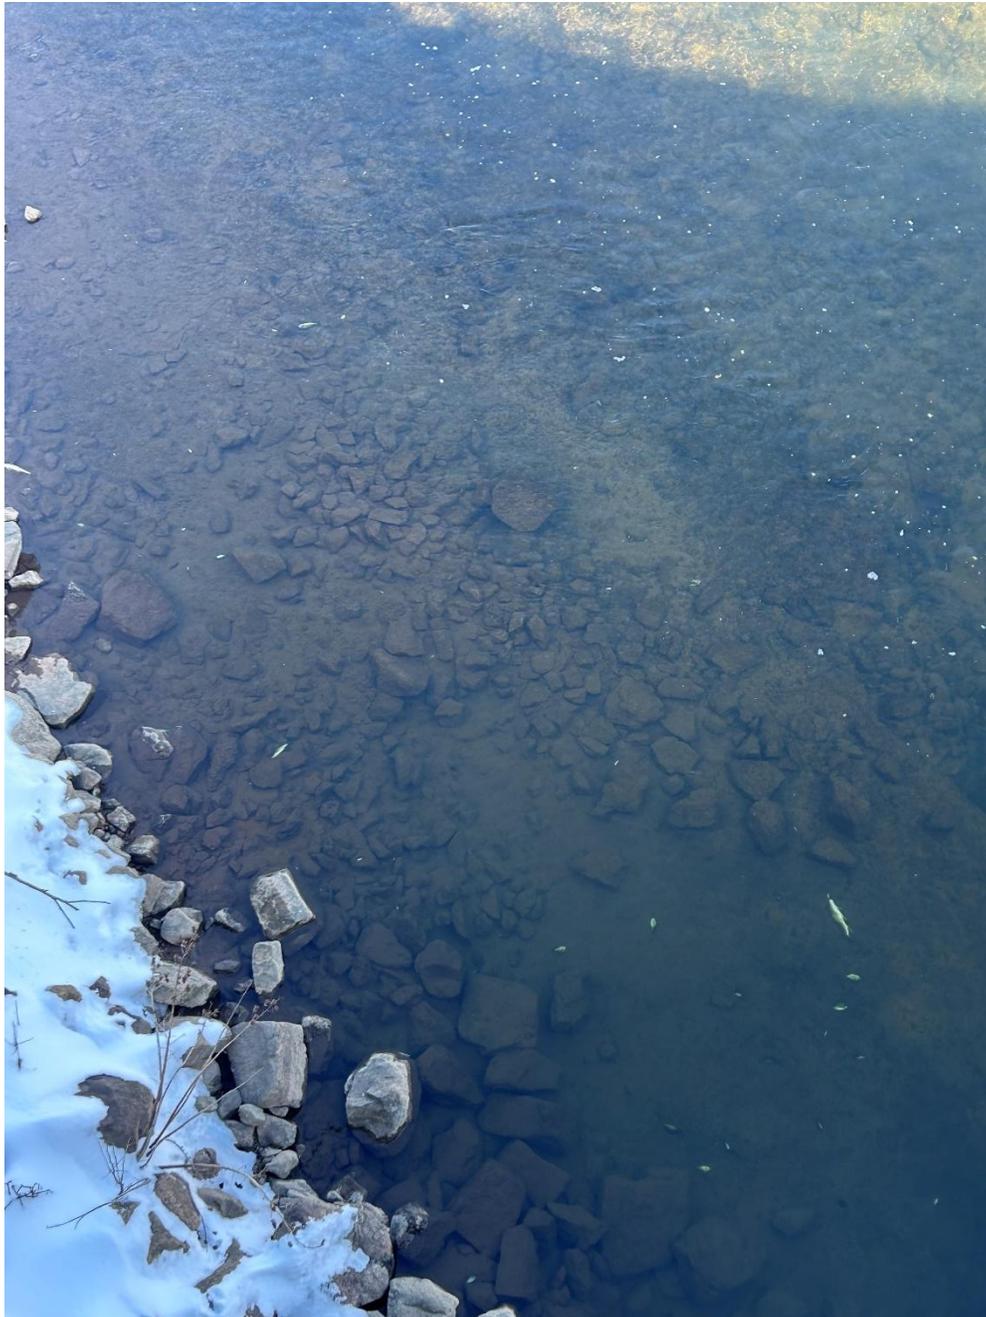
Figure 2- Deceased fish upstream of the CT intakes. Water conditions were notably shallow and clear.

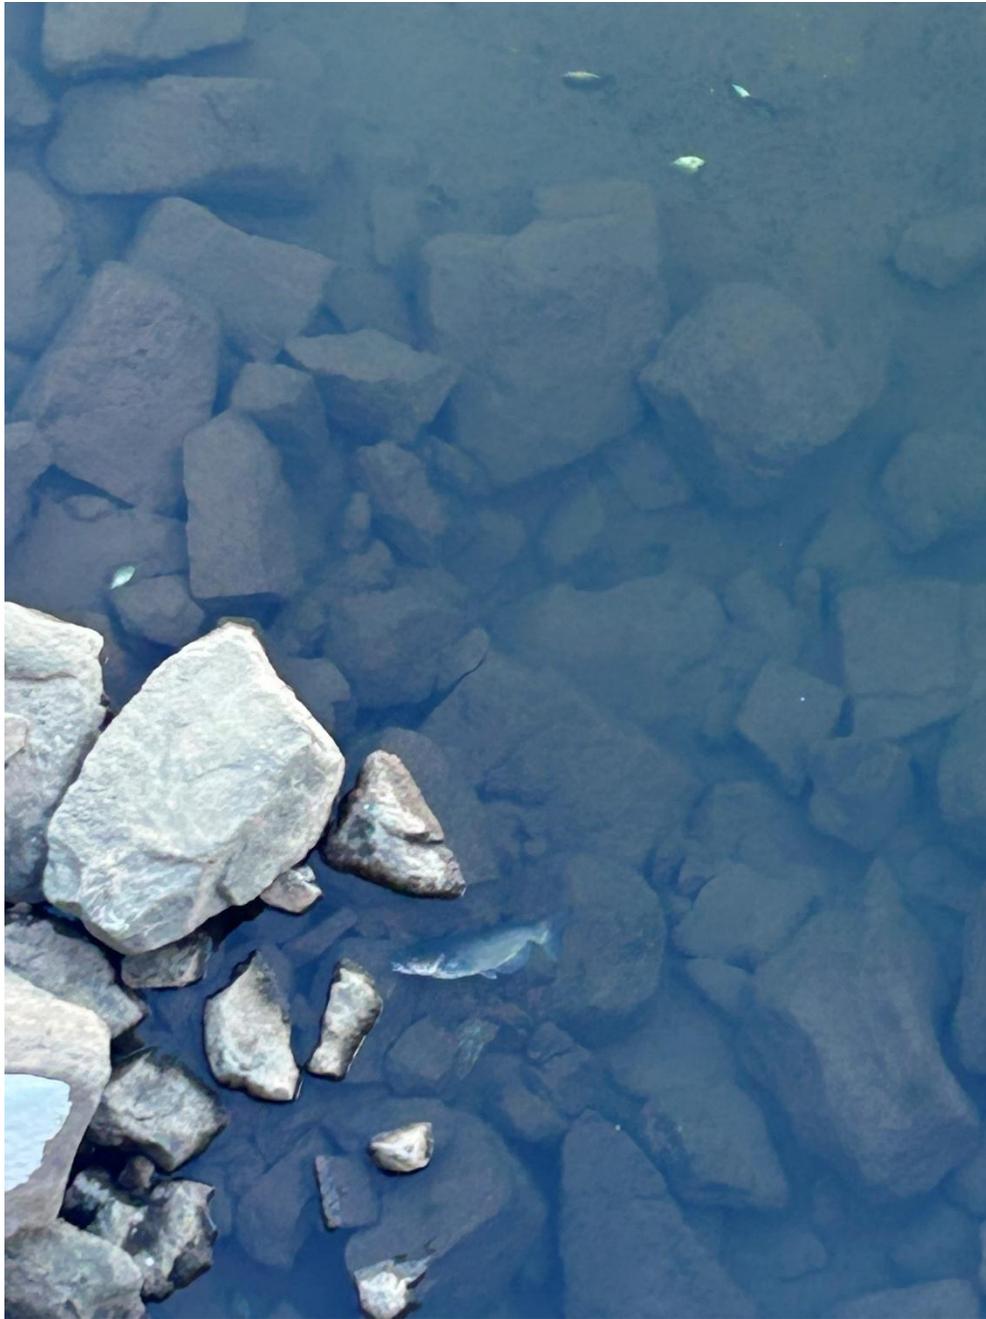
Figure 3- Channel Catfish (*Ictalurus punctatus*) and various sunfish observed in nearby shallow areas.

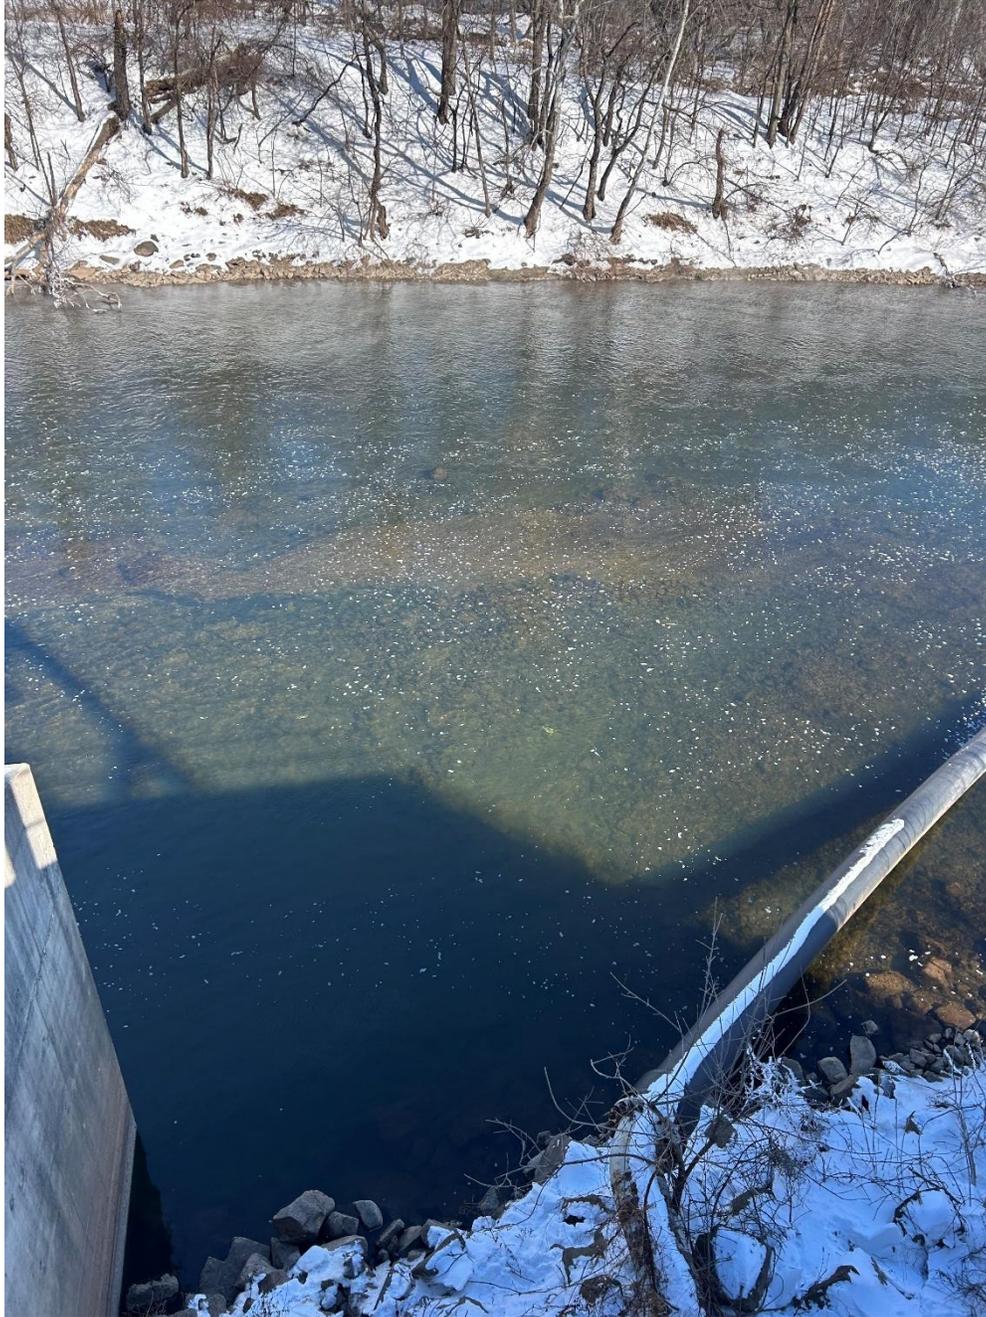
discharge canal (figures 4 & 5). Water clarity was clear to bottom, except in some of the deepest parts nearest the intakes or in mid-channel areas.

Figure 4- Downstream of CT discharge.

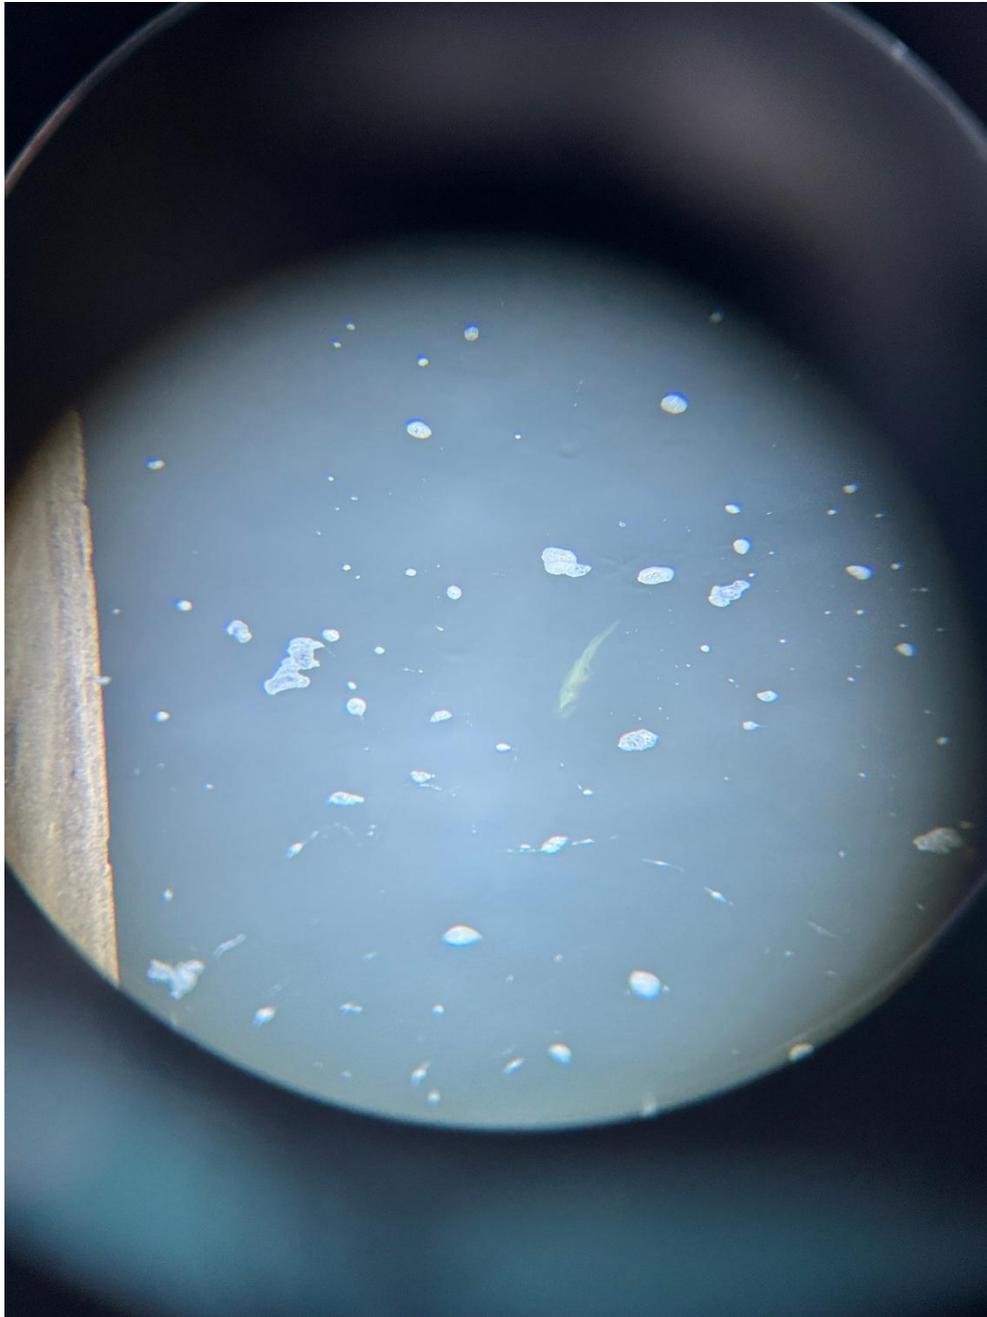
Figure 5- Affected fish observed downstream of CT discharge, via use of binoculars.

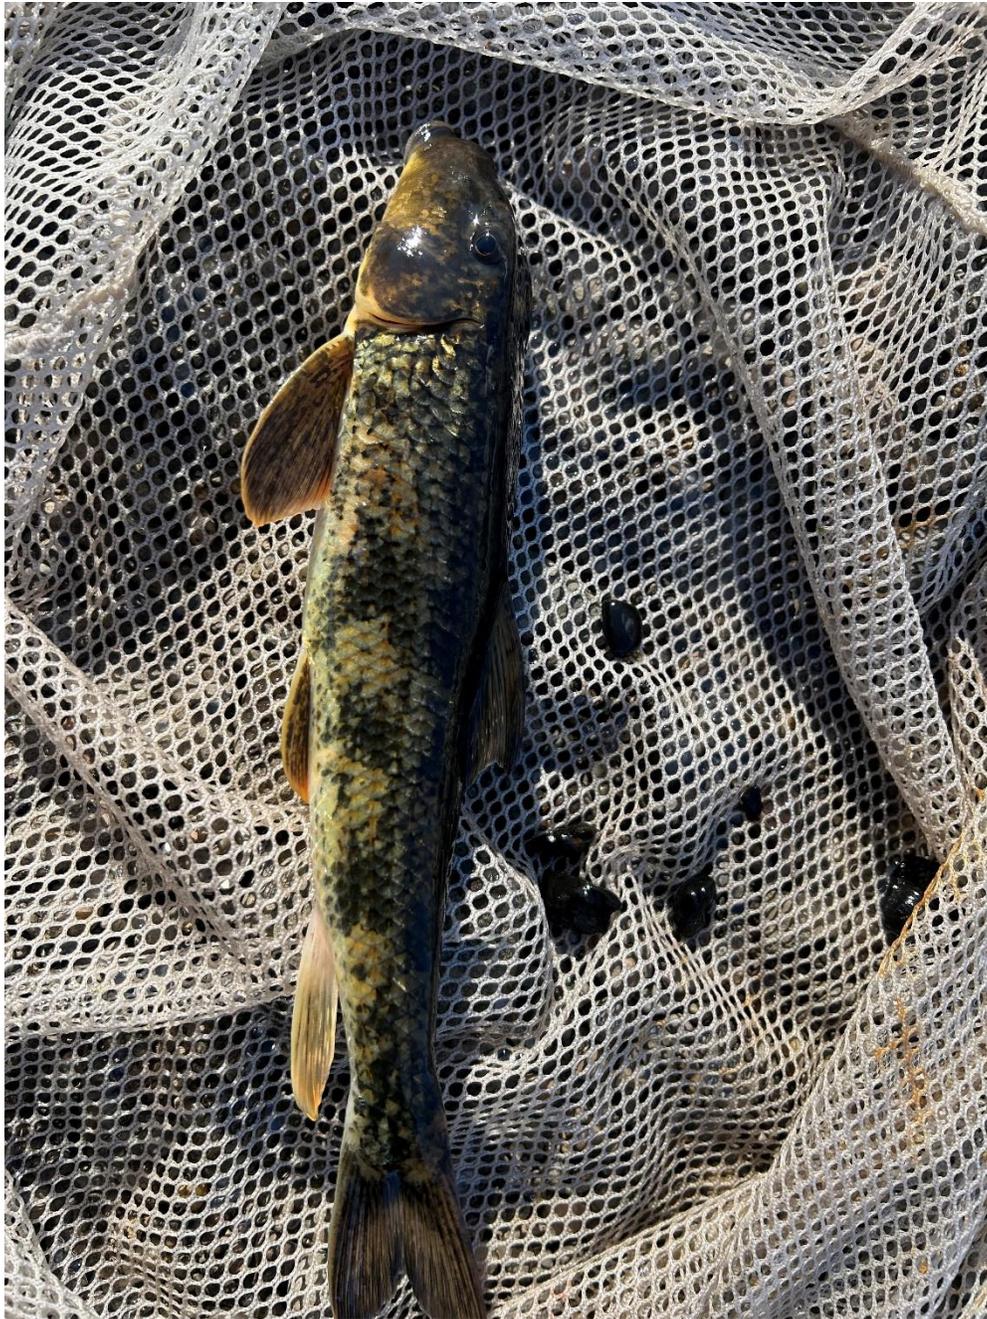
At 12:24 pm, NAI arrived downstream of the discharge canal, at the old public parking lot/confluence of the Susquehanna River. A water temperature reading was taken- 6.6°C (43.88°F). More fish were observed in the confluence area, primarily around the shoreline (figures 6-8). A total count of six fish was observed: two Northern Hogsuckers (*Hypentelium nigricans*) with one collected dead and the other observed stressed; one stressed Rock Bass; two stressed Spottfin Shiners (*Cyprinella spiloptera*) and one stressed Shield Darter (*Percina peltata*). The deceased Northern Hogsucker measured 249mm total length (TL). The remaining fish that were in a state of distress were not measured to avoid extended handling.

Figure 6- Deceased Northern Hogsucker (*Hypentelium nigricans*). TL=249mm

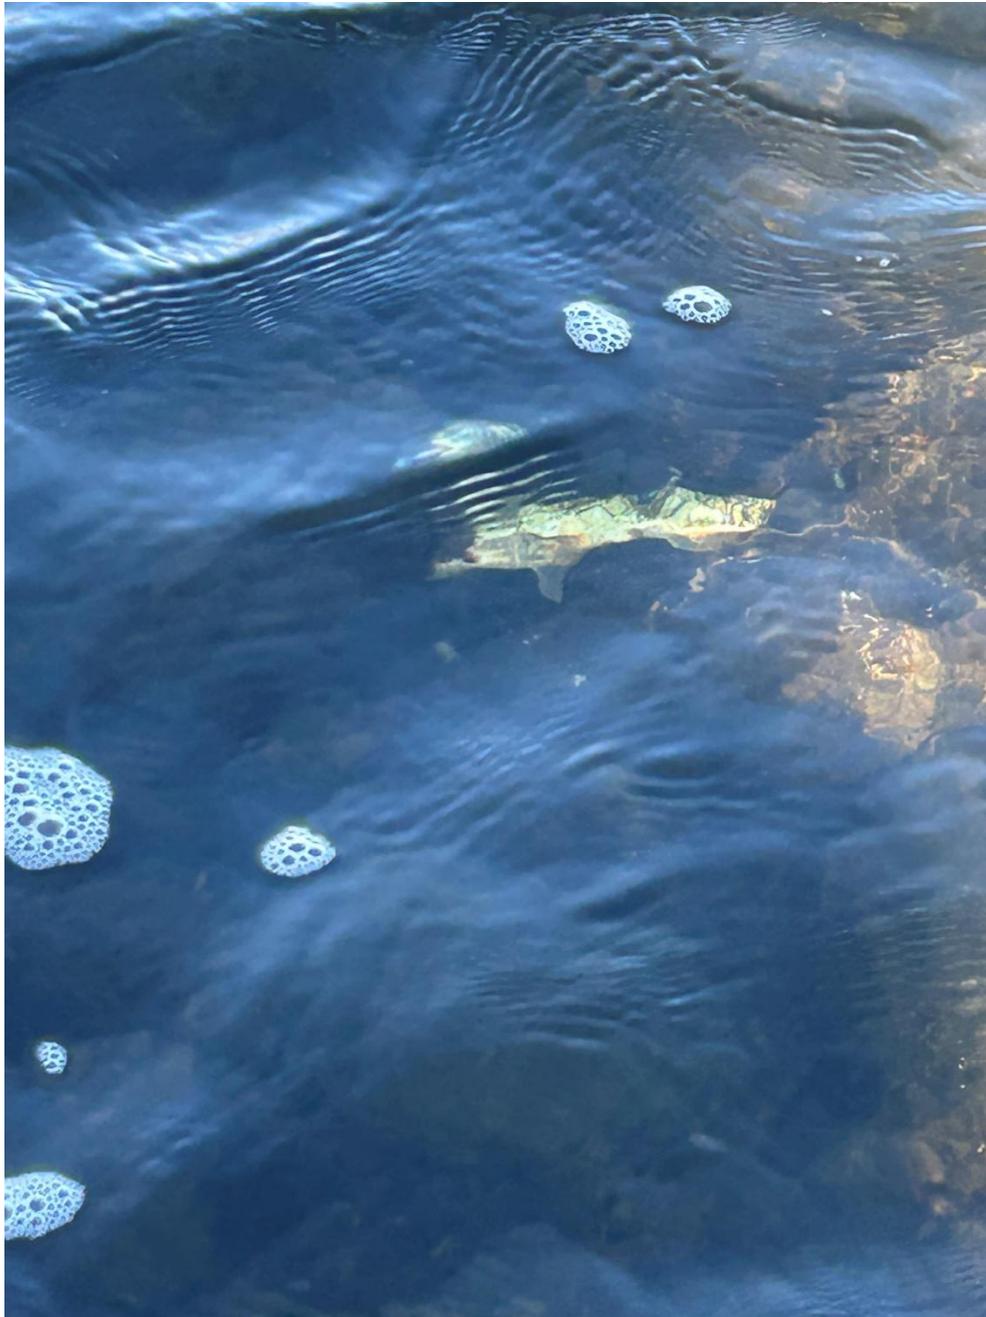
Figure 7- Northern Hogsucker observed stressed and exhibiting uncoordinated swimming.

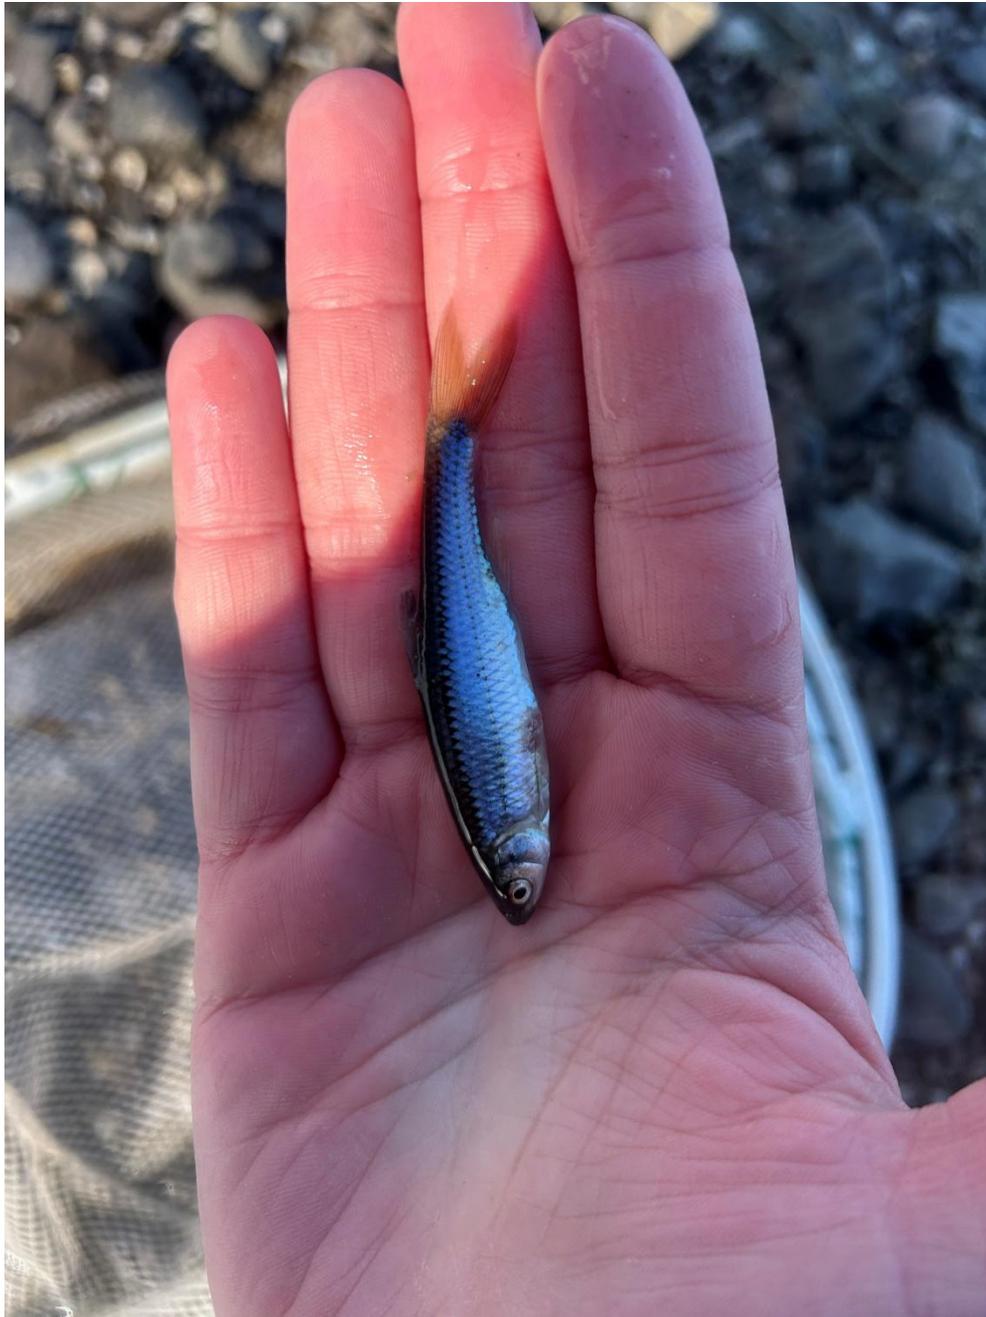
Figure 8- Spotfin Shiner (*Cyprinella spiloptera*) observed stressed, released after identification and handling.
