## CHAPTER 102 INSPECTION REPORT

PA Department of Environmental Protection

Permit No.: PAD510225

| Project/Site Name: | <u>Alliance 51<sup>st</sup> Street, Philadelphia</u> | Permit Issuance Date: | <u>9/5/2023</u> |

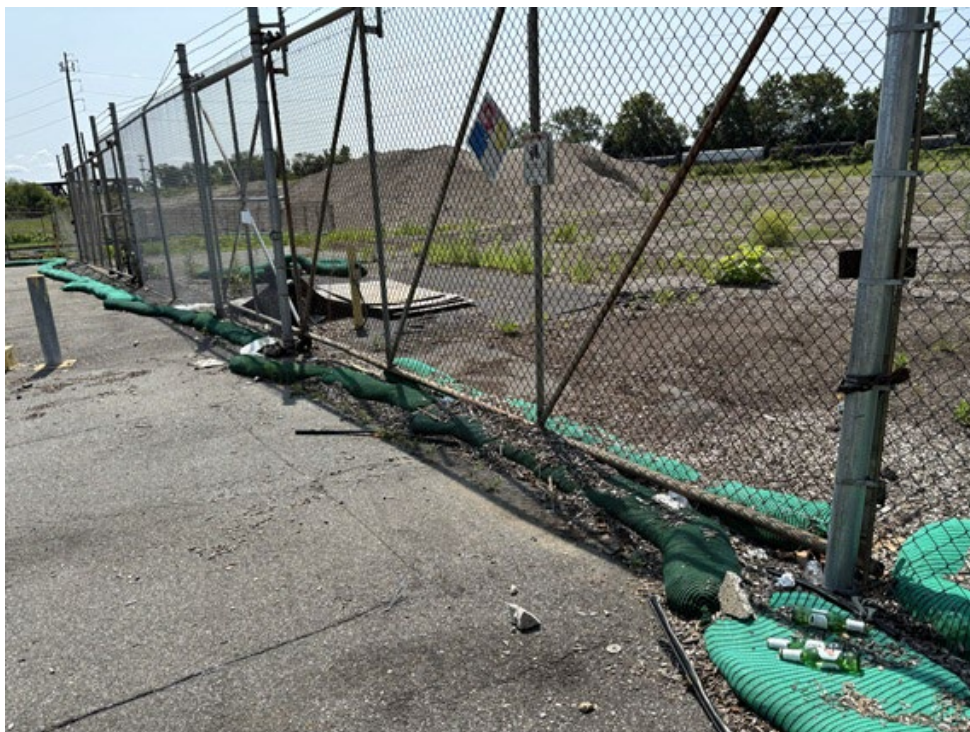
**Upslope gate area of site.**

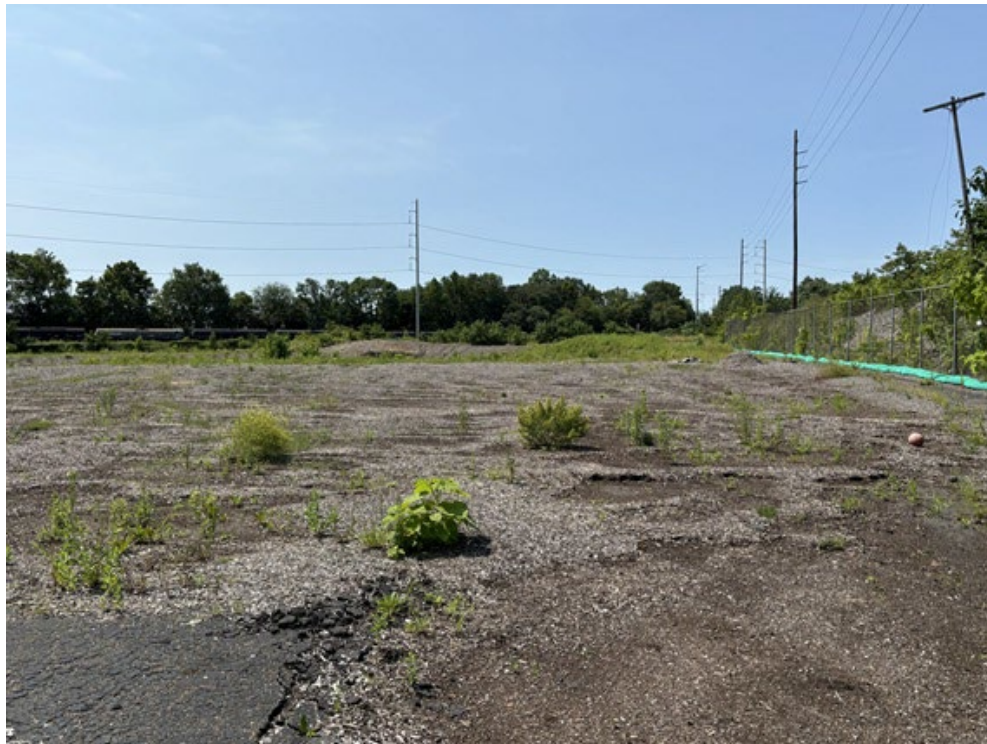
The observed upslope portion of the site maintained adequate mulching levels. The "For Lease" signage remains in place, and the stone stockpile appeared to be unchanged.

**Mulching in upslope portion of site.**

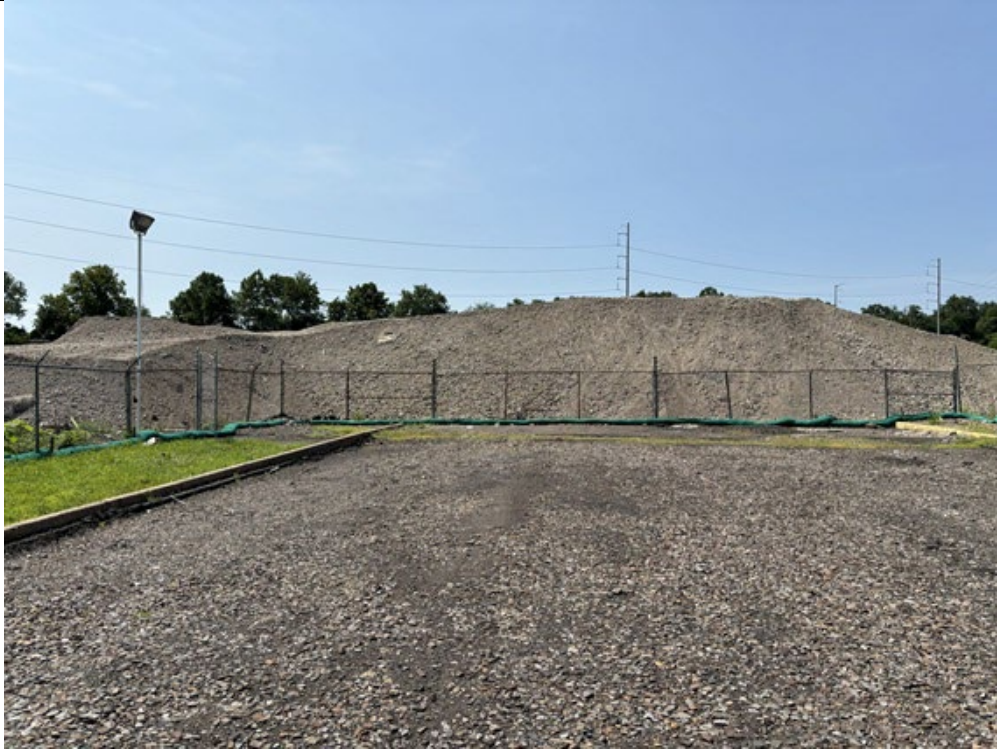
Stone stockpile in midslope section of site.

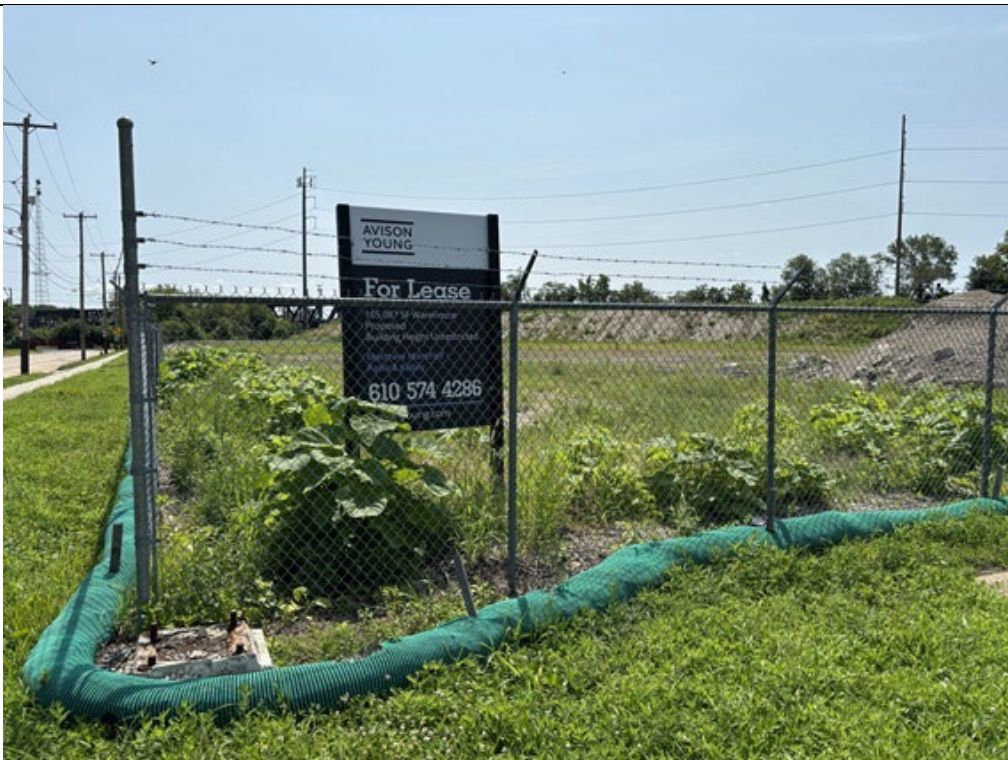
“For Lease signage”, filter sock, and stabilization in midslope portion of site.

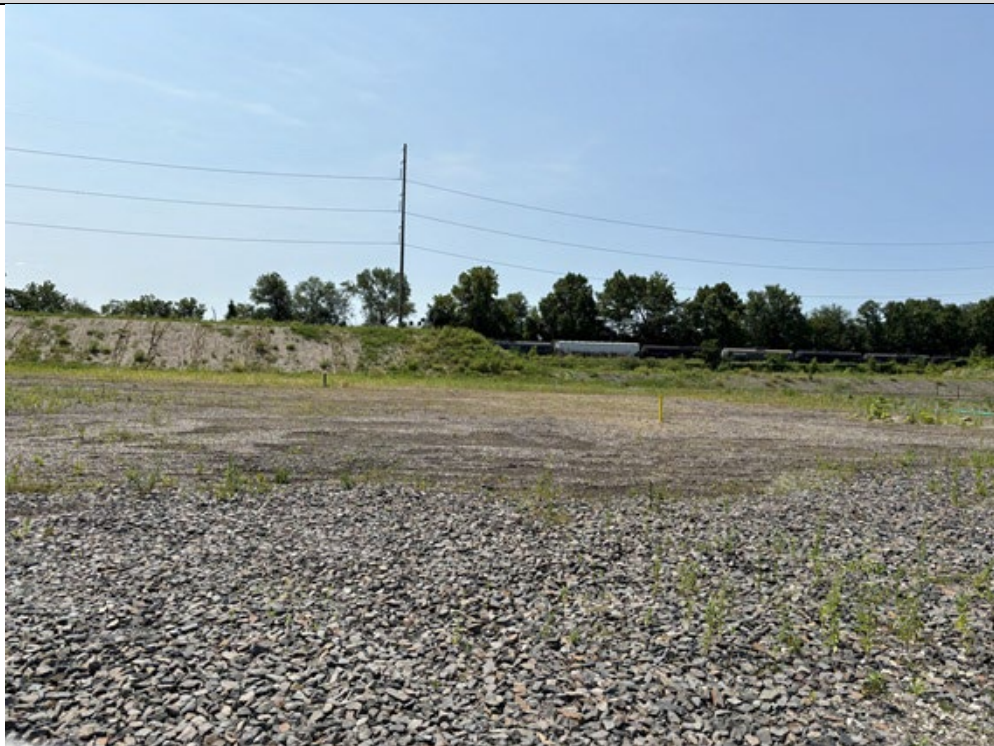
The midslope portion of the site was noted to have maintained adequate mulching levels. A short stretch of security fence along 51<sup>st</sup> Street near Botanic St. was damaged.

Midslope portion of site.

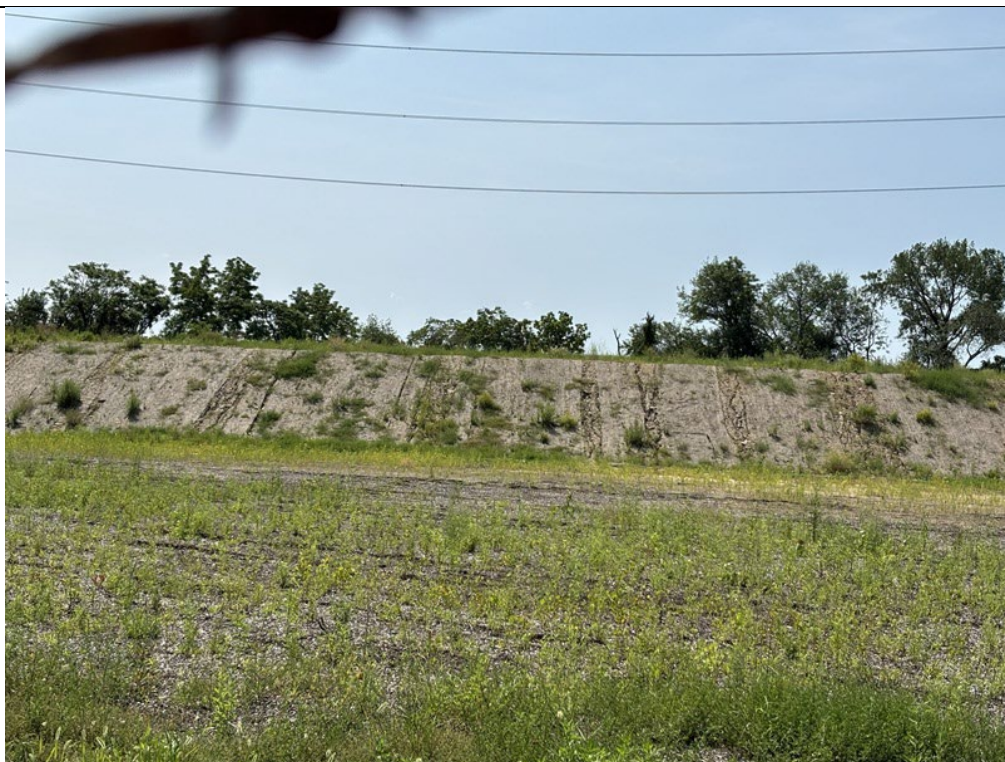
I observed significant rilling, gullying, and erosion on the large fill dirt stockpile. Failure to temporarily stabilize any stage or phase of any activity where a cessation of activity will exceed 4 days, by seeding, mulching, or otherwise protecting from accelerated erosion and sedimentation pending future earth disturbance activities, is a violation of 25 Pa. Code, Section 102.22(b).

Large fill dirt stockpile, with erosion rills and gullies present.

1. DEP requests that the large fill dirt stockpile be fully temporarily stabilized, to maintain compliance with 25 Pa. Code, Section 102.22(b). Permanent stabilization measures are recommended. DEP's Erosion and Sediment Pollution Control Program Manual, Technical Guidance No. 363-2134-008 (March 2012), Chapter 11, may be consulted for further information regarding stabilization.

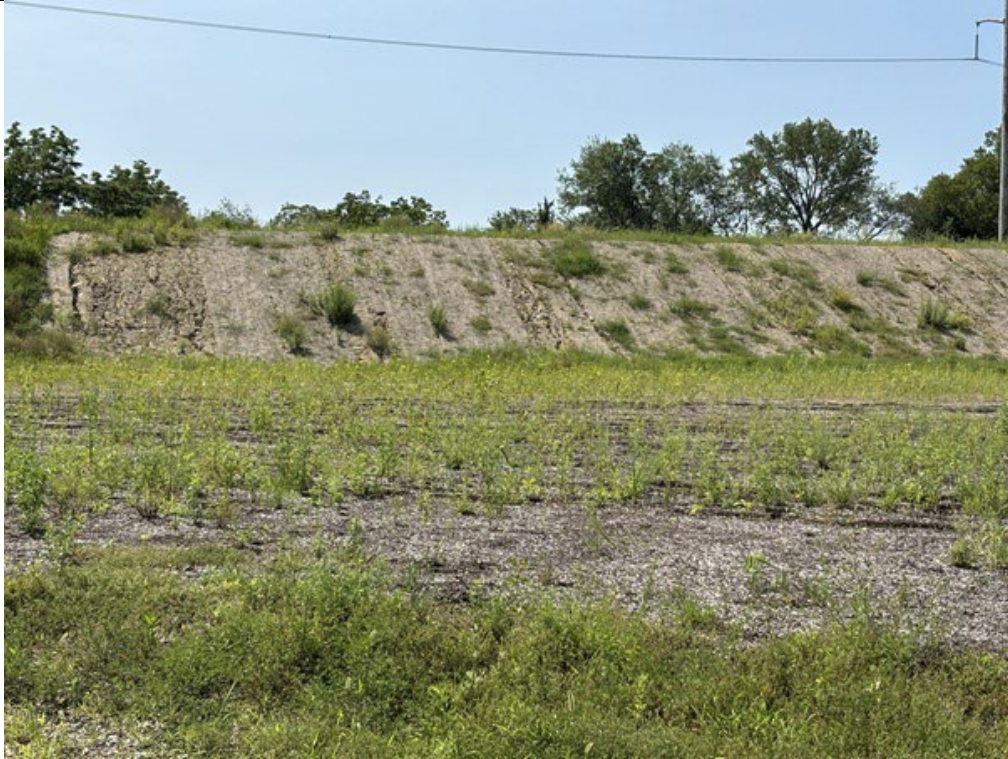
**Downslope portion of large fill dirt stockpile, with significant erosion present.**

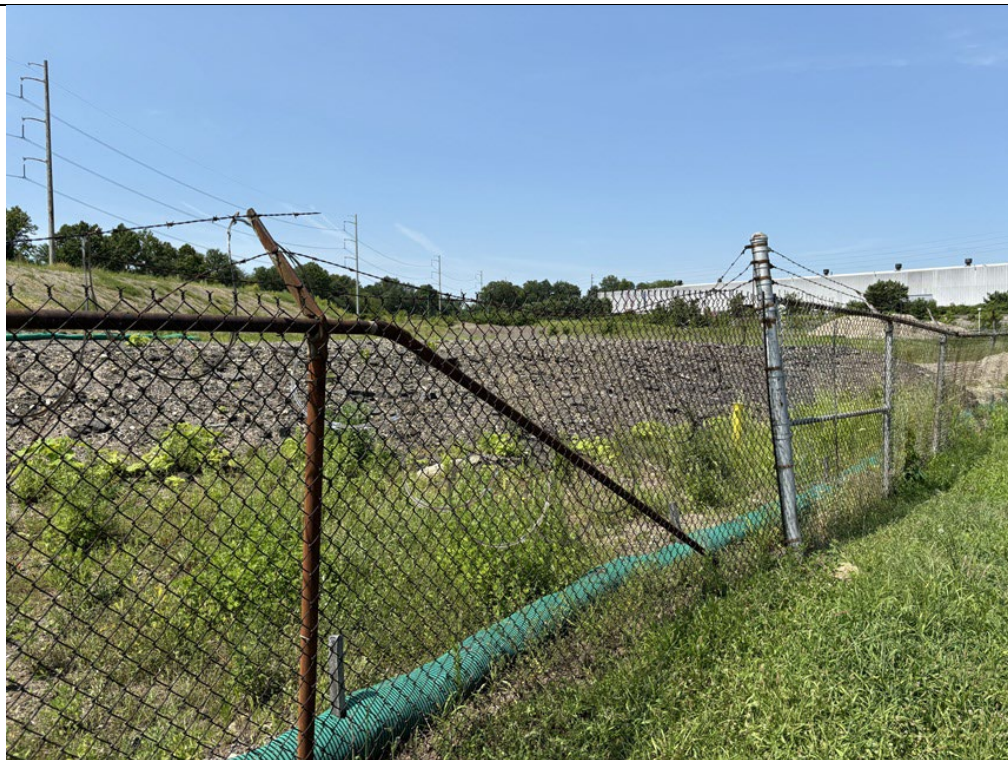
**Section of damaged security fence along 51<sup>st</sup> St.**

3. It is recommended to investigate the addition of a storage BMP (i.e., a sediment basin) in the downslope portion of the site.
4. Repairing the section of the damaged security fence near the intersection of 51<sup>st</sup> and Botanic Sts. is recommended.

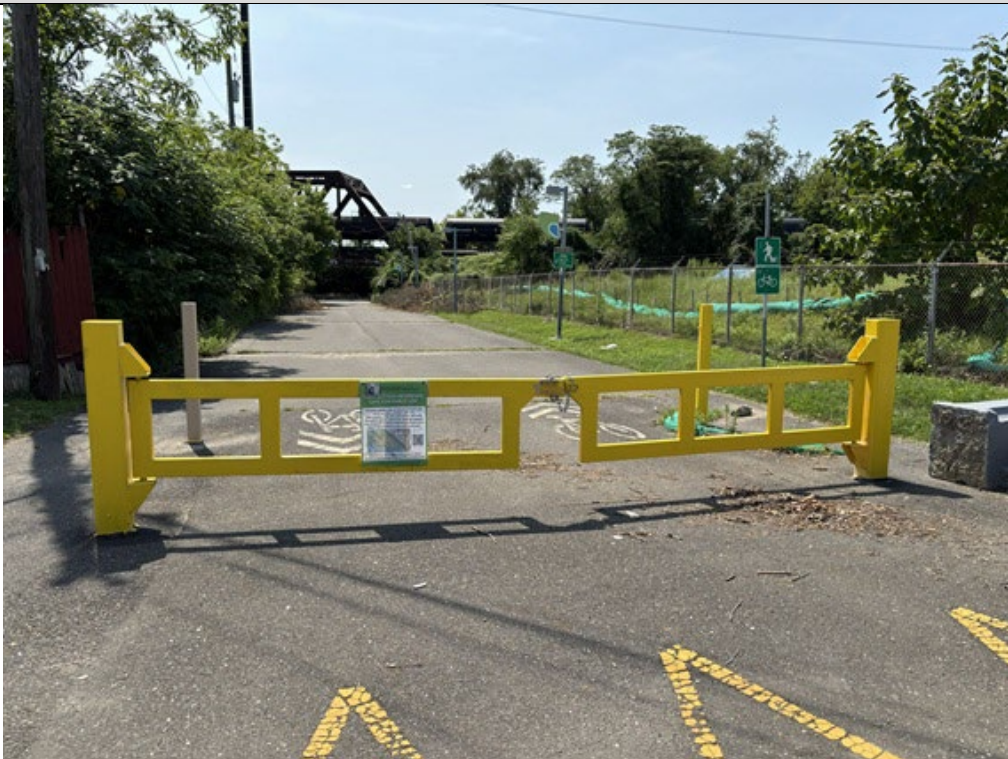
The downstream set of Bartram's Garden trail yellow gates were closed, but the signage indicating that the trail is open, remained in place.

Closed gate of Bartram's Garden trail at 51<sup>st</sup> & Botanic Sts., but signage on gate indicates trail is open.

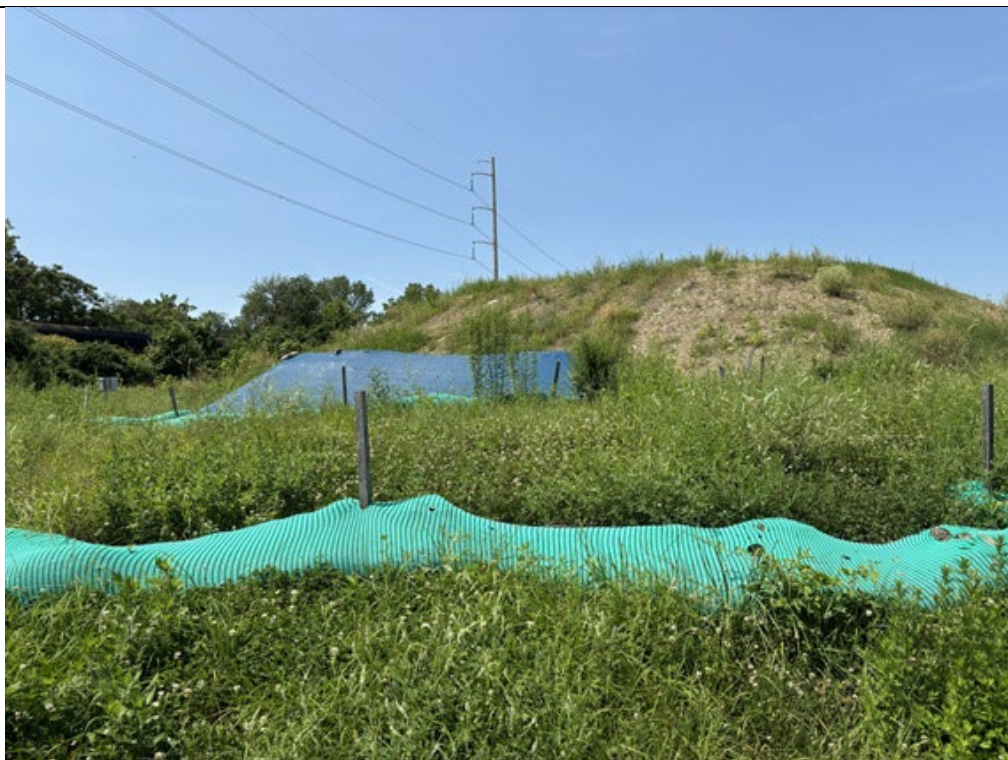
I observed that the tarp covering the contaminated fill dirt stockpile was in good condition, and was protective of the stockpile.

Contaminated fill dirt stockpile covered by blue tarp, with filter sock in foreground.

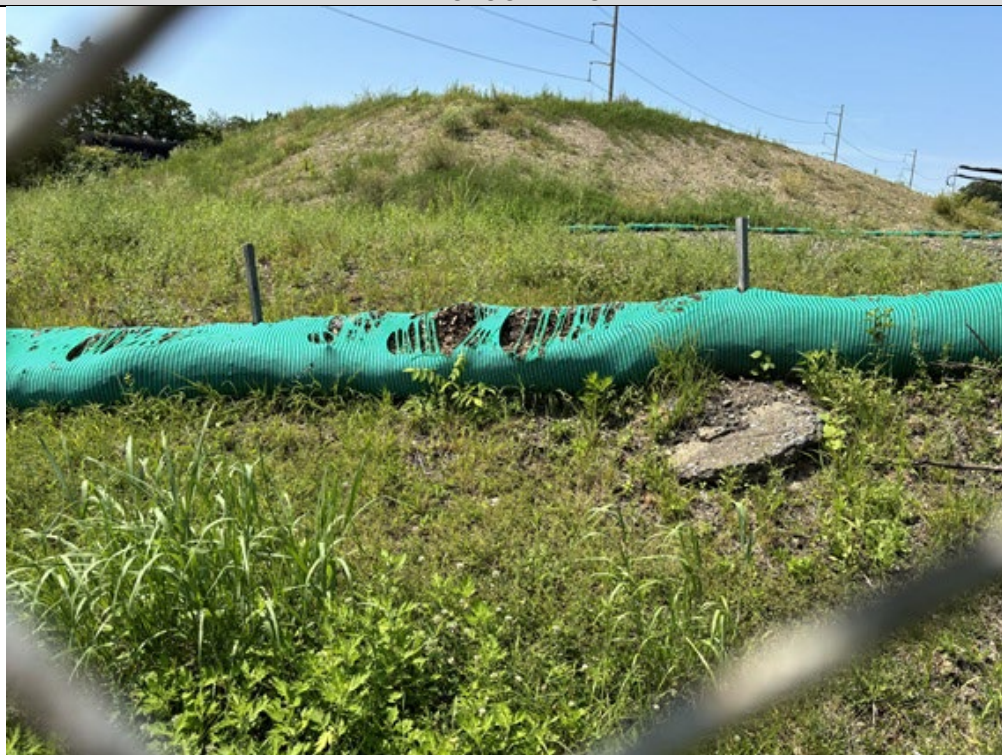
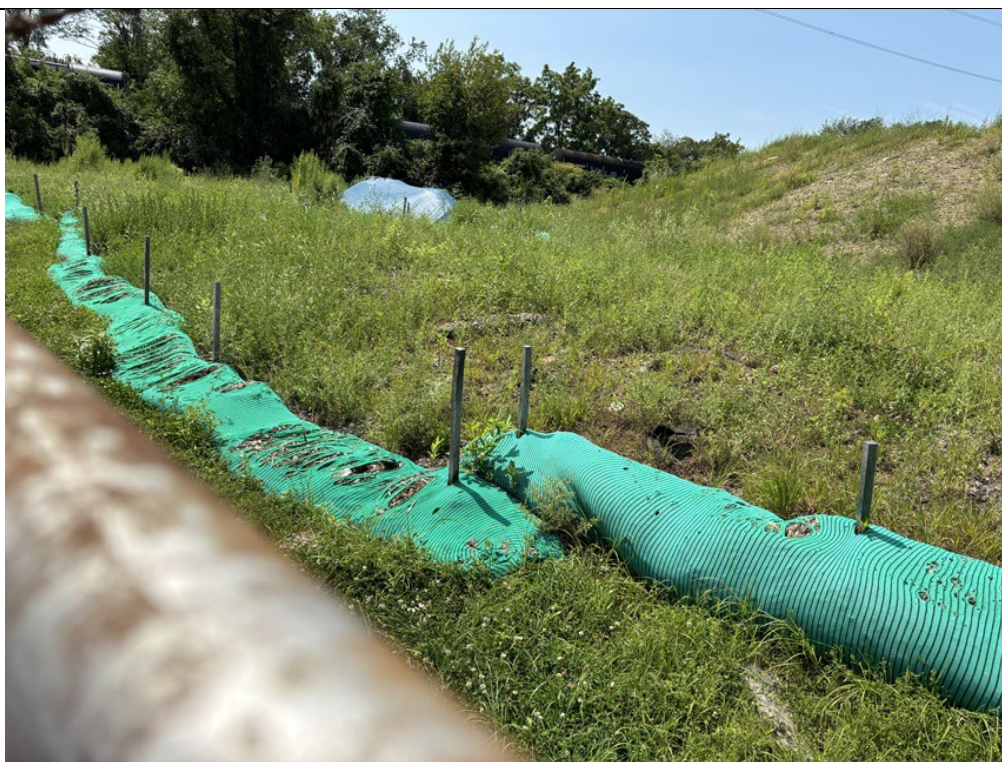
I observed the compost filter sock along the downslope (Eastern) portion of the site to be showing significant wear, with all portions still functional, but some near the end of their functional timeframe.

Filter sock at downslope border of site showing wear.

2. In accordance with DEP's Erosion and Sediment Pollution Control Program Manual, Technical Guidance No. 363-2134-008 (March 2012), Page 65, inspect filter socks weekly and after each runoff event. In addition, DEP requests that damaged socks be repaired according to manufacturer's specifications or replaced within 24 hours of inspection.

5. Replacing the worn-out sections of downslope filtersock is recommended.

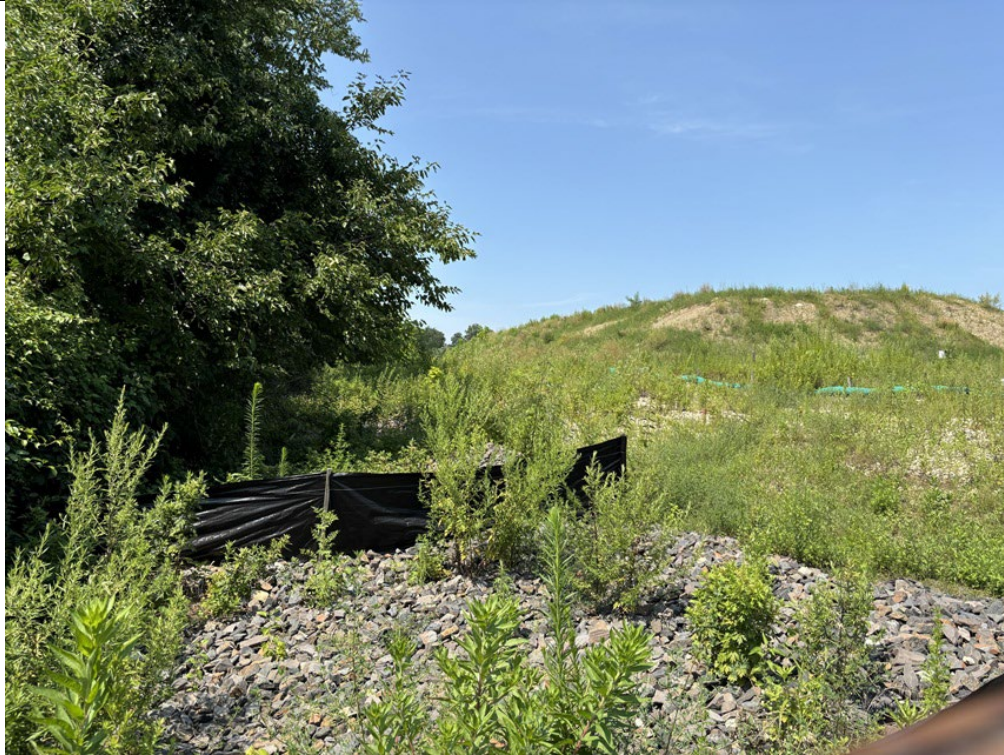
The far side of the large fill dirt stockpile (facing the railroad tracks) had some stabilization observed. No changes were noted regarding the rock-lined swale and silt fences.

Silt fence and stone lined swale at eastern end of site.

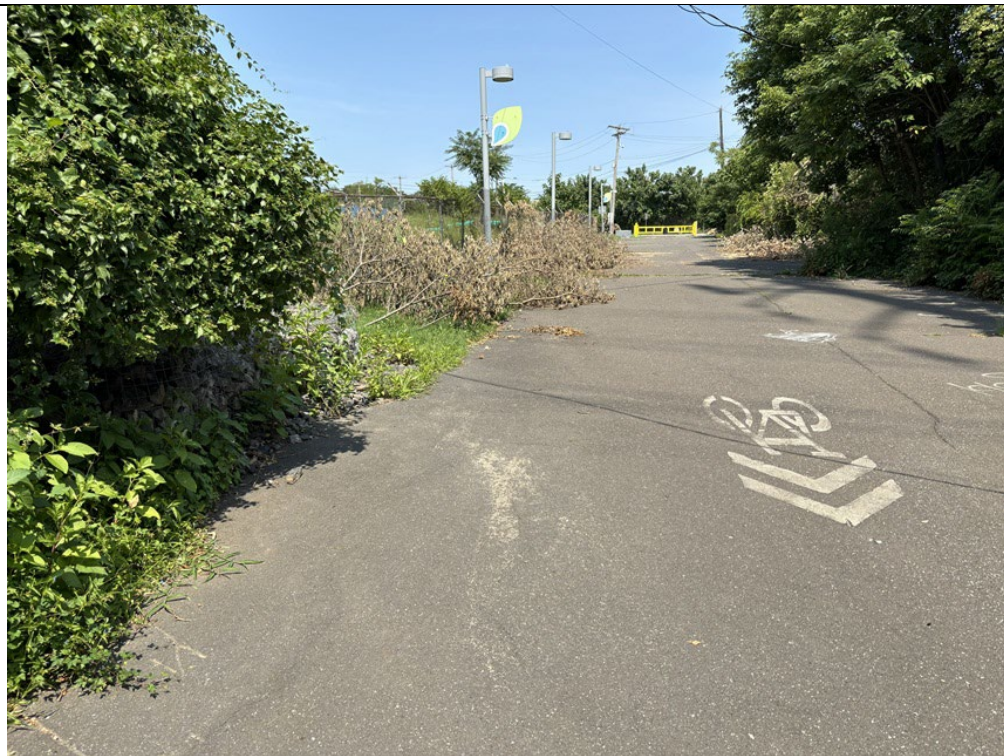
Bartram's Garden trail at downslope-most boundary of site.

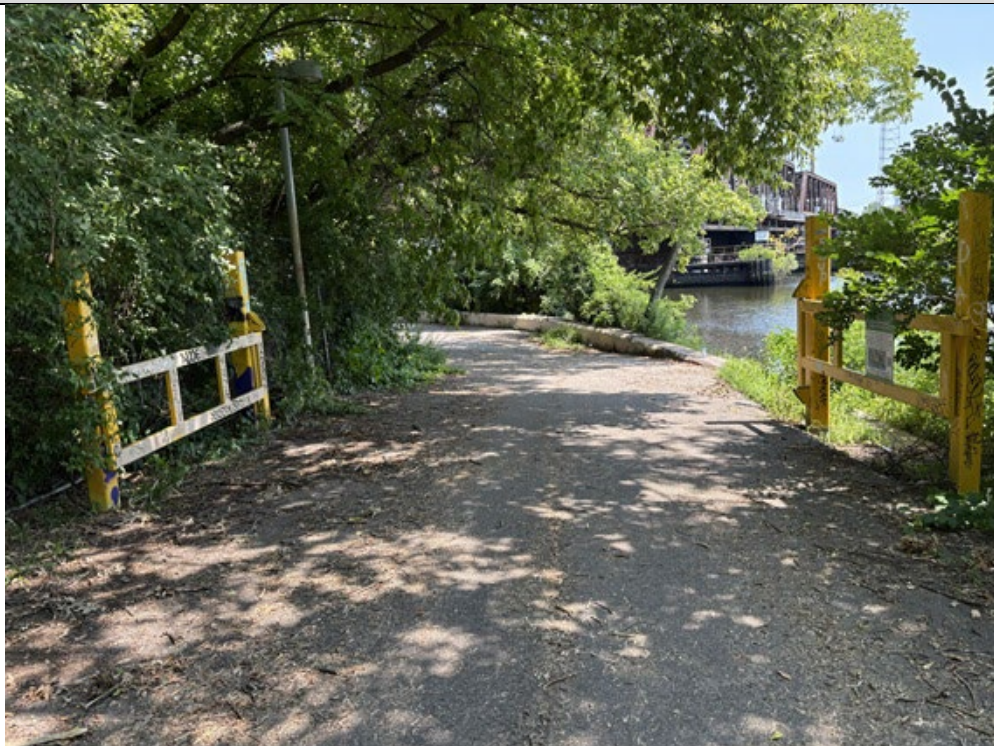
The downstream set of Bartram's Garden trail gates were open.

**Downstream set of gates on the Bartram's Garden trail.**

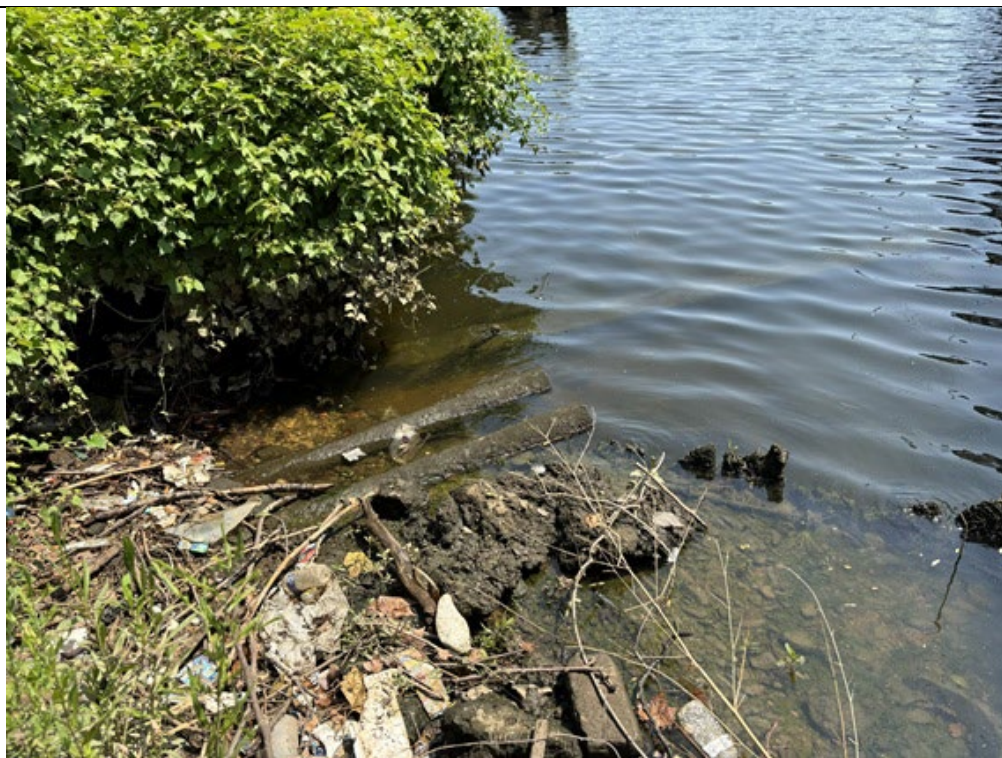
The two pipe outfalls (the pipes currently of undetermined origin) along the Schuylkill River, across the Bartram's Garden trail from the site, were half-submerged within the high tide status of the River during this inspection.

**Pipe outfalls (pipes of undetermined origin) across the Bartram's Garden trail from site; half submerged by high tide.**

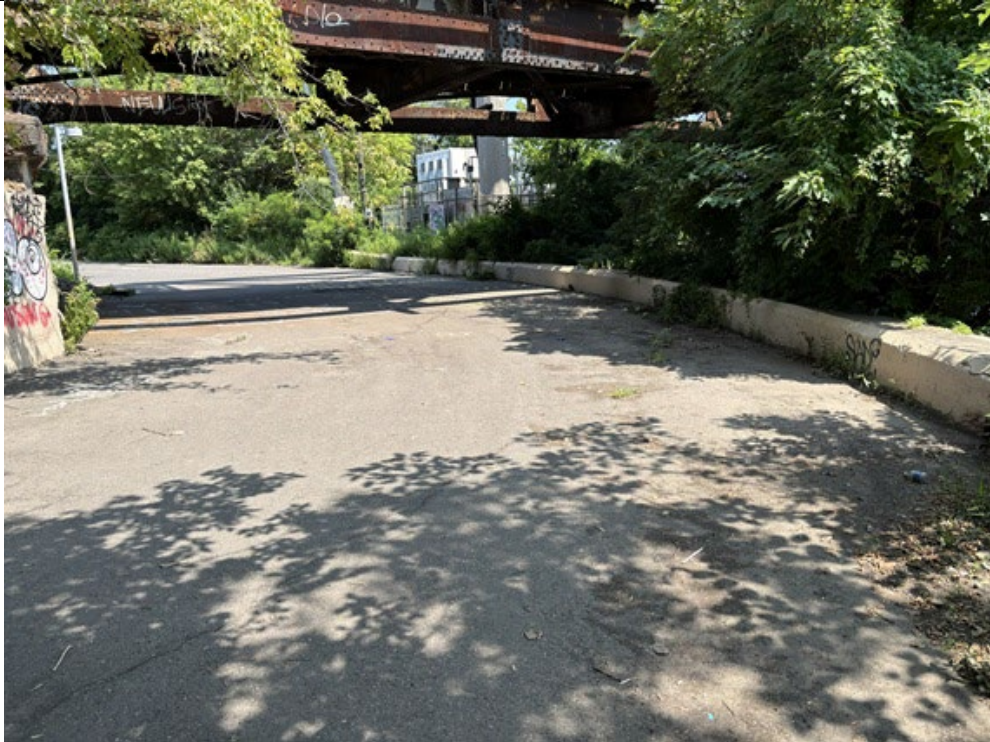
Bartram's Garden trail on opposite side of railroad bridge from site.  
End of photo log.
