CHAPTER 102 INSPECTION REPORT

Permit No.: PAD510225

Report No.: 20

GENERAL INFORM	ATION		
Project/Site Name:	Alliance 51 st Street, Philadelphia	Permit Issuance Date:	9/5/2023	
Site Address:	1656 S. 51 st St.	Permit Expiration Date:	9/4/2028	
Site City, State, ZIP:	Philadelphia, PA 19143	Permit Type:	NPDES IP	
RP/Permittee Name:	Eric Carlson	Site Municipality(ies):	Philadelphia	
RP/Permittee Address:	40 Morris Ave., Suite 230	Site County(ies):	Philadelphia	
RP/Permittee City, State, Z	ZIP: Bryn Mawr, PA 19010	Earth Disturbance:	11.54	acres
RP/Permittee Email:	ecarlson@alliancehp.com	Site Latitude:	39.935278	
Surface Water(s):	Schuylkill River	Site Longitude: -	75.209236	
Special Protection?	🗌 Yes 🖾 No	Complaint Inspection?	🛛 Yes	🗌 No
Construction Stage:	Inactive	Activity:	Construction	⊧ <u>></u> 1 ac.
Operator Name	Operator Company	Operator E	mail	Approved
n/a				
		IATION		
Inspection Date:	4/2/25	Inspection Time:	11:45	АМ 🗌 РМ
Lead Inspector Name:	Robert Page	Inspector Email:	ropage@pa.ge	vc

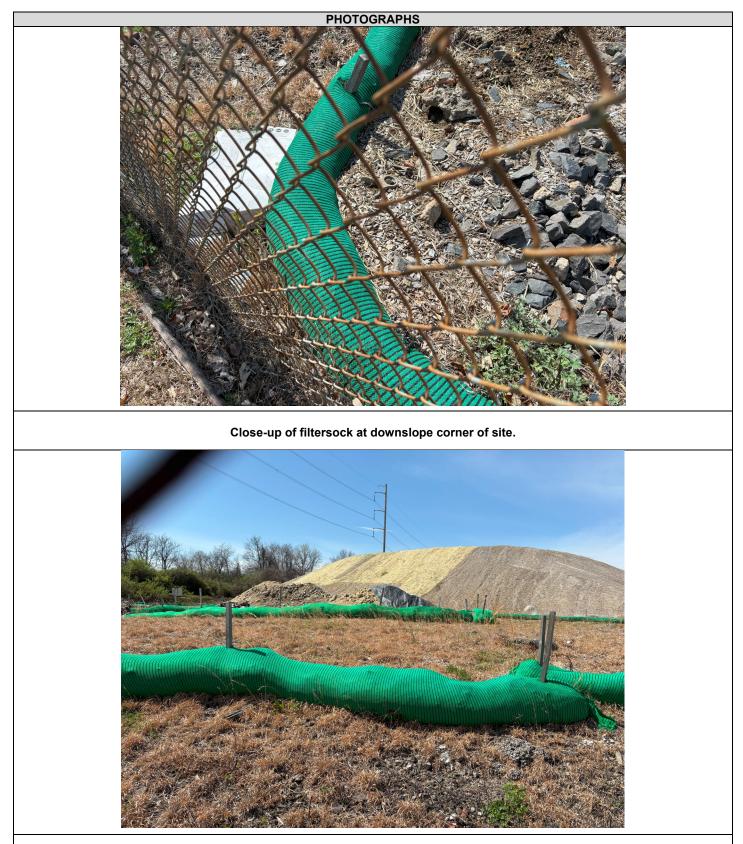
The black tarp covering the small pile of contaminated soil downslope of the large fill dirt stockpile had again appeared to be mostly blown off the pile and indicated signs of shredding. Perimeter control (filter sock) around this pile, and the downslope site perimeter, remained intact.

Downslope filtersock (foreground); contaminated fill dirt stockpile without tarp (at center); downslope end of large fill dirt stockpile with erosion matting (background).
