CHAPTER 102 INSPECTION REPORT

PA Department of Environmental Protection

Permit No.: PAD510225

Project/Site Name:	<u>Alliance 51st Street, Philadelphia</u>	Permit Issuance Date:	<u>9/5/2023</u>
Site Address:	<u>1656 S. 51st St.</u>	Permit Expiration Date:	<u>9/4/2028</u>
Site City, State, ZIP:	<u>Philadelphia, PA 19143</u>	Permit Type:	<u>NPDES IP</u>
RP/Permittee Name:	<u>Eric Carlson</u>	Site Municipality(ies):	<u>Philadelphia</u>
RP/Permittee Address:	<u>40 Morris Ave., Suite 230</u>	Site County(ies):	<u>Philadelphia</u>
RP/Permittee City, State, ZIP:	<u>Bryn Mawr, PA 19010</u>	Earth Disturbance:	<u>11.54</u> acres
RP/Permittee Email:	<u>ecarlson@alliancehp.com</u>	Site Latitude:	<u>39.935278</u>
Surface Water(s):	<u>Schuylkill River</u>	Site Longitude:	<u>- 75.209236</u>
Special Protection?	<input type="checkbox"/> Yes <input checked="" type="checkbox"/> No	Complaint Inspection?	<input checked="" type="checkbox"/> Yes <input type="checkbox"/> No
Construction Stage:	<u>Inactive</u>	Activity:	<u>Construction ≥ 1 ac.</u>

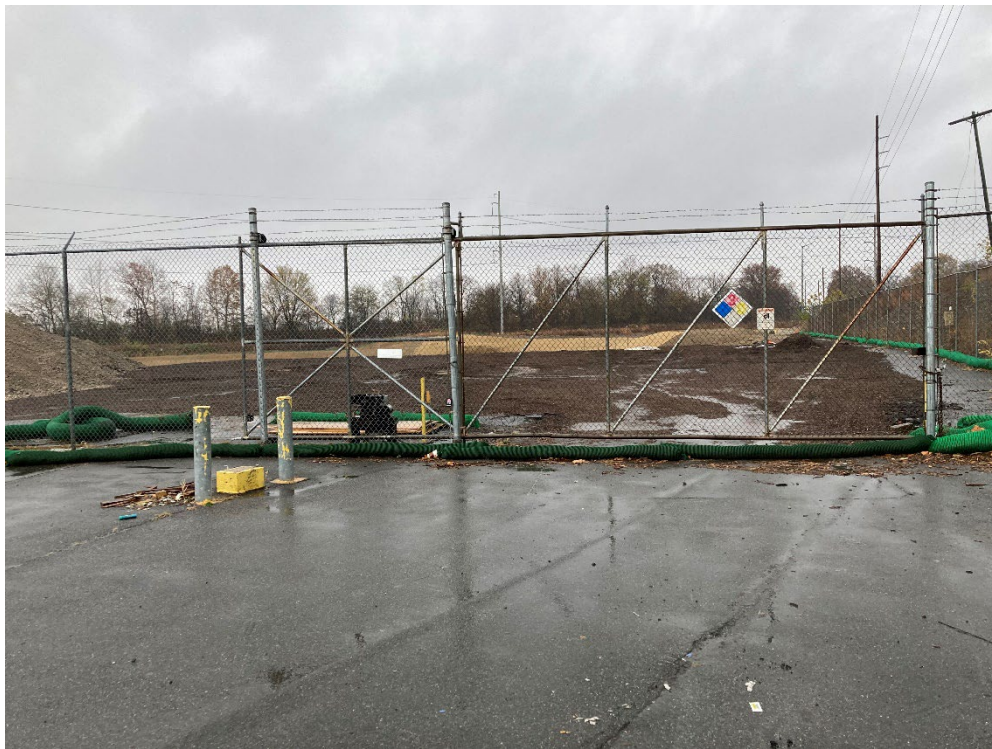
I noted that the filter sock along the most upslope gate to the site was in proper position and in good operating condition. The filter sock along the more downslope gate was not replaced to proper position after the gate had been last closed.

Most upslope gate, along 51st St.

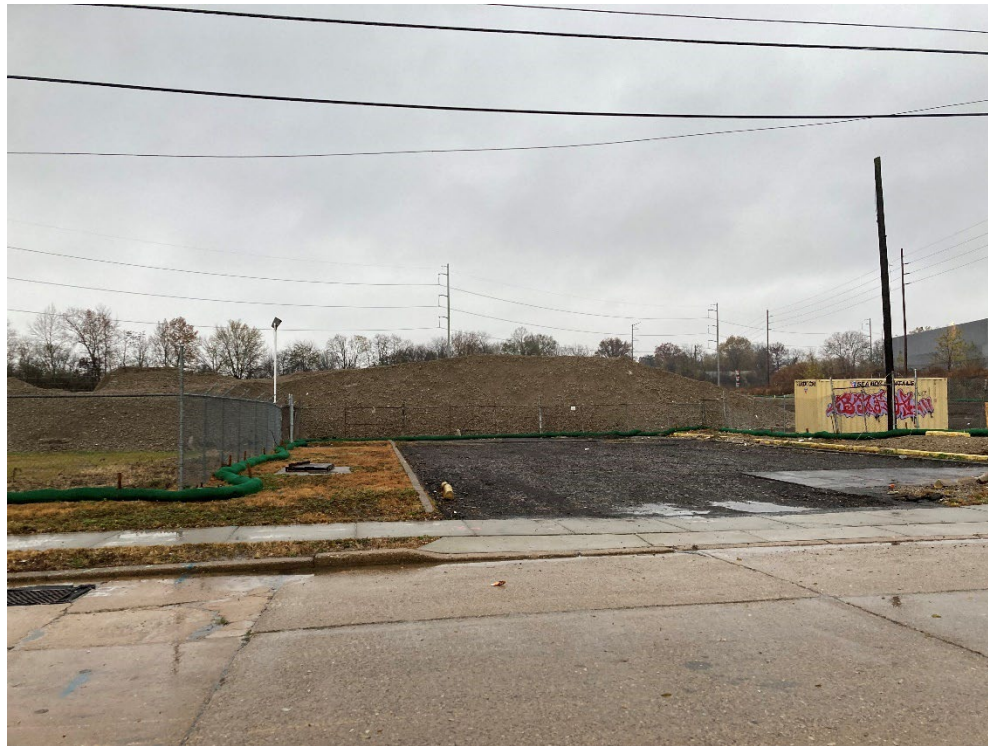
Stone stockpile, taken from 51st St.

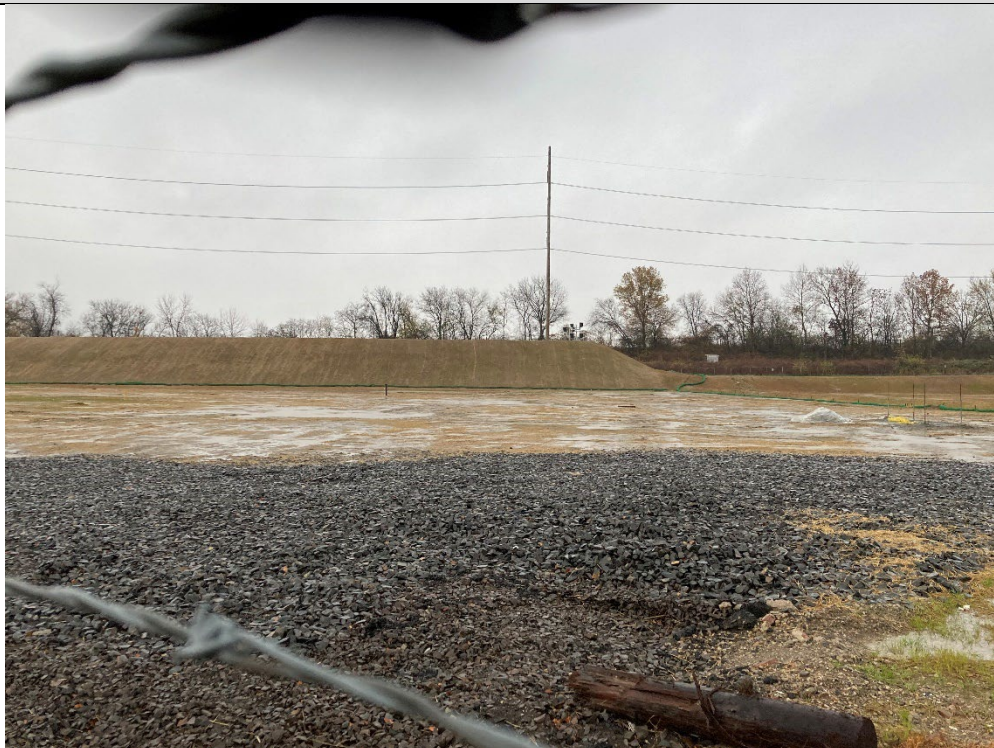
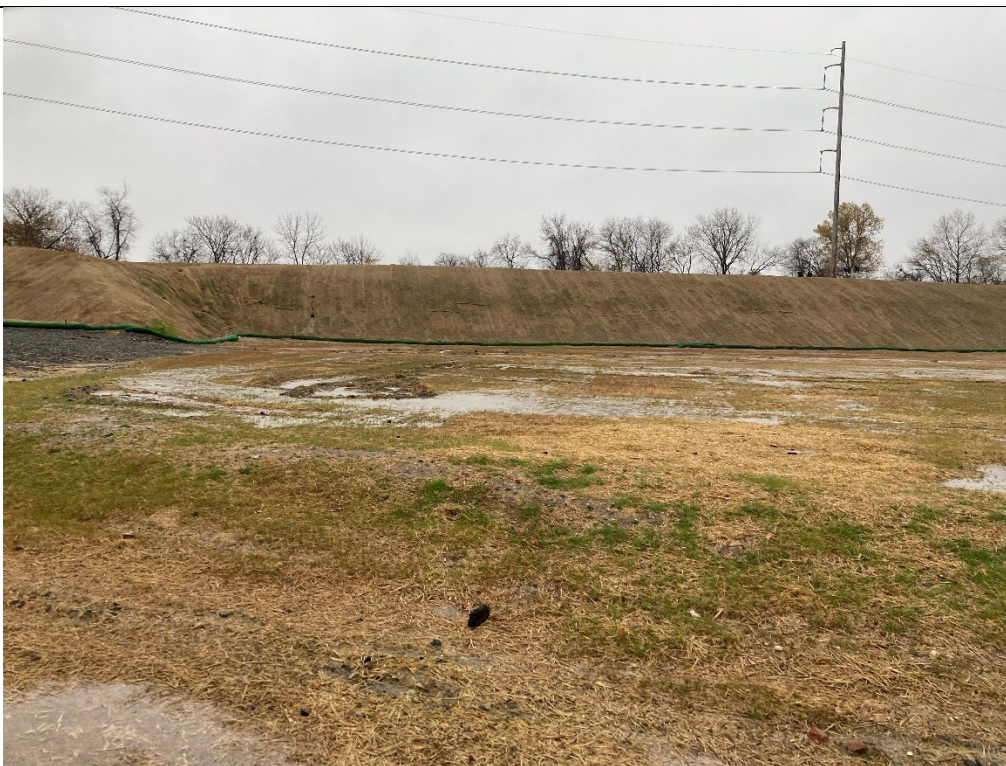
Significant puddling was noted on the flat area in the middle and downslope portion of the site.

Puddling on site during rain event, with large fill dirt stockpile in background.

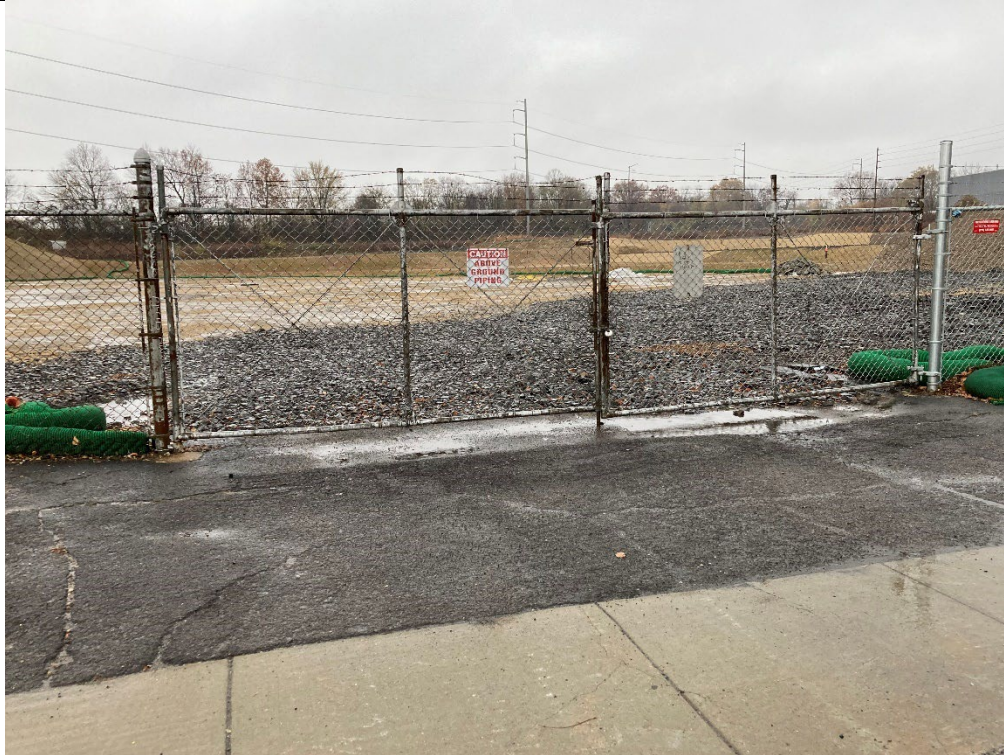
The more downslope of the two gates to the site, along 51st St.

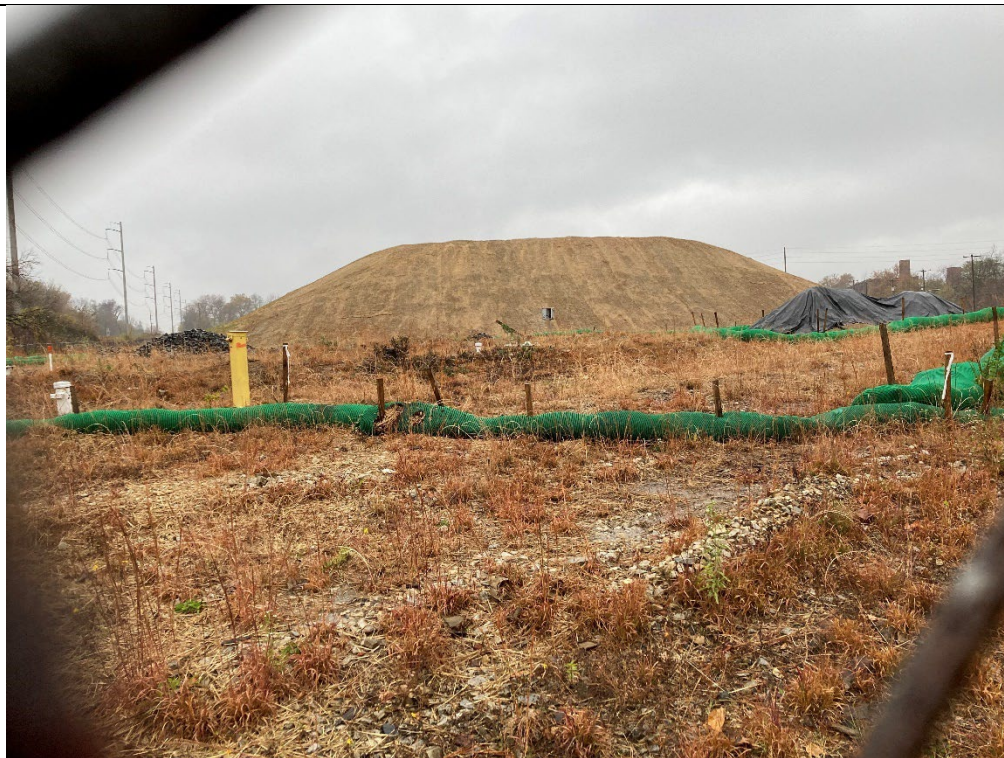
The erosion gullies first noted on the large fill dirt stockpile (first described in Report No. 10, 10/22/24), remained present. Failure of temporary stabilization to minimize accelerated erosion and sedimentation is a violation of 25 Pa. Code, Section 102.22(b).

The black tarp covering the small pile of contaminated soil downslope of the large fill dirt stockpile was re-placed to its proper position since the last inspection on 11/21/24. Perimeter control (filter sock) around this pile, and the downslope site perimeter, remained intact.

Downslope end of the large fill dirt stockpile, with smaller tarped stockpile at center-right.

1. Significant erosion gullies remain on the large fill dirt stockpile. To maintain compliance with 25 Pa. Code, Section 102.22(b), addressing and maintaining the temporary stabilization of the large fill dirt stockpile is recommended.
2. In accordance with DEP's Erosion and Sediment Pollution Control Program Manual, Technical Guidance No. 363-2134-008 (March 2012), Page 65, inspect filter socks weekly and after each runoff event. In addition, DEP requests that damaged socks be repaired according to manufacturer's specifications or replaced within 24 hours of inspection.
3. Ensure that filter socks are re-placed into proper position at the gates along 51st St. after vehicles leave the site.
3. Repair of the security fence along 51st St. is recommended.

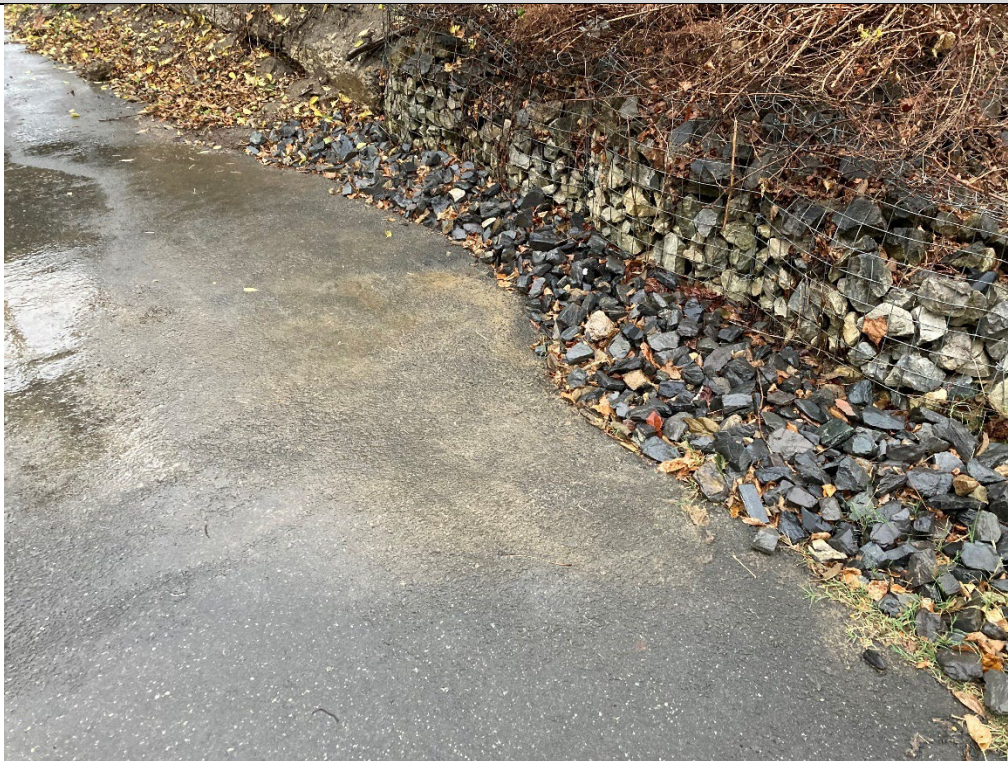
I noted that stormwater discharge from the site, as seen just downslope of the silt fences, where previous sediment staining is present on the trail, appeared to be clear during today's inspection.

Sediment staining on Bartram's Garden trail at most downslope boundary of site.

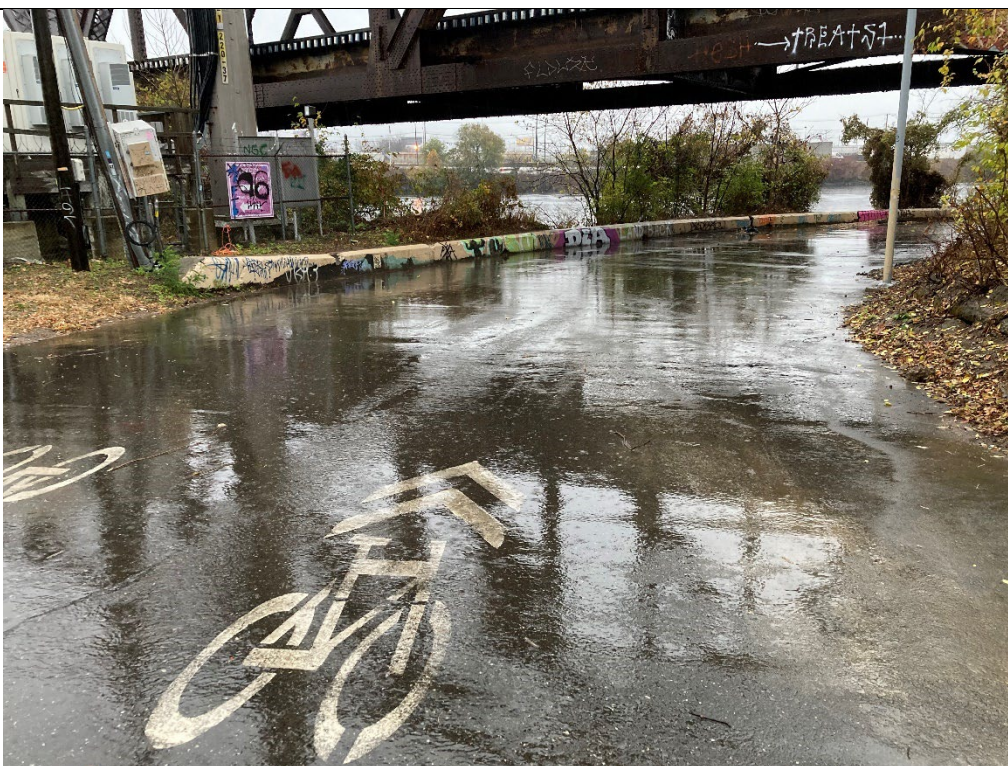
Bartram's Garden trail with previous sediment staining visible.

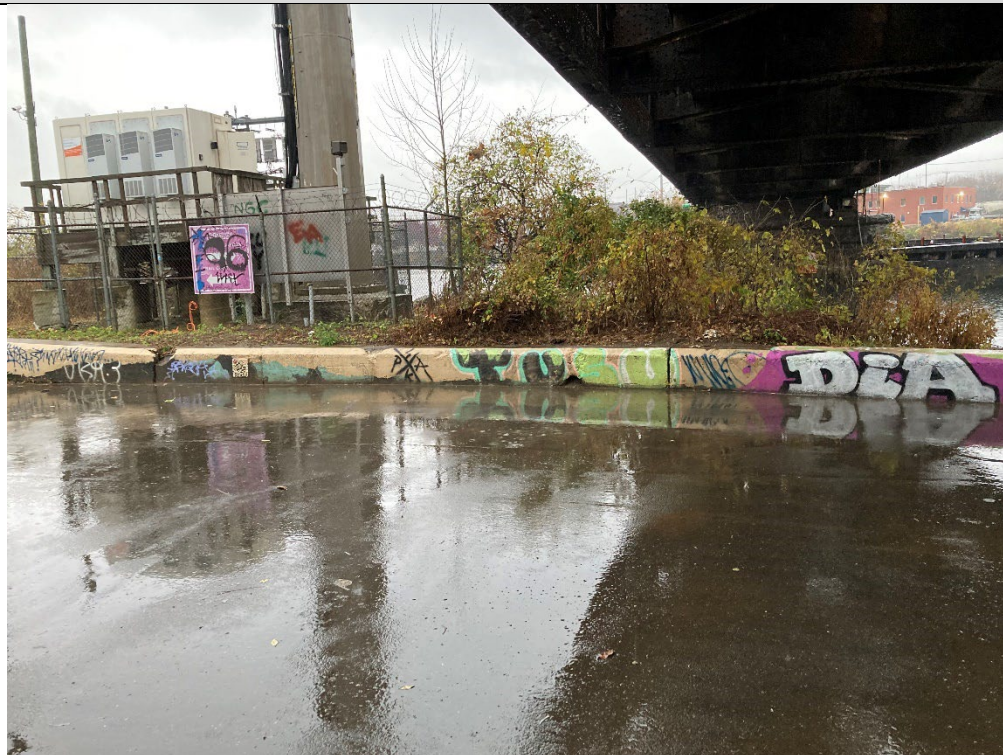
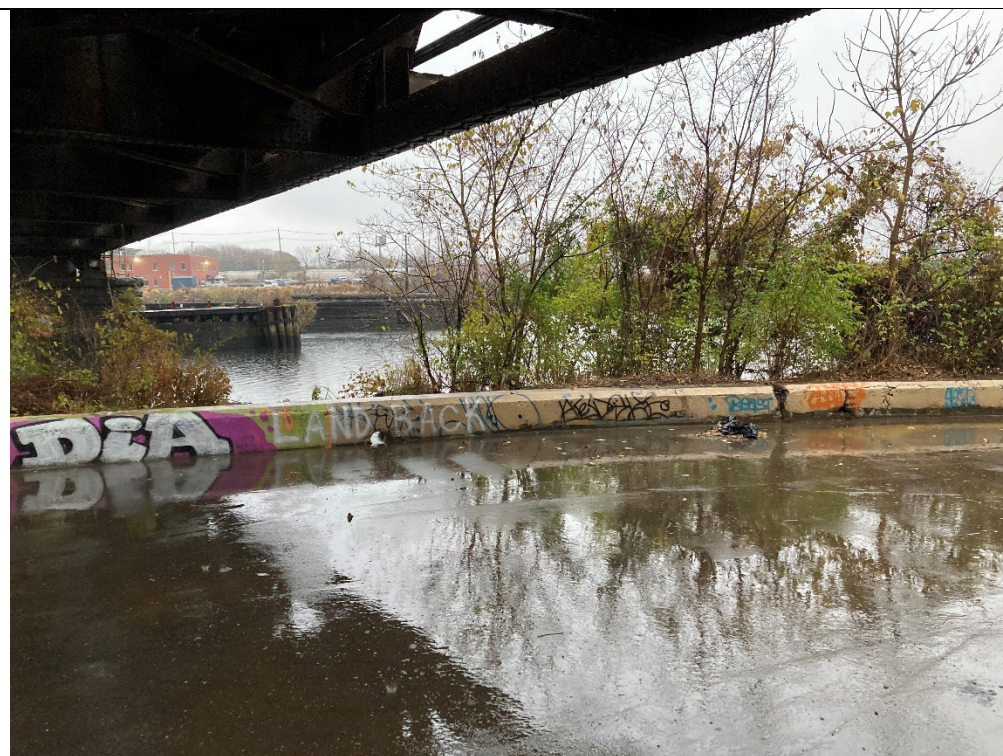
Bartram's Garden trail under railroad bridge.

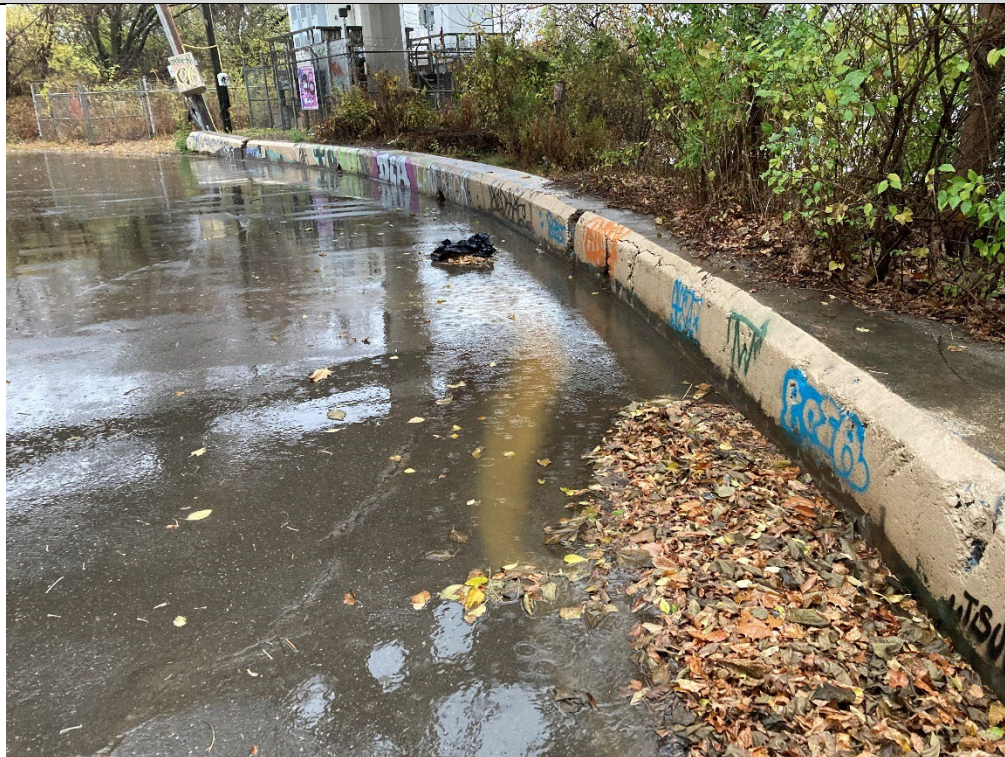
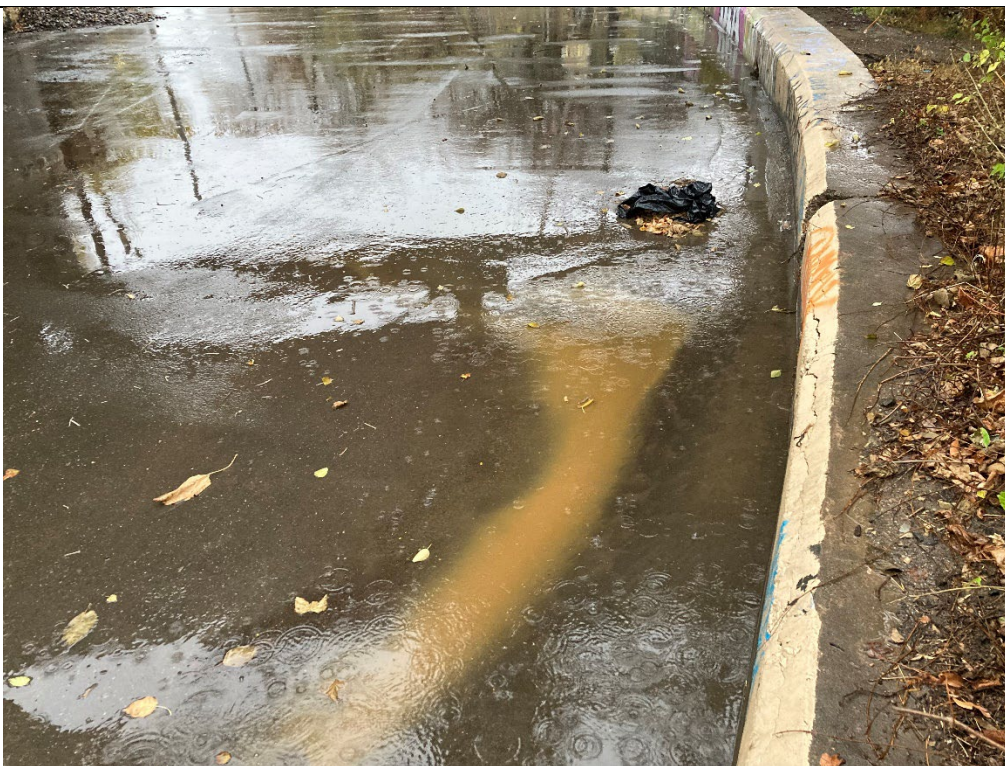
A plume of yellowish sediment discharge was present in the stormwater at the lowest point of the Bartram's Garden trail, as seen in the photo log accompanying this inspection report. I traced this plume to originate from the embankment of ballast stone for the train tracks. Stormwater from the site appeared to enter drain inlets in the wall upslope (to the north) of the location of the active plume.

Sediment plume in stormwater during active rain event, on Bartram's Garden trail under railroad bridge.

Close-up photo of sediment plume in stormwater during active rain event, on Bartram's Garden trail under railroad bridge.

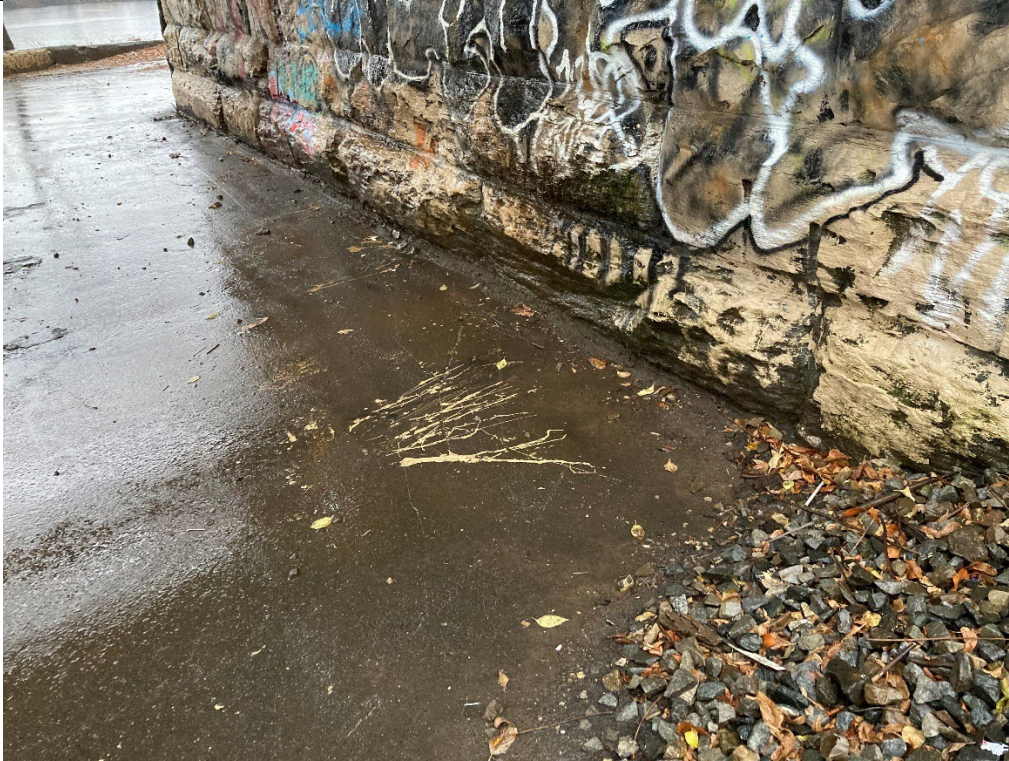
Upslope bridge abutment of railroad bridge over Bartram's Garden trail.

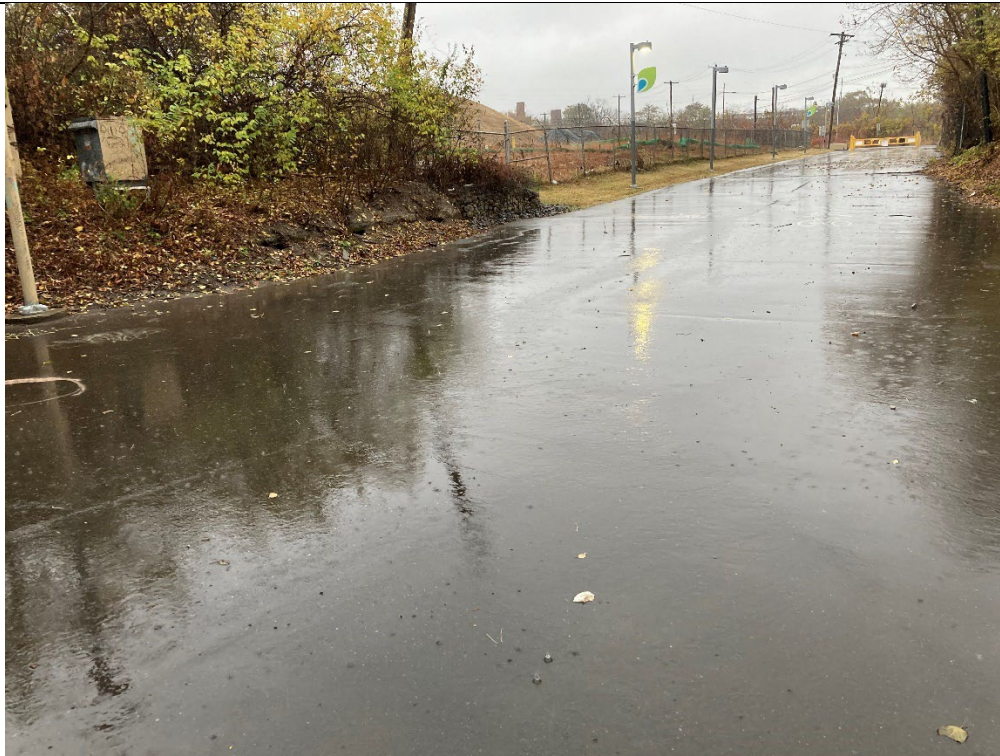
Bartram's Garden trail looking towards downslope boundary of site. Light streak seen on trail is reflection of street lamp during active rain event.

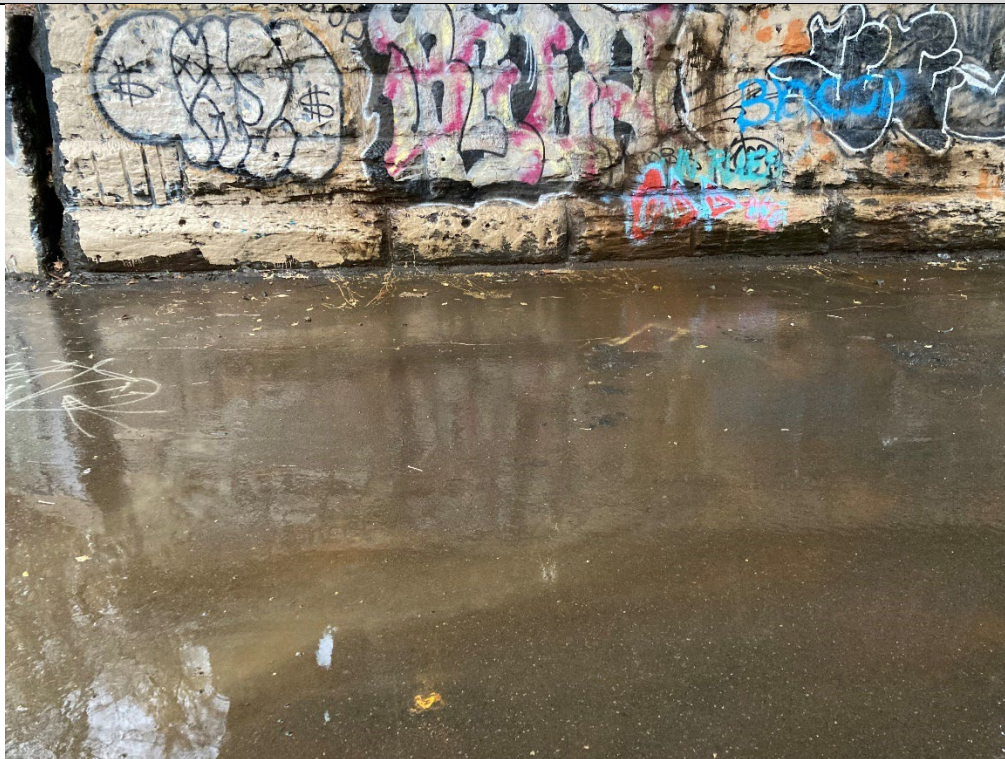
Bartram's Garden trail under railroad bridge, with sediment plume visible.

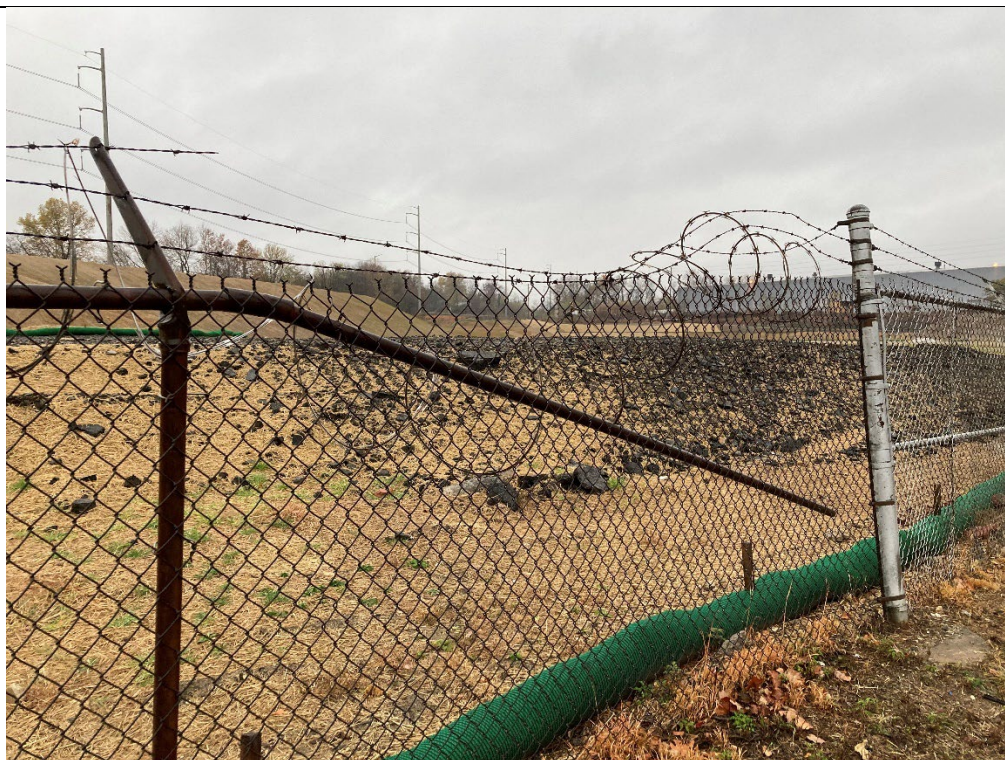
I saw that parts of the security chain-link fence along 51st St. were damaged.

Damage to security fence near corner of 51st and Botanic Sts.
End of photo log.
