GENERAL INSPECTION REPORT (Non-NPDES)

Name and Location of Facility or Pollution Incident	County	Municipality
51st and Botanic Ave.	Philadelphia	Philadelphia

This continuing incident investigation of the former PBF petroleum tank farm was done by WQS Paul Jardel. Mr. Carlson was interviewed by phone at the time of inspection. He gave permission for entry to the site.

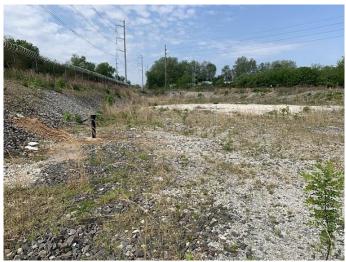
The tank containment located in the western corner of the site was viewed. It is upgradient of the ditch and the TK-7550 and TK-7551 tank containment. The containment near MW-9 held deposited areas of soil, brown sand, a plaster like material, and clinker residue mixed with glass and other materials. The area should be investigated as a possible source.

MW-9 and deposited fill in the upgradient tank containment

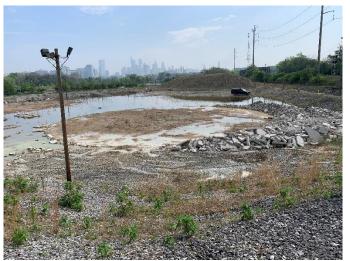
Pooled water in the former TK-7550 and TK-7551 tank containment now shows similar yellow-green discoloration in the western upgradient section.

TK-7550 / TK-7551 tank containment with discoloration

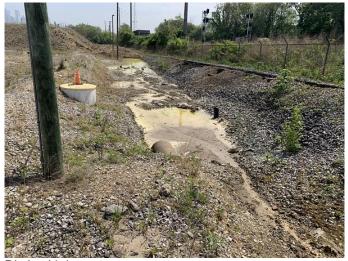
Mr. Carlson stated that they have placed numerous berms across the impacted drainage ditch to prevent the yellow-green colored material from leaving the site

Ditch with berms at rear

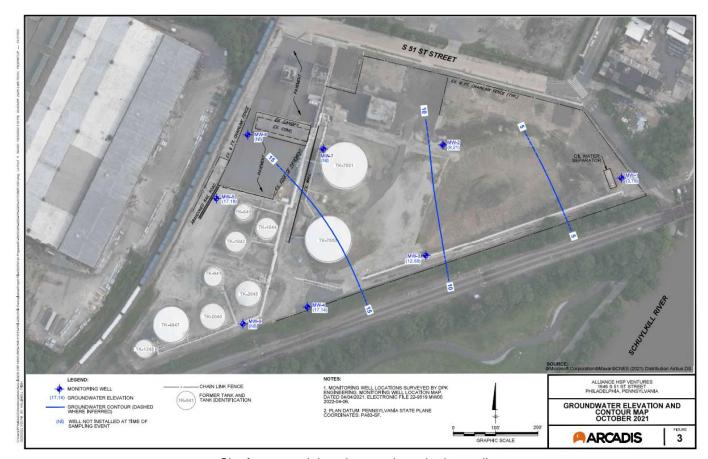
Site former tank locations and monitoring wells
