CHAPTER 102 INSPECTION REPORT

Permit No.:	PAD510225

Clear Report			Report No.: 2	7			
GENERAL INFORMATION							
Project/Site Name: Site Address: Site City, State, ZIP: RP/Permittee Name: RP/Permittee Address: RP/Permittee City, State, Z RP/Permittee Email: Surface Water(s):	ecarlson@alliancehp.com Schuylkill River	Permit Issuance Date: Permit Expiration Date: Permit Type: Site Municipality(ies): Site County(ies): Earth Disturbance: Site Latitude: Site Longitude:	NPDES IP Philadelphia Philadelphia 11.54 39.935278 75.209236	acres			
Special Protection?	Yes No	Complaint Inspection?	⊠ Yes	∐ No			
Construction Stage:	Inactive Company	Activity:	Construction				
Operator Name	Operator Company	Operator E	maii	Approved			
n/a							
	INSPECTION INFORM	IATION					
Inspection Date: 10/9/25 Inspection Time: 11:30 ☑ AM ☐ PM Lead Inspector Name: Robert Page Inspector Email: ropage@pa.gov Inspector Title: Environmental Group Manager Inspector Phone: 484.250.5104 Other Inspector(s): n/a Weather: Sunny, 64°F Was a representative of the project on-site during the inspection? ☐ Yes ☒ No Representative Name: n/a Email: n/a Representative Company: n/a Phone: n/a Type of Inspection: ☐ Initial ☒ Follo

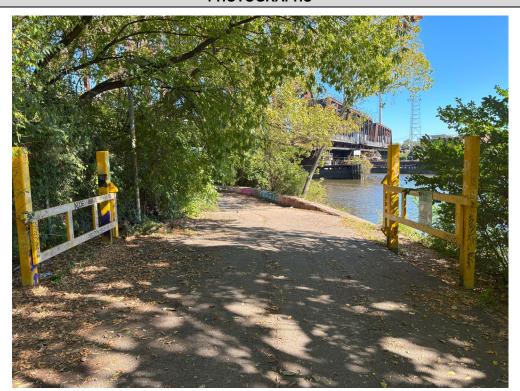
Open gates of Bartram's Garden trail downstream of railroad bridge.

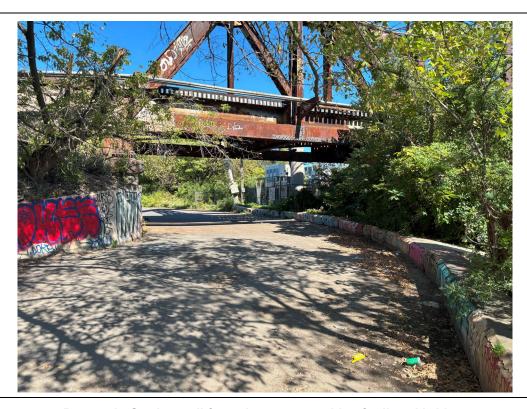
Bartram's Garden trail from downstream side of railroad bridge.

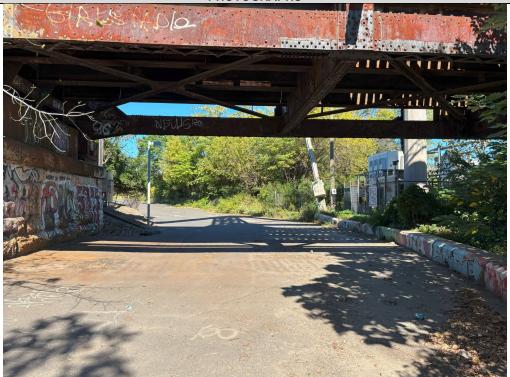
Bartram's Garden trail under railroad bridge.

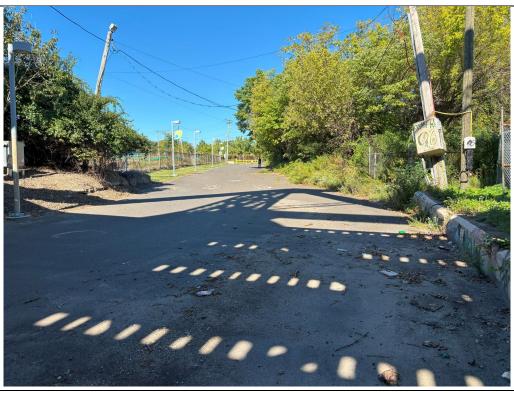
I observed that the pebbles and sediment deposition on the Bartram's Garden trail to be generally similar in condition, quality, and quantity. No new sediment trail or new sediment staining was observed leading from the site, as seen in attached photo log.

Bartram's Garden trail with pebbles, sediment, and leafy debris under railroad bridge.

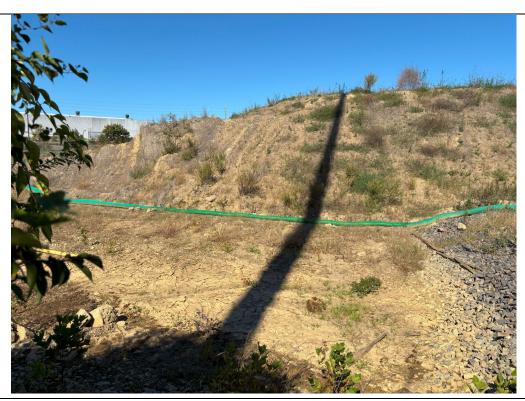
Upslope, back side of large fill dirt stockpile and beginning of stone-lined swale at bottom right.

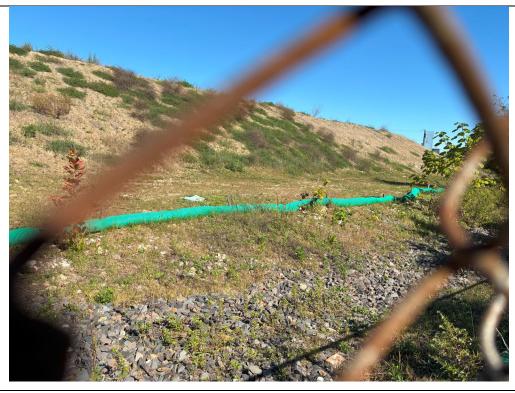
I noted that erosion gullies and rills remain present on the large fill dirt stockpile. Significant portions of the stockpile and midslope sections of the site did not have any vegetation, including the back side of the stockpile (facing the railroad tracks). Small sections of compost filter sock were near an overtopping condition. Failure to adequately provide permanent stabilization of the site and protect from accelerated erosion & sedimentation is a violation of 25 Pa. Code, Section 102.22(a). Failure to implement and maintain E&S BMPs to minimize the potential for accelerated erosion and sedimentation is a violation of 25 Pa. Code, Section 102.4(b)(1).

Back slope of large fill dirt stockpile from security chainlink fence along railroad tracks.

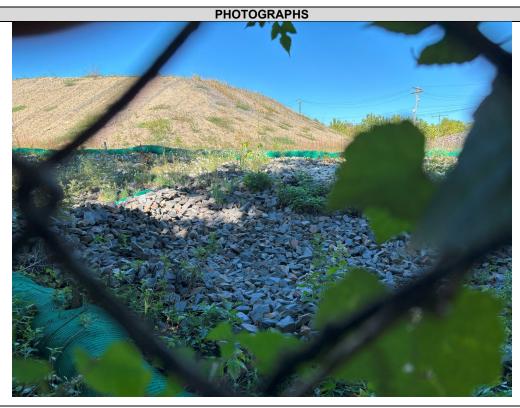
Stone lined swale and downslope end of large fill dirt stockpile from security chainlink fence along railroad tracks.

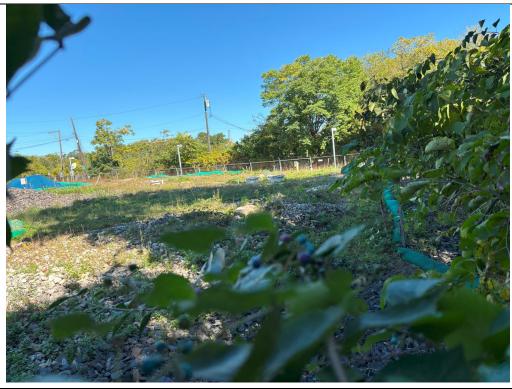
I observed that the tarp covering the contaminated fill dirt stockpile was intact and covering the pile.

Looking towards downslope corner of site along railroad tracks (opposite 51st St.) Tarped contaminated fill dirt stockpile at left.

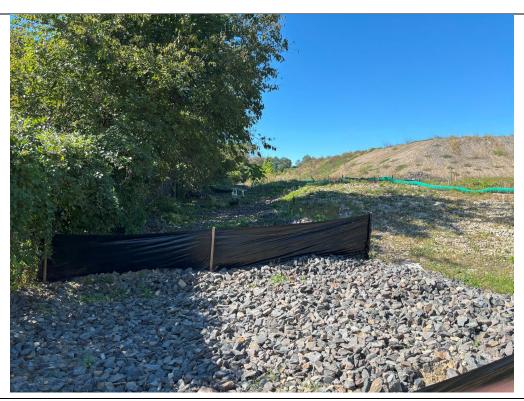
Stone-covered swale and silt fence along railroad tracks.

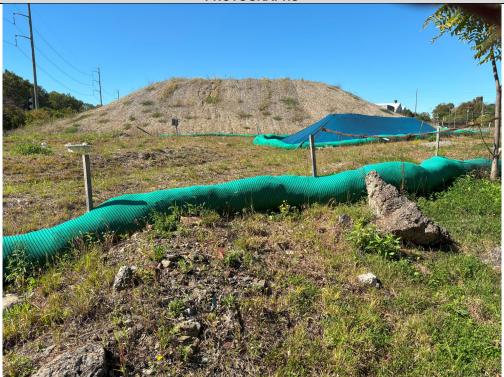
Downslope facing slope of large fill dirt stockpile with covered contaminated fill dirt stockpile in front.

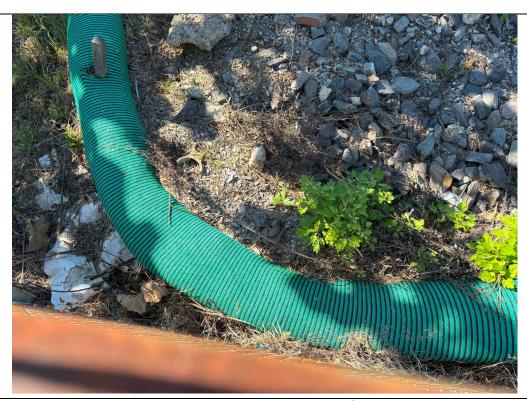
Silt sock at downslope corner of site adjacent to 51st St. and Botanic Ave.

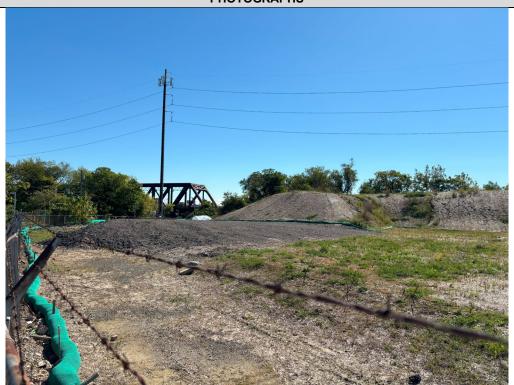
Downslope area of site.

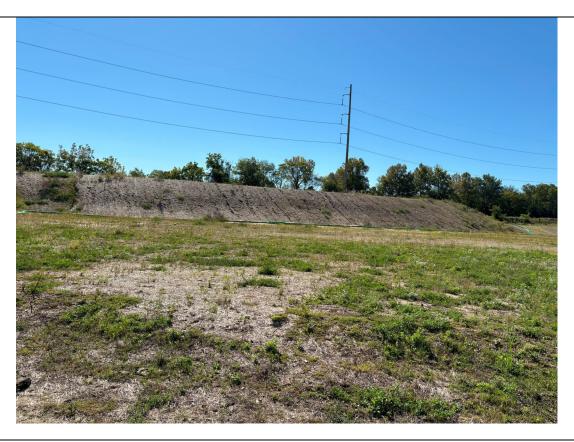
Large fill dirt stockpile in distance with erosions rills and gullies present.

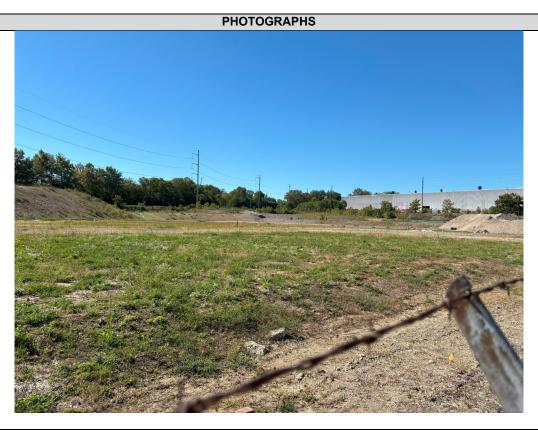
Looking upslope from the midslope portion of the site.

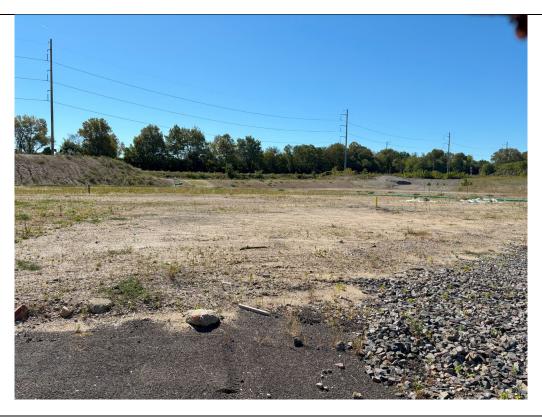
I noted that the filter sock along the midslope portion of the site along 51st St. remained in overall good condition.

Midslope portion of site.

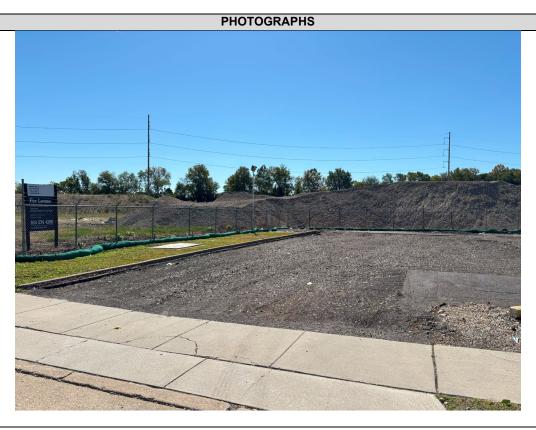
The "For Lease" signage remains in place, and the stone stockpile appeared to be unchanged.

Stone stockpile at midslope parking lot and "For Lease" signage.

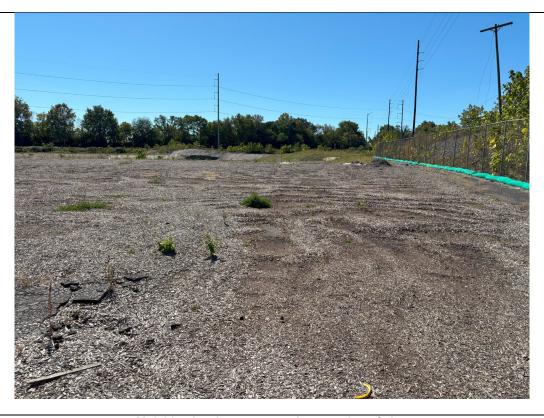
Mulching levels at most upslope portion of site.
