2700-FM-BAQ0023 2/2015 pennsylvania Department of Environmental Protection	INS	NSPECTION REPORT			Commonwealth of Pennsylvania Department of Environmental Protection Air Quality Program			
Date(s) of Inspection: TV D PA D SM GP D	Permit #(s):	Expiratio	n Date:	Case	#: PF	= ID #:	
8 22 23 NM D MEGA D				<u></u>			151121	
Company Name: HELDELBORG MATERIALS /	Municipa	-			Cour	-		
				TOWNSHIP N. ROCKHILL ROMA		BUCKS COUNTY Federal ID — Plant Code #:		
EAST RUCKHILL QUARRY SELLERINLLE , PA Responsible Official:			Mailing Address:

8/22/23 Heidelberg Materials East Rockhill Quarry Sampling Photos

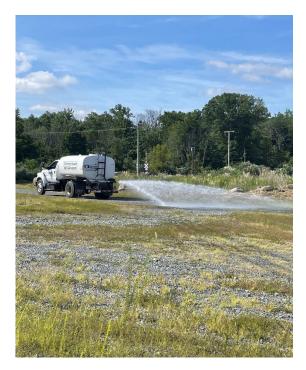
Water truck wetting the roadway- 8/22/23,10:17am

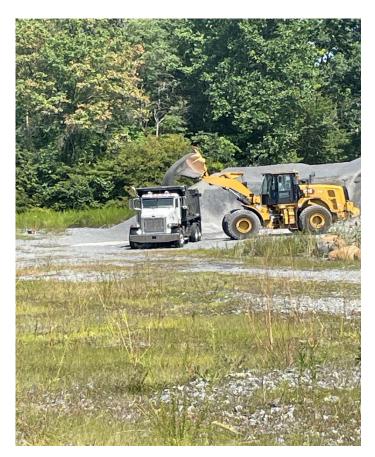
Rubber tire loader loading the truck with aggregate from stockpile- 8/22/23, 1136am

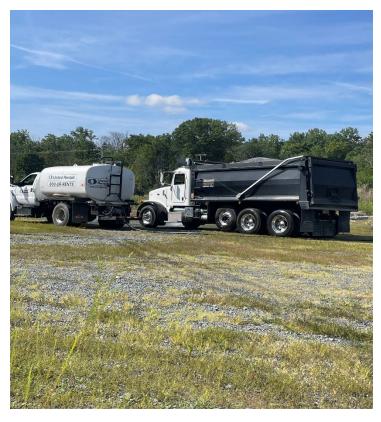
Water truck being used to wash the wheels of the truck-8/22/23, 1024am
