**COMMONWEALTH OF PENNSYLVANIA  
DEPARTMENT OF ENVIRONMENTAL PROTECTION  
BUREAU OF MINING PROGRAMS**

**Inspection Report**

<b>Inspection Type</b>	RTNC - Routine/Complete Inspection	<b>Permit Number</b>	7974SM1
<b>DEP Office</b>	EP DMO Pottsville Dstr Mng Off	<b>NPDES Number</b>	PA0594121
<b>Permittee Name</b>	HANSON AGGREGATES PA LLC	<b>PF Name</b>	HANSON AGGREGATES PA ROCK HILL QUARRY
<b>Address 1</b>	7660 IMPERIAL WAY	<b>Permit Type</b>	IMMO - Industrial Mineral Mining Operation
<b>Address 2</b>		<b>Permit Kind</b>	LARGE - Surface Large
<b>City</b>	ALLENTOWN	<b>License Number</b>	24143
<b>State/ZIP Code</b>	PA 18195-1016	<b>Permit Status</b>	ACTIV - Active
<b>Arrival Date / Time</b>	09/08/2021 09:03 AM	<b>Municipality</b>	East Rockhill Township
<b>Depart Date / Time</b>	09/08/2021 09:41 AM	<b>County</b>	Bucks
<b>Inspection ID</b>	3246345	<b>GP12 Permit Number</b>	
<b>Contract Operator Name</b>		<b>Contract Operator License Number</b>

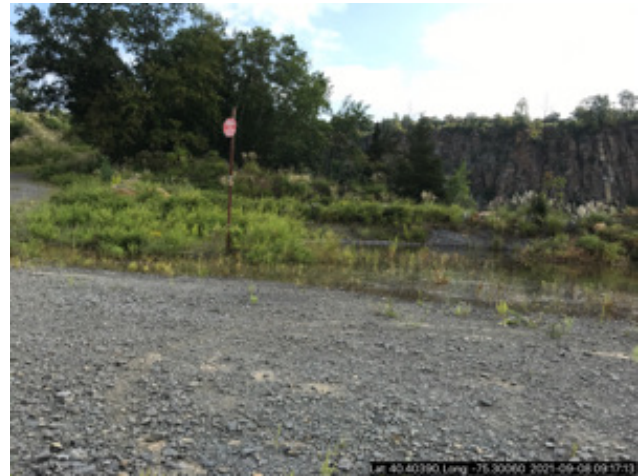
No activity observed. All erosion and sedimentation (E&S) observed and functioning. Water level in the pit has risen and flooded a small area where the water truck fill station was placed previously but is contained and not on the haul road. Water in all traps and ponds appeared clear. Water in discharge channel was clear. Water at Rockhill Rd was clear.

Pit water covering water truck fill area
