## NARRATIVE REPORT FORM

Facility Name: Glenwood Drive & Walker Road

Primary Facility ID: 881609

| Inspection Purpose: Oversight of supply well installation at [REDACTED] Washington Crossing, PA 18977 (Photo #1) and complaint inspection at [REDACTED], Washington Crossing, PA 18977. | | | | | |

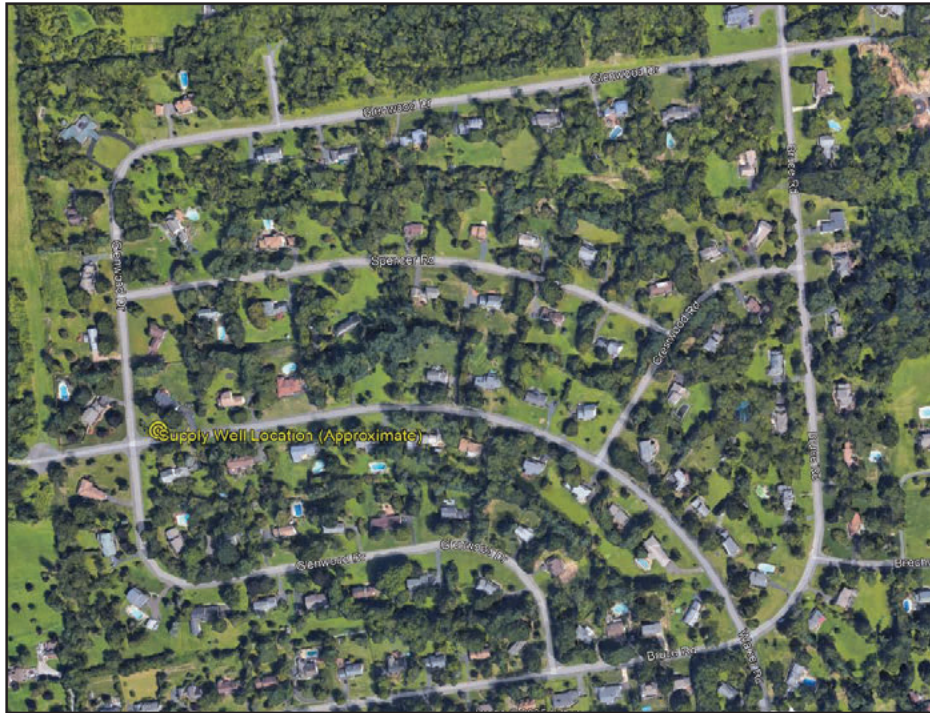
**Photo #1**

Supply well installation location, Washington Crossing, PA

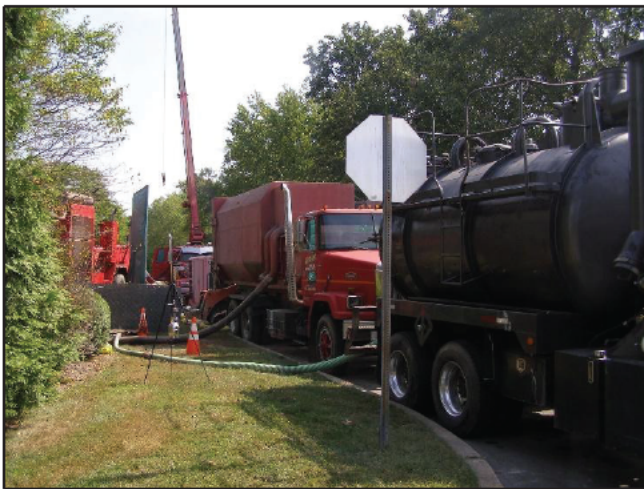
**Photo #2**Raab Drilling Equipment at Supply Well Drilling Area  
9/23/2025 @ 11:44

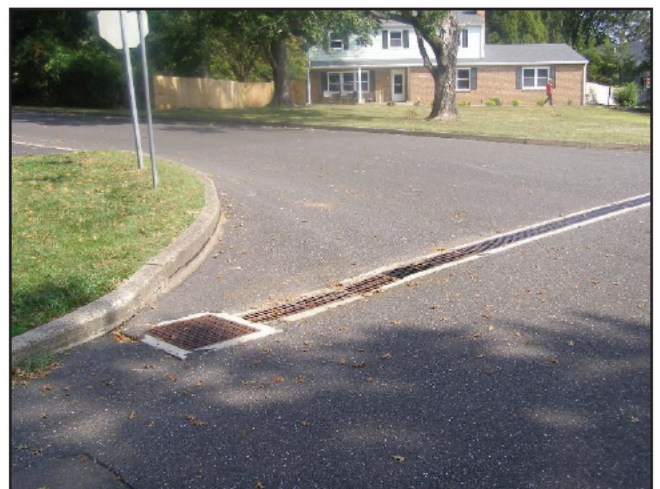
At 14:10, DL asks Rick Raab of Raab if he or his team had drained or dropped water at the corner of Glenwood Drive and Bruce Road upon leaving the Site on Monday, September 22, 2025. Rick tells DL that Raab staff did not.

**Photo #3**Storm Drain, Corner of Glenwood Drive and Bruce Road.  
9/23/2025 @ 11:58

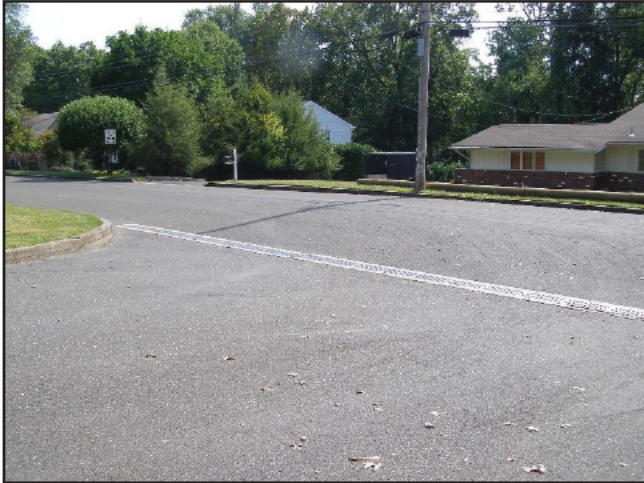
**Photo #4**

Storm Drain, Corner of Glenwood Drive and Bruce Road.  
9/23/2025 @ 12:03

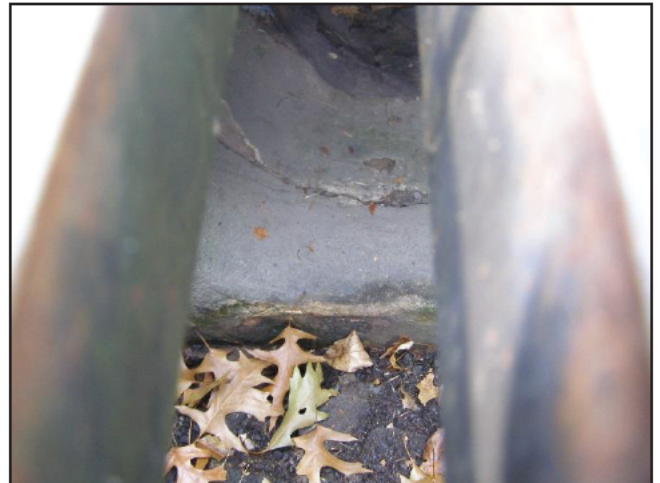
**Photo #5**

Interior of Storm Drain, Corner of Glenwood Drive and Bruce Road.  
9/23/2025 @ 11:58

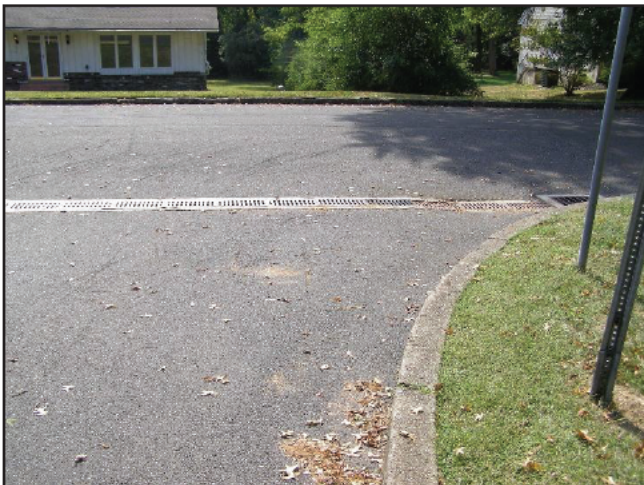
**Photo #6**

Storm Drain, Corner of Glenwood Drive and Bruce Road.  
9/23/2025 @ 12:03

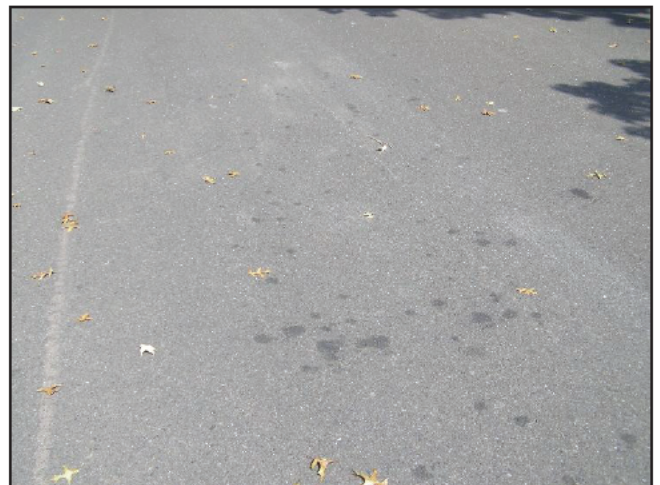
**Photo #7**

Asphalt Staining near Storm Drain, North of Bruce Road  
9/23/2025 @ 12:03
