## NARRATIVE REPORT FORM

Facility Name: Glenwood Drive & Walker Road

Primary Facility ID: 881609

| Inspection Purpose: Observation of pipeline repair at [REDACTED] Washington Crossing, PA 18977 (Photo #1). | | | | | |

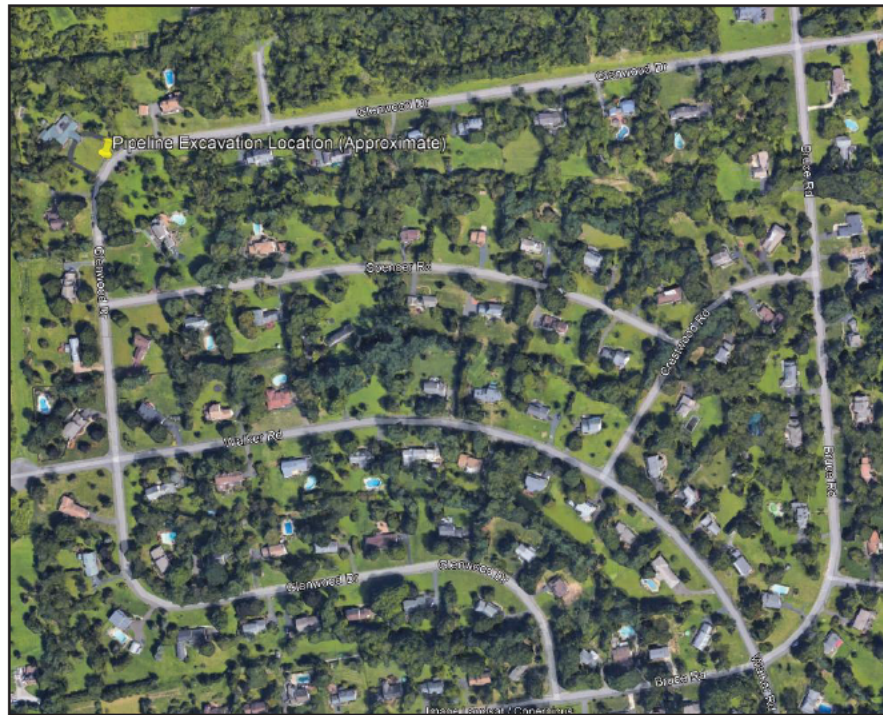
**Photo #1**

Pipeline Excavation Location, Washington Crossing, PA

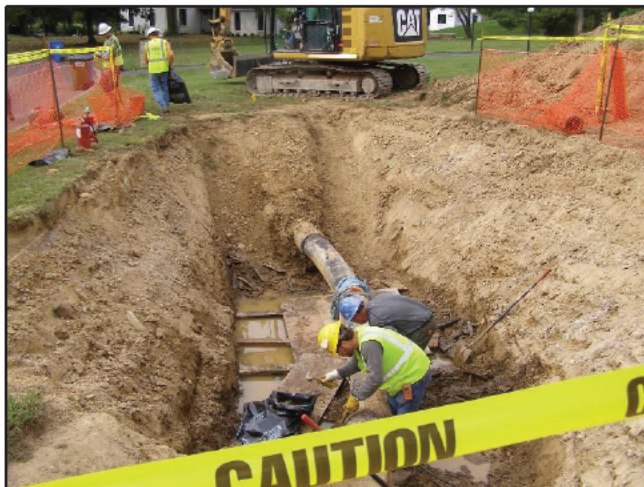
**Photo #2**Staff removing coating from pipe section.  
9/23/2025 @ 10:10

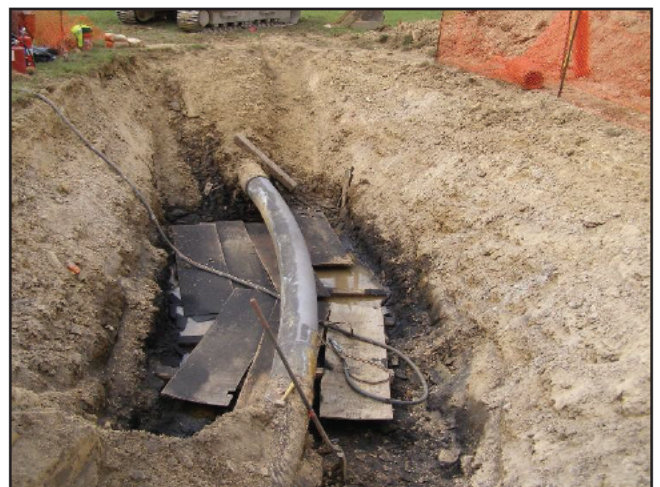
At 11:50, sandblasting activities temporarily cease due to an overheated compressor. DL notes that about half of the exposed pipe had been sandblasted (Photo #3) and that the contractor was using Black Beauty abrasive sand (Photo #4), which is black in color, to conduct the sandblasting work. An ET/SPLP vac truck arrives (Photo #5) to be on standby for removal of water entering the excavation.

**Photo #3**Pipe section midway through sandblasting.  
9/30/2025 @ 11:39

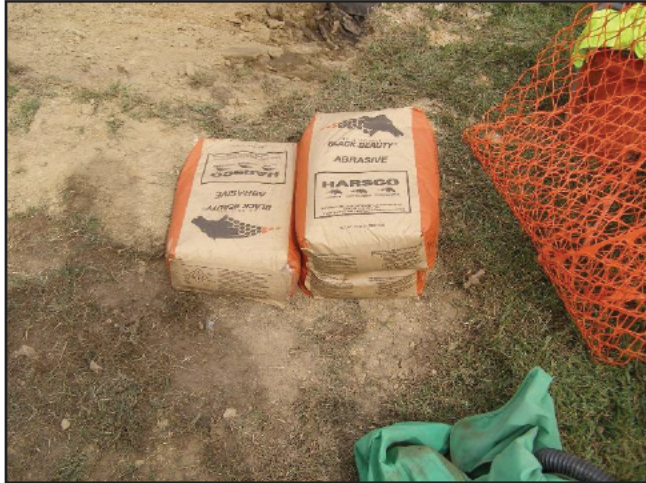
**Photo #4**

Black Beauty abrasive sand used for sandblasting of pipe.  
9/30/2025 @ 12:00

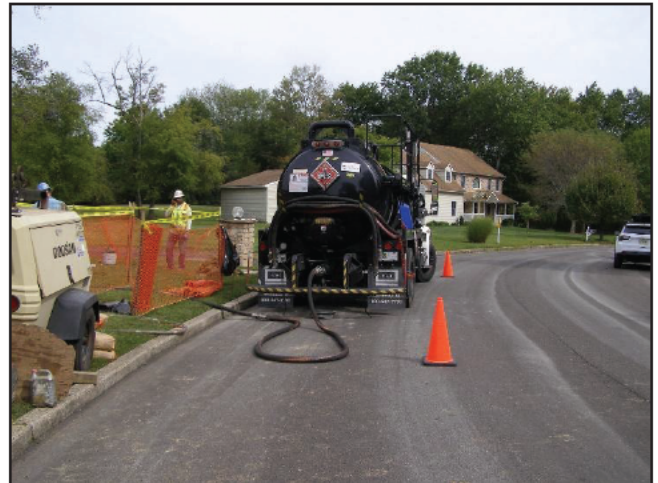
**Photo #5**

Vac truck on standby for groundwater removal, if needed.  
9/30/2025 @ 12:00

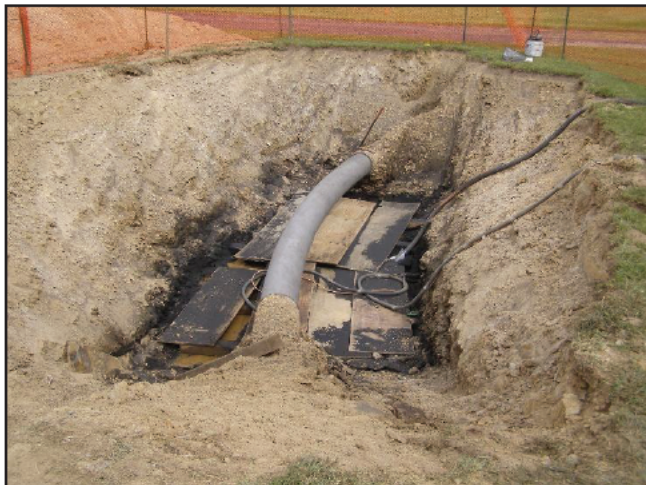
**Photo #6**

At 12:45, sandblasting is complete (Photo #6). Contractors begin preparations for additional diagnostic testing of the pipe (Photo #7).

Pipe section following completion of sandblasting.  
9/30/2025 @ 12:46

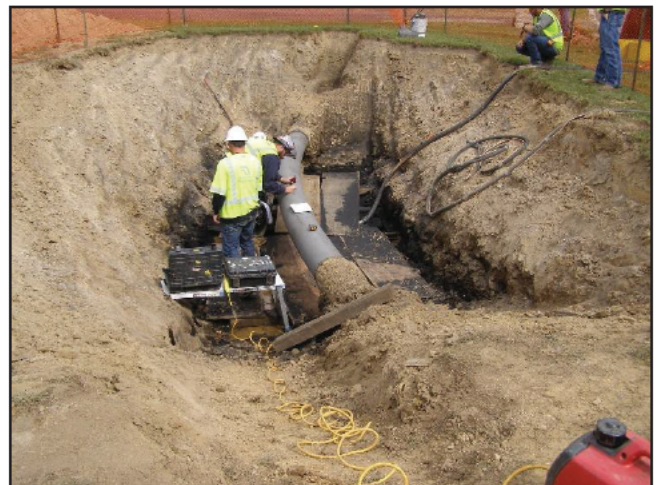
**Photo #7**

Staff preparing for additional diagnostic testing of pipe section.  
9/30/2025 @ 12:56
