New Hope Crushed Stone

Monthly Update
Solebury Communications Group
October 2016

October 2016 Project Status

| STATUS AS OF: | October 31, 2016 | | |
|---|---|--|--|
| PROJECT | New Hope Crushed Stone (NHCS) Quarry Reclamation and Stream Restoration | | |

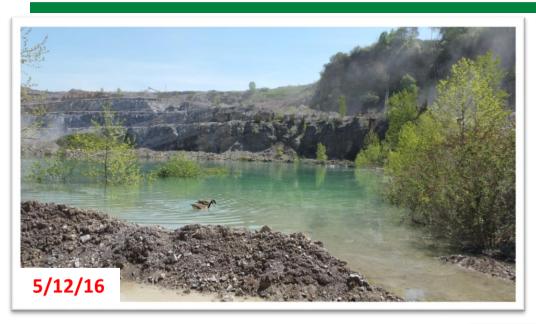
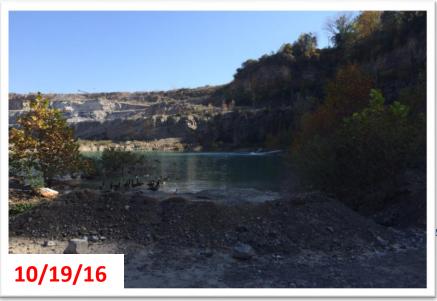
Sump - Reclamation

By months end, no change in water level.

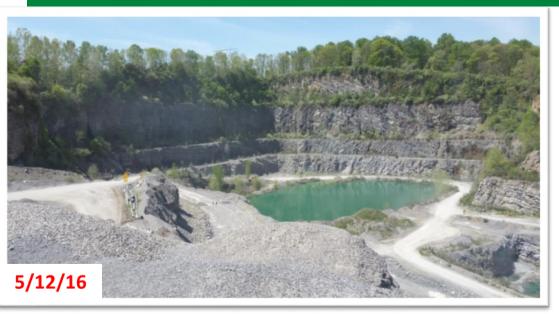
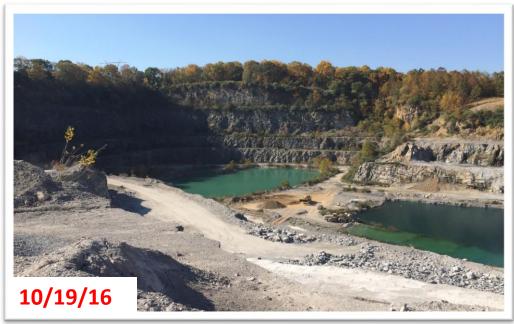
Ramp, Looking South - Reclamation

Sump area unchanged. Pit area to the right is up to about -85 MSL, or 35 feet above the floor.

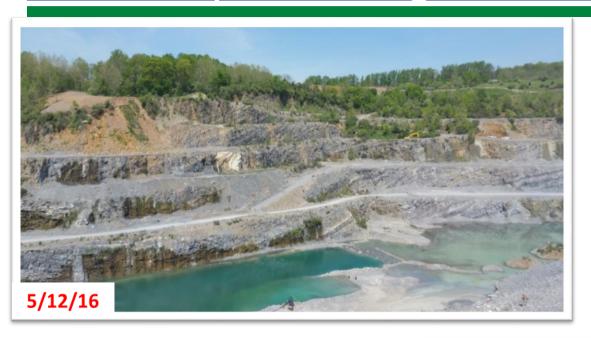
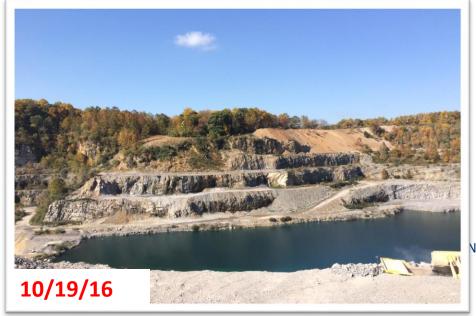
Ramp, Looking West - Reclamation

Overburden has been pushed over the northwest corner. Pit area water is at the -85 MSL level, or 35 feet above the floor.

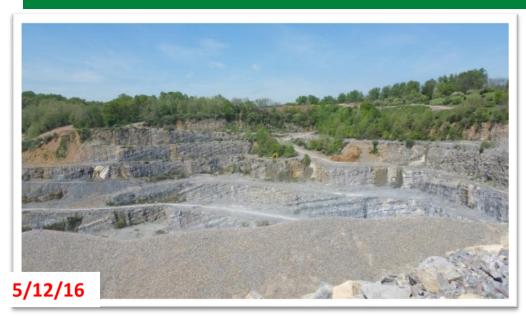
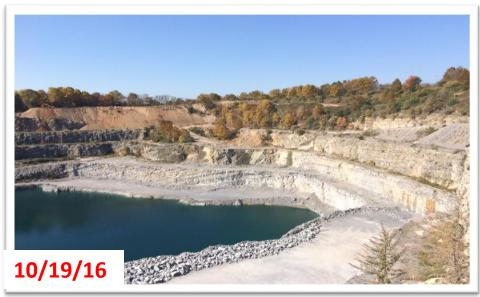
Garage, Looking North - Reclamation

Reclamation work continues in the northwest corner.

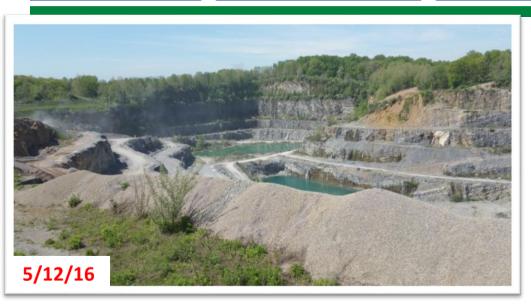
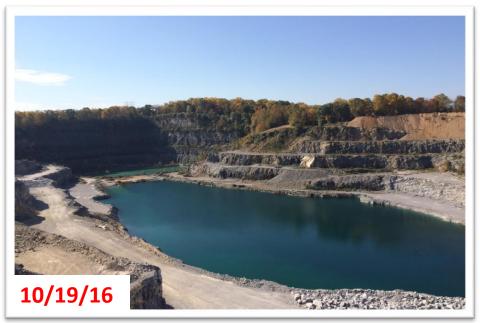
Garage, Looking South - Reclamation

Water levels continue to rise in the pit area. Reclamation work to the top right.
