New Hope Crushed Stone

Monthly Update Solebury Communications Group September 2017

STATUS AS OF:	October 5, 2017					
PROJECT	New Hope Crushed Stone (NHCS) Quarry Reclamation and Stream Restoration					
START DATE	Reclamation: January 29, 2016 Stream Restoration: January 29, 2016					
ANTICIPATED COMPLETION DATE	Reclamation: March 2019 Stream Restoration: March 2019					
CURRENT STATUS	Quarry Reclamation On Schedule Stream Restoration On Schedule

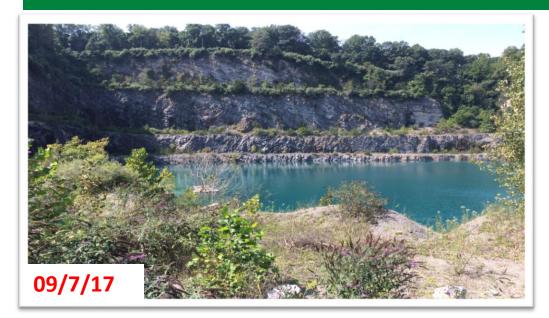
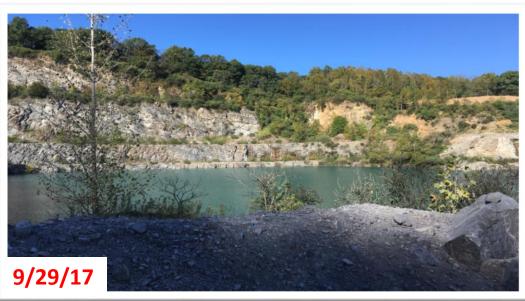
Sump Area

Looking west.

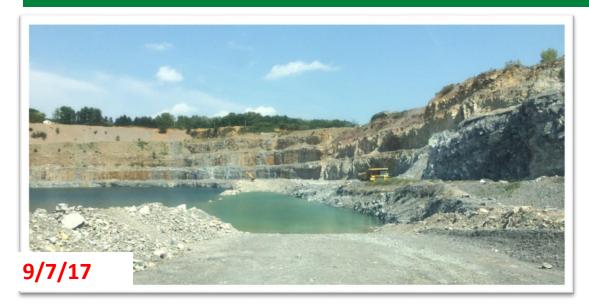
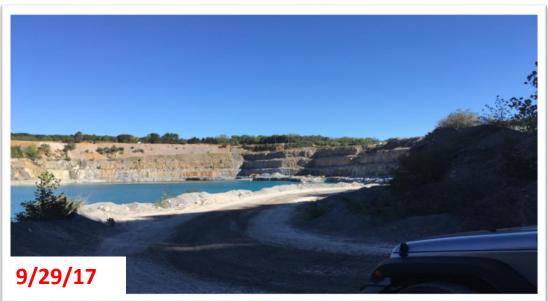
North and East Wall

Taken from the ramp area.

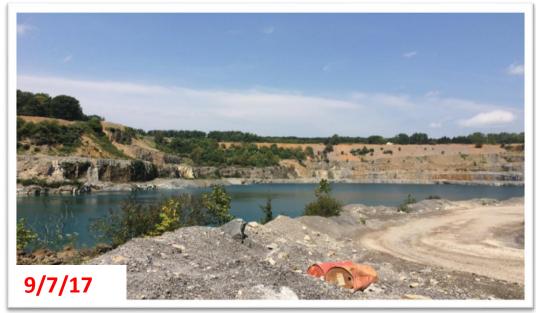
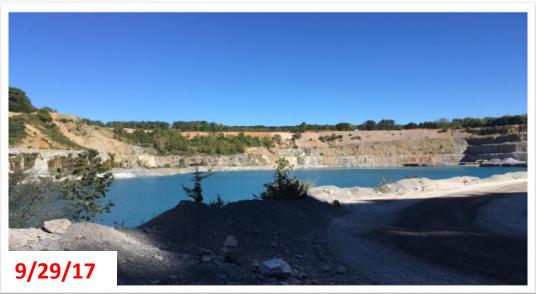
North and West

Taken from the ramp area.

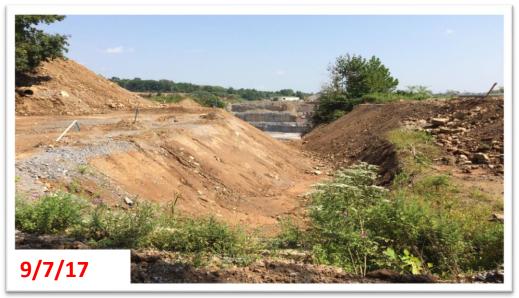
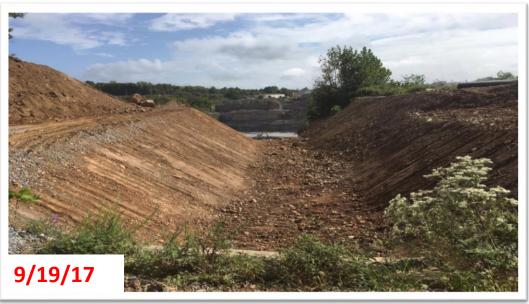
Stream Inlet to Quarry

- Work was also done on the inlet entering the quarry.
 - Highwall Reclamation Progress (New for September)
 - Total need is approximately 4,875 linear feet around the quarry (excludes pre-act areas at the southern end).

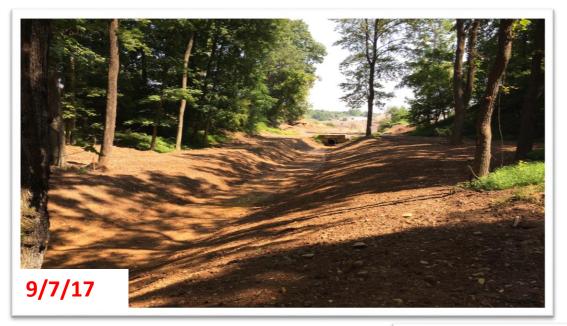
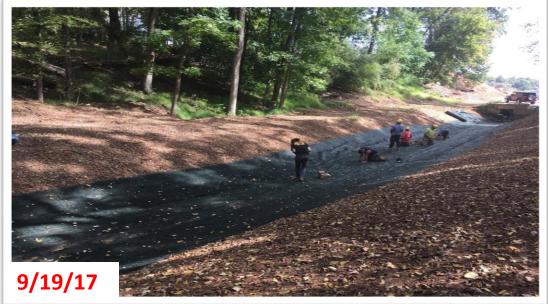
Stream Towards Quarry

- With DEP concurrence, stream restoration was emphasized starting in August to help insure the stream is stabilized moving forward.
 - Stream channel work including the installation of matting.
