Shell Chemical Appalachia LLC
300 Frankfort Rd
Monaca, PA 15061

May 23, 2025

RE: PA-04-00740C HP Ground Flares #1 and #2 (Source IDs C205A and B) Visible Emissions Malfunction Report

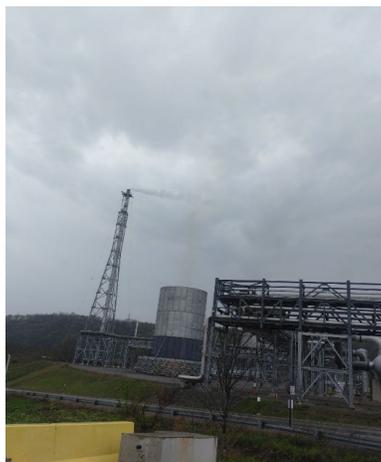
Observer Name: [REDACTED]
 Observer Title: Field Operator
 Date and Time (MM/DD/YY XX:XX): 4/25/25 9:58
 Sky Conditions: Cloudy
 Precipitation: Light Rain
 Wind Direction (direction from): SN 155.35
 Wind Speed (m/s): 0.8
[Site MET Data \(Wind Direction 500QT-060A and Speed 500QT-050A\)](#)
 Visible Emissions Source: High Pressure Ground Flare A (A-59001A)
 Observation Location: R (HPEF)
 Observation Picture:

Date (MM/DD/YY)	Clock Time (hh:mm)	Observation Period (accumulated time when you are looking at stack h:mm:ss, Example: 0:00:00-0:15:00 OR 0:15:00)	Emissions Observed (cumulative time you see smoke during observation period (mm:ss))
Begin	4/25/25	9:58	9:58:00	18:00:00
End	4/25/25	10:16	10:16:00	
Compliant? (Y/N)			N

Emission for the entire 18 min

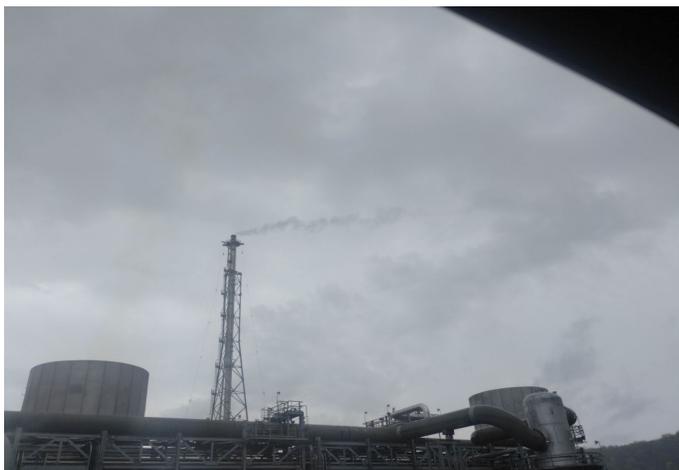
Observer Name: [REDACTED]
 Observer Title: Field Operator
 Date and Time (MM/DD/YY XX:XX): 4/25/25 0:00
 Sky Conditions: Cloudy
 Precipitation: Light Rain
 Wind Direction (direction from): SN 203.67
 Wind Speed (m/s): 0.71
[Site MET Data \(Wind Direction 500QT-060A and Speed 500QT-050A\)](#)
 Visible Emissions Source: HPGF A & B (A-59001A, A-59001B)
 Observation Location: R (HPGF A/HPGF B)
 Observation Picture:

Begin	Date (MM/DD/YY)	Clock Time (hh:mm)	Observation Period (accumulated time when you are looking at stack h:mm:ss, Example: 0:00:00-0:15:00 OR 0:15:00)	Emissions Observed (cumulative time you see smoke during observation period (mm:ss))
	4/25/25	11:57	11:57:00 AM- 12:08:00	11:00:00
End	4/25/25	12:08		
Compliant? (Y/N)	N

Emission for the entire 11 min

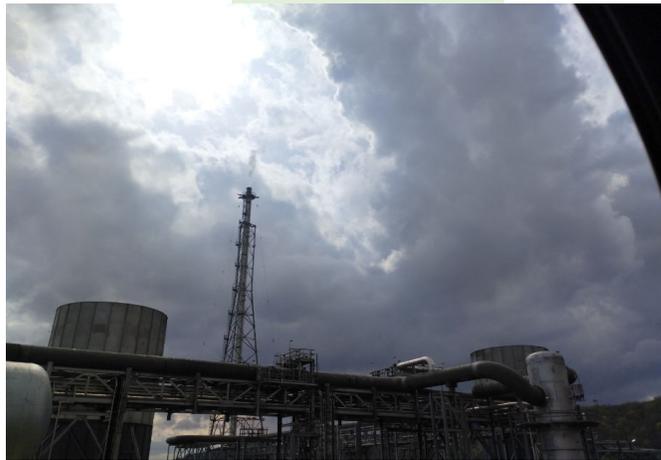
Observer Name: [REDACTED]
 Observer Title: Field Operator
 Date and Time (MM/DD/YY XX:XX): 4/25/25 15:52
 Sky Conditions: Cloudy
 Precipitation: None
 Wind Direction (direction from): SN 122.64
 Wind Speed (m/s): 0.5
[Site MET Data \(Wind Direction 500QT-060A and Speed 500QT-050A\)](#)
 Visible Emissions Source: HPGF A & B (A-59001A, A-59001B)
 Observation Location: R (HPGF A/HPGF B)
 Observation Picture:

Date (MM/DD/YY)	Clock Time (hh:mm)	Observation Period (accumulated time when you are looking at stack h:mm:ss, Example: 0:00:00-0:15:00 OR 0:15:00)	Emissions Observed (cumulative time you see smoke during observation period (mm:ss))
Begin	<u>4/25/25</u>	<u>15:52</u>	<u>15:54:00 -15:54:05</u>	<u>5 SEC</u>
			<u>15:56:00</u>	<u>10 SEC</u>
			<u>15:58:00</u>	<u>30 SEC</u>
			<u>16:00:00</u>	<u>5 SEC</u>
			<u>16:02:00</u>	<u>5 SEC</u>
			<u>16:03:00</u>	<u>3 SEC</u>
			<u>16:04:00</u>	<u>3 SEC</u>
			<u>16:05:00</u>	<u>5 SEC</u>
End	<u>4/25/25</u>	<u>18:02</u>		
Compliant? (Y/N)			<u>Y</u>
