Shell Chemical Appalachia LLC
300 Frankfort Rd
Monaca, PA 15061

RE: PA-04-00740C LP Incinerator (C204A) Visible Emissions Malfunction Report

Shell Chemical Appalachia LLC (“Shell”) is submitting this malfunction report to the Pennsylvania Department of Environmental Protection (PADEP) for visible emissions from the LP Incinerator on February 10, 2024.

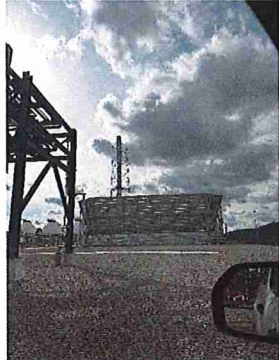
Observer Name: [REDACTED]
 Observer Title: Field Operator
 Date and Time (MM/DD/YY XX:XX): 2/10/24 9:39
 Sky Conditions: Cloudy
 Precipitation: None
 Wind Direction (direction from): E 70.15
 Wind Speed (m/s): 0.75
[Site MET Data \(Wind Direction 500QT-060A and Speed 500QT-050A\)](#)
 Visible Emissions Source: Continuous Vent Thermal Oxidizer (A-59003)
 Observation Location: A (MPGF/CVTO)
 Observation Picture: North of North Retension Pond

Smoking out of CVTO stack upon start up in intervals. Smoke was dark black for 5 out of the 8 instances. The last one at 1000 last about 1 min 42 seconds and was dark black, then we put waste gas back to the ground flare.
