Shell Chemical Appalachia LLC
300 Frankfort Rd
Monaca, PA 15061

October 9, 2024

RE: PA-04-00740C LP Multipoint Ground Flare (C204B) Ethylene Header Visible Emissions Malfunction Report

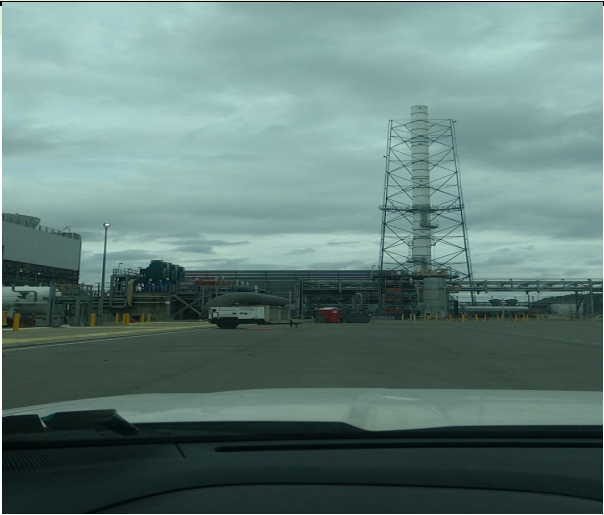
Shell Polymers Monaca			
Method 22 Visible Emissions Observation Form SPM-HSE-FO-0003			
Observer Name:			
Observer Title:		Field Operator	
Date and Time (MM/DD/YY XX:XX):		9/18/24 15:07	
Sky Conditions:		Cloudy	
Precipitation:		None	
Wind Direction (direction from):		E	112.17
Wind Speed (m/s):		2.42m/s	
		Site MET Data (Wind Direction 500QT-060A and Speed 500QT-050A)	
Visible Emissions Source:		Multipoint Ground Flare (A-59004)	
Observation Location:		H (MPGF)	
Observation Picture:

Observations			
Begin	9/18/2024 15:07	Clock Time 15:07	Observation Period (when you are actually looking at stack) 15 minute intervals End
			Emissions Observed (when you actually see smoke) 0:00:00 15:07:00 15:09:00 0:00:00 0:00:00 0:00:00 0:00:00 0:00:00 0:00:00 0:00:00
End	9/18/2024 17:07	17:07	
Compliant? (Y/N)	Y	Y	
General Notes			
Field Operator noticed that the Multipurpose ground flare was smoking at 1507. Contacted console operator and he made adjustments to the fan blower on the ethylene vapor line. Smoke stopped at 1509. No other observation of smoke during the two hour period.
