Shell Chemical Appalachia LLC  
300 Frankfort Rd  
Monaca, PA 15061

July 9, 2026

**RE: PA-04-00740C HP Ground Flares #1 and #2 (Source IDs C205A and B) Flaring Emissions and HP Ground Flare #1 Visible Emissions Malfunction Report**

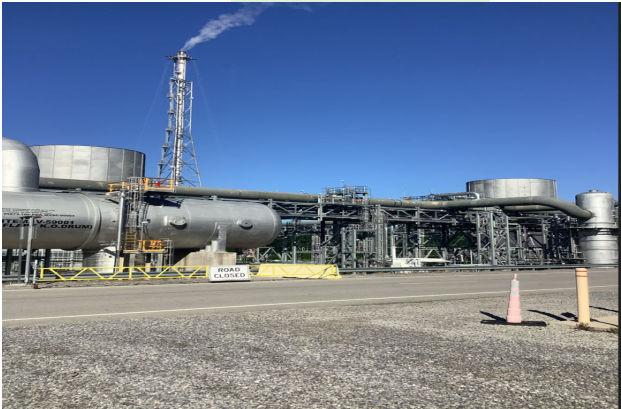
| <b>Shell Polymers Monaca</b><br><b>Method 22 Visible Emissions Observation Form SPM-HSE-FO-0003</b> | | | | |
|---|---|---|---|---|
| SMOKE OBSERVED ON A TEGF FOR 3 MINUTES, 9:05-9:08<br>NO SMOKE OBSERVED ON B TEGF | | | | |
