Landslide Hazard Evaluation and Temporary Slope Stabilization Plan

Revolution Pipeline
Butler, Beaver, Allegheny, and
Washington Counties, Pennsylvania

for
ETC Northeast Pipeline, LLC

February 23, 2019

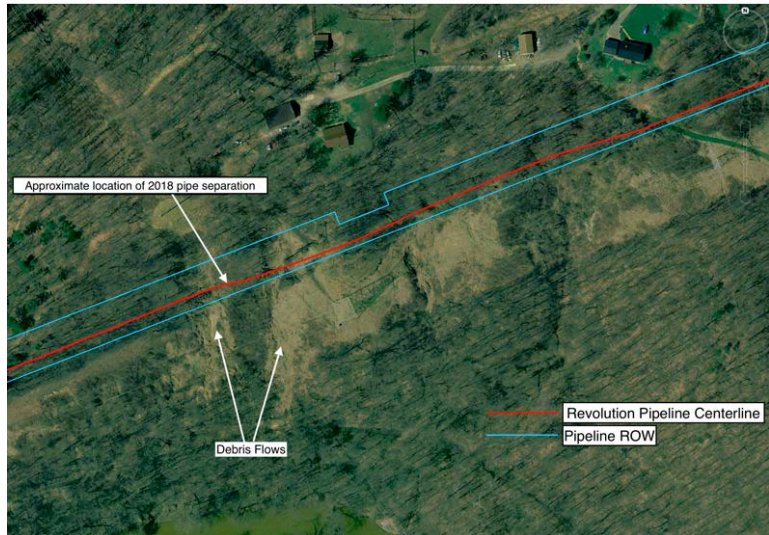
Landslide features were first observed in the photograph record in the December 7, 1975 black and white aerial photograph. A relatively large void in the canopy is apparent, starting from the First Energy powerline corridor and extending to the base of the slope as shown in the adjacent photograph. We interpret this void to represent a shallow-rapid debris flow that appears to have emanated from the cleared powerline ROW near the location of the slope failure that caused the pipeline separation.

December 1975 Aerial Photograph (USGS 1975)

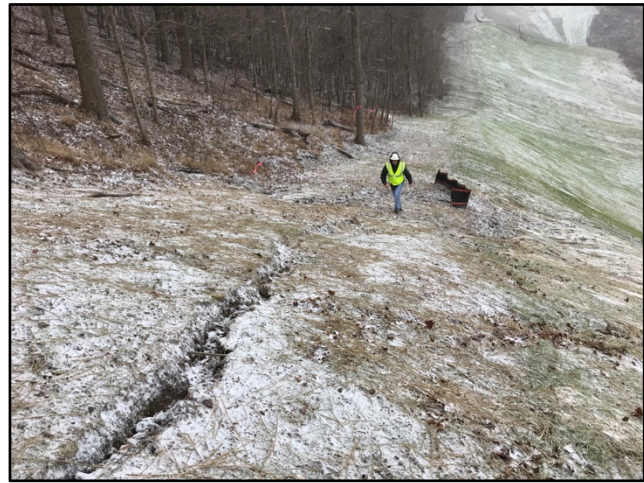
GeoEngineers observed arcuate ground cracks at the upslope (south) side of the ROW exhibiting up to 6 inches of vertical displacement (see photo to the right). A spring emerges from within the ROW and flows north towards the scarp of LS-1. Based on our observations, it is our opinion that the ground cracks indicate that a segment of the fill placed for the pipeline ROW restoration is failing.

Looking West along Pipeline ROW at Elkhorn Run Site 1.

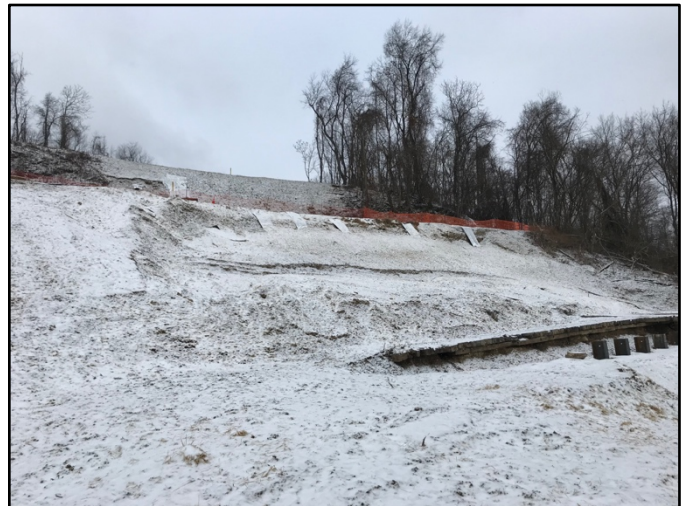
Looking northwest at reggraded landslide below Penny Hollow Road and H-piles installed at toe.

A fill slope failure within the ROW (first observed February 2018) initiated near the outboard edge of Penny Hollow Road but north of the pipeline centerline from approximate stations 1212+00 to 1213+50. Geo-Mechanics, Inc. performed a subsurface exploration program and designed slope stabilization measures, which included a soldier pile wall near the toe of the slope failure. Prior to the stop work order being issued, the H-piles for the wall had been installed along with construction access roads and timber matting to facilitate the wall construction.

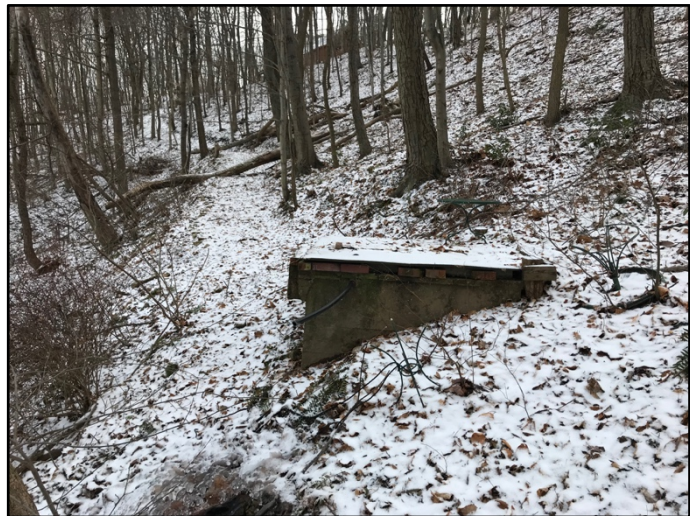
Looking east at a concrete vault on natural slopes north of the pipeline ROW.

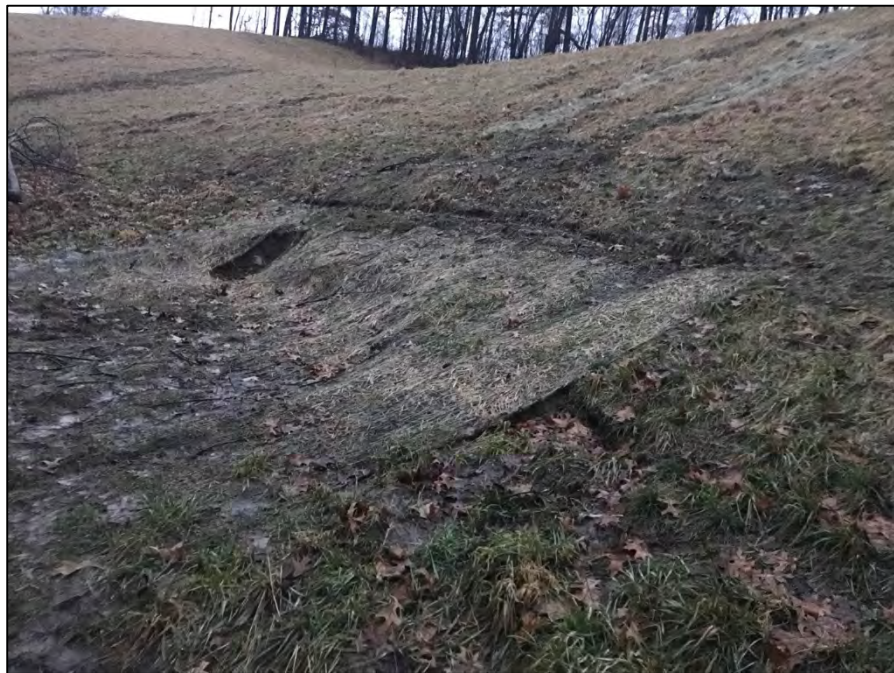
Looking north at the shallow fill failure near station 451+00

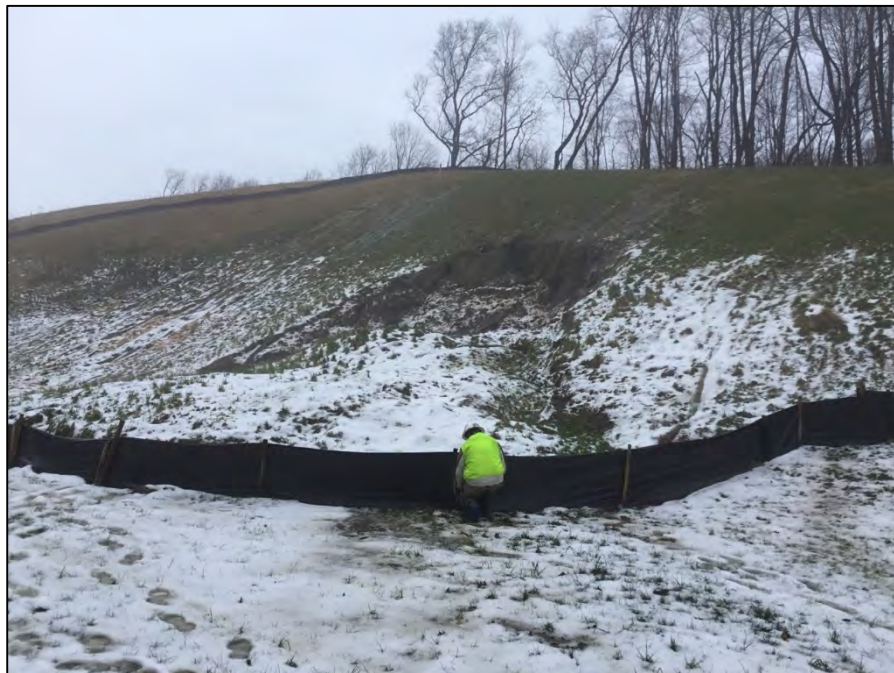
Fill failure near station 734+50

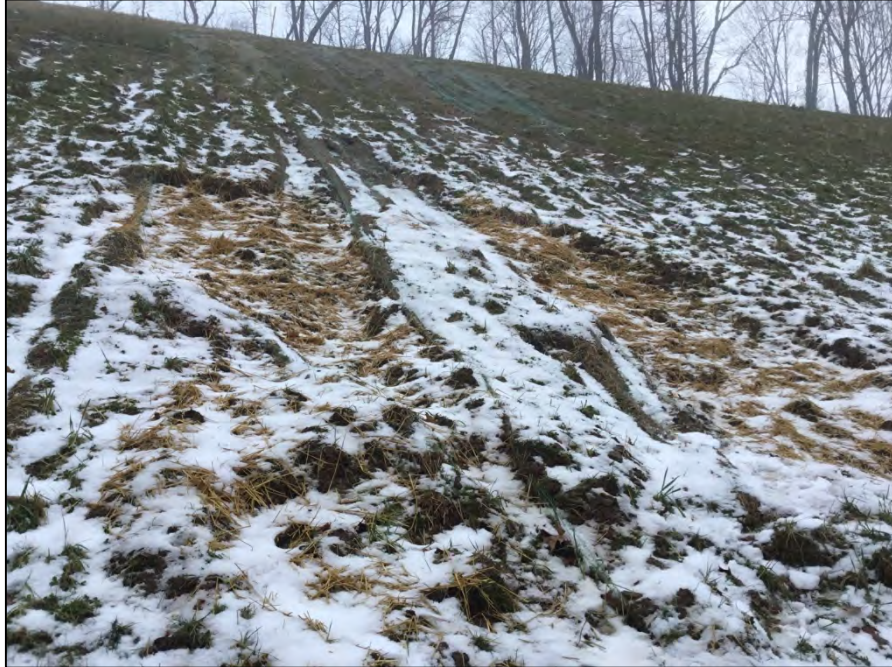
Shallow surface raveling near station 735+50

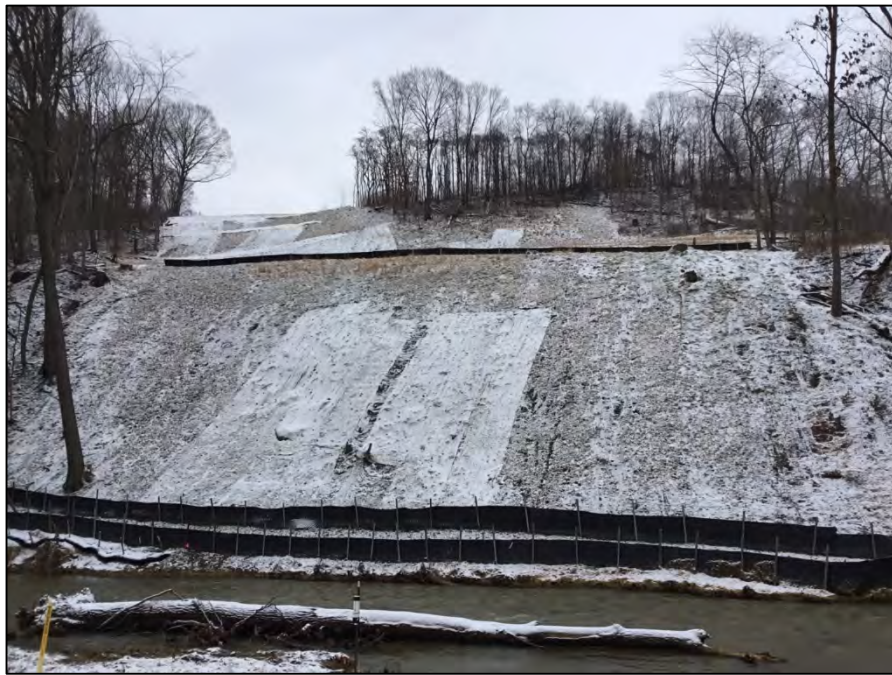
Looking east towards the surface failure near station 789+00

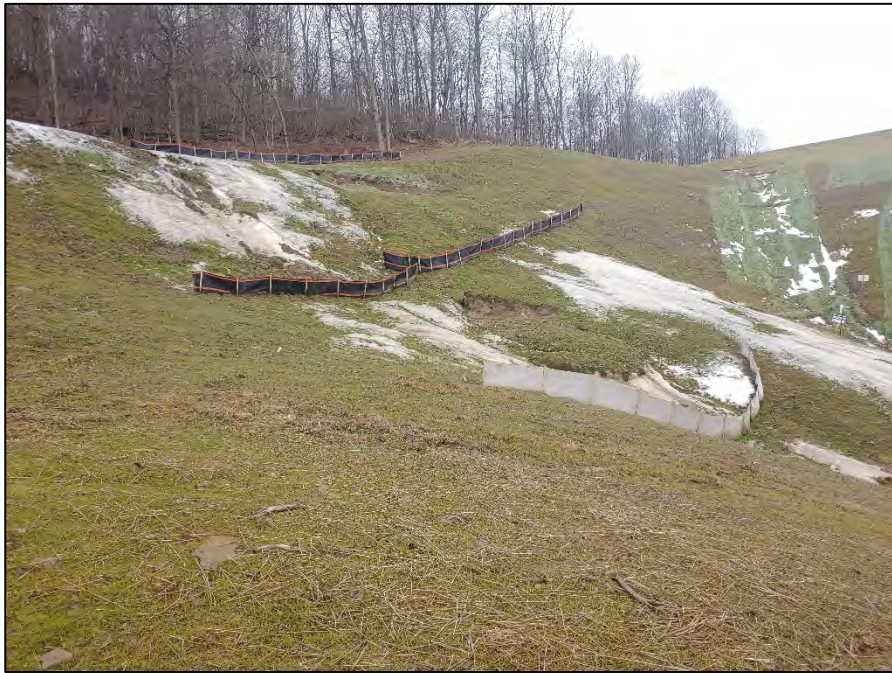
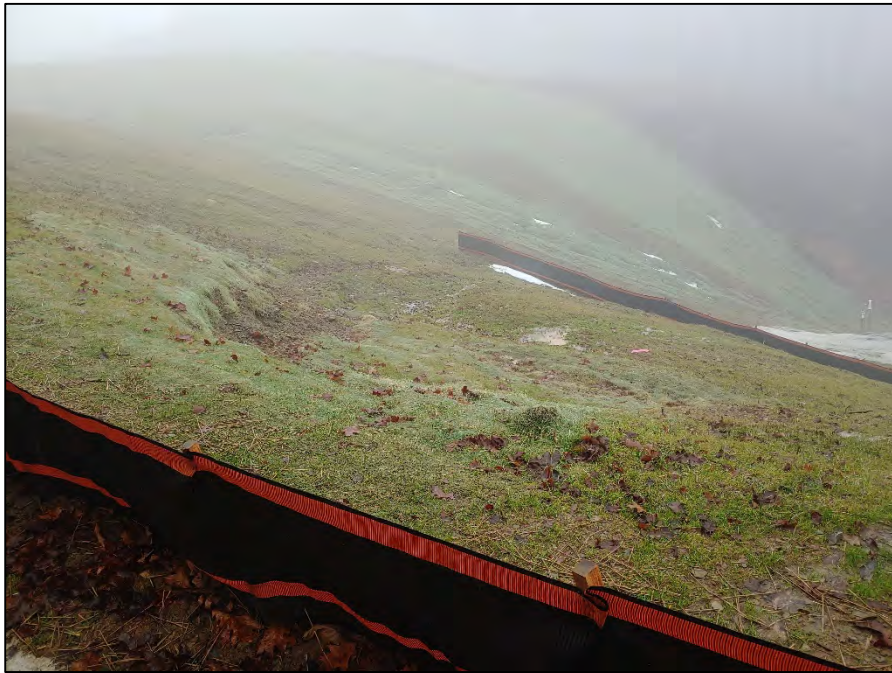
Looking west towards the slump material at Elkhorn Run 2 near station 872+00

Looking north towards the slump material at Elkhorn Run 2 near station 872+00

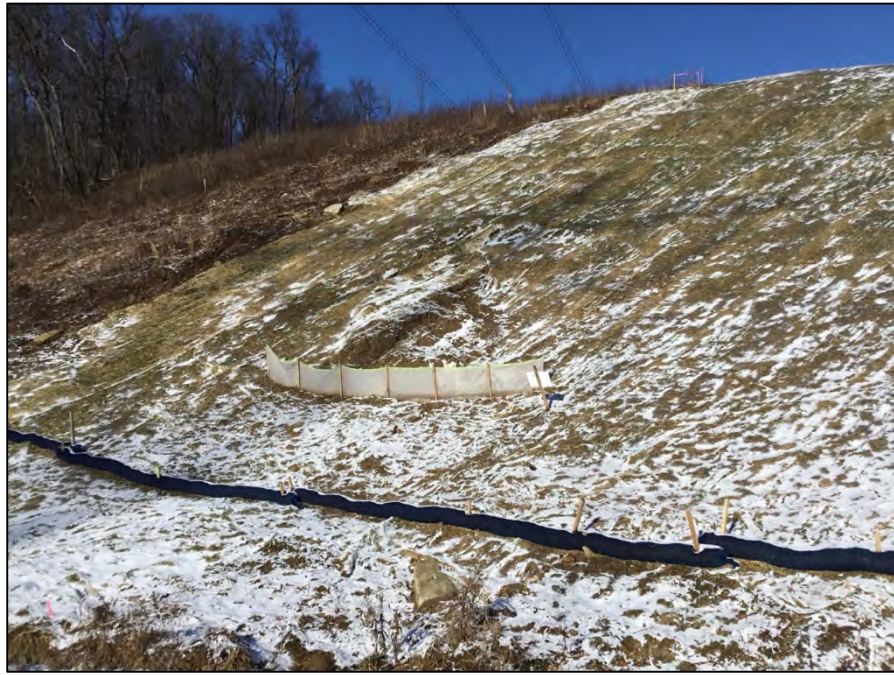
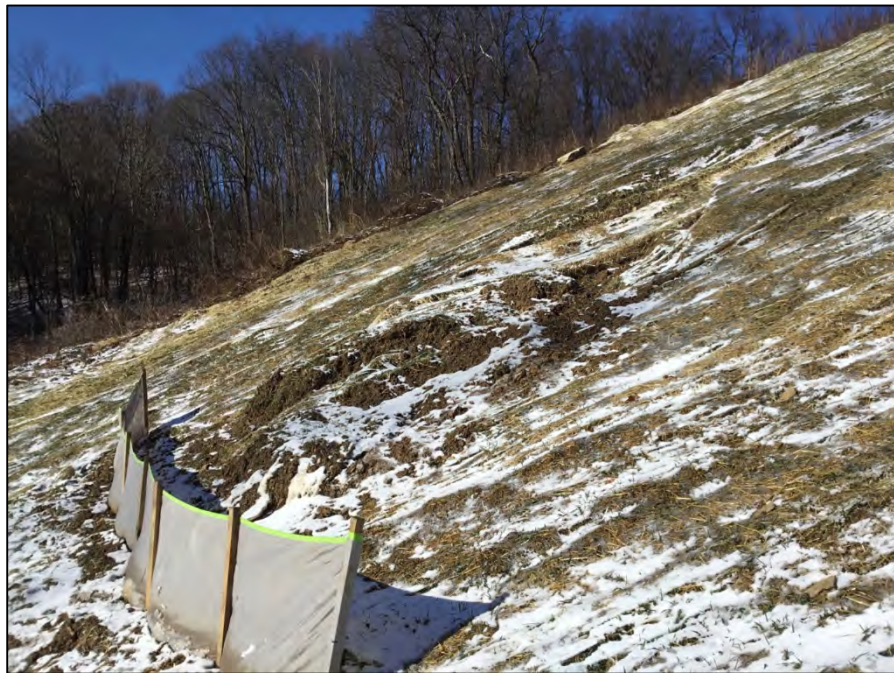
Looking northwest at the shallow surface slump near station 962+50

Looking west at the shallow surface slump near station 962+50

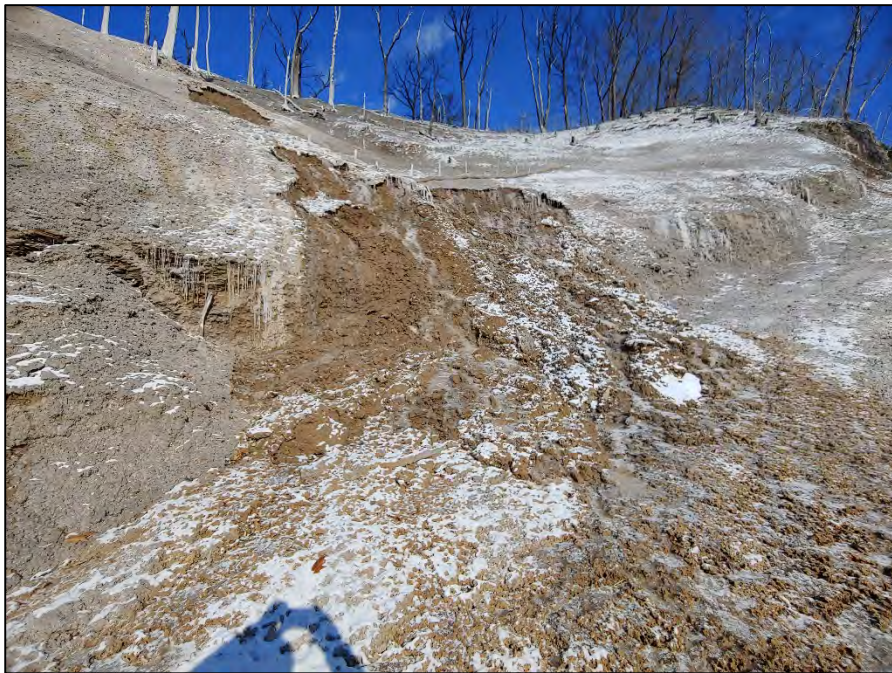
Looking upslope at the shallow landslide near station 1115+50

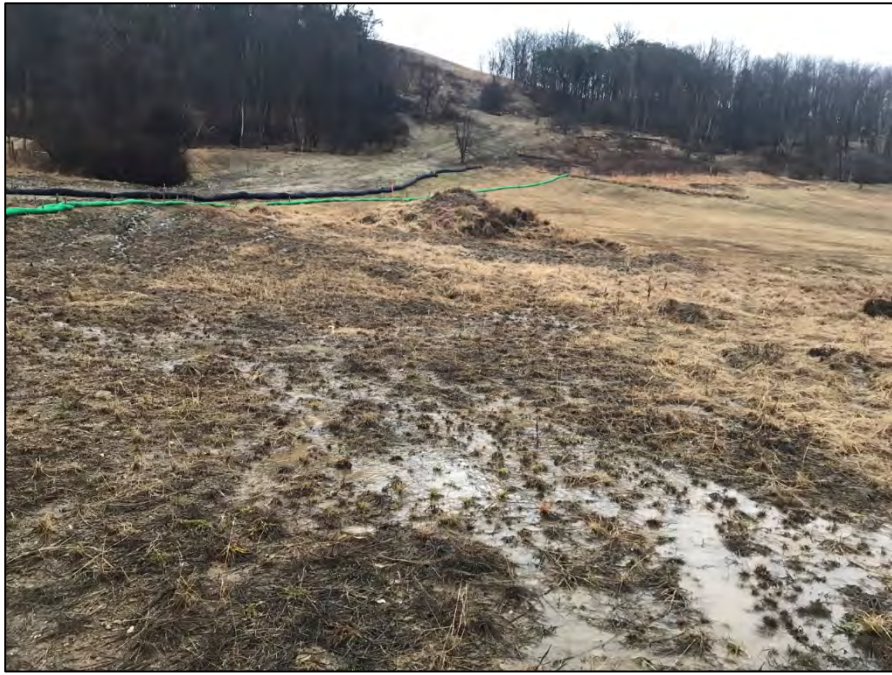
Looking east at groundwater seepage near station 1162+75

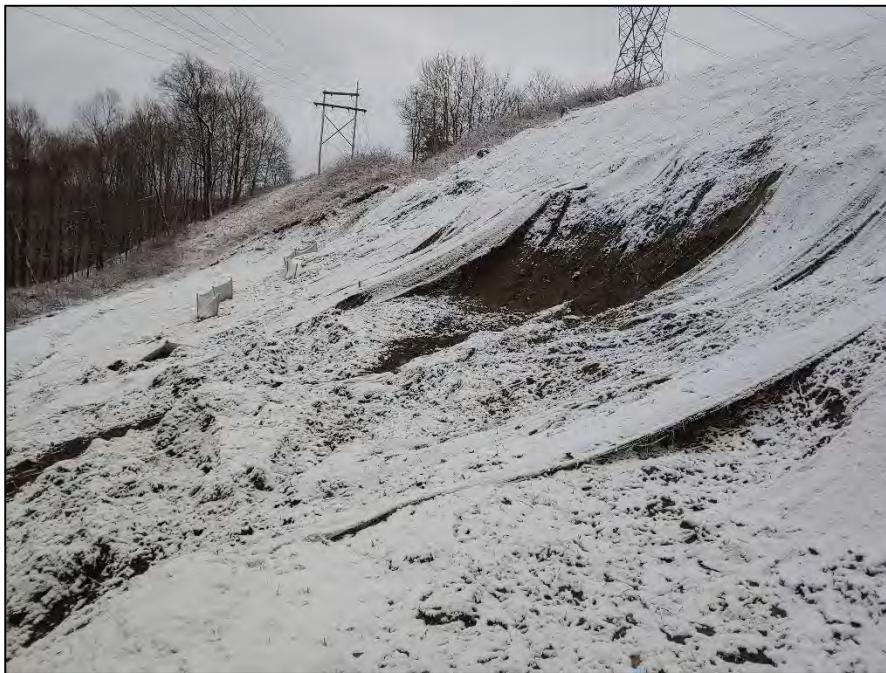
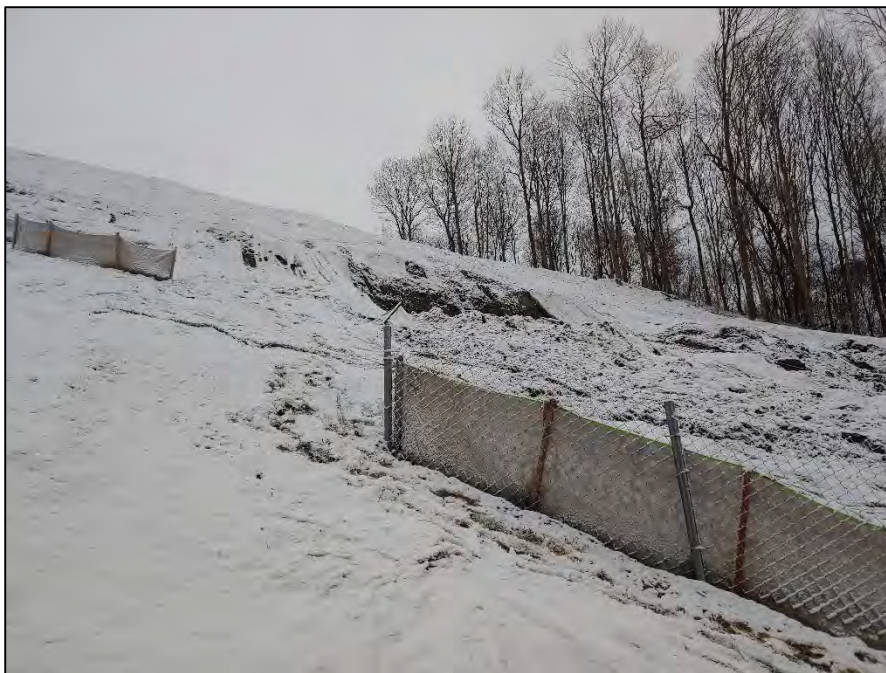
Looking south at the landslide near station 1173+00

Looking west at the landslide near station 1173+00

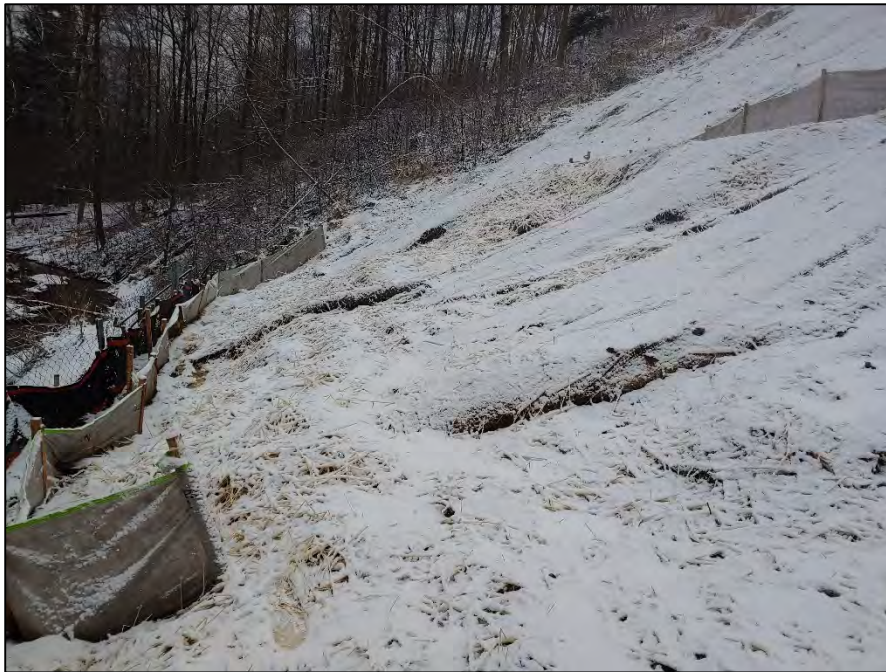
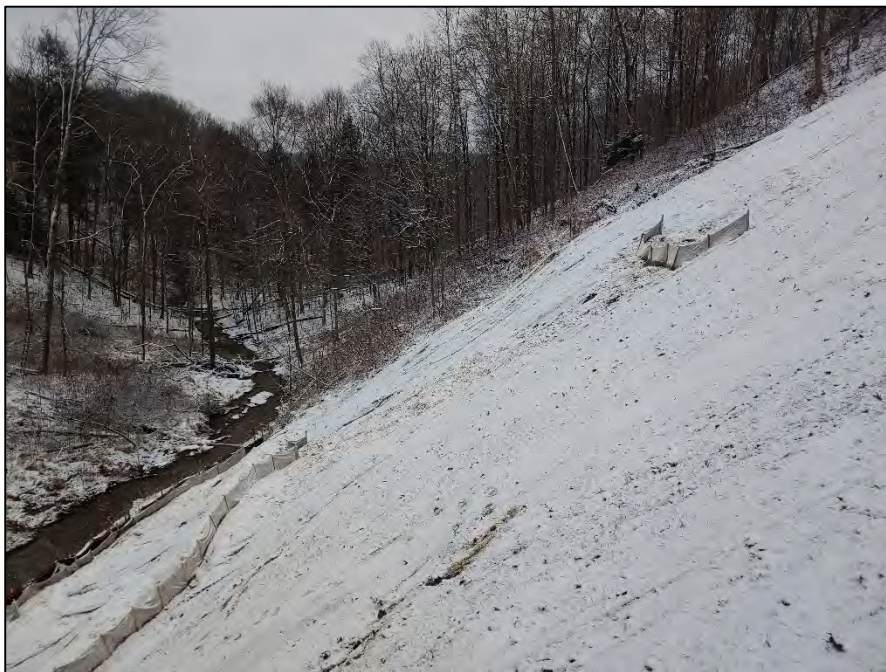
Looking at the landslide near station 1313+00

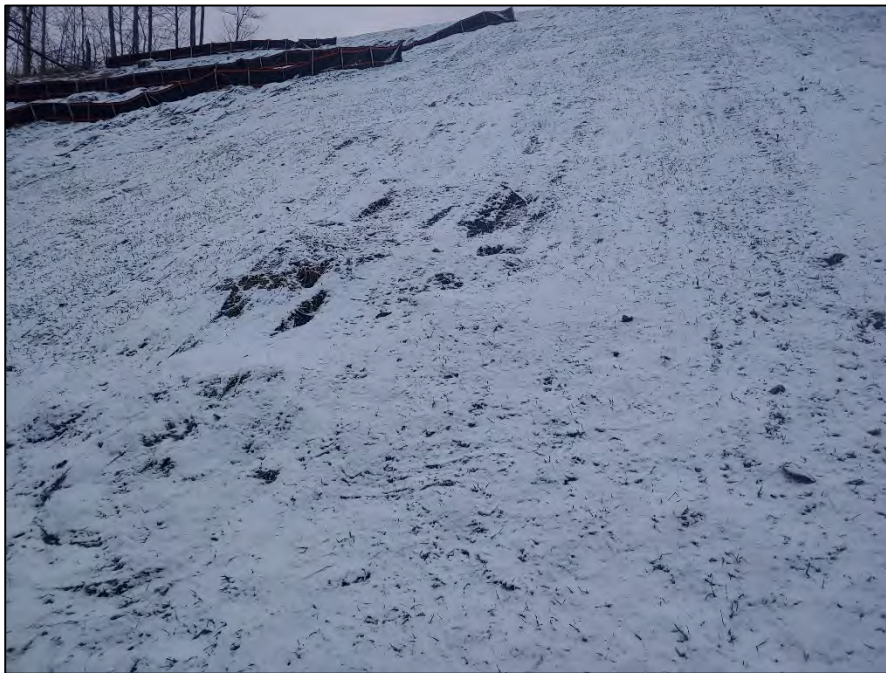
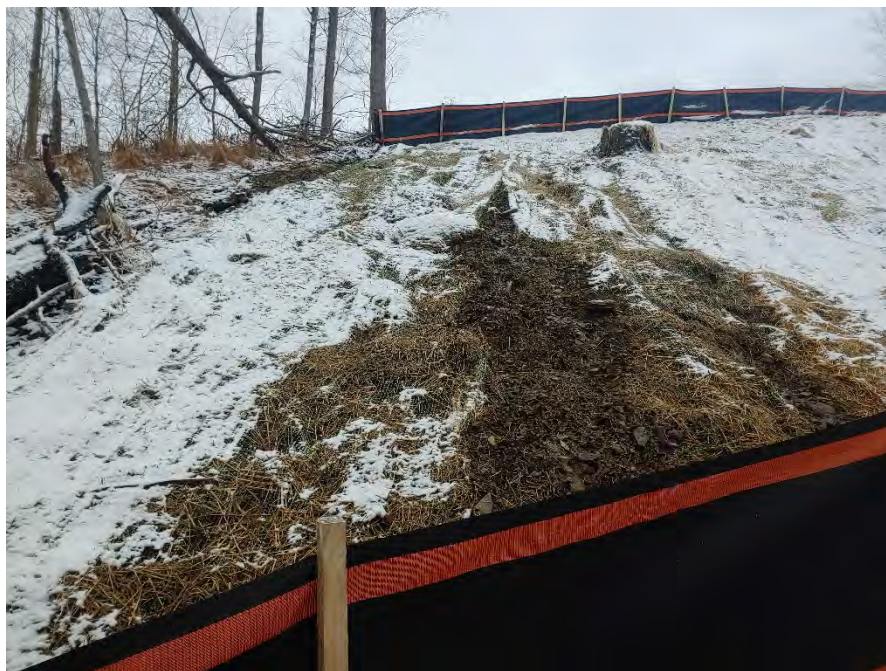
Looking upslope at the slope failure near station 1351+00

Looking upslope at the slope failure near station 1353+00

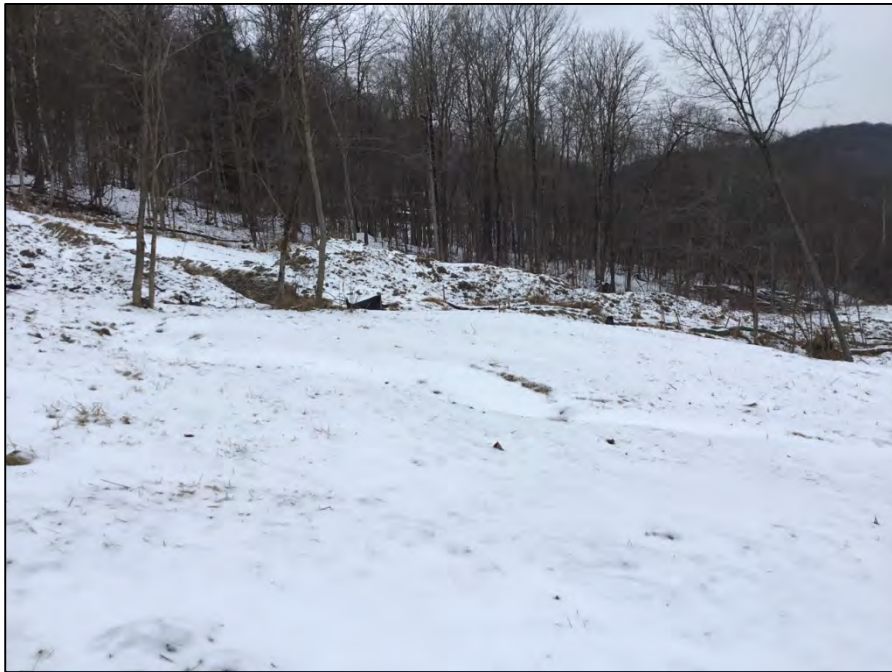
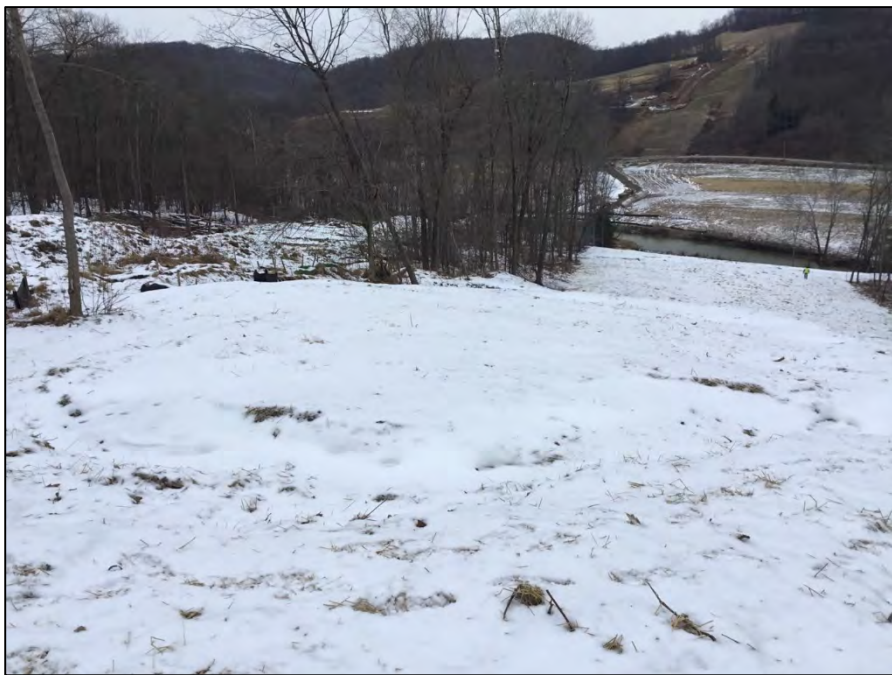
Looking northwest at the landslide near station 1632+00

Looking north at the landslide near station 1632+00

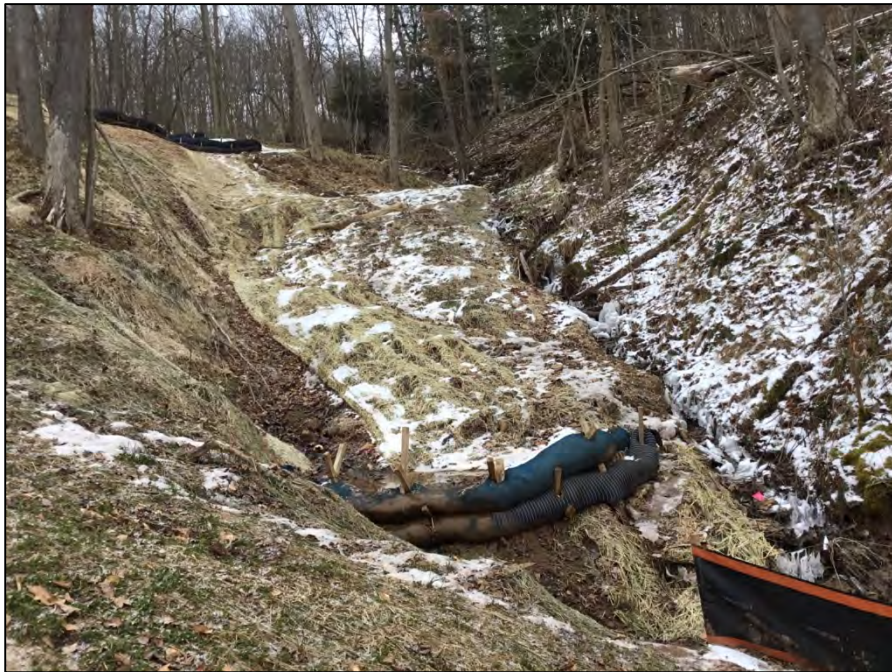
Looking northeast at the sediment delivery near station 1641+00

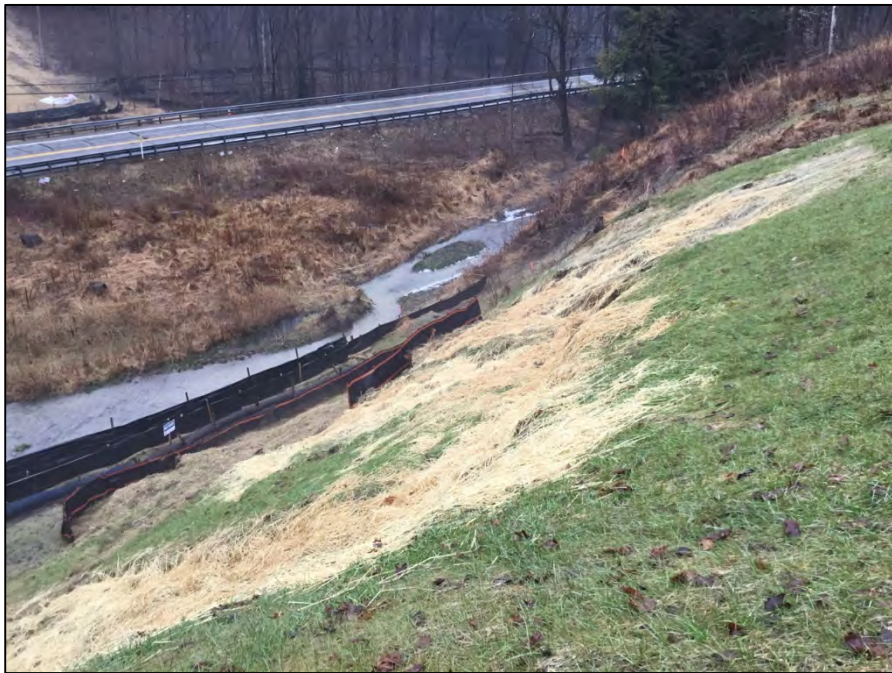
Looking east toward the surface failure near station 1698+00

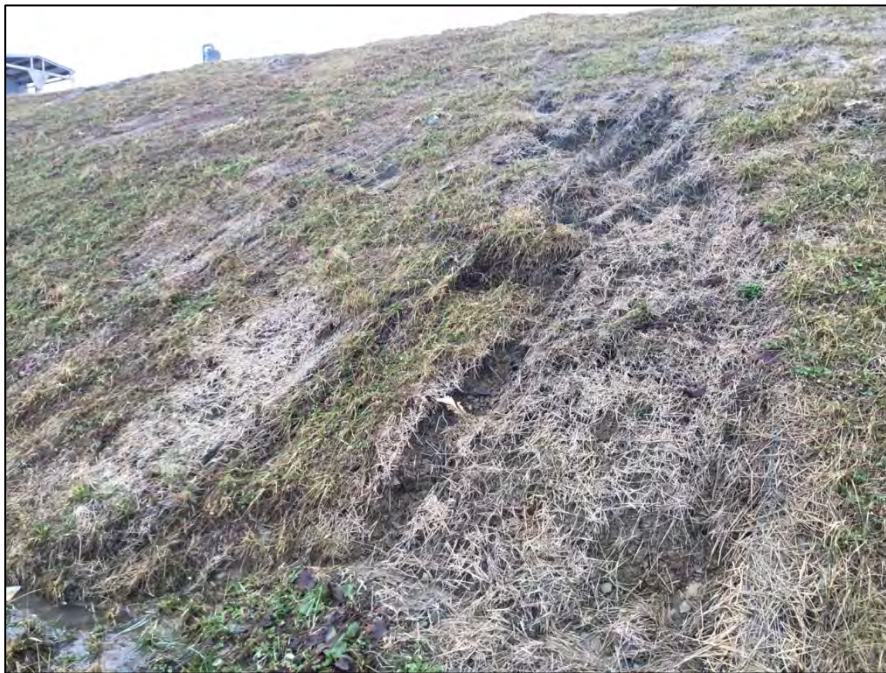
Looking south at the surface slump near station 2151+50
