HORIZONTAL DIRECTIONAL DRILL RE-ANALYSIS  
JOANNA ROAD CROSSING  
PADEP SECTION 105 PERMIT NO: E06-701  
PA-BR-0181.0000-RD-16  
(SPLP HDD No. S3-0250-16)

Comments prepared by Mr. David W. Anspach III  
Resident 609 Joanna Road, Morgantown, Pa 19543  
324 Feet from HDD Western Entry Point

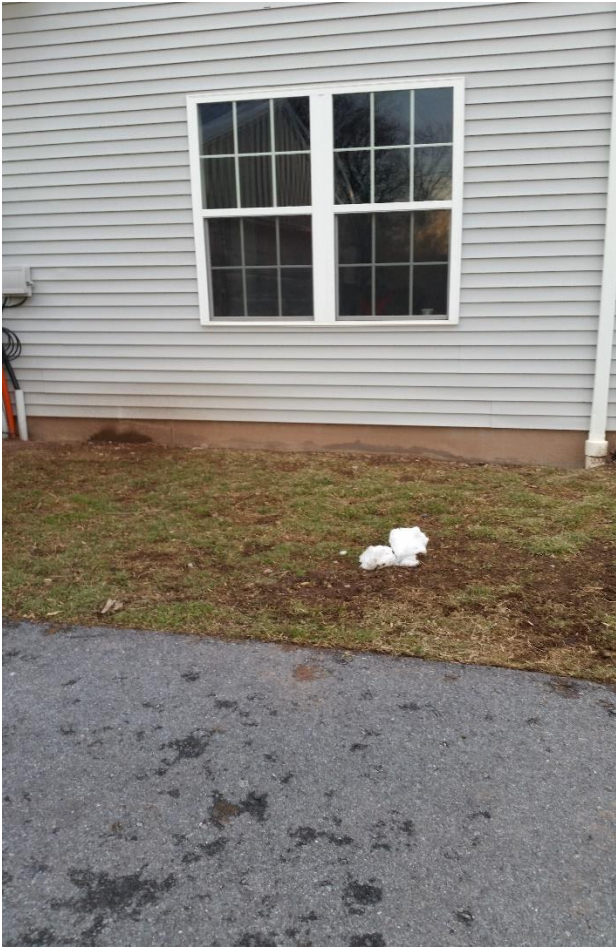
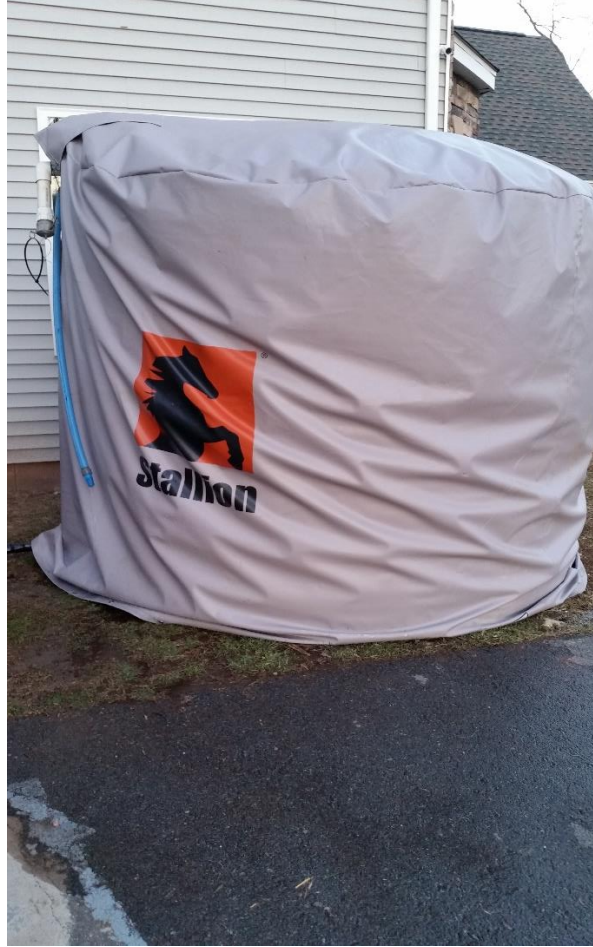
**March 16, 2018**, Per PADEP requirements a Water Buffalo is placed at landowner residence as the residential well is located 324 feet from the HDD Western entry point.

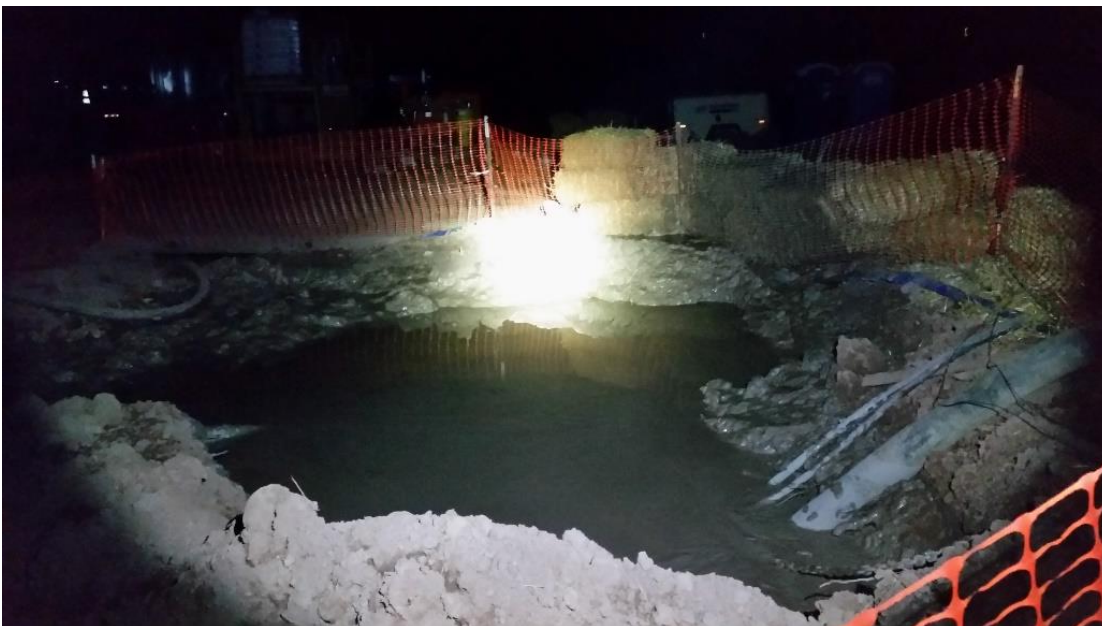
**March 20, 2018** Ground water infiltration into the drill pit continues in the off hours.

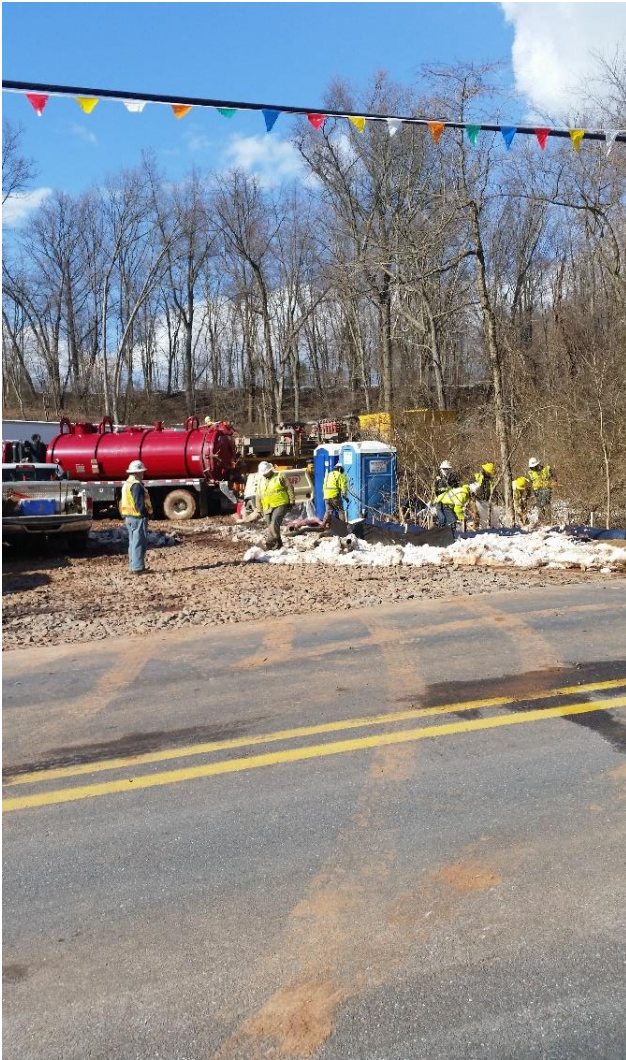
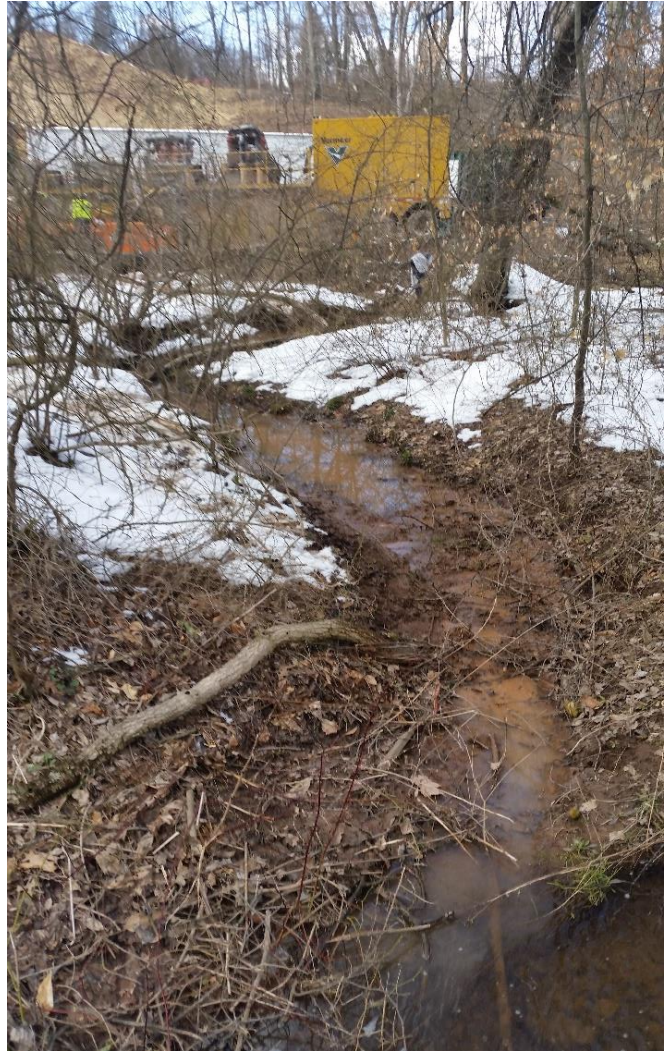
**March 25, 2018** Drilling mud exits the Limit of Disturbance and is cleaned up utilizing a Hydraulic Vacuum (vac) truck (red truck in the rear of left photo) without notification to the Landowner or the PADEP. Turbid conditions are noted in the unnamed tributary (right photo). No note of this cleanup is noted in provided drilling activity log. All staff ignored No trespassing signs and accessed property not granted, Police report filled.

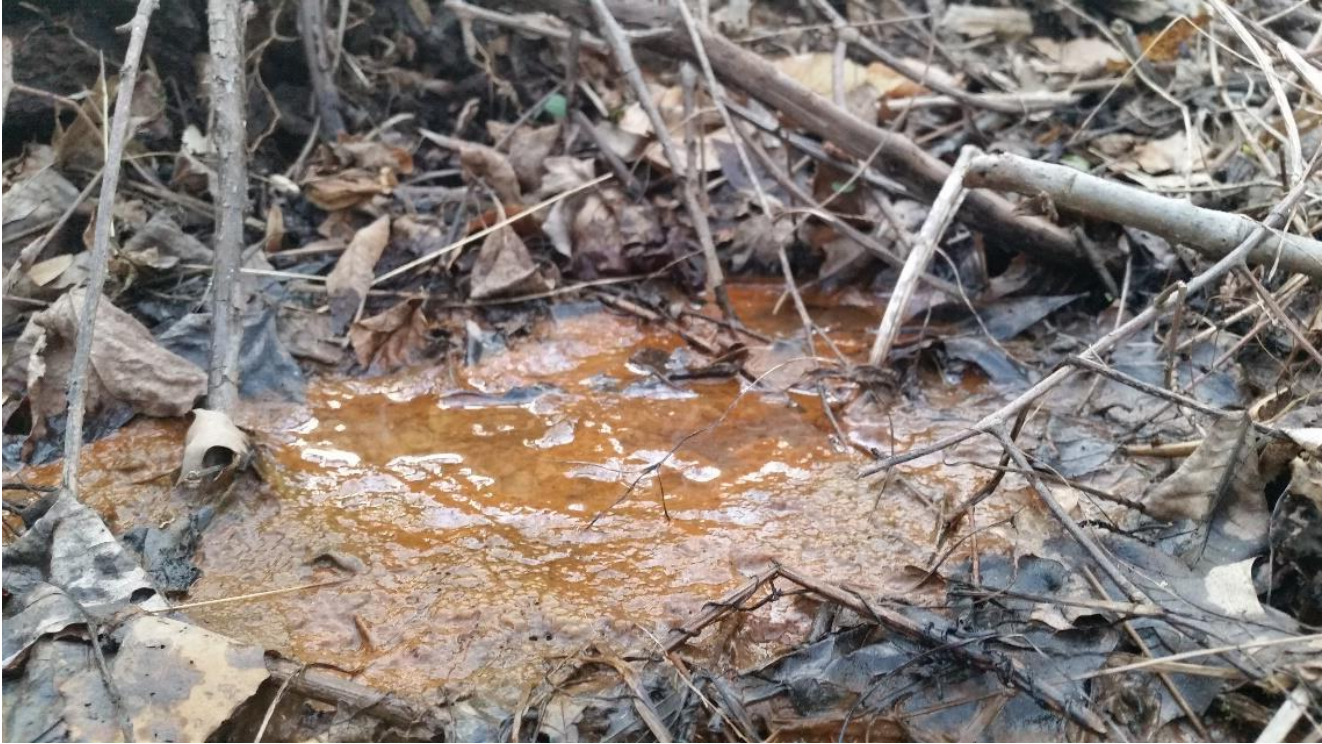
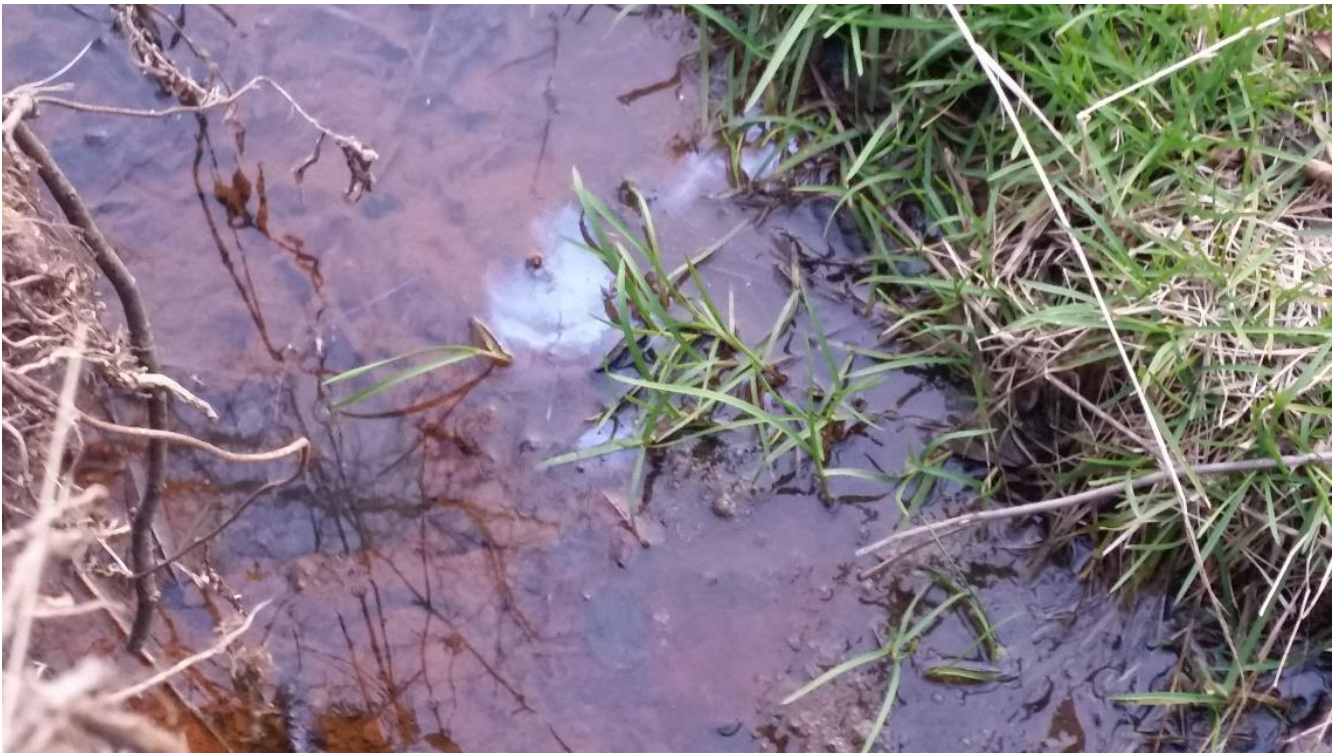
**April 12, 2018** Presence of oil and grease sheen as well as billowy orange growth noted in the unnamed tributary to the East branch of the Conestoga River, Thick orange billowy growth noted as well.

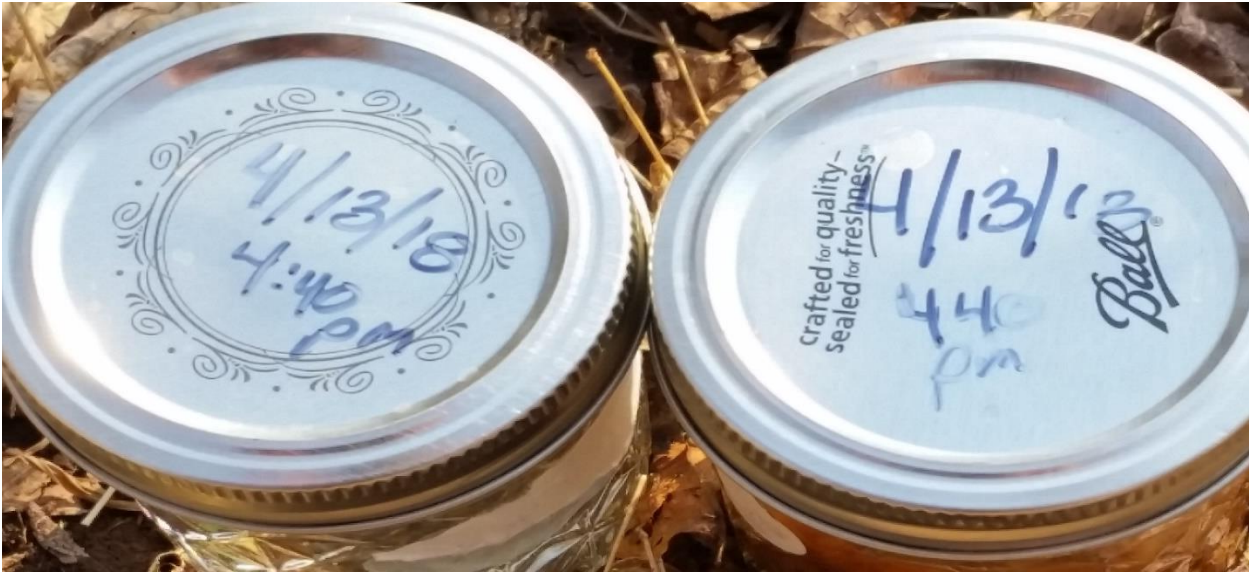
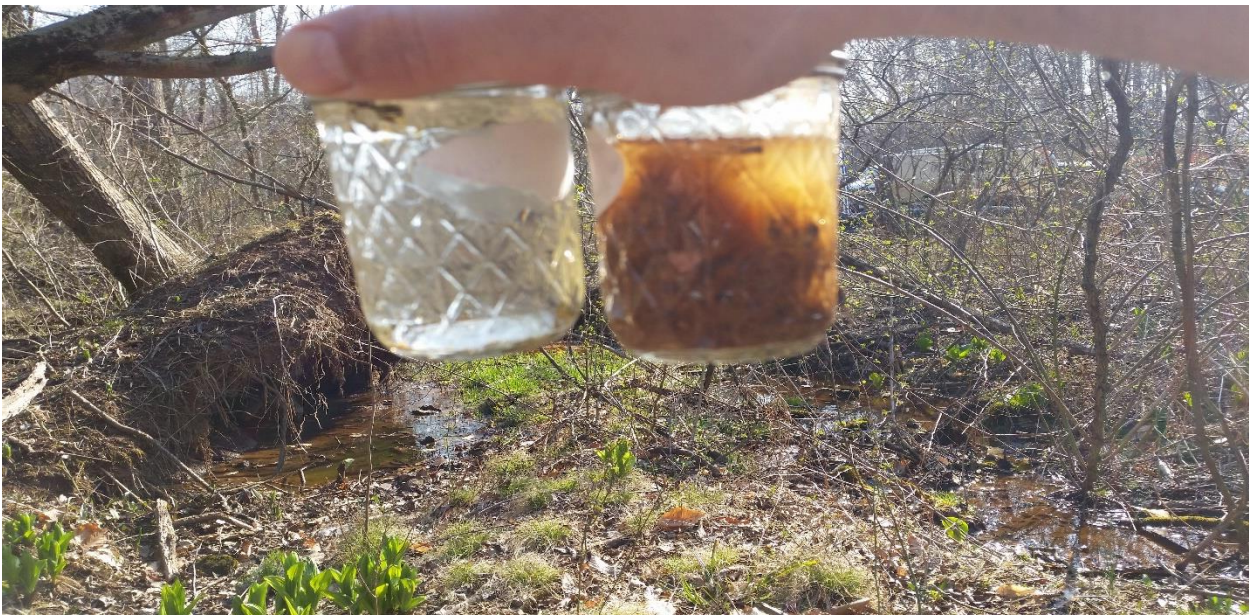
**April 13, 2018** Samples drawn and photographed depicting condition of the unnamed tributary above the influence of the HDD rig and filter plant.

*Left container upstream, Right adjacent to the drill filter plant.*

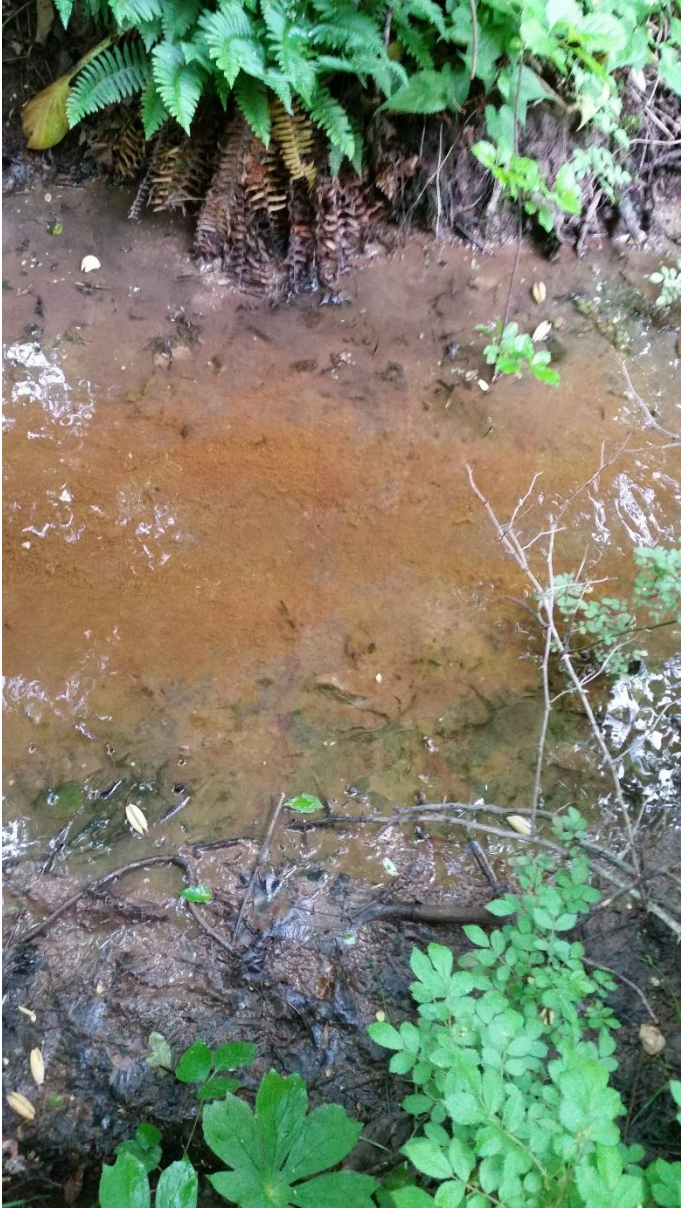
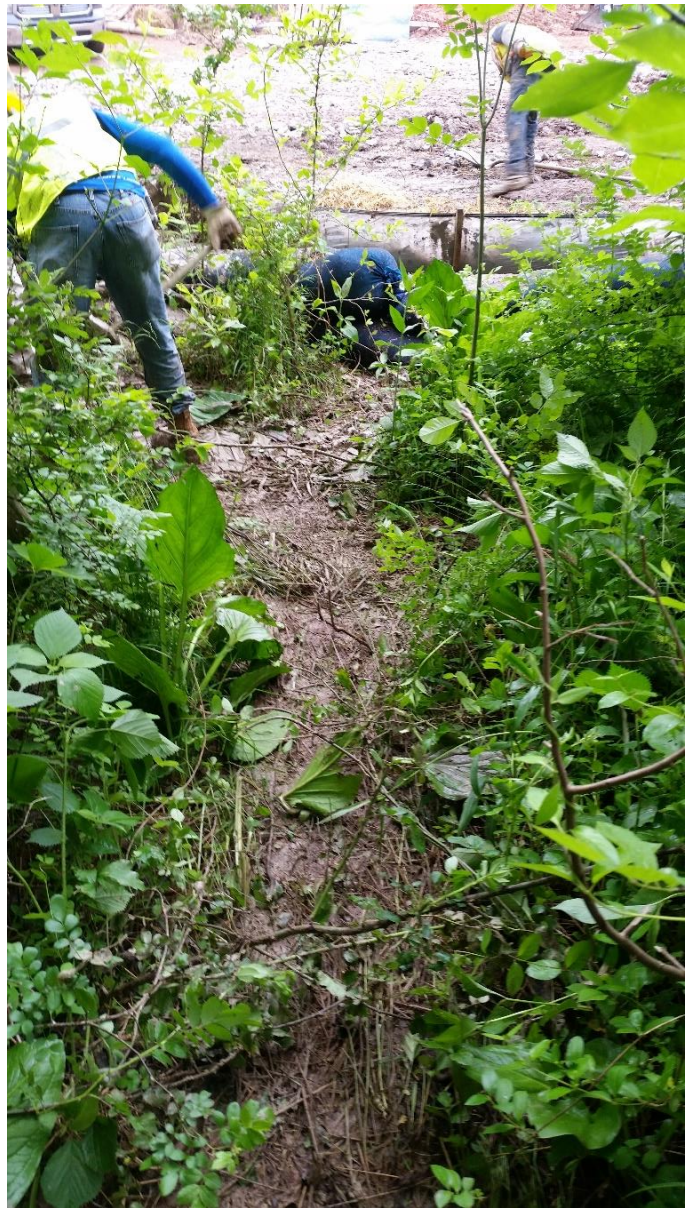
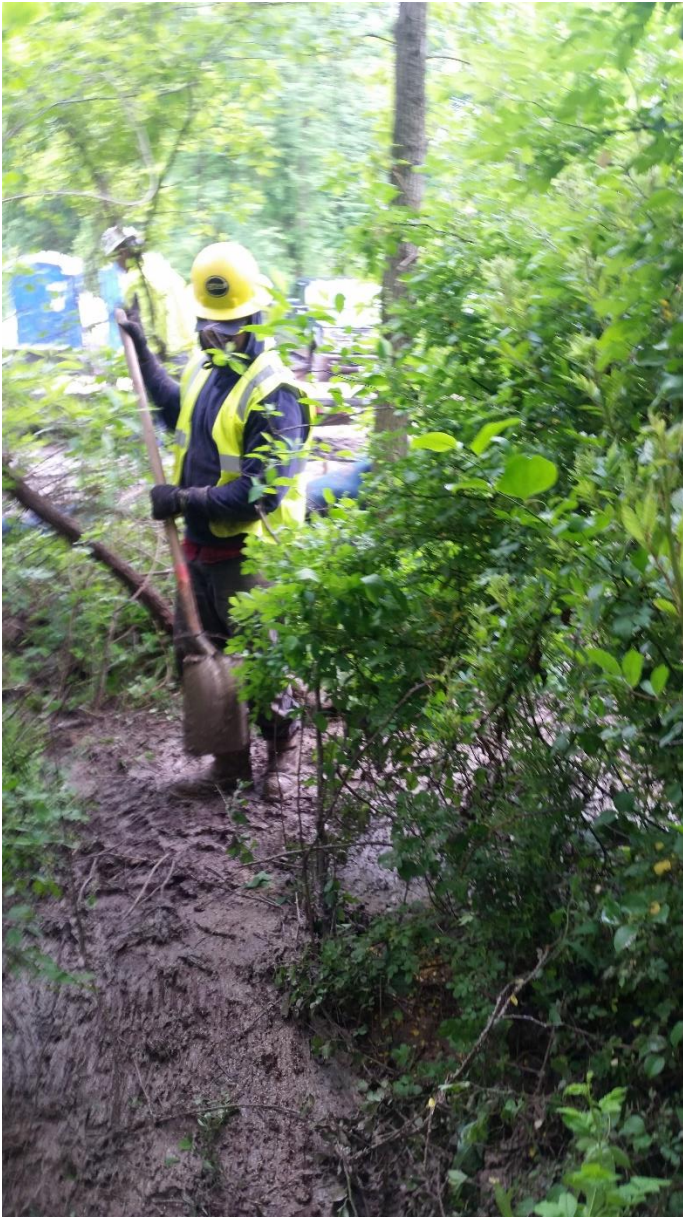
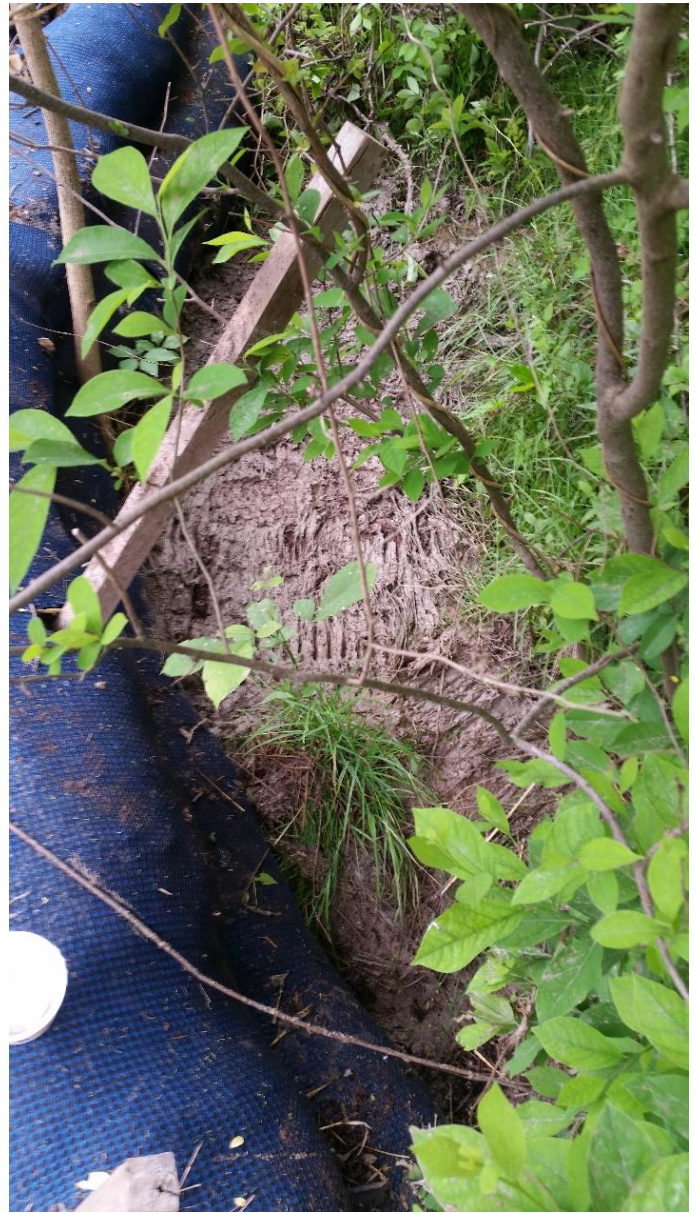
**May 28, 2018** Drilling mud is again reported outside the drilling pit, covers surrounding property outside the Limit of Disturbance and enters the unnamed tributary. No report was filed with the PADEP nor mention made in the reanalysis.

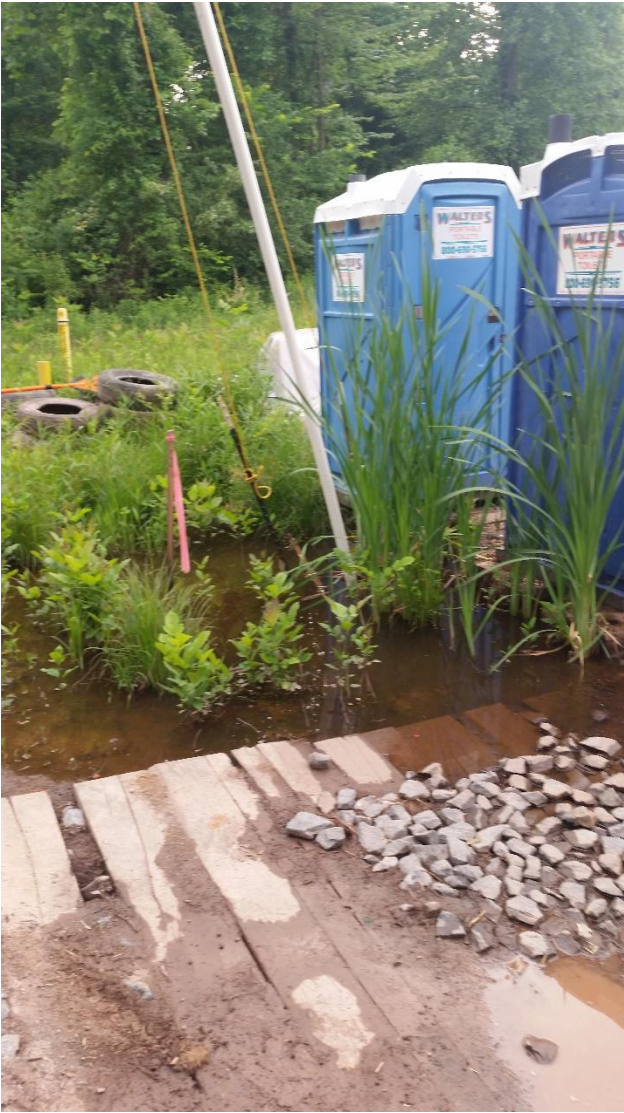
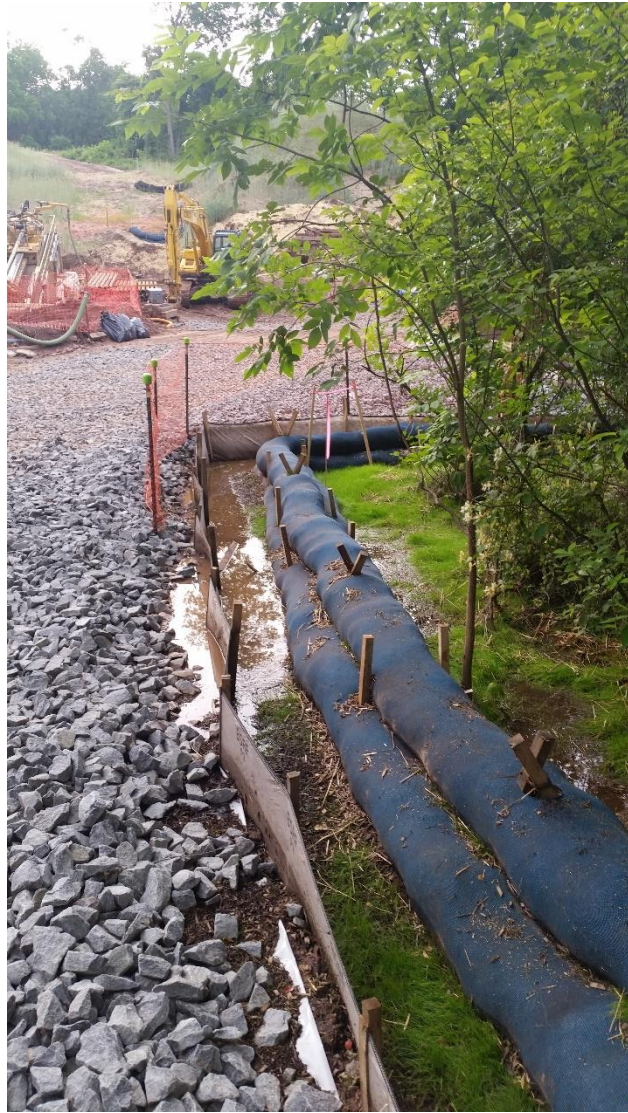
June 11, 2018 Significant saturation noted flooding remains consistent around drill western entry point.

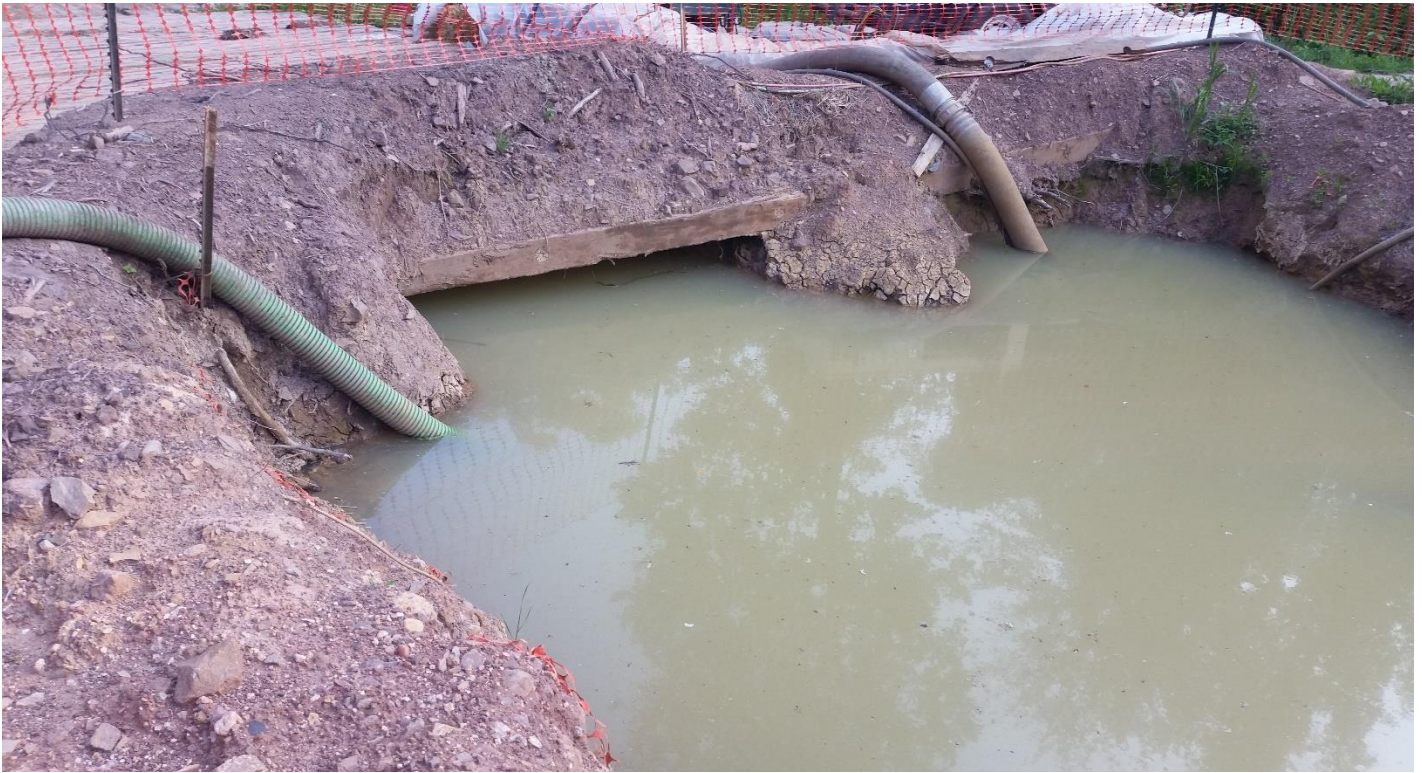
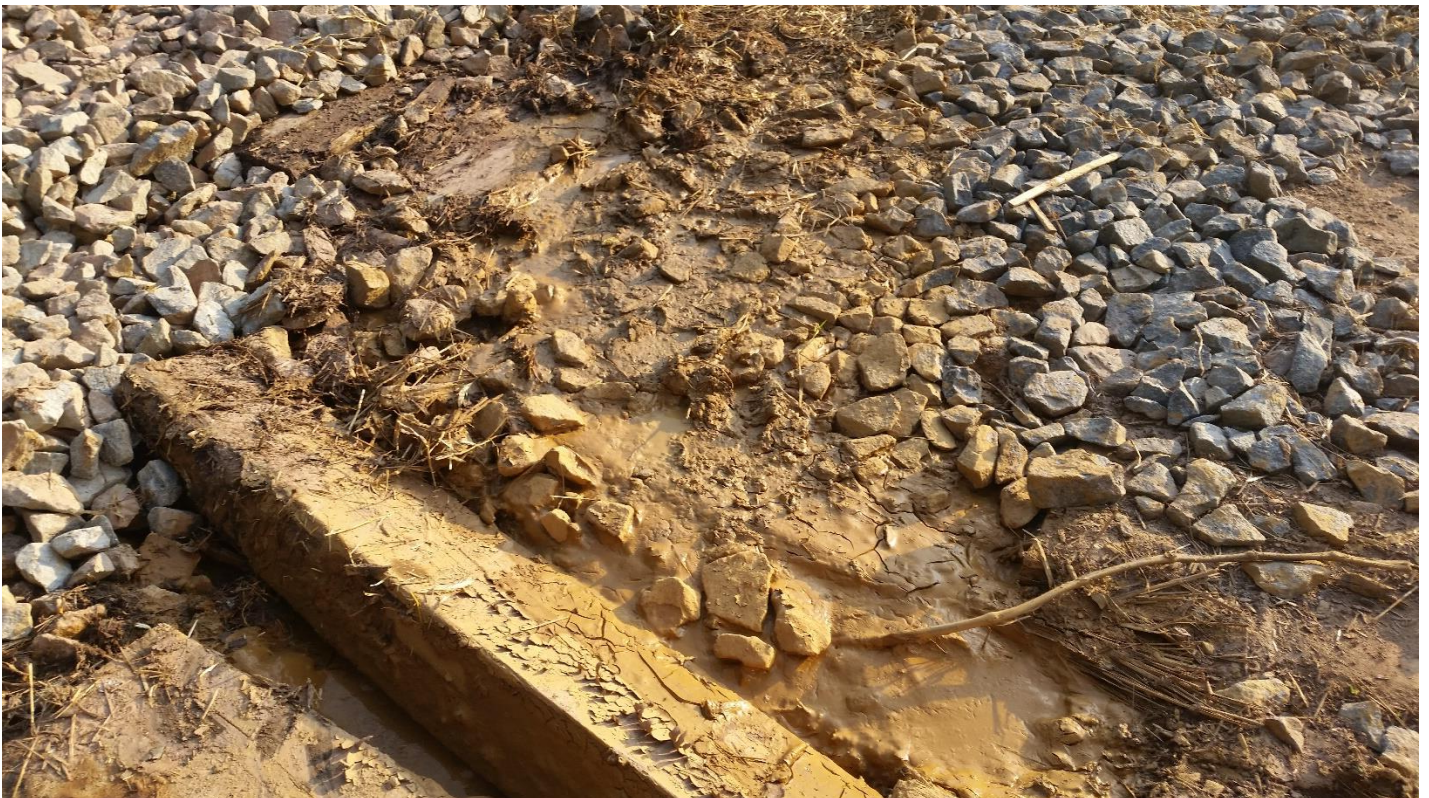
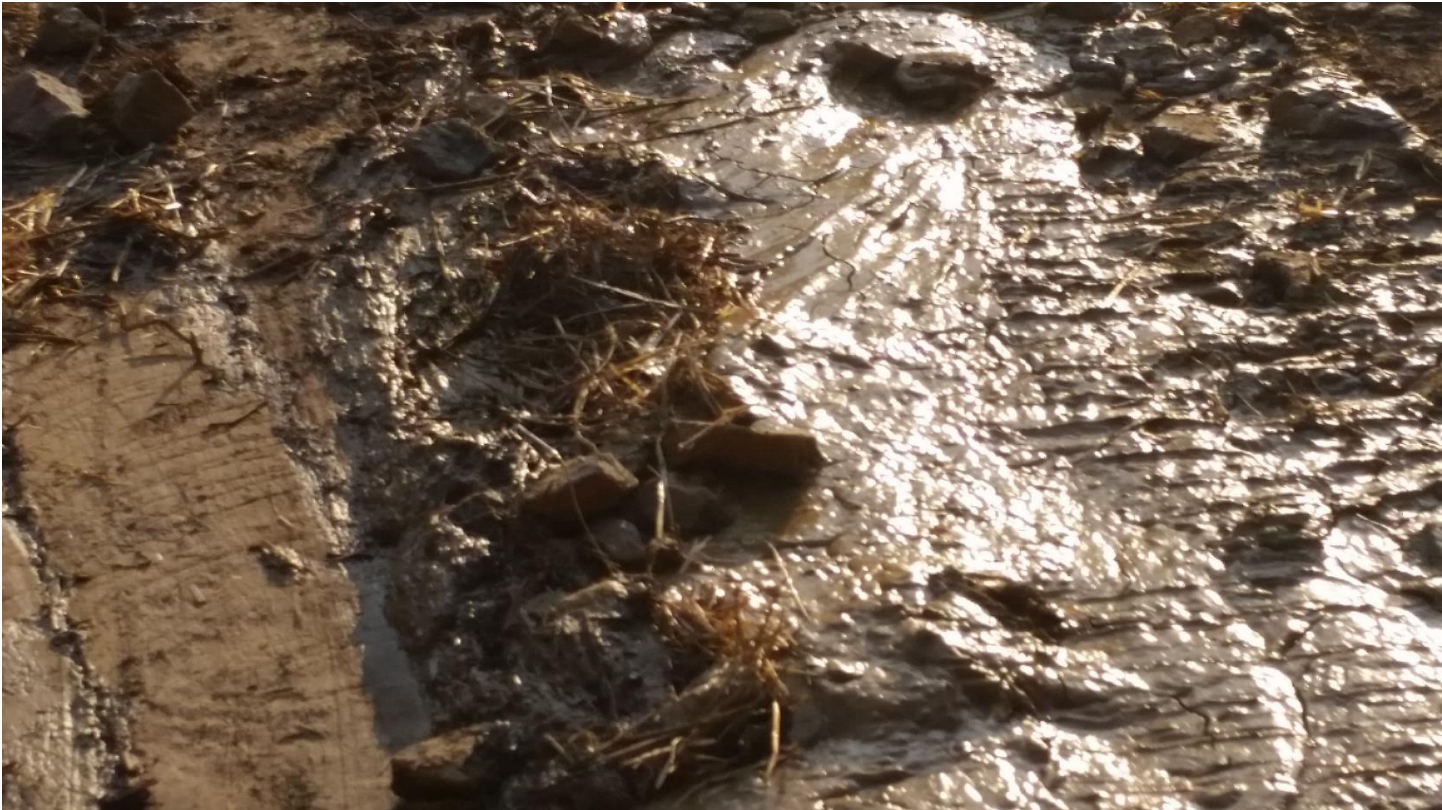
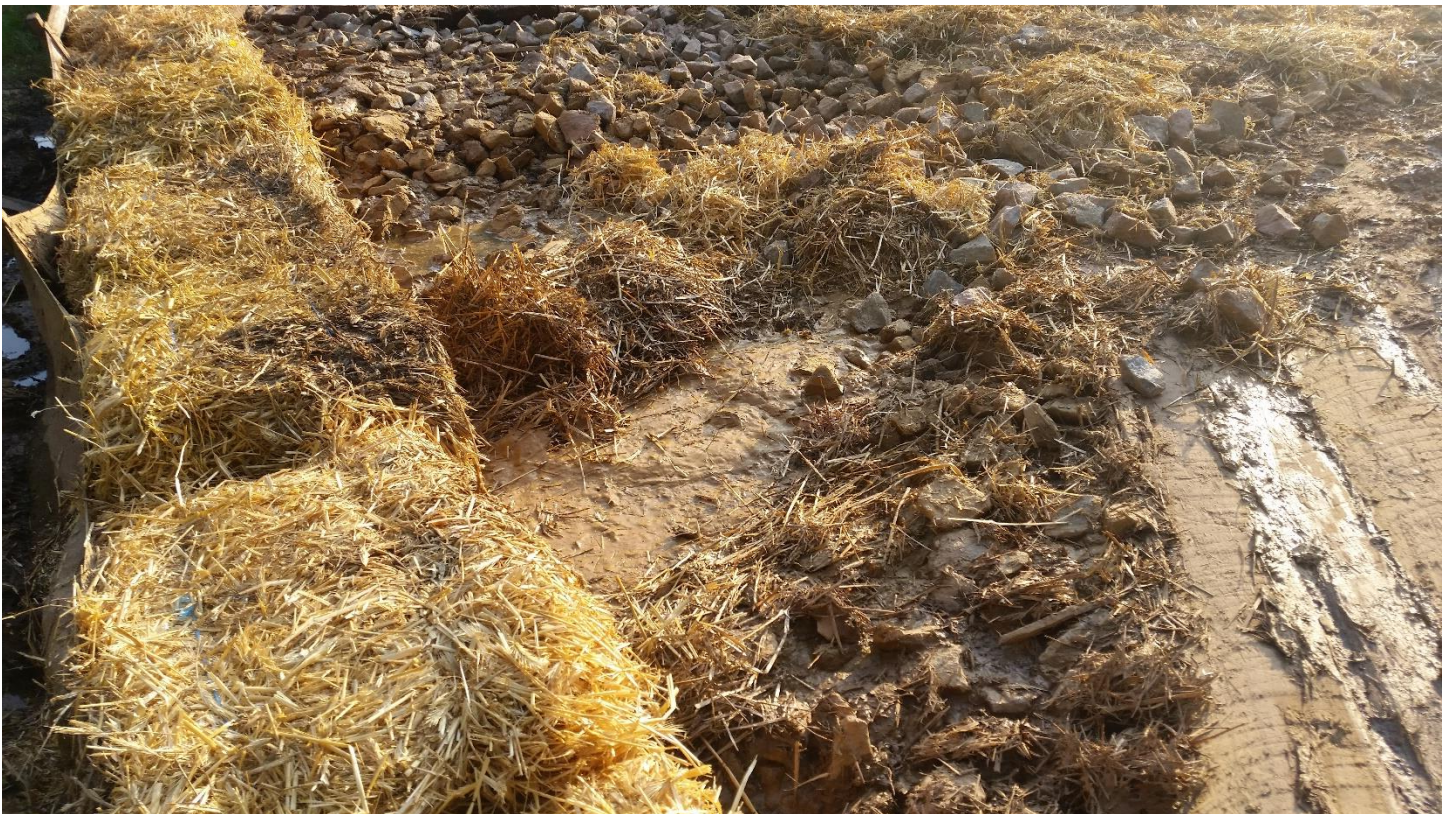
**July 12, 2018** Ground water consistently fills the drilling pit and must be removed 24 hours a day via vac truck or on site pumping. Drill rig filter plant is removed revealing drill mud leaks under equipment. Soils are removed against landowner's requests and without compensation. Land agent does not provide reason upon request.

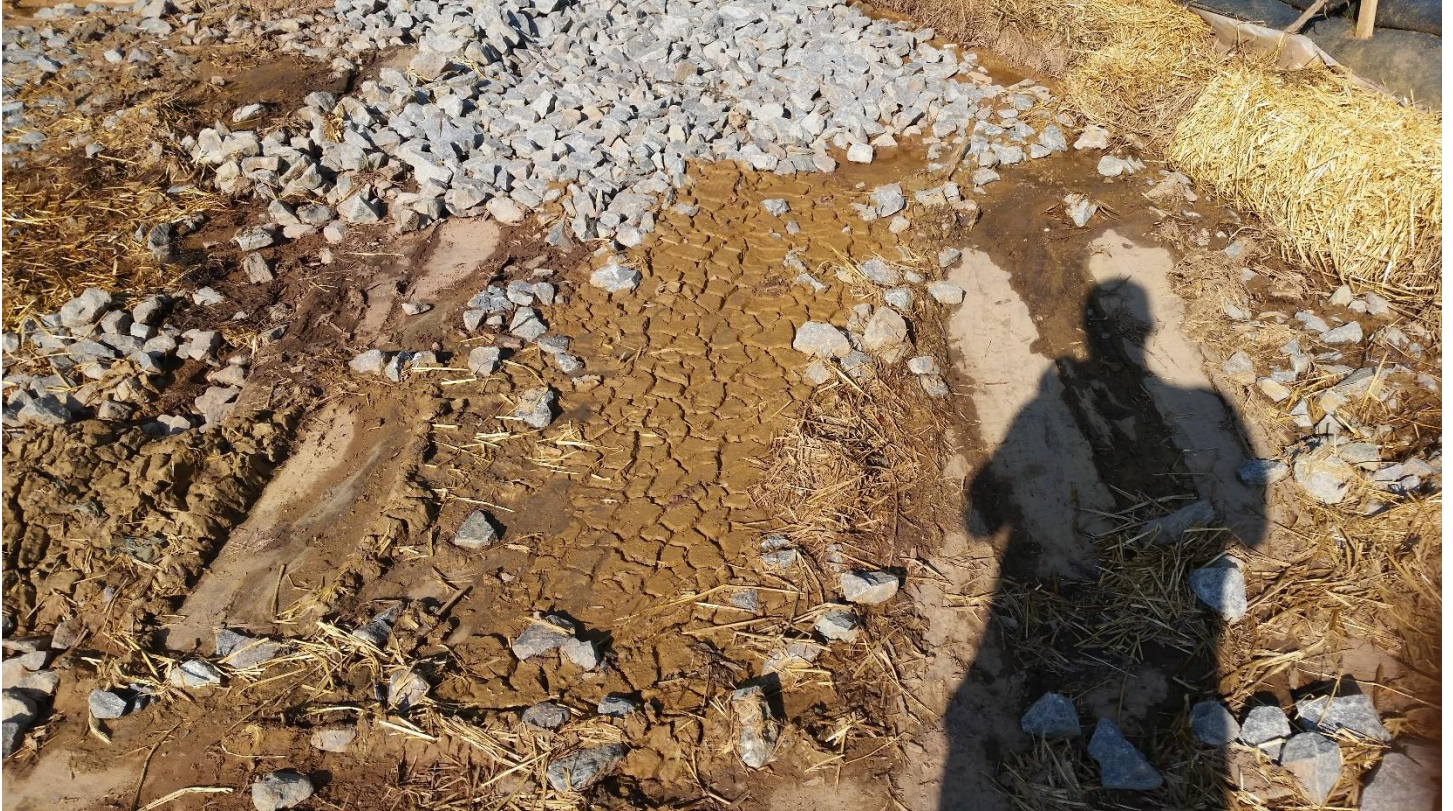
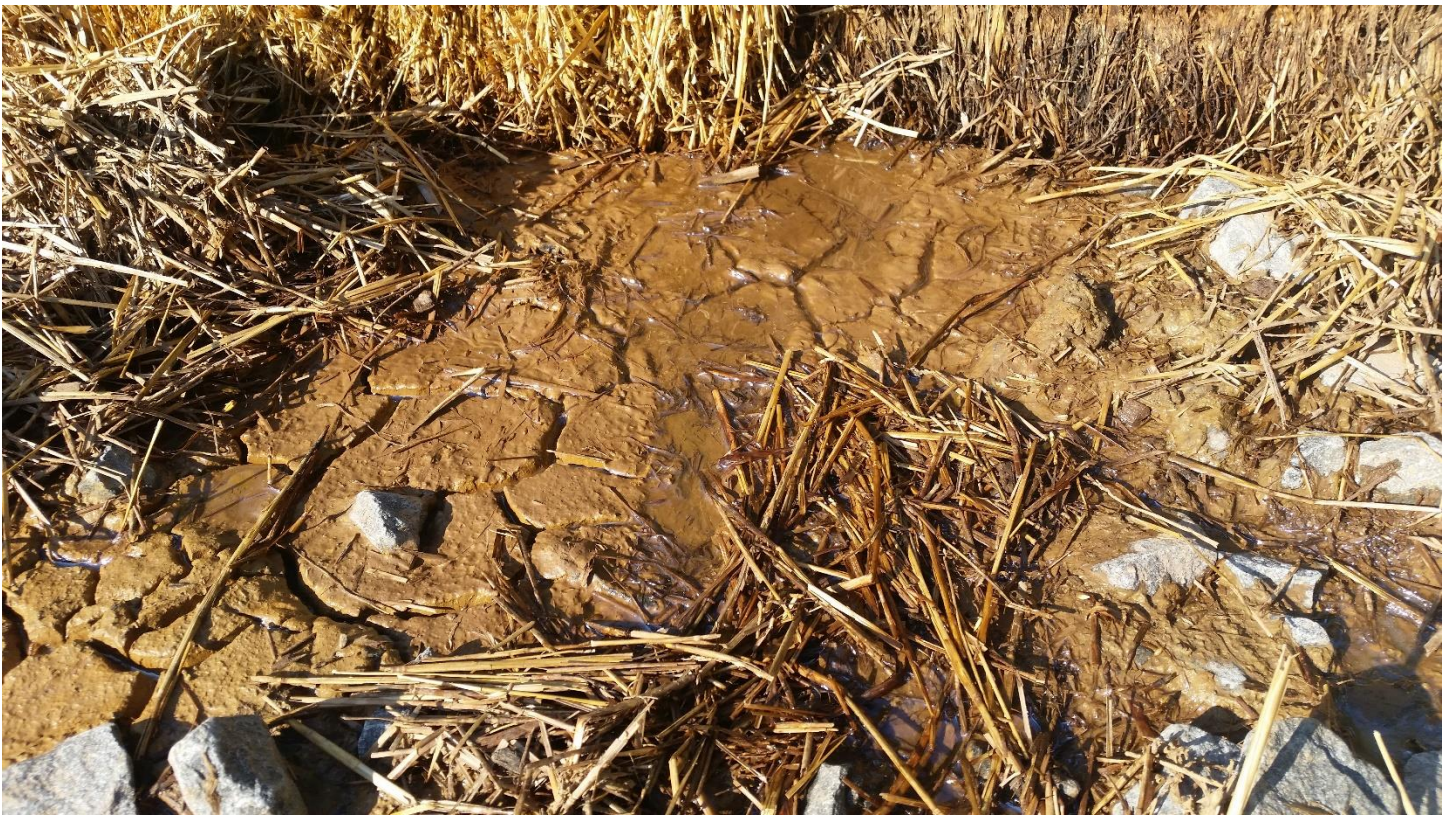
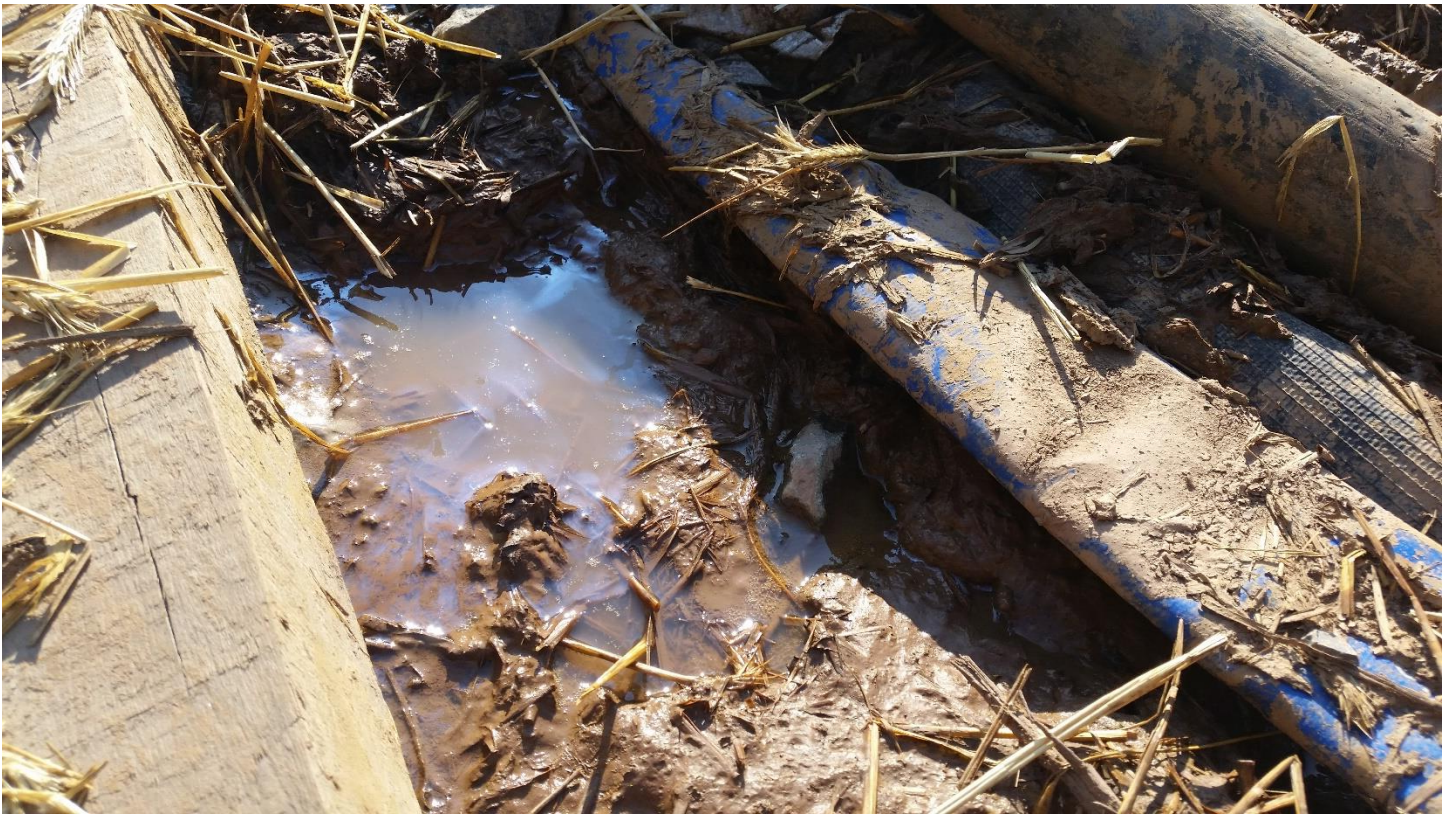
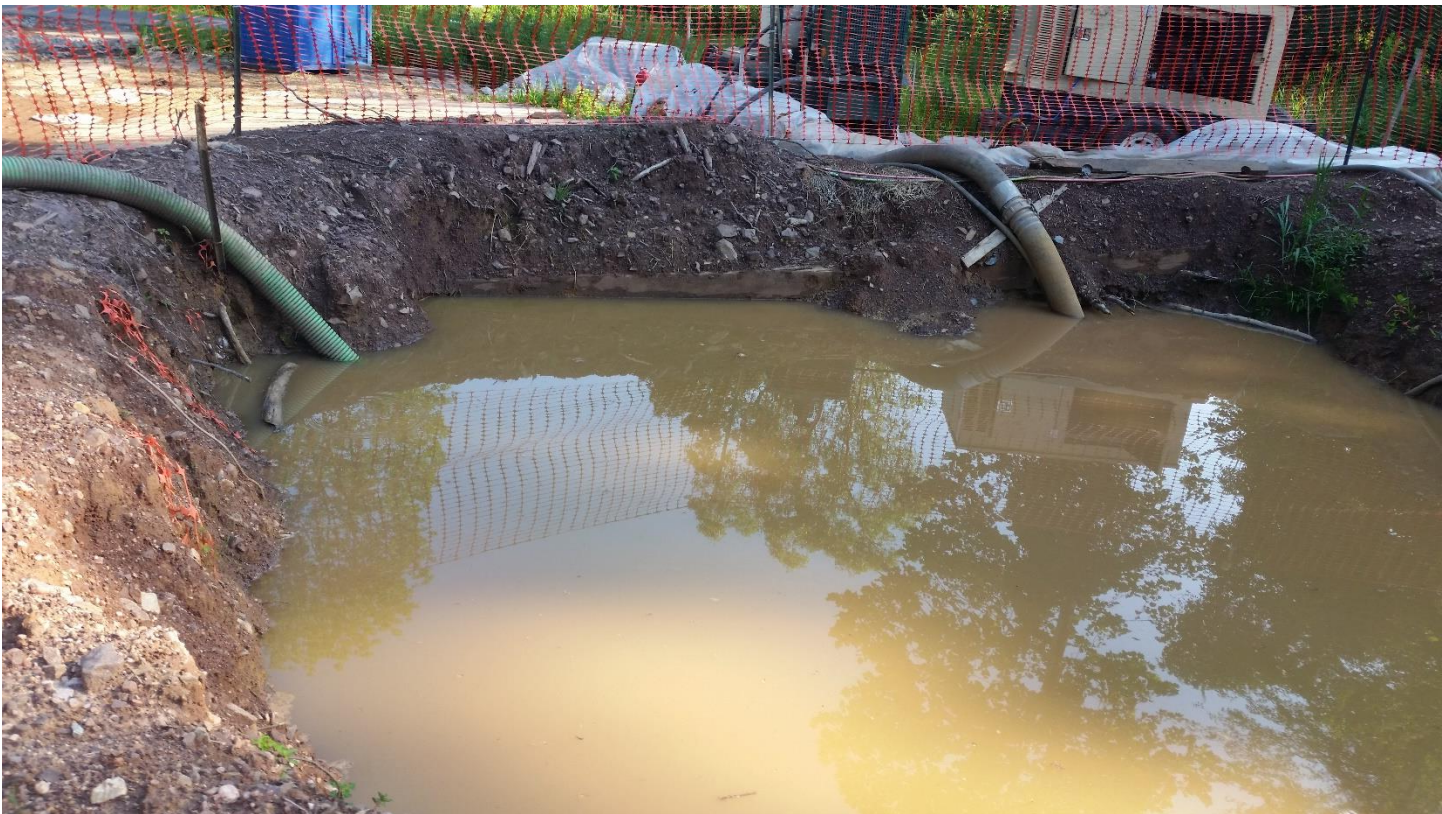
**July 15, 2018** Drilling mud still present on site up to 3 inches thick in places, thick oil and grease sheen inside LOD while drilling pit continues to fill with water.

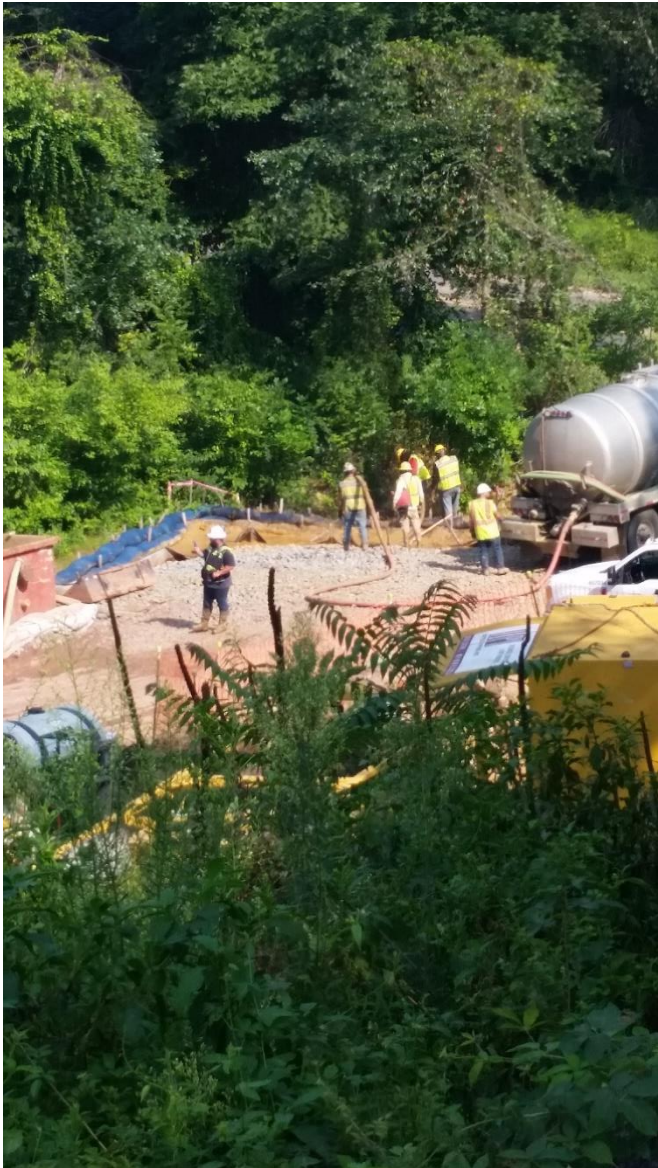
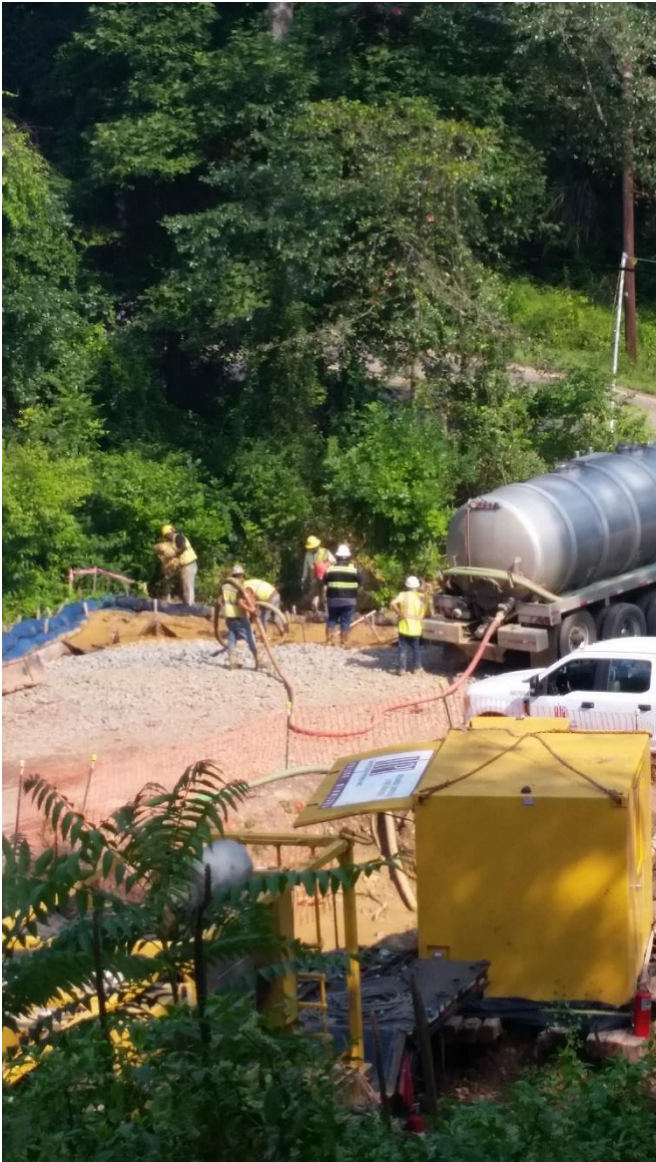
**August 15, 2018** Vac truck is again observed outside the LOD cleaning up spilled drilling fluids. Again no report made to the PADEP nor mentioned in the provided timeline.
