HORIZONTAL DIRECTIONAL DRILL RE-ANALYSIS  
JOANNA ROAD CROSSING  
PADEP SECTION 105 PERMIT NO: E06-701  
PA-BR-0181.0000-RD-16  
(SPLP HDD No. S3-0250-16)

Comments prepared by Mr. David W. Anspach III  
Resident 609 Joanna Road, Morgantown, Pa 19543  
324 Feet from HDD Western Entry Point

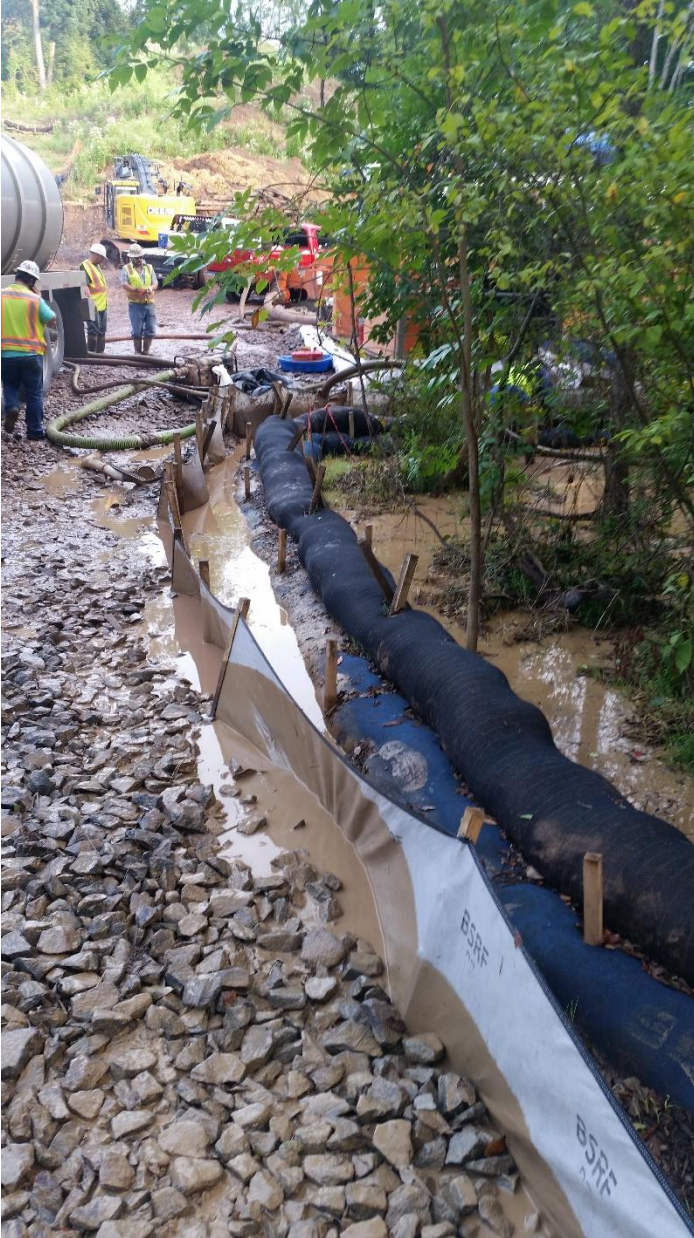
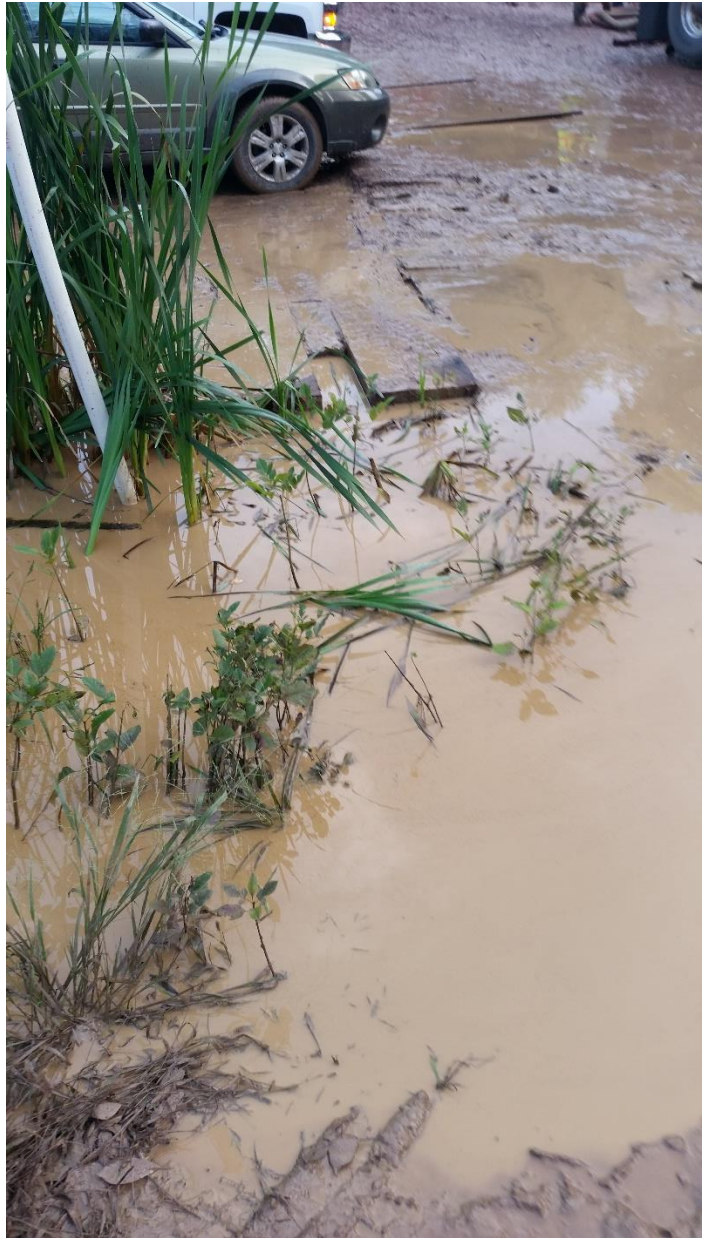
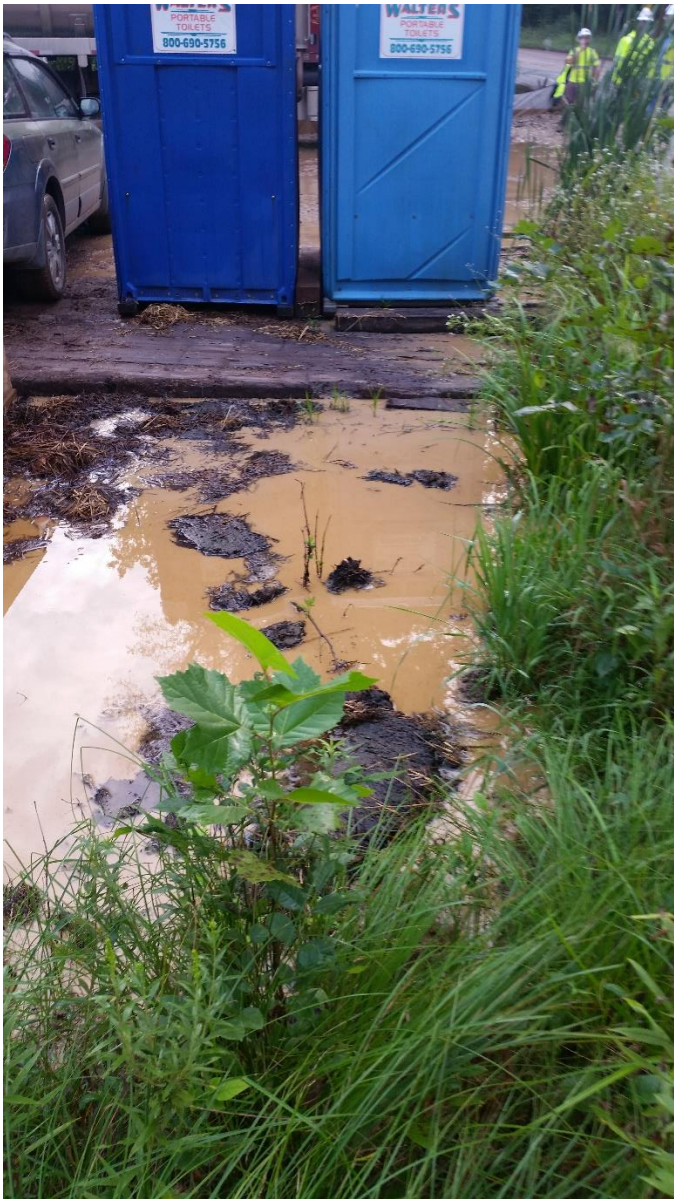
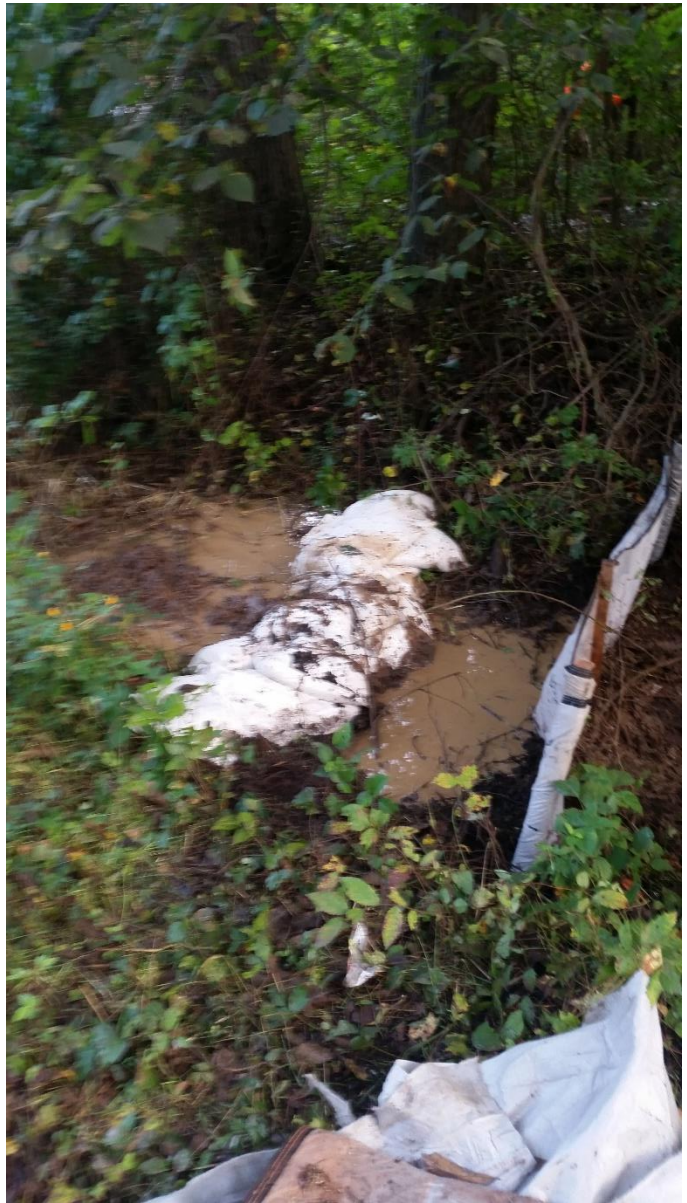
**September 15, 2018** This is the only report of drilling mud outside the LOD as recorded by the timeline and reported to the PADEP. The unnamed tributary was again dammed in order to prevent extensive environmental damages.

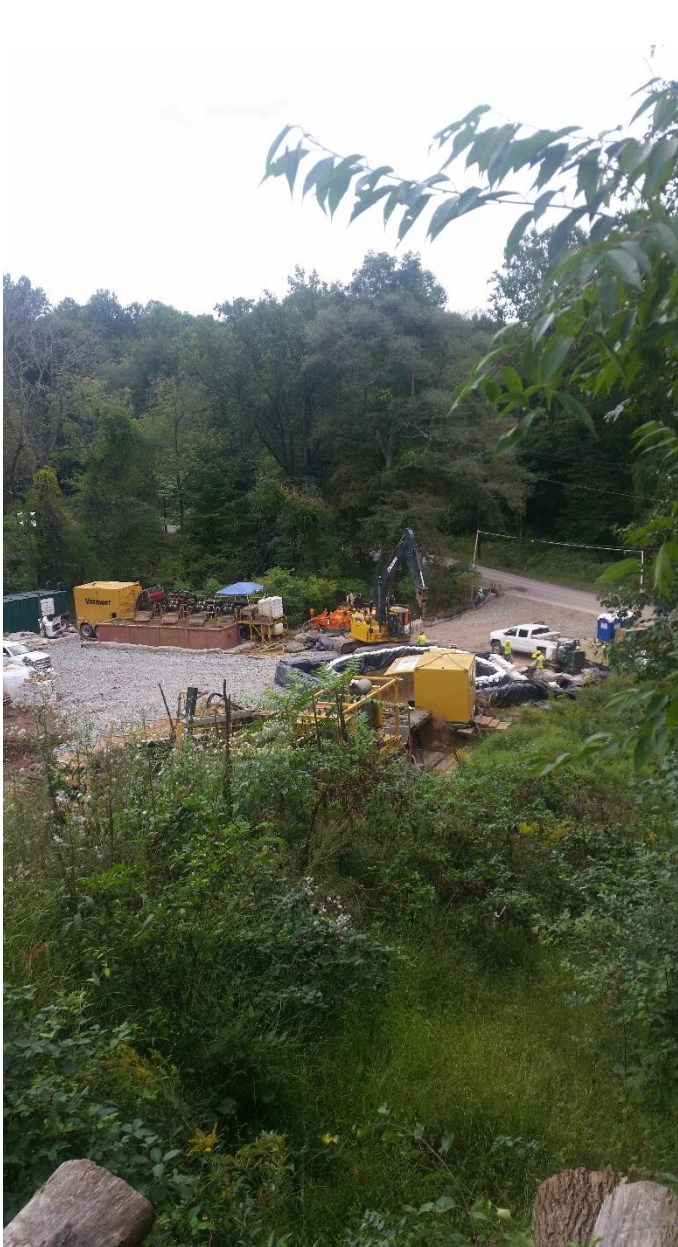
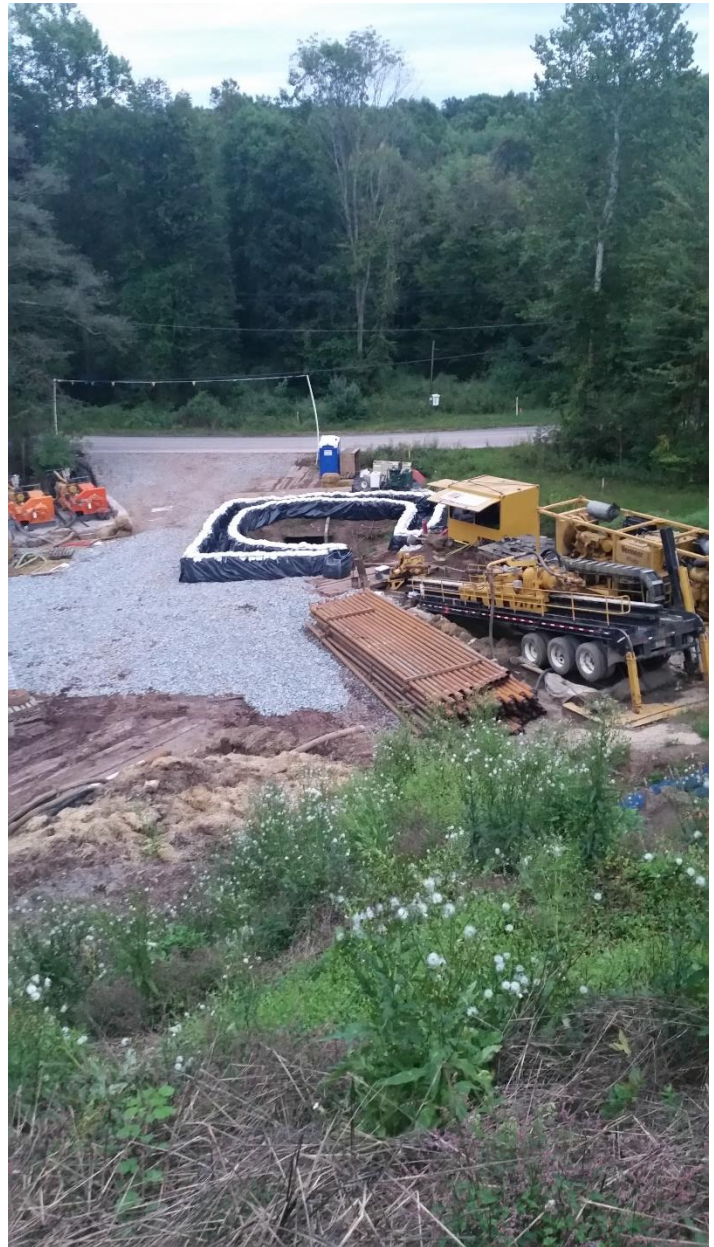
September 22, 2018 Erosion and Sediment (E&S) Controls are increased around the drilling pit.

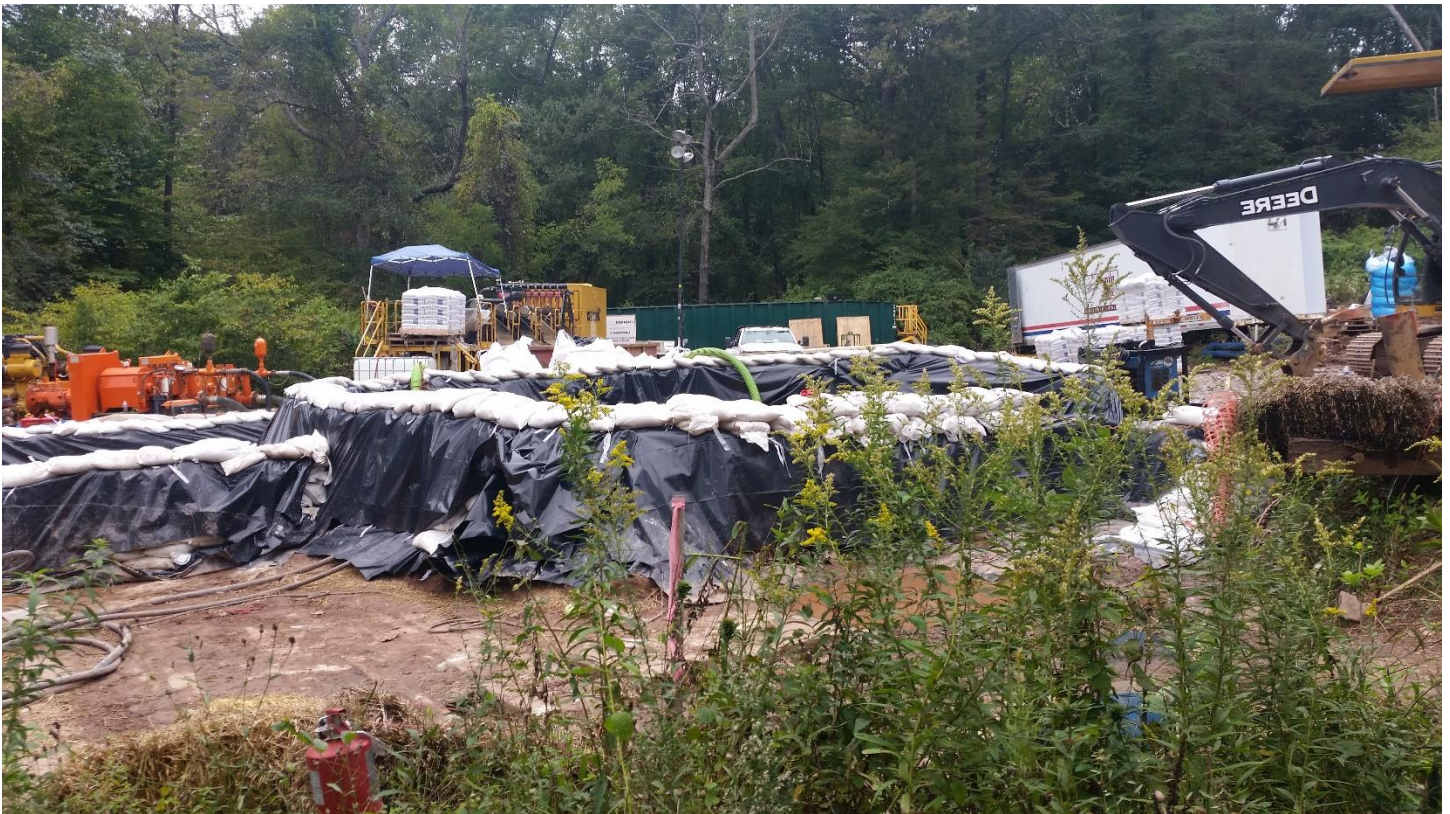
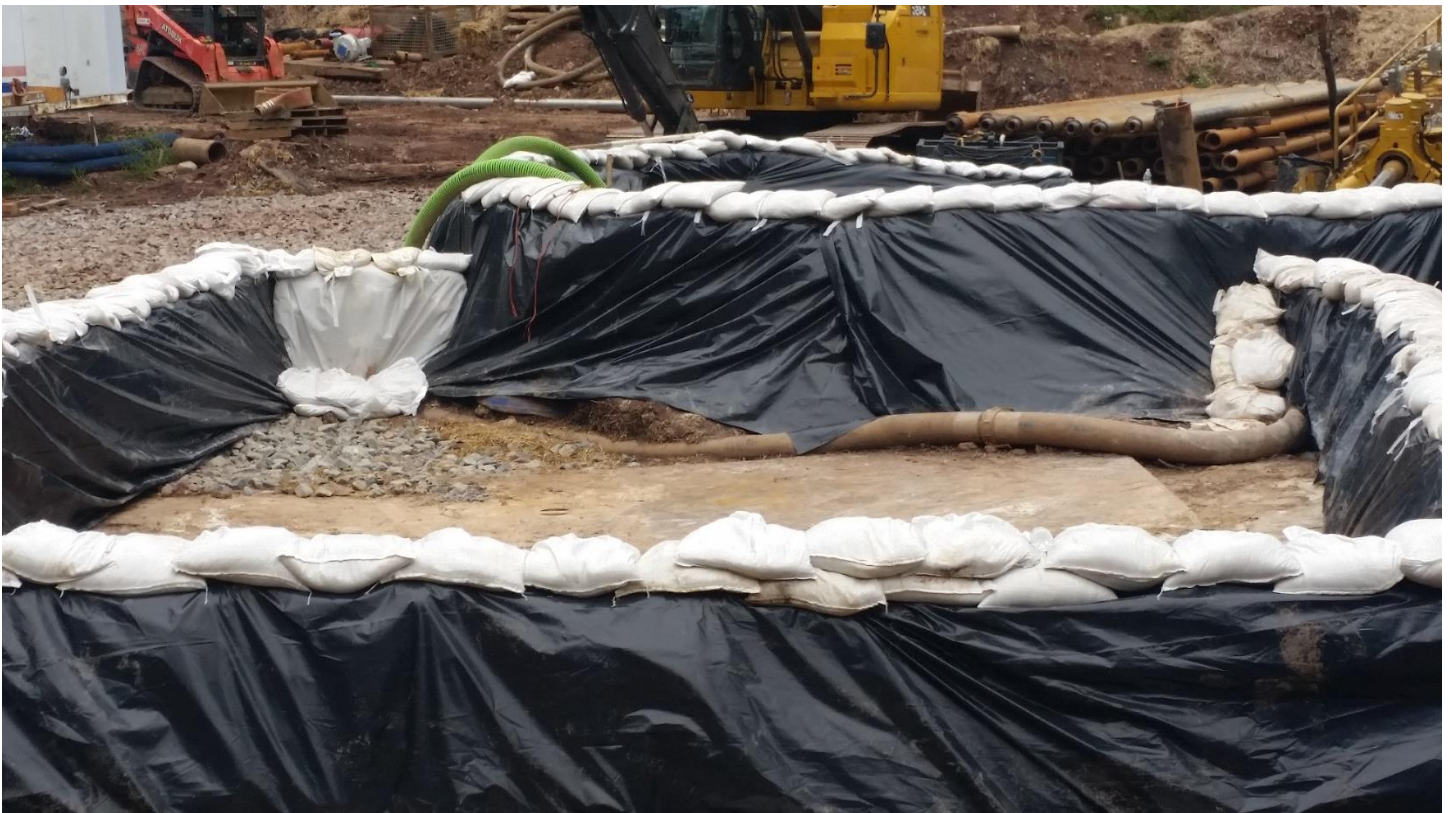
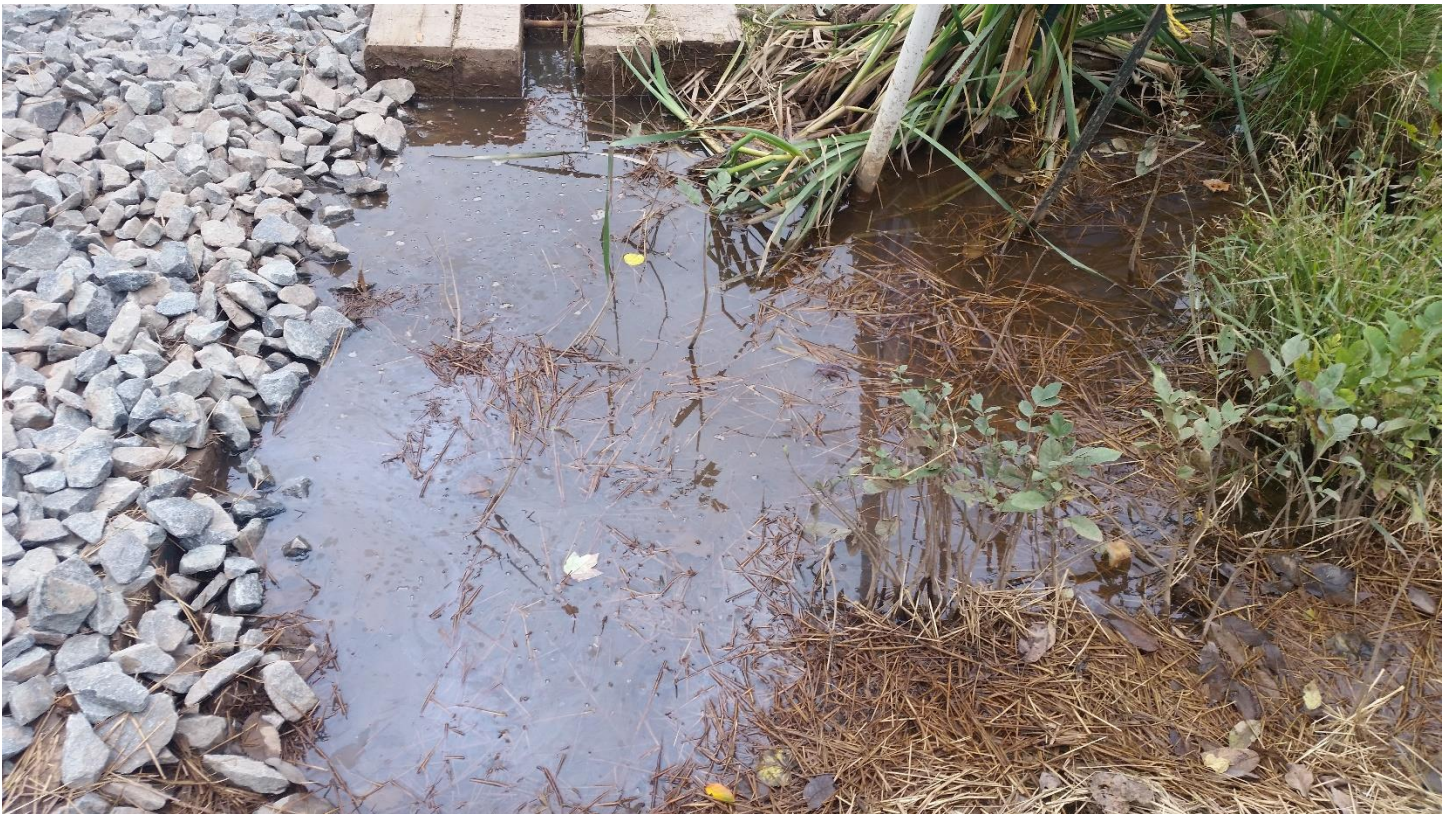
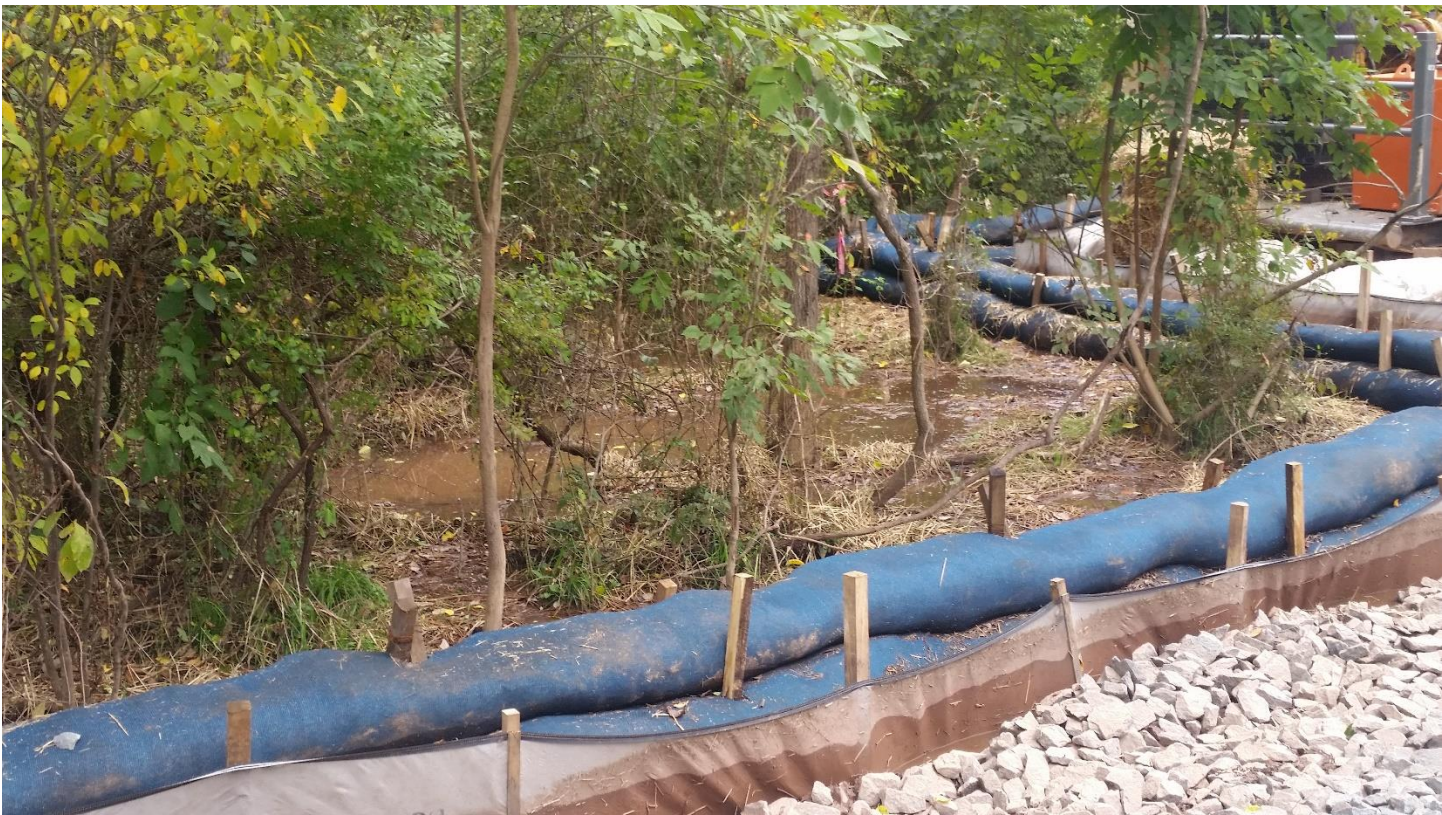
**September 27, 2018** Upon discussion with landowner, Right of Way Agent informs drill staff to increase E&S controls due to understanding that the drill extensively undermined the top soils and additional leak points were observed. Heavy oil and grease presence observed in and ponding persists.

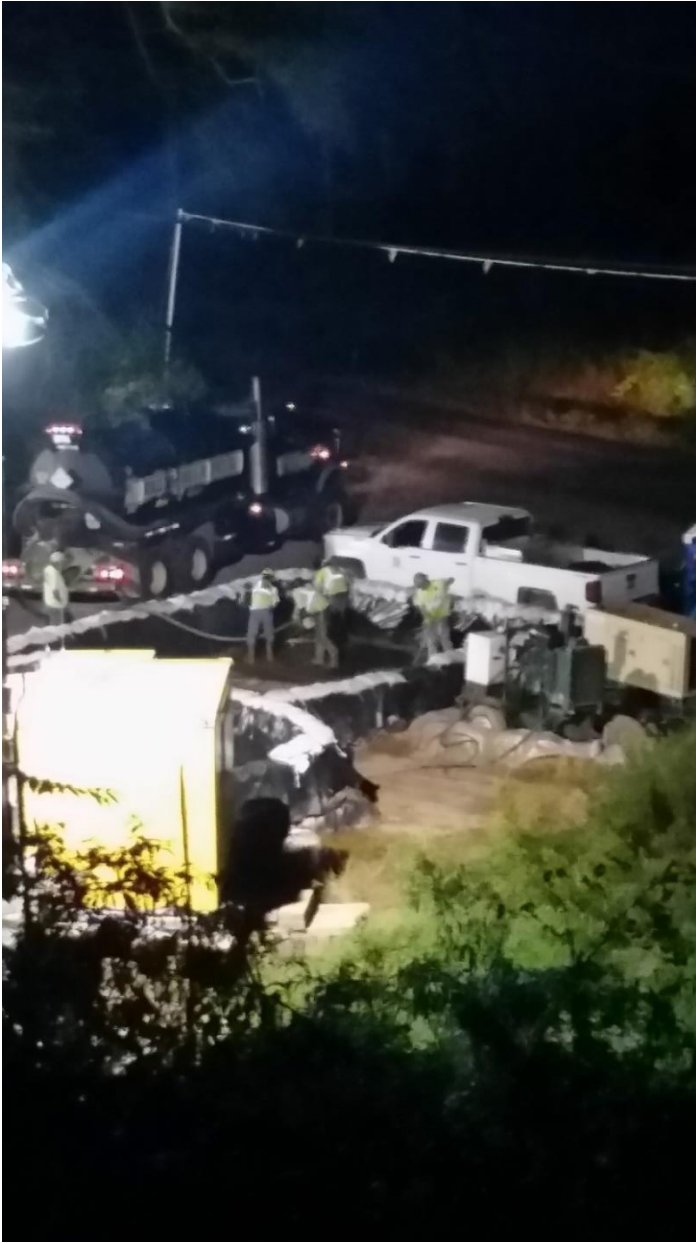
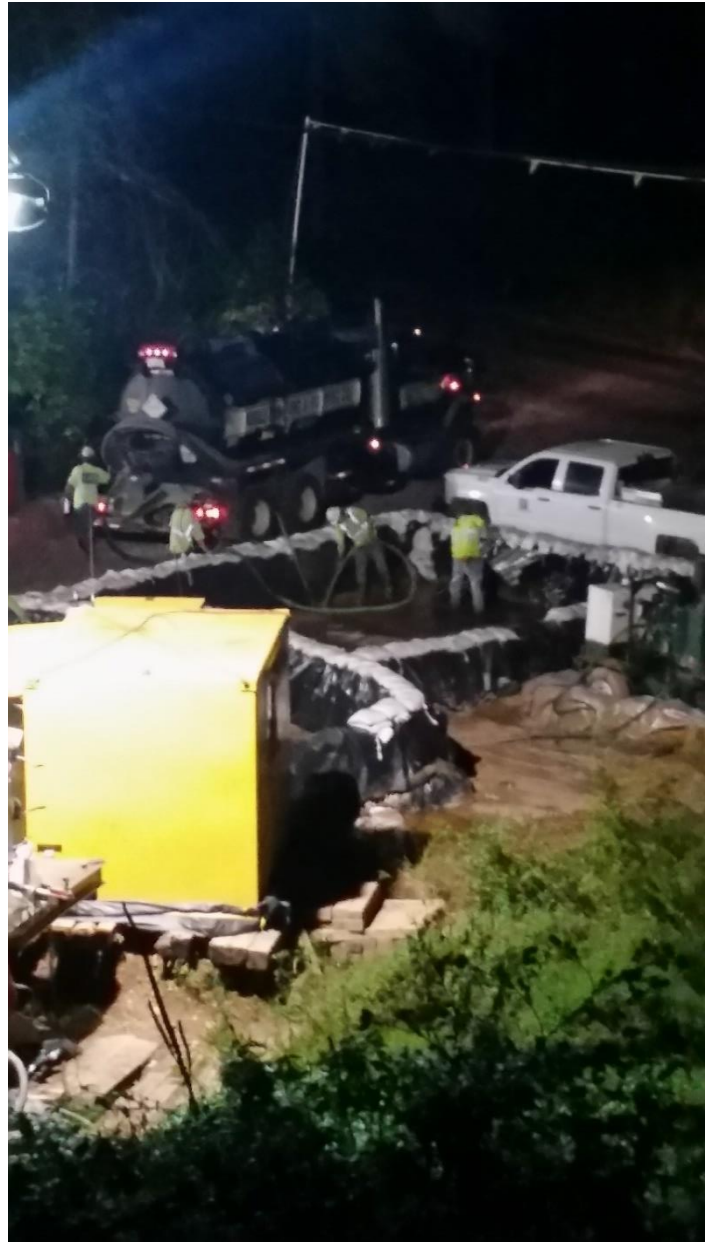
**October 2, 2018** Drilling mud observed being cleaned up inside additional containment area recommended by landowner.

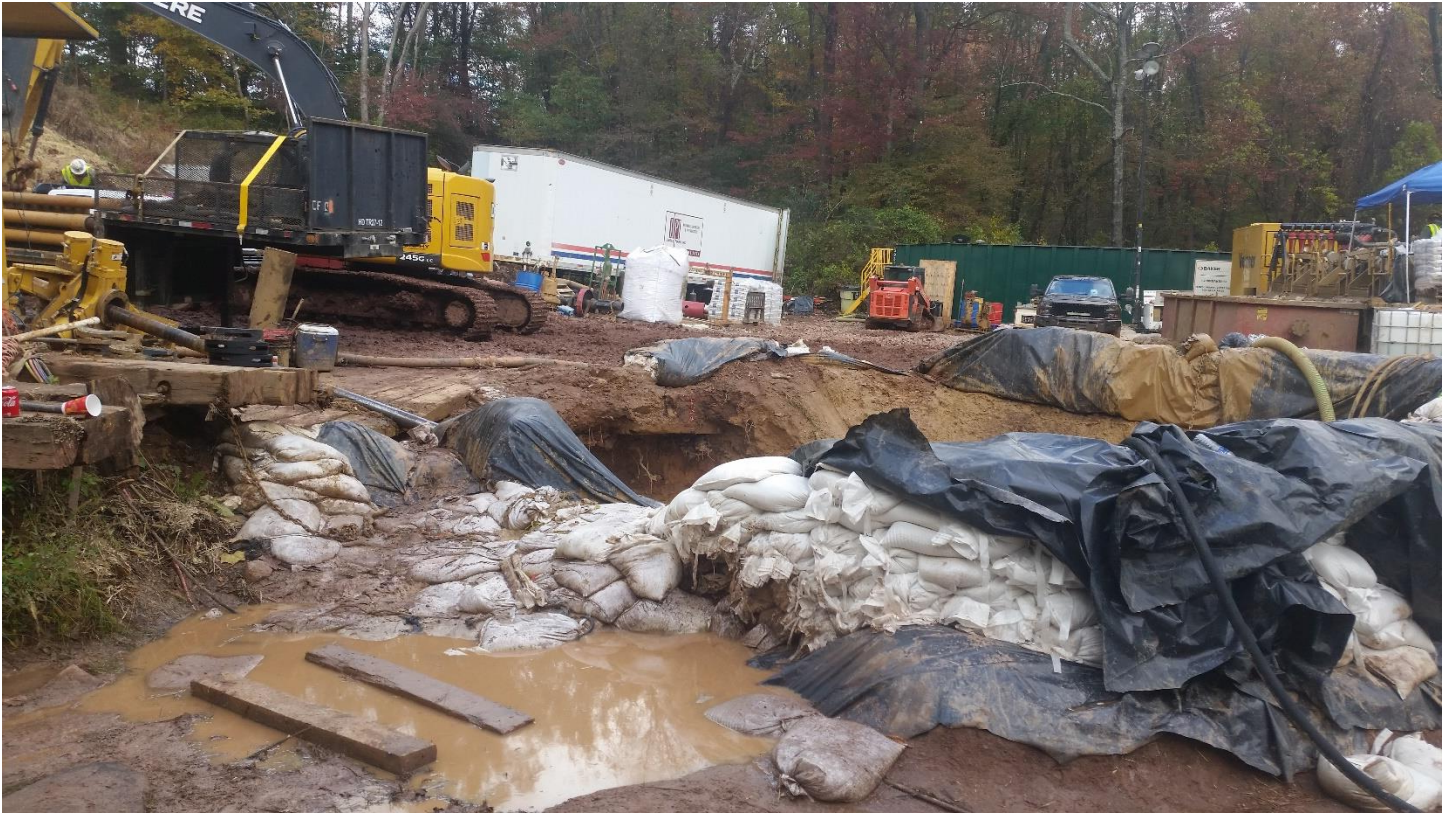
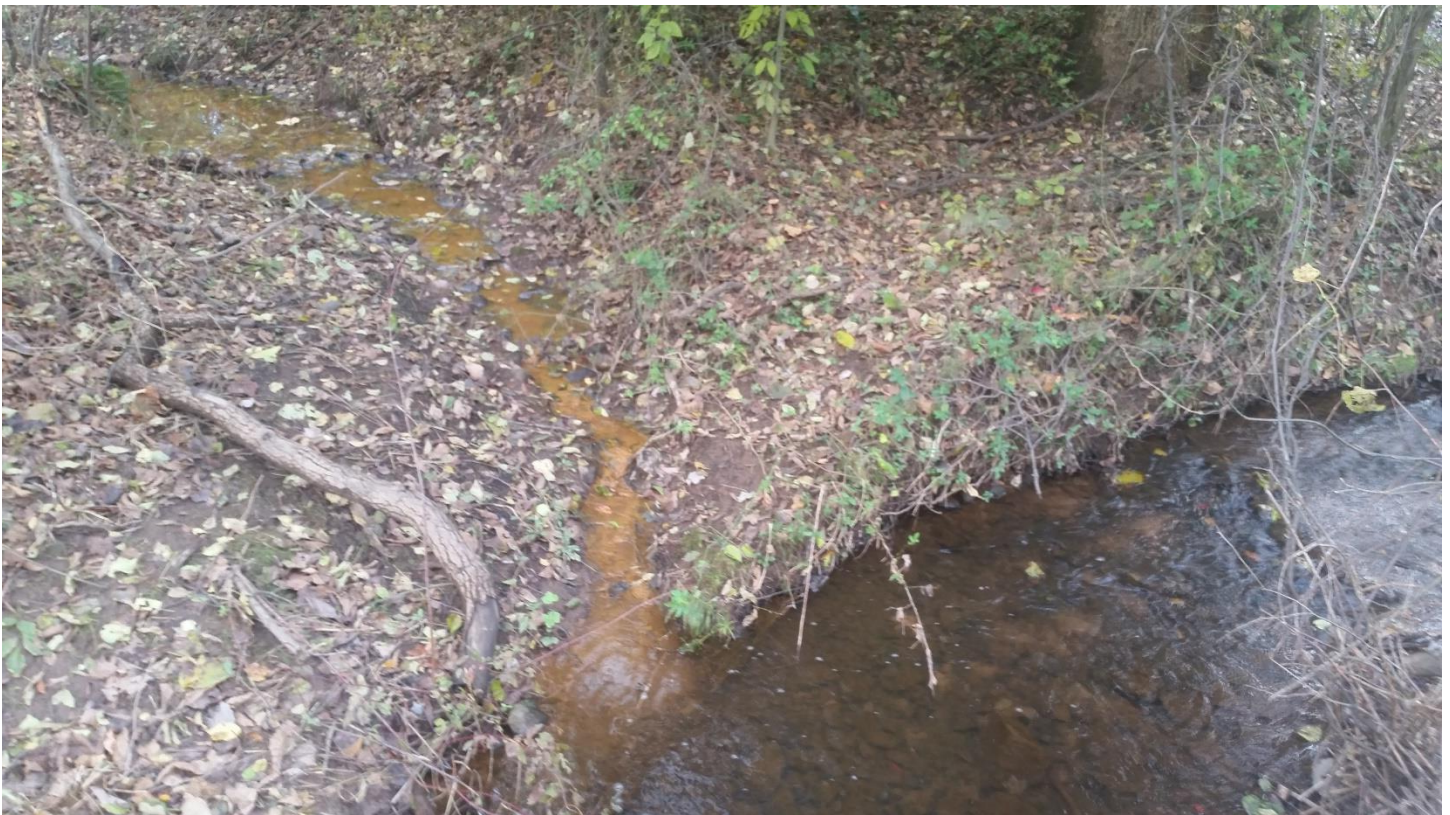
**October 29, 2018** E&S controls are in complete disarray. Side walls are collapsed and covered in drilling fluid. Unnamed tributary again shows signs of sedimentation. No report to PADEP or mention of conditions in the timeline report.

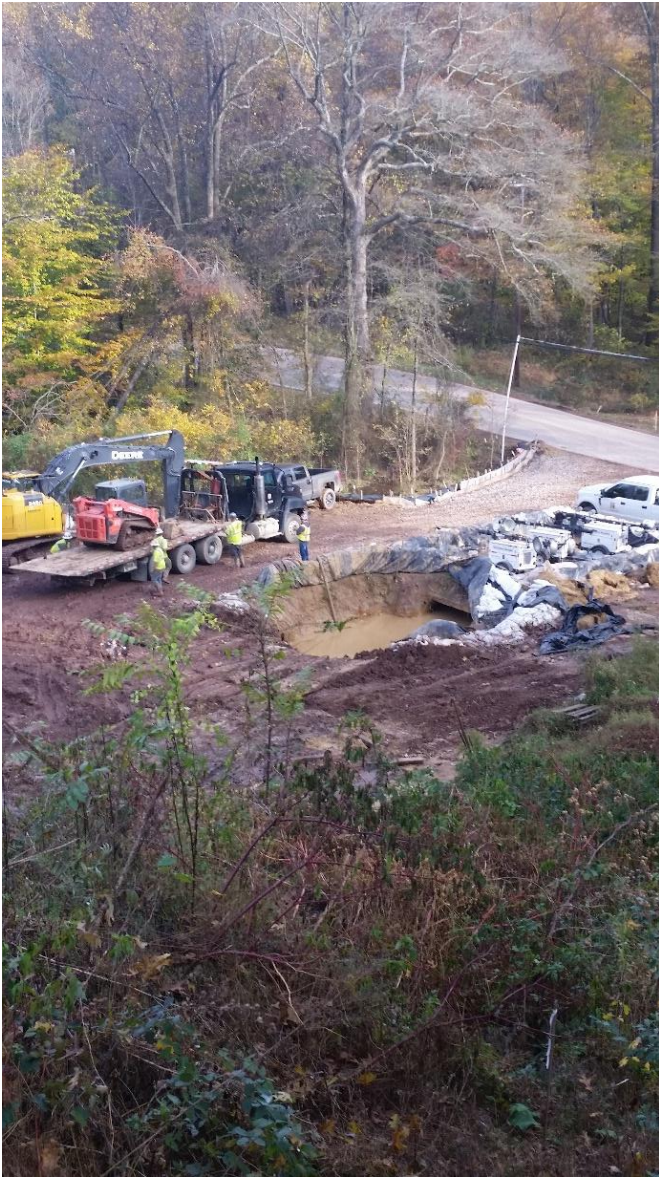
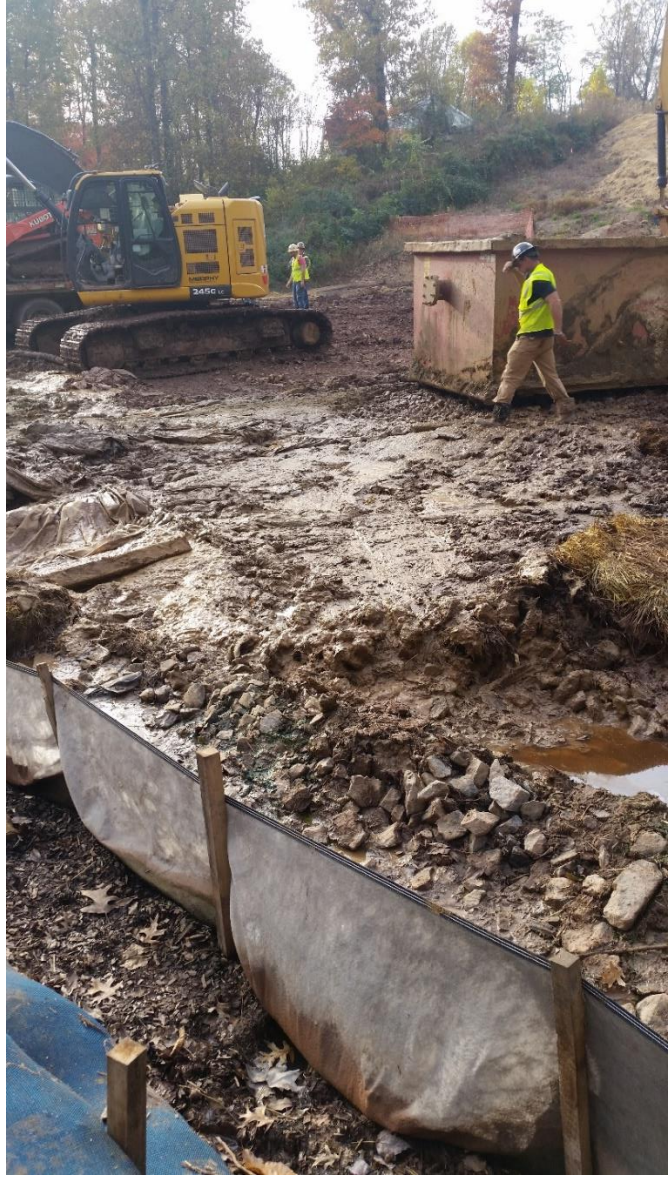
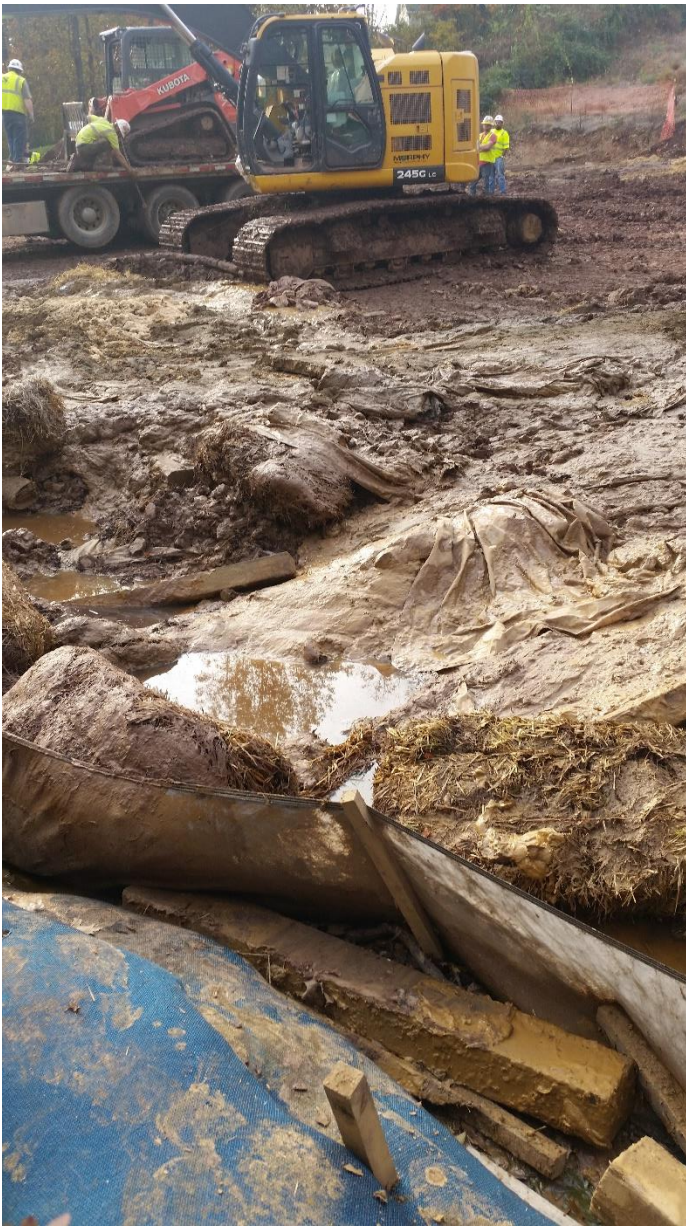
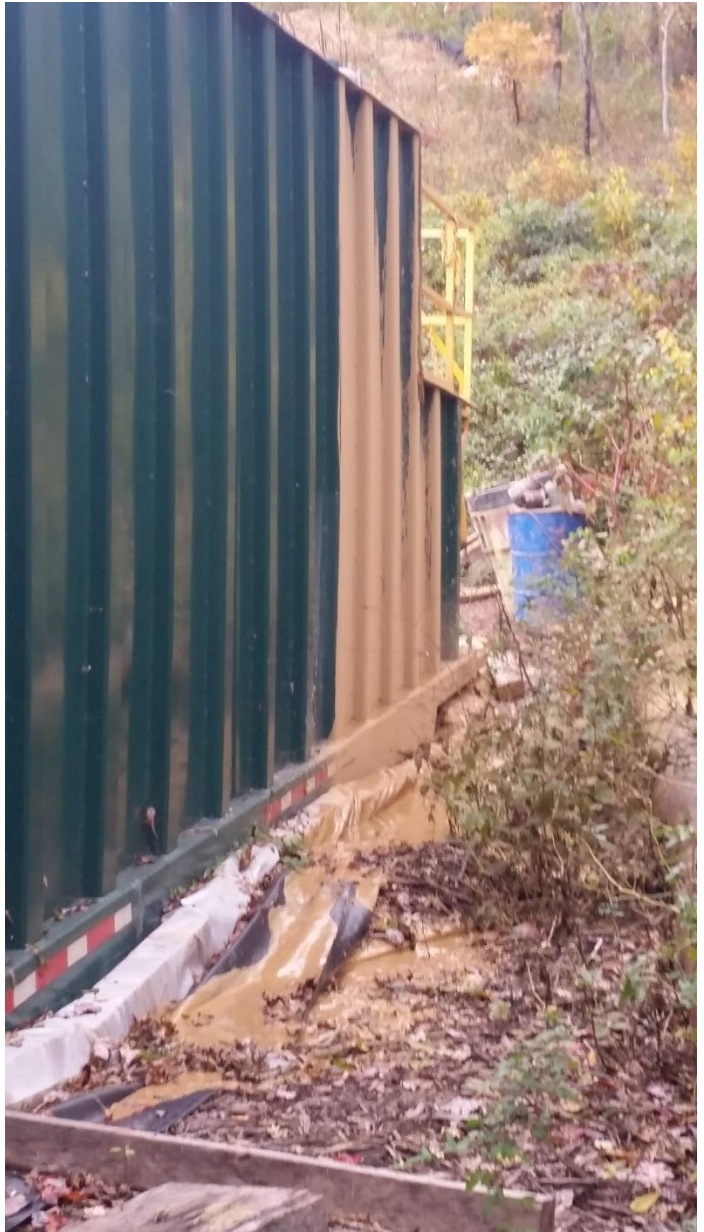
**November 1, 2018** Driller UPI was relieved of duty and the drill was removed. Drill pit continues to be pumped continually and turbidity is again observed in the creek. Drilling fluid is observed throughout the site due to equipment spills during work and careless removal.

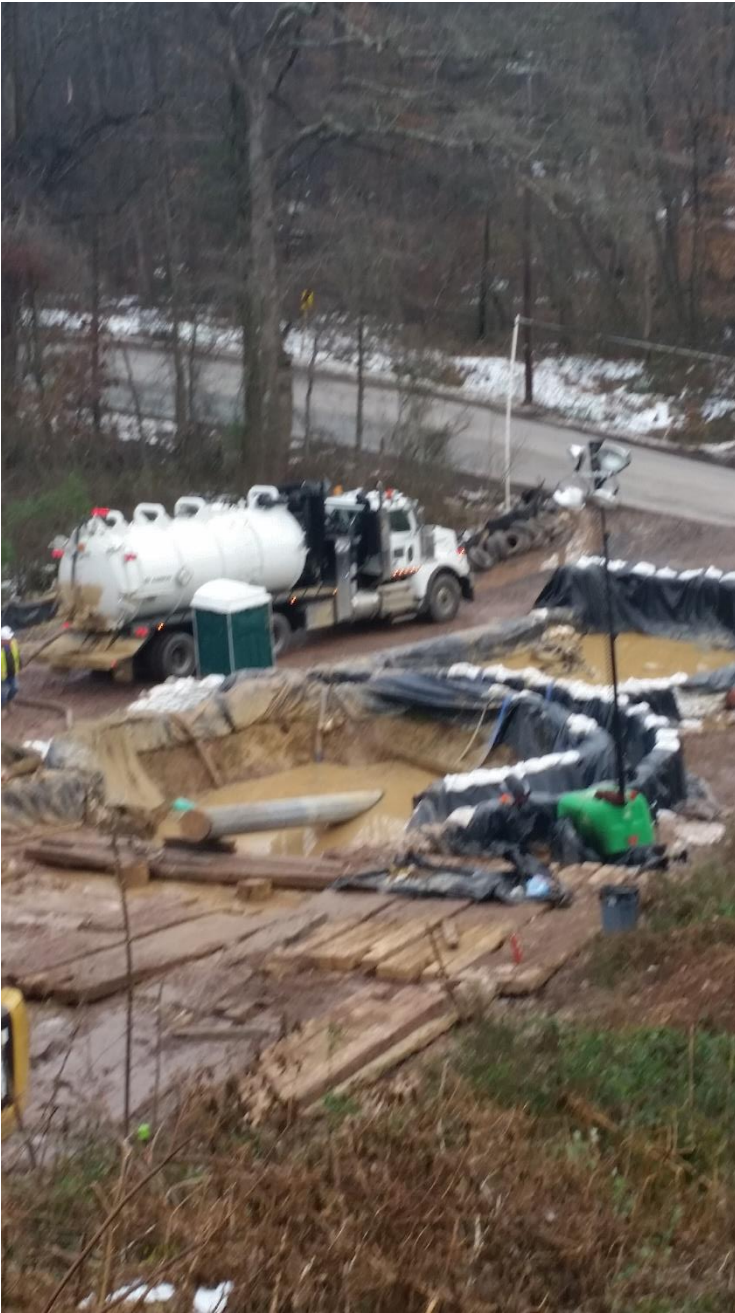
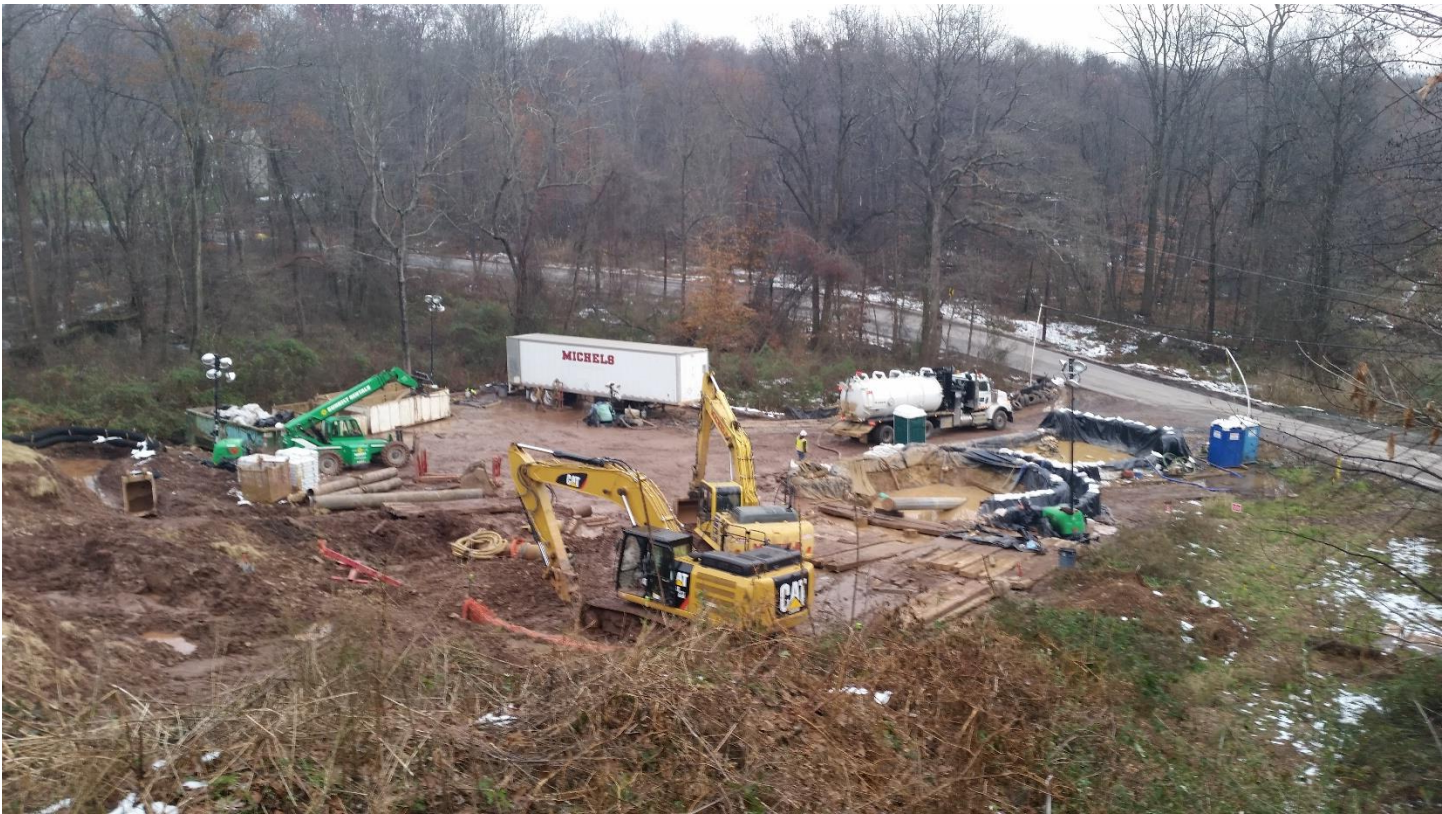
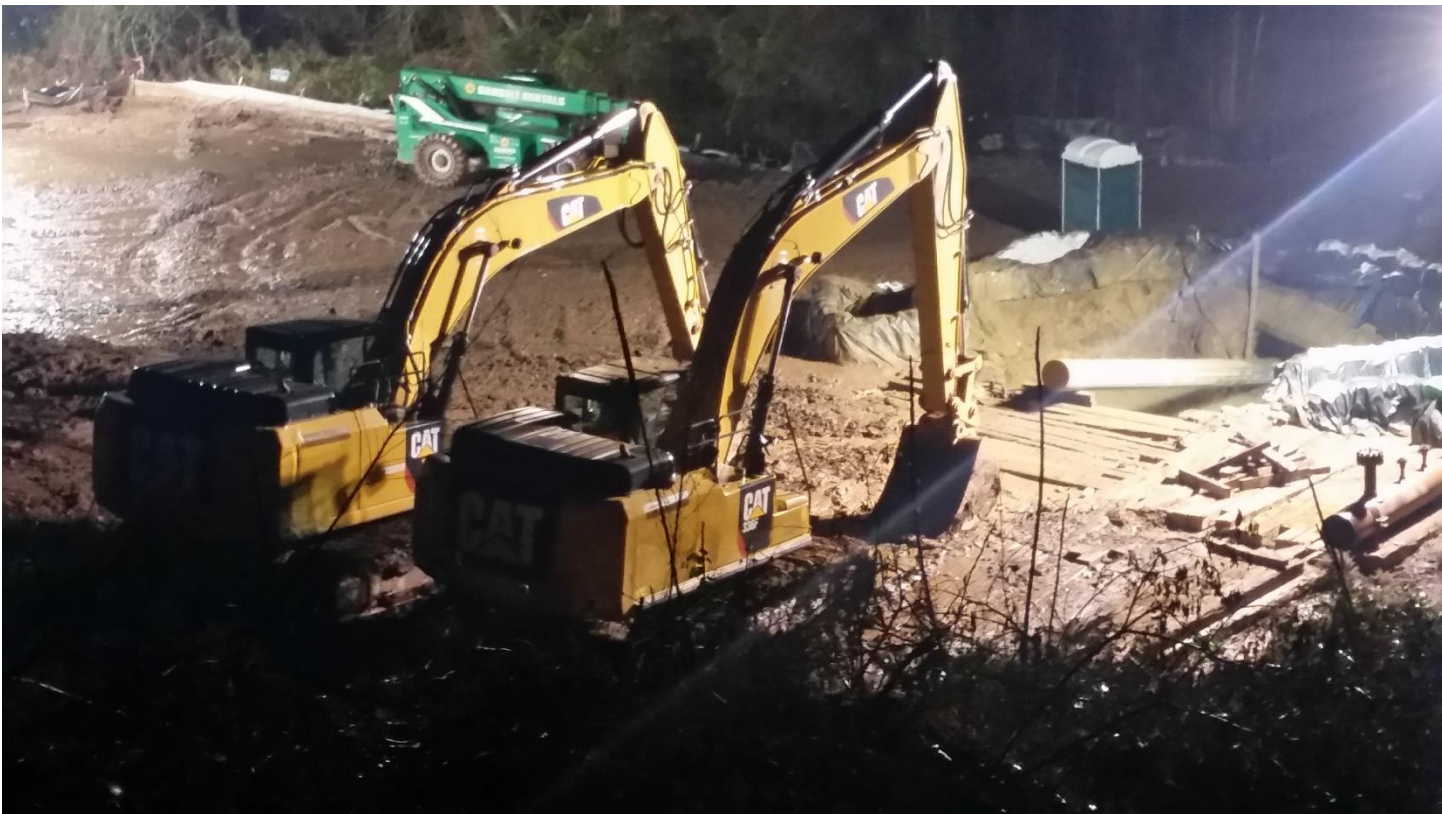
**November 19, 2018** Pipe is pulled through, both containment areas are full flooded with drilling mud.
