HORIZONTAL DIRECTIONAL DRILL RE-ANALYSIS  
JOANNA ROAD CROSSING  
PADEP SECTION 105 PERMIT NO: E06-701  
PA-BR-0181.0000-RD-16  
(SPLP HDD No. S3-0250-16)

Comments prepared by Mr. David W. Anspach III  
Resident 609 Joanna Road, Morgantown, Pa 19543  
324 Feet from HDD Western Entry Point

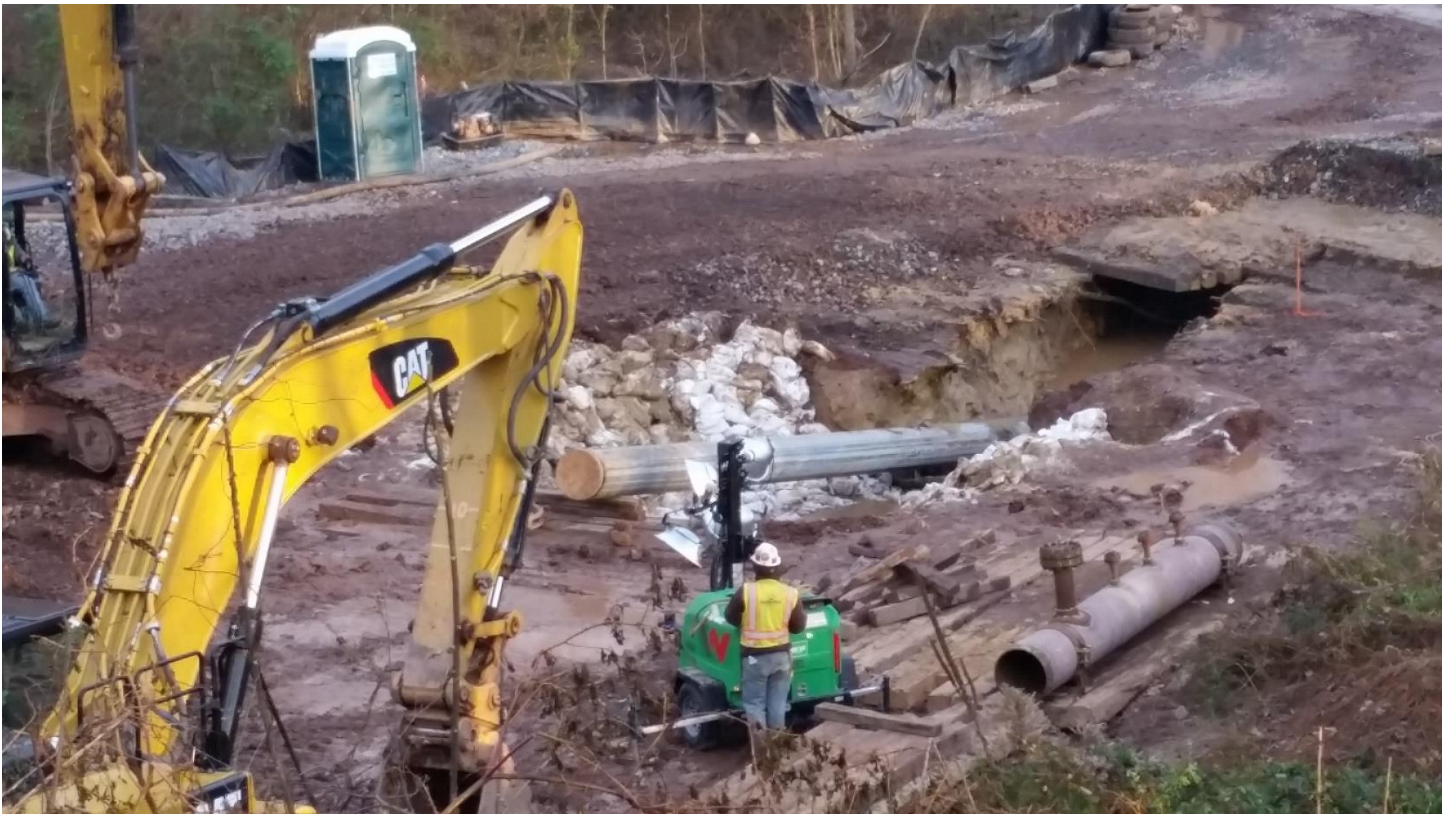
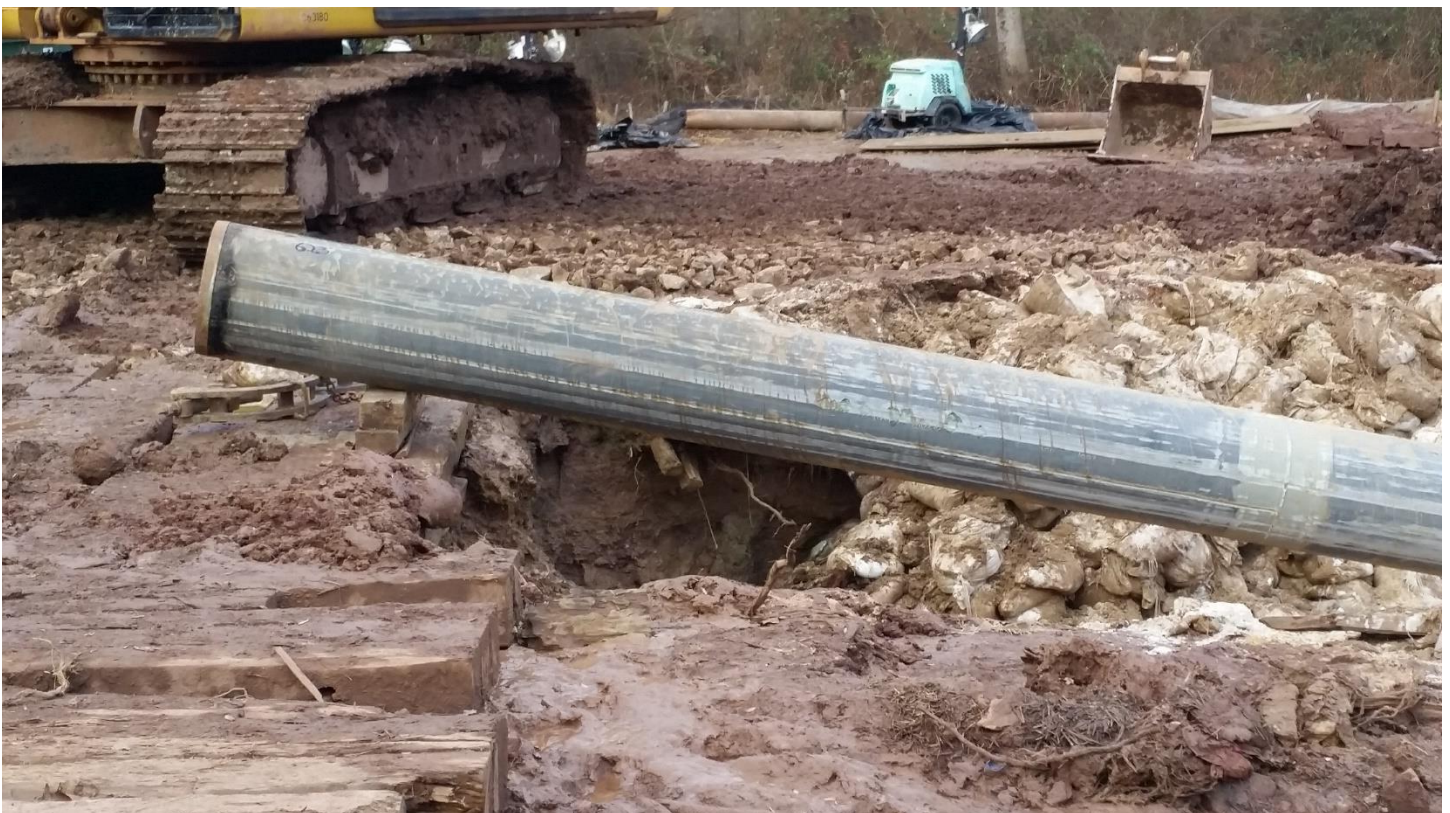
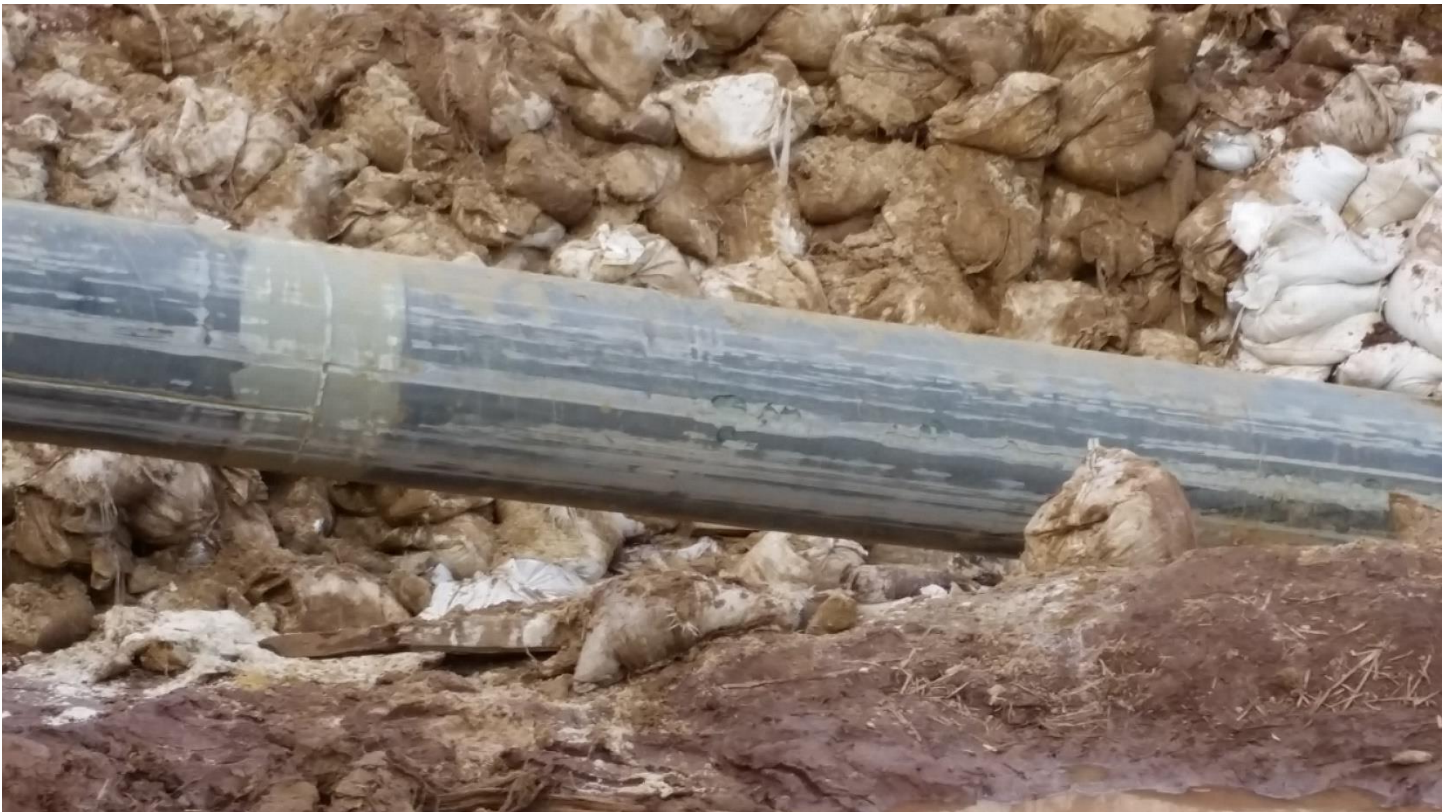
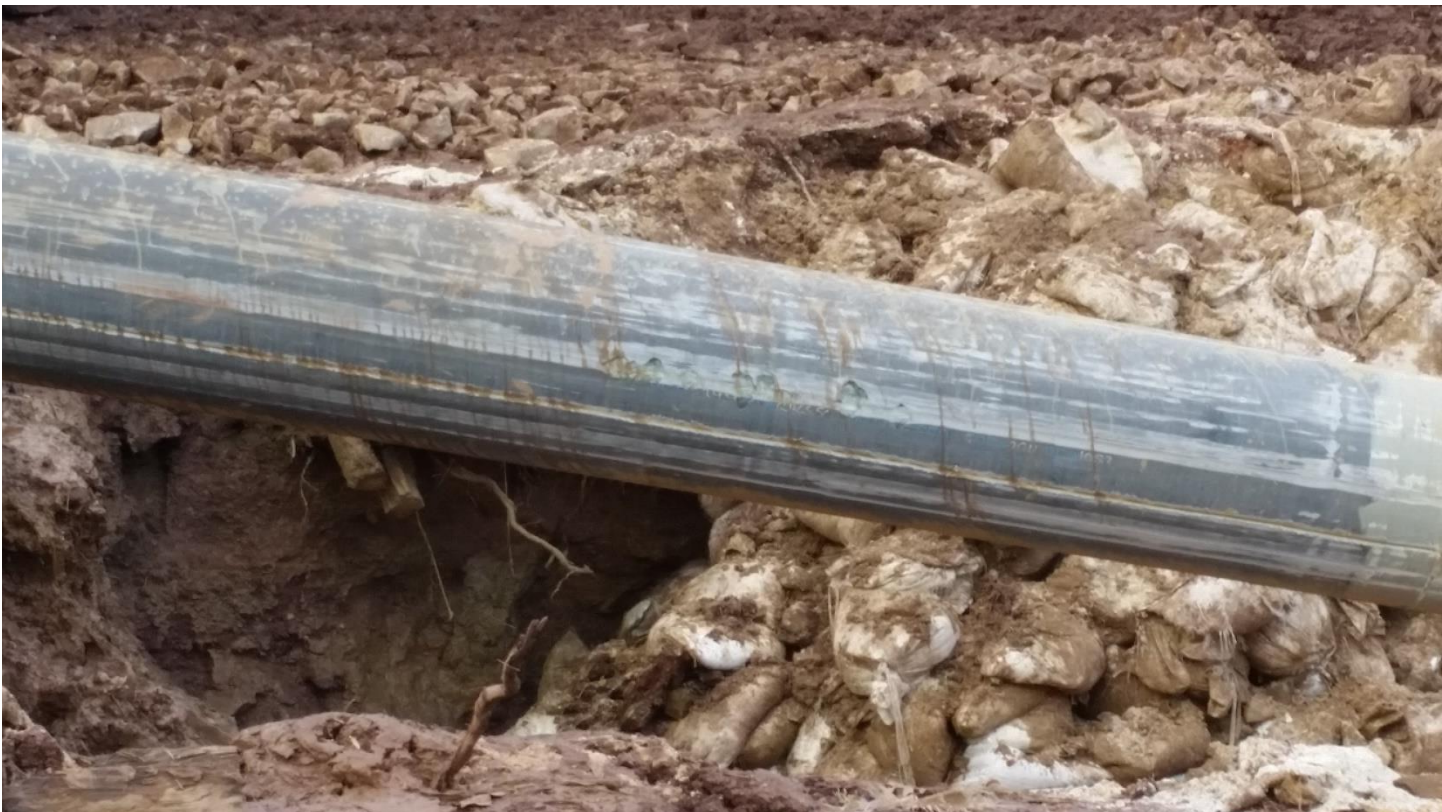
**November 20, 2018** Timber mats removed revealing undermined top soils which landowner warned Land Agent about. Pull through pipe shows extensive damages to coatings. Ground water continues to fill drilling pit, sand bag E&S structure is pushed into soils and presumed buried.

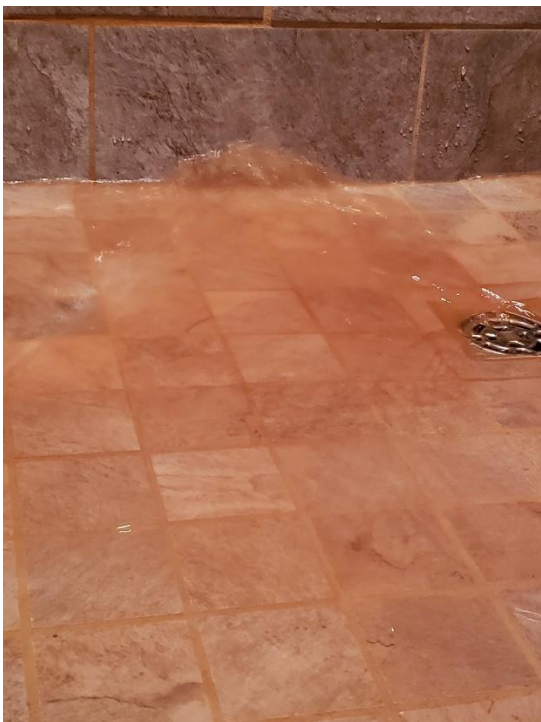
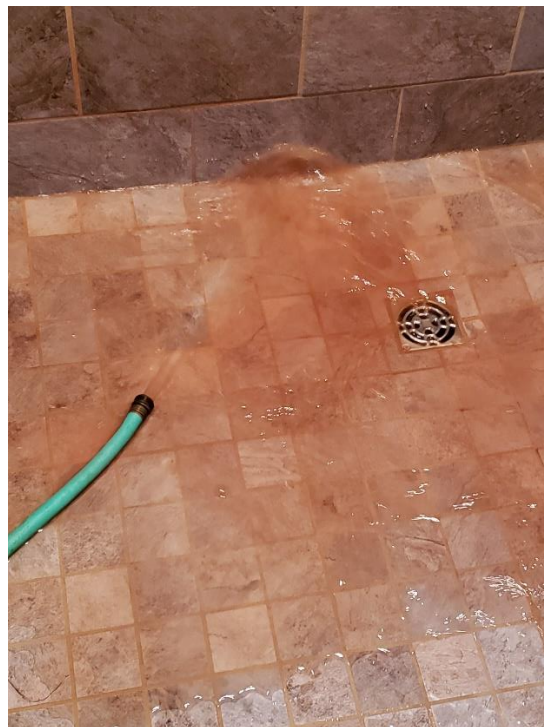
**January 21, 2019** 2 months after drilling has been completed and upon having the water buffalo freeze under severe cold weather, Landowner attempted to test home water supply. The water supply was turbid and sediment filled for more than an hour at take-off from pressure tank prior to water buffalo connection point.

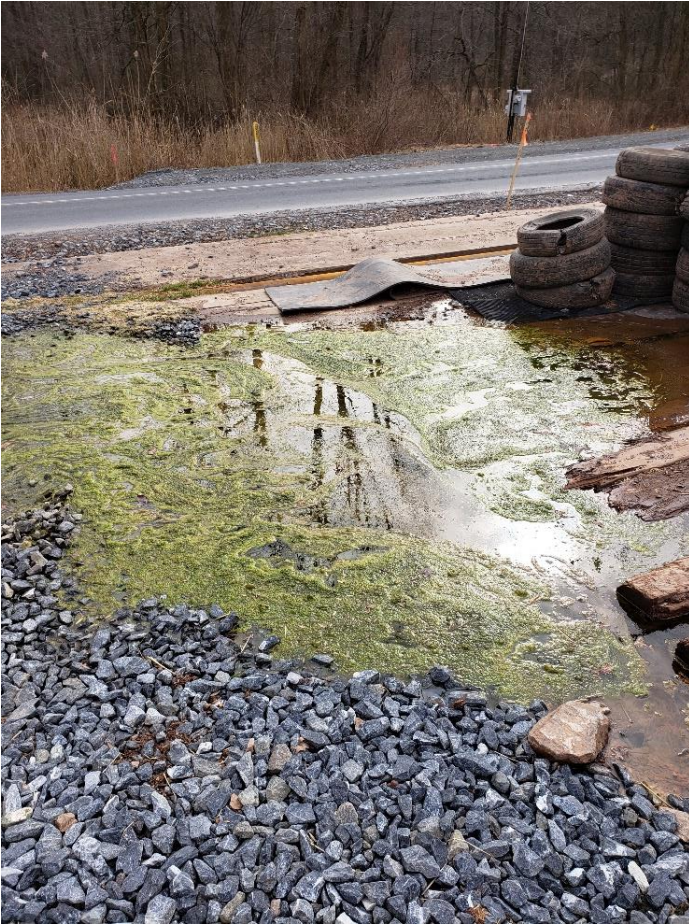
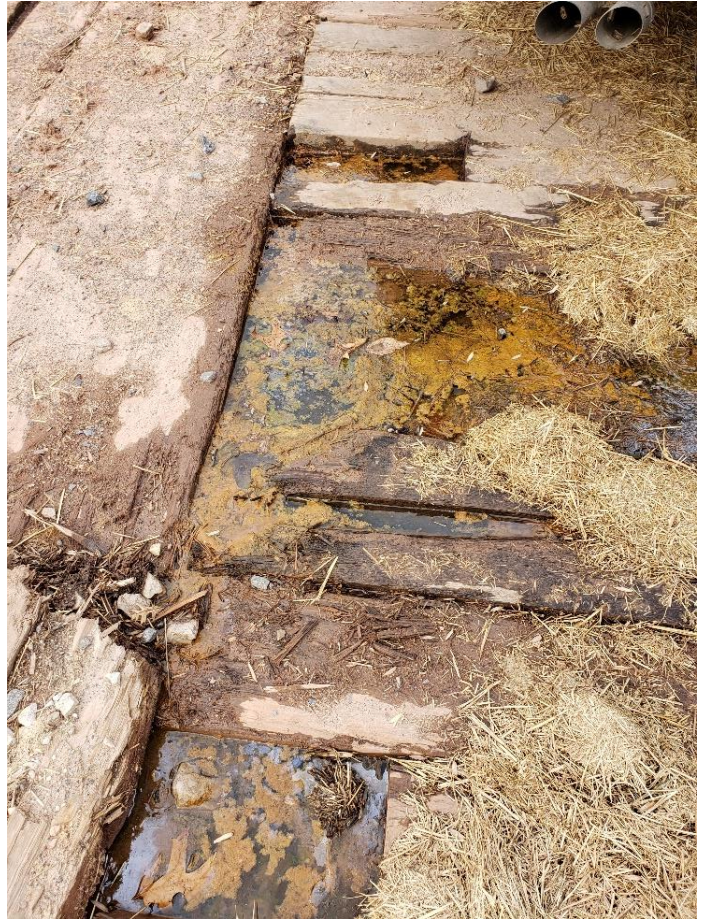
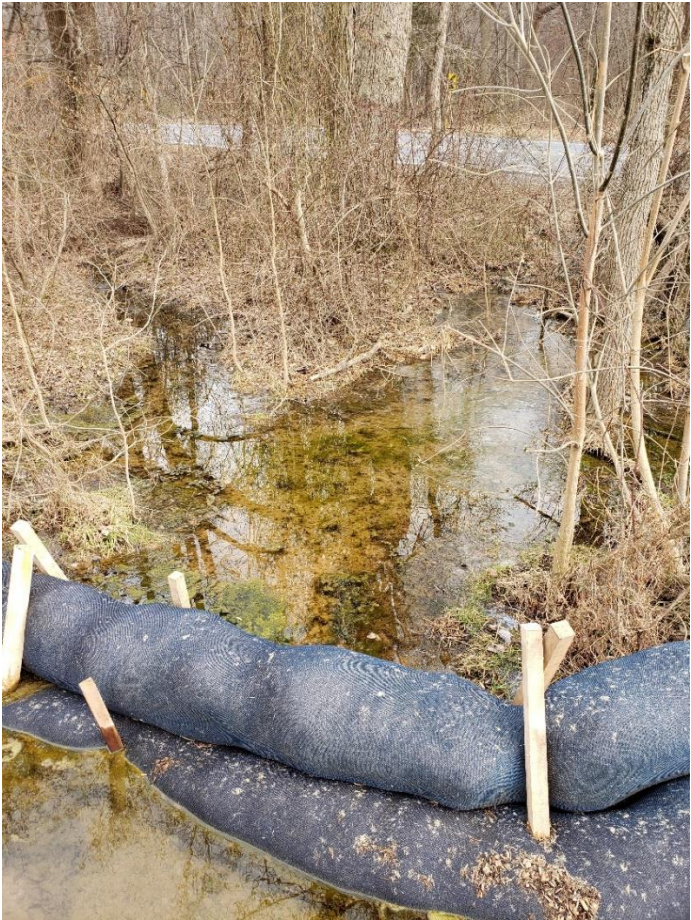
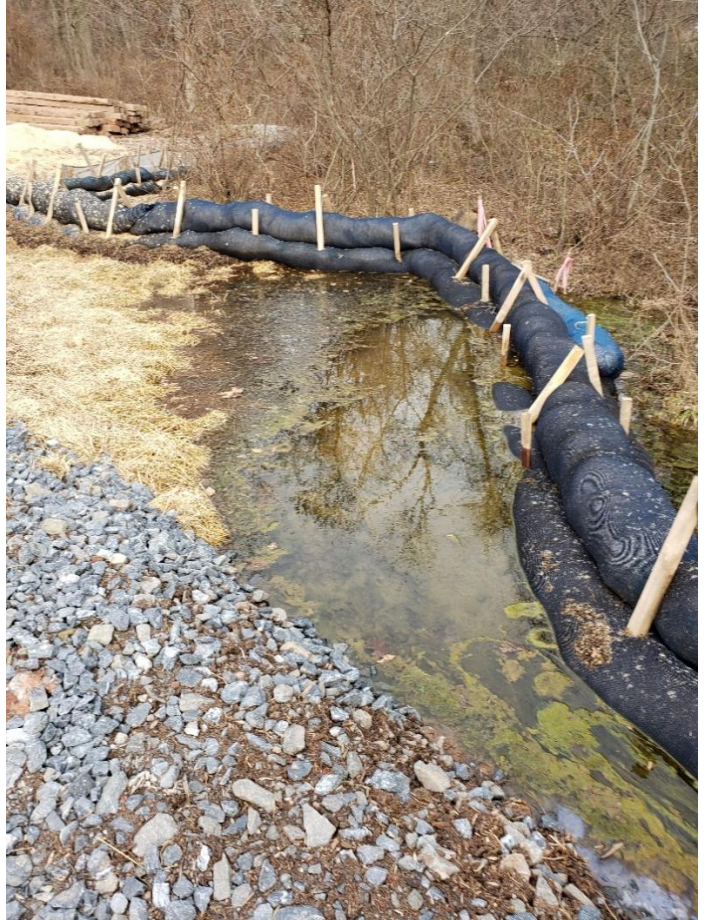
**February 10, 2019** Landowner observes continued pooling of water as well as formation of algae bloom in the area of the drill pipe entrance. A heavy presence of Oil and grease as well as the previously mentioned orange billowy fluff is observed. The origin of the flow is determined to be under the remaining timber mats covering ME2X. Heavy water flow from under the mats has created a new wetlands on adjacent property off LOD.

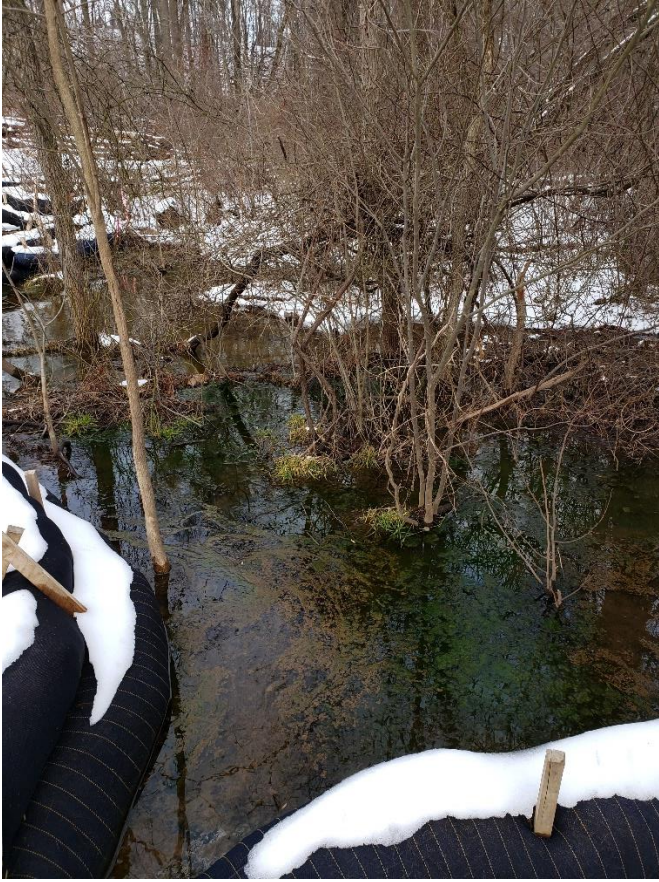
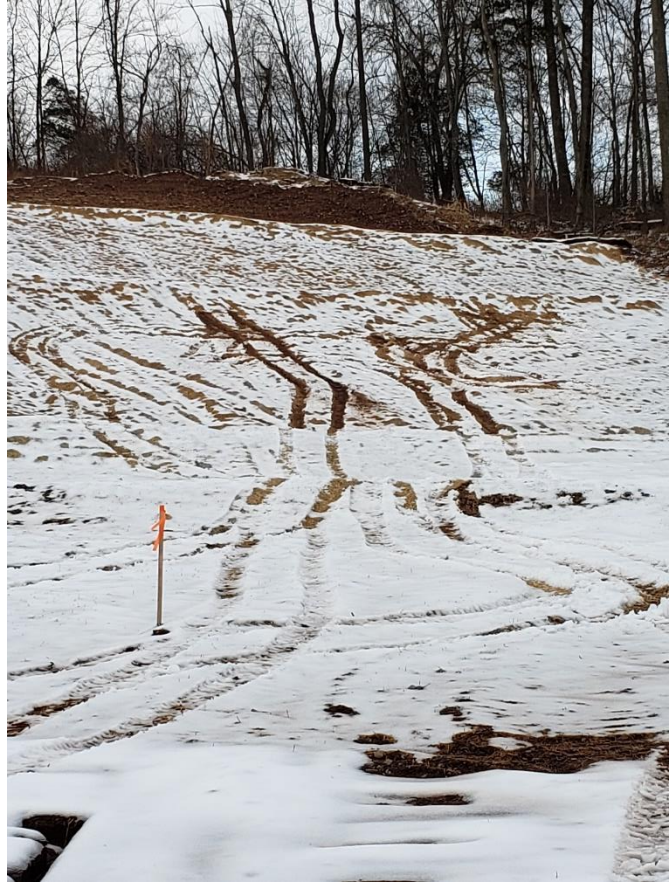
**February 13, 2019** Upon investigating trespassing four wheeler ATV's on landowners property the continuation of flow is noted. The flow is not freezing indicating a consistent flow at a volume to prevent freezing even in pooled areas.

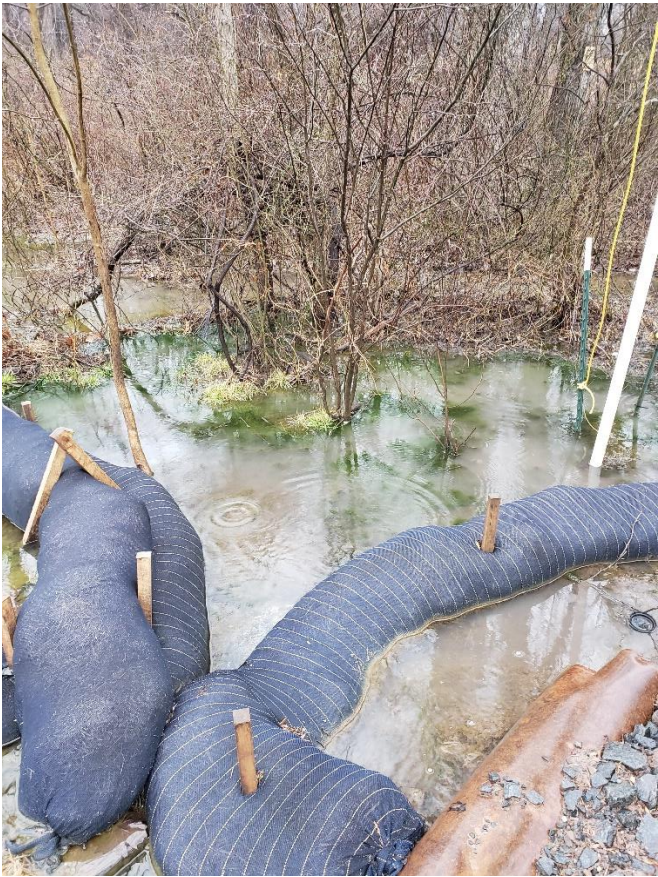
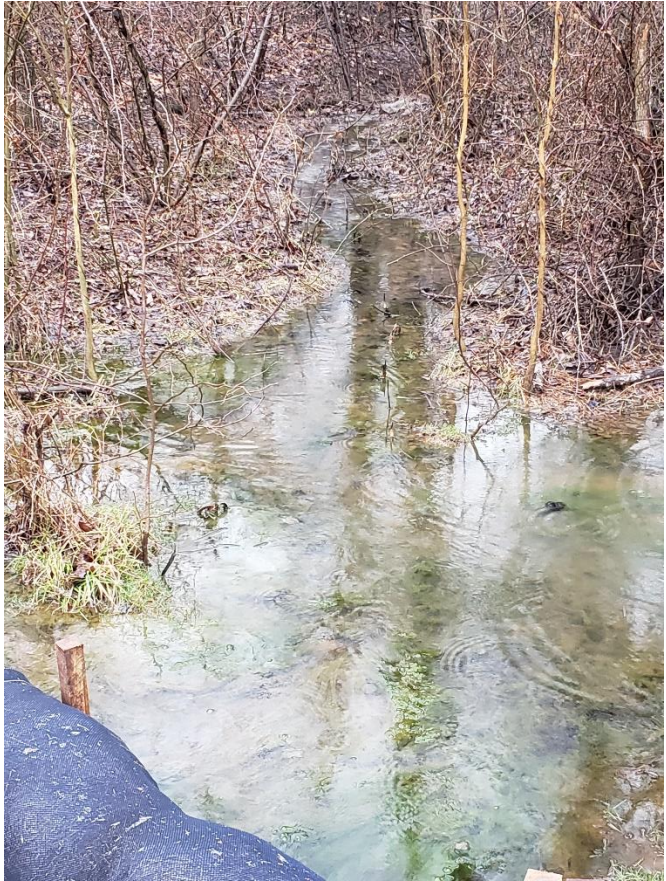
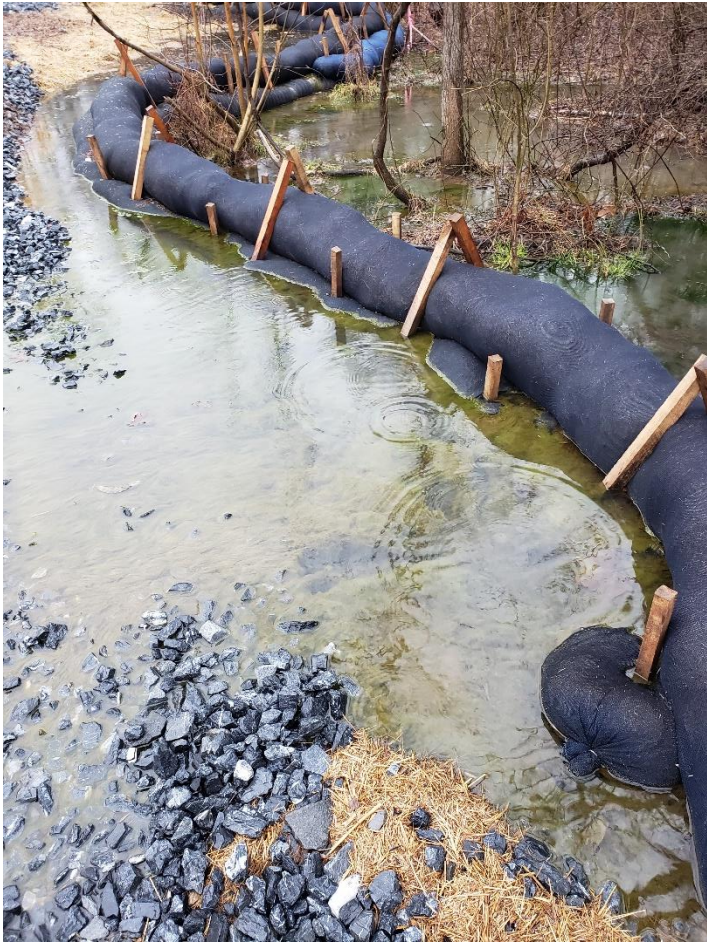
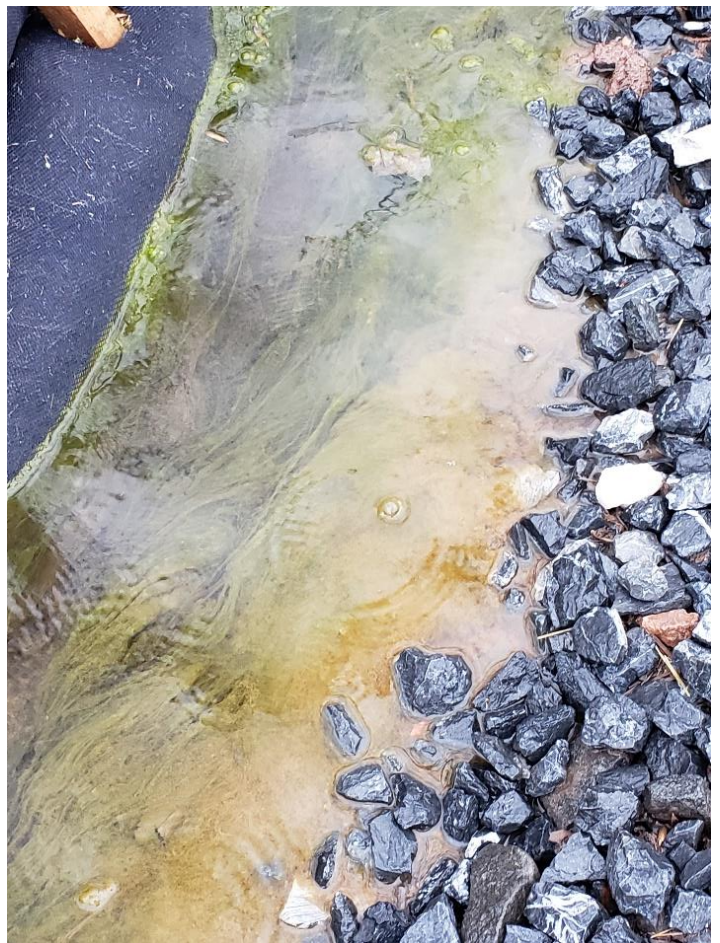
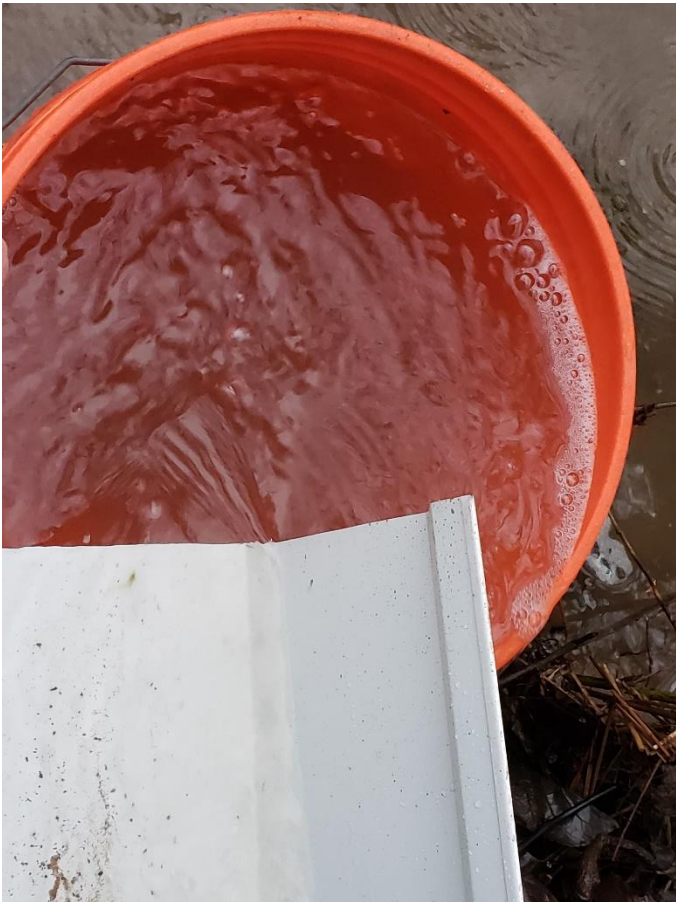
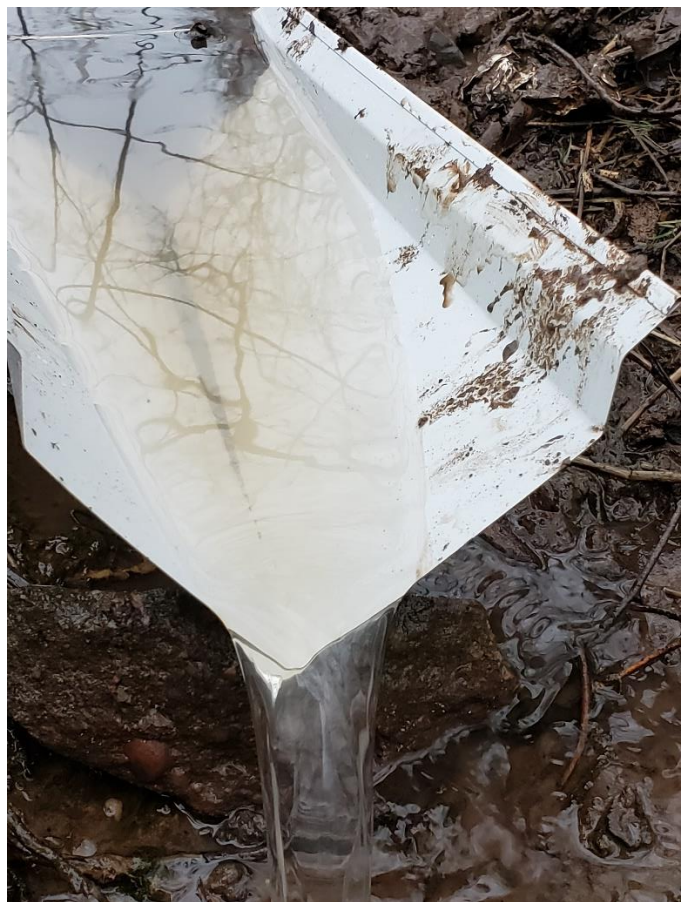
**February 24, 2019** Landowner continues to observe heavy flow and documents. Flow is showing signs of turbid cloudy nature in all streams. Flow without full capture by bucket and stop watch method is determined to be in excess of 14.5 gpm or 21,000 gpd.

The flow analysis of the puncture aquifer was calculated via watch and bucket method, an industry accepted standard for production. The two streams yielded a production of Flow #1, 5 gallons in 26.52 seconds and Flow #2, .5 gallons on 9.48 seconds without having full capture of the streams, calculated combined to be 14.47 gallon per minute. These yield a calculated volume of Flow #1 16,290 gallons per day and Flow #2 4,557 gallons per day or an annual total of 7,609,155 gallons. Undoubtedly, this will have a significant impact on the landowner's aquifer, well water supply and yield, potentially resulting in a dry well condition and loss of use. It should be noted that this flow is presumed to originate as the drill passed through the aquifer and therefore is now the location of the Mariner East 2X pipe. There is an active pipeline flowing inside this aquifer puncture, a failure of the pipe in this location would yield an immediate contamination event in a local waterway and directly impact downstream users.

I again call for significant hydrogeological testing to be conducted on the entire length of this HDD up to and including the impacts of any well within 450 feet of the HDD alignment. The presence of wells, emergent wetlands, forested wetlands, and the crossing of various streams places a significant amount of the areas water supply in a direct impact zone of construction. It would be ill advised not to perform testing to determine the impacts, given that IRs have already occurred on this project.
