**HORIZONTAL DIRECTIONAL DRILL ANALYSIS
STATE ROUTE 88 (SR-88)/WHEELING AND LAKE ERIE RAILROAD CROSSING
PADEP SECTION 105 PERMIT NO.: E63-674
PA-WA-0171.0000-RR
(SPLP HDD# S1B-0120)**

SR-88/WHEELING AND LAKE ERIE RR CROSSING
PADEP SECTION 105 PERMIT NO.: E63-674
PA-WA-0171.0000-RR
(SPLP HDD# S1B-0120)

This reevaluation of the horizontal directional drill (HDD) installation of a 20-inch diameter pipeline, HDD No. S1B-0120, has been completed in accordance with paragraphs 4 and 5 of the Stipulated Order (Order) issued under Environmental Hearing Board Docket No. 2017-009-L. This HDD is number 1 on the list of HDDs included on Exhibit 2 of the Order.

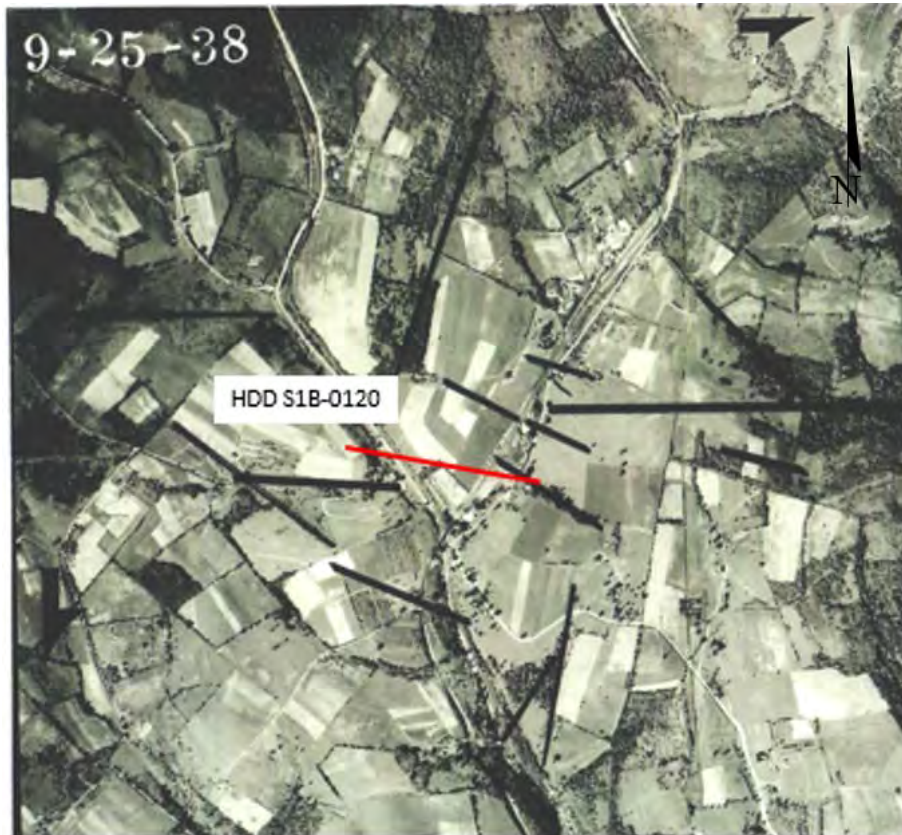
Figure 5: Fracture Trace Map

Figure 5 shows a fracture trace map prepared for this reevaluation. This mapping was performed using aerial stereographic pairs flown in the fall of 1938. As such, much of the land surface appears undeveloped; therefore, fracture traces are more easily seen. Three general orientations are present in the set of fracture traces. Two of the orientations generally match the systematic joint alignments mapped by Nickelsen and Hough (1967); a northwest trending set and a east-west trending set (systematic joint sets). The third orientation trends north-northeast and is sub-orthogonal to the east-west trending set.

Because bedrock fractures and jointing systems represent weak points in the bedrock, they are preferential pathways for groundwater infiltration and migration. The 1938 aerial imagery indicates the surrounding area was dominated by agriculture, so it had not been subjected to the property re-development activities more common today. The proposed path of the HDD is shown in red on Figure 5 and transects one northwest trending trace near its eastern entry/exit point.

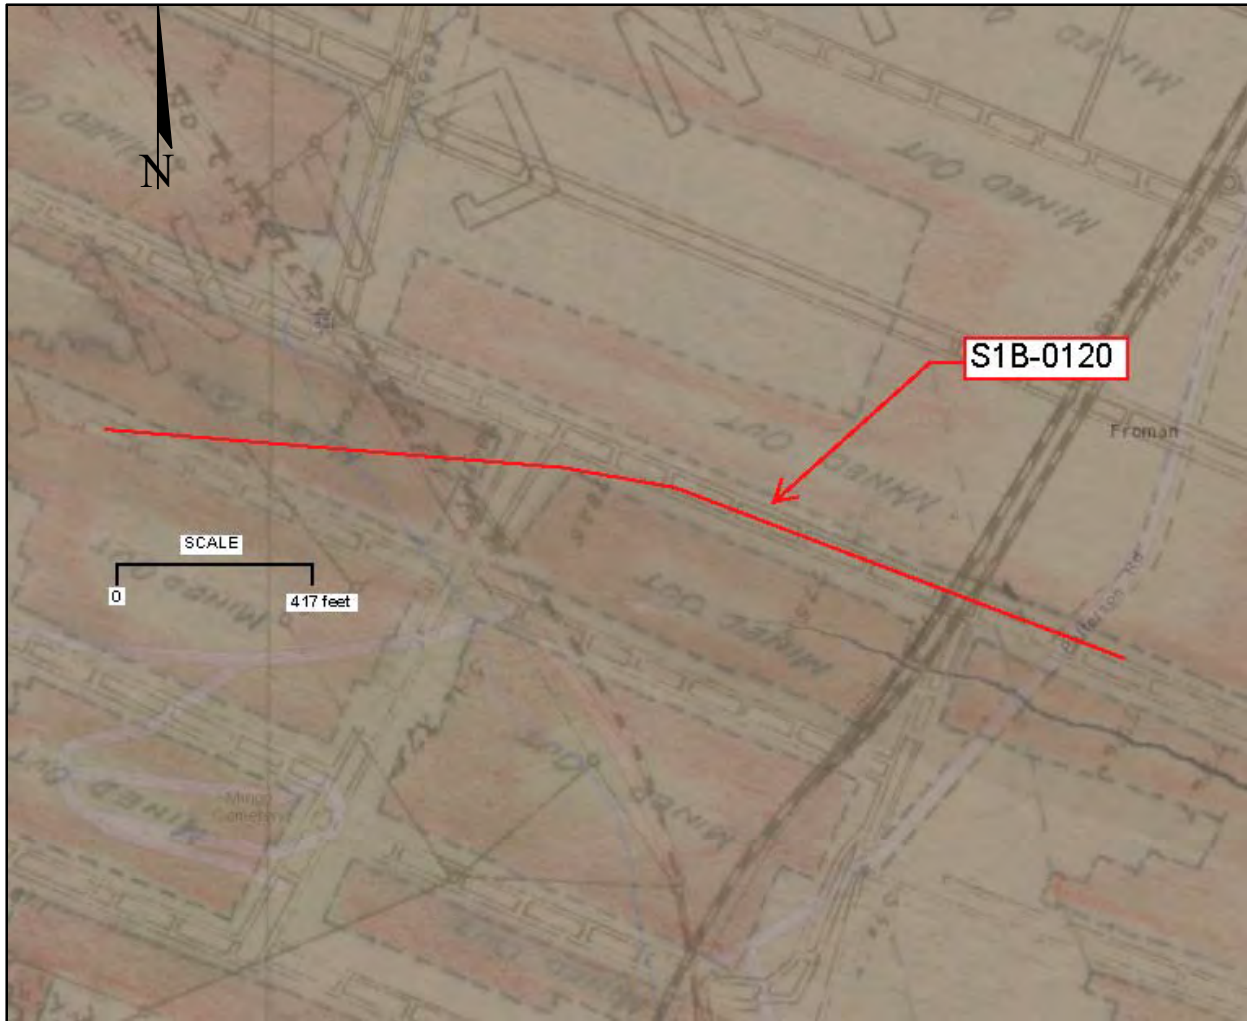
Figure 6: Mine Map, Cincinnati Coal Mine (from Pennsylvania State University, 2017)

A review of the PADEP on-line records revealed a mine subsidence complaint was filed with the PADEP in the area of interest on January 1, 2001. The subsidence complaint was mapped between Mingo Church and the HDD S1B-0120 drill path. However, the available records do not indicate if the complaint was the result of a change in well water quality/quantity or an actual subsidence event involving damage to homes or property.

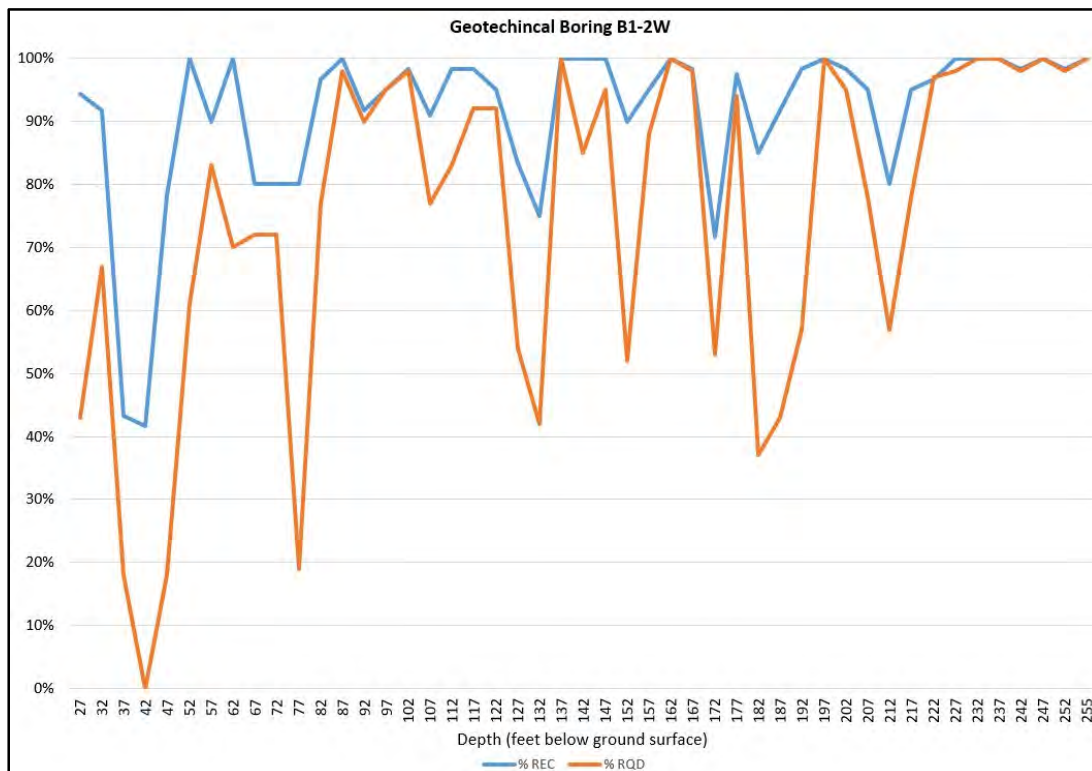
Figure 7: Percent Recovery and RQD with Depth in B1-2W

Rock Quality Determinations (RQDs) generally improved with depth over the cored interval averaging 61% from 24 to 102 ft bgs, 77% from 102 to 202 ft bgs, and 91% from 202 to 255 ft bgs. Vertical to high angle fractures and joints were observed from 57 to 62 ft bgs, 67 to 72 ft bgs, 107 ft bgs, 132 to 137 ft bgs, 140 ft bgs, and 166 ft bgs. **Figure 7** presents a graphical representation of the percent recovery and percent RQD with depth in boring B1-2W. While the average RQD improves with depth, there is a variability to the RQD values throughout the boring, and RQDs less than 60% occurred at multiple intervals.

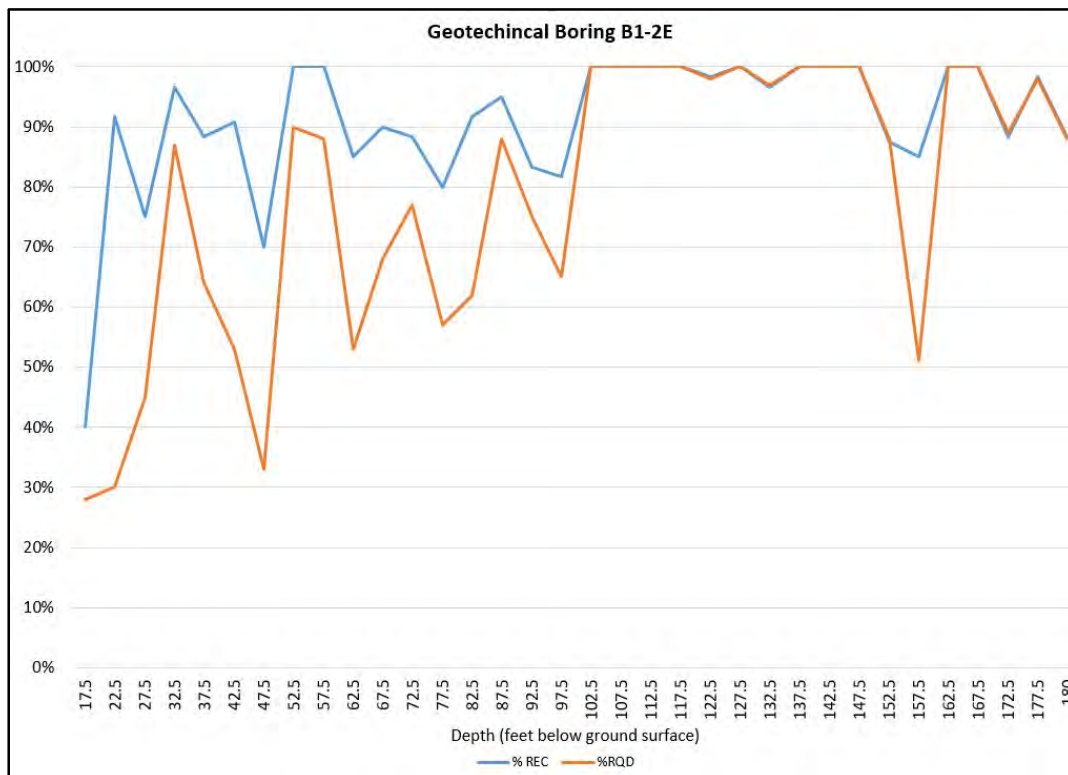
Figure 8: Percent Recovery and RQD with Depth in B1-2E

Rock Quality Determinations (RQDs) generally improved with depth over the cored interval averaging 65% from 12.5 to 102 ft bgs and 95% from 102 to 180.0 ft bgs. Vertical to moderate angled fractures and joints were observed from 15 to 17.5 ft bgs, 49 ft bgs, 67.5 to 72.5 ft bgs, and 177.5 to 180 ft bgs. **Figure 8** presents a graphical representation of the percent recovery and percent RQD with depth in boring B1-2E to define the zones where fractures, bedding plane and horizontal fractures, are most common. Note RQDs were high and varied little between 97.5 and 147.5 ft bgs but some variability returned to the RQD values between 147.5 and 182.5 with a value near 50% over the five foot run from 152.5 to 157.5 ft bgs.

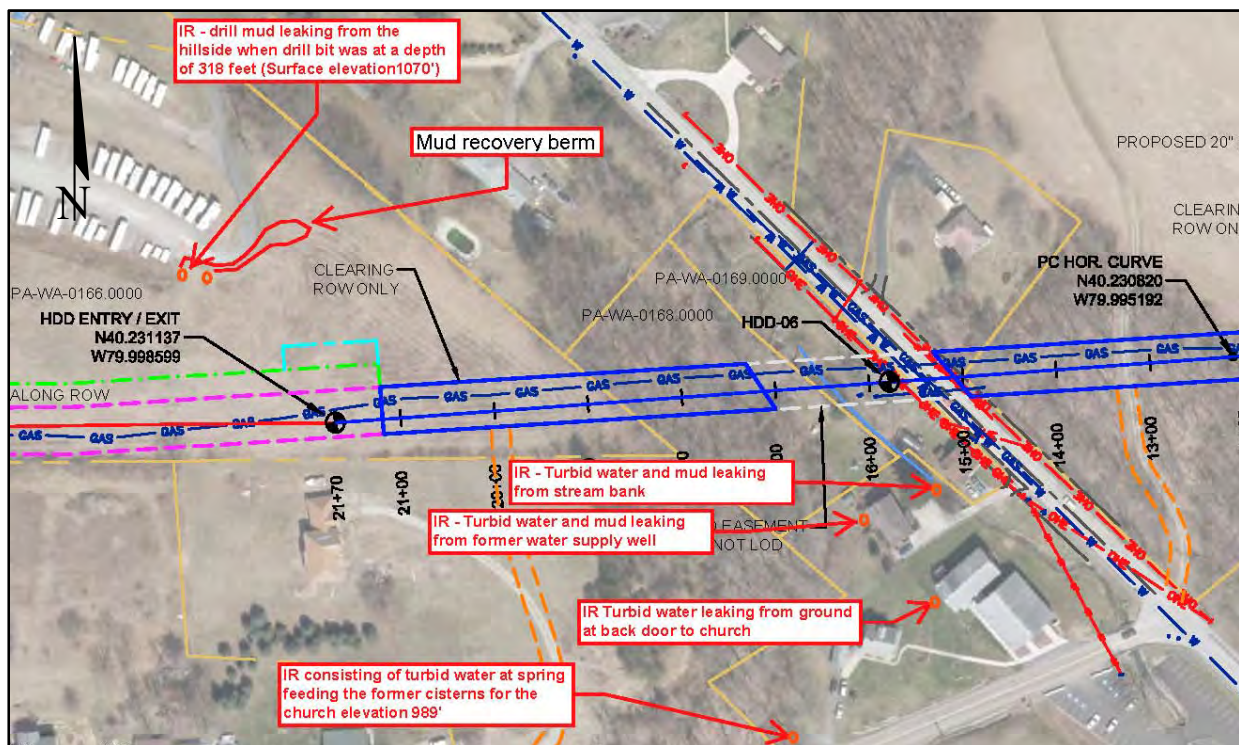
Figure 12: 2017 IR Location Map (Modified from Tetra Tech Rooney April 4, 2017)

IRs observed during the advancement of the ME I HDD included, turbid water entering the cistern for the Mingo Presbyterian Church, located at the intersection of State Route 88 and Mingo Church Road, and an intrusion of drilling liquids into stream S27 along Patterson Road.

From May 27 to June 15, 2017 attempts were made to drill the pilot hole for HDD S1B-0120. During the initial advancement of the pilot hole for HDD S1B-0120, from west to east, drilling fluid returns were lost shortly after advancing the drill bit into bedrock. Loss of drilling fluid began during the advancement of the 2nd joint (approximately 65 feet). In addition, approximately 5,000 gallons of drilling liquids in the mud pit drained into the formation at the western end of the HDD profile. IRs were subsequently identified at five separate locations between the entry point and State Route 88. The locations of the ME II IRs are illustrated on **Figure 12**.

As a result of additional geological investigations, the proposed HDD at this location is being abandoned, and will be replaced by a combination of conventional open cut construction, one conventional horizontal bore, and two FlexBors. The intended pilot process in advance of the FlexBor reaming is an "air hammer", therefore no pressurized drilling fluids will be used during the pilot phase. The Flexbor reaming process does not use pressurized bentonite based drilling fluids, but rather high volume air flows with minimal water injection, with the cuttings returning to the entry through an enclosed casing. As a result, the new construction plan substantially reduces the risk that pipeline construction will impact private water supplies.

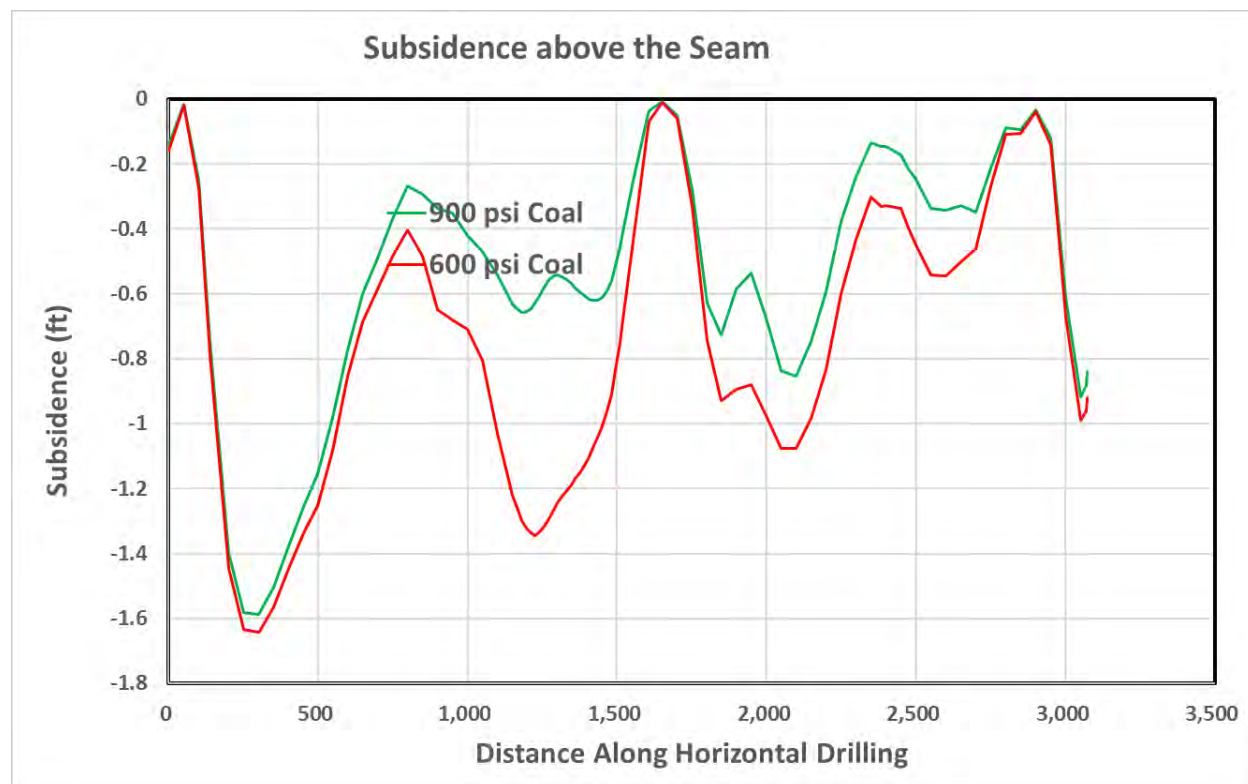
Figure 4. Estimated Subsidence

LaModel was chosen as the mining-induced stress analysis program to estimate strain on the strata at the location of the pipeline within the strata. This program is primarily designed to calculate the seam stress and displacement within an underground mine. The software uses boundary elements for calculating the stresses and displacements in coal mines or other thin tabular seams or veins. During active mining, it can be used to optimize pillar sizes and mine layout by minimizing pillar stress. Multi-seam mining stress can also be reviewed. This program can also reasonably calculate surface subsidence. A medium distance of 200 feet above the Cincinnati Mine was chosen for detailed analysis of mine subsidence. In the LaModel program, the overburden is modeled as a continuum. Therefore, the program shows the subsidence directly over the mined areas and within the angle of draw. The magnitude of subsidence decreases as the distance from the mine increases and the subsidence spreads. The program does not model any dilation of the overburden.

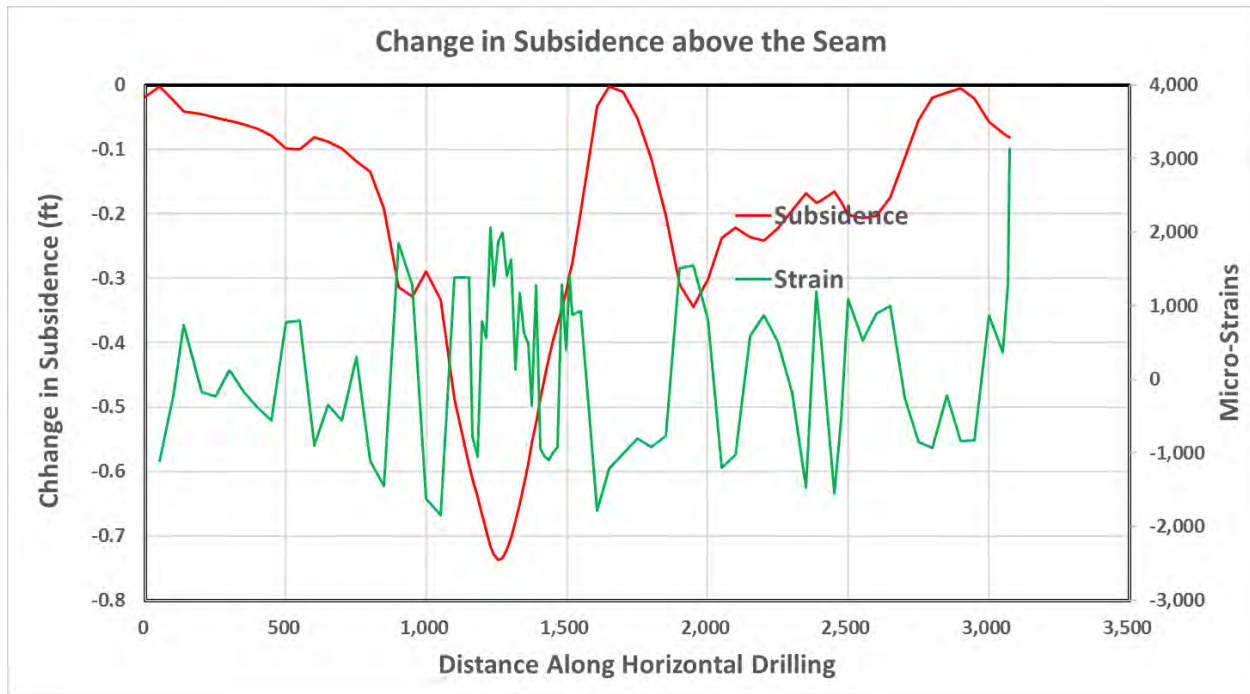
Figure 5. Change in Subsidence

The modeled strains are in the strata at the location of the pipeline alignment. The bored excavation for both Flexbors will be larger than the pipe to be installed. As shown on Figure 6, the strain in the strata encompassing the hole, is not directly correlated to the strain imparted to the pipeline. The overbore (larger diameter of the hole compared to the pipe) leaves room for potential movement of the pipe within the strata. Transmission of the strain from the strata to the pipe associated with this project is being reviewed by pipeline engineers.

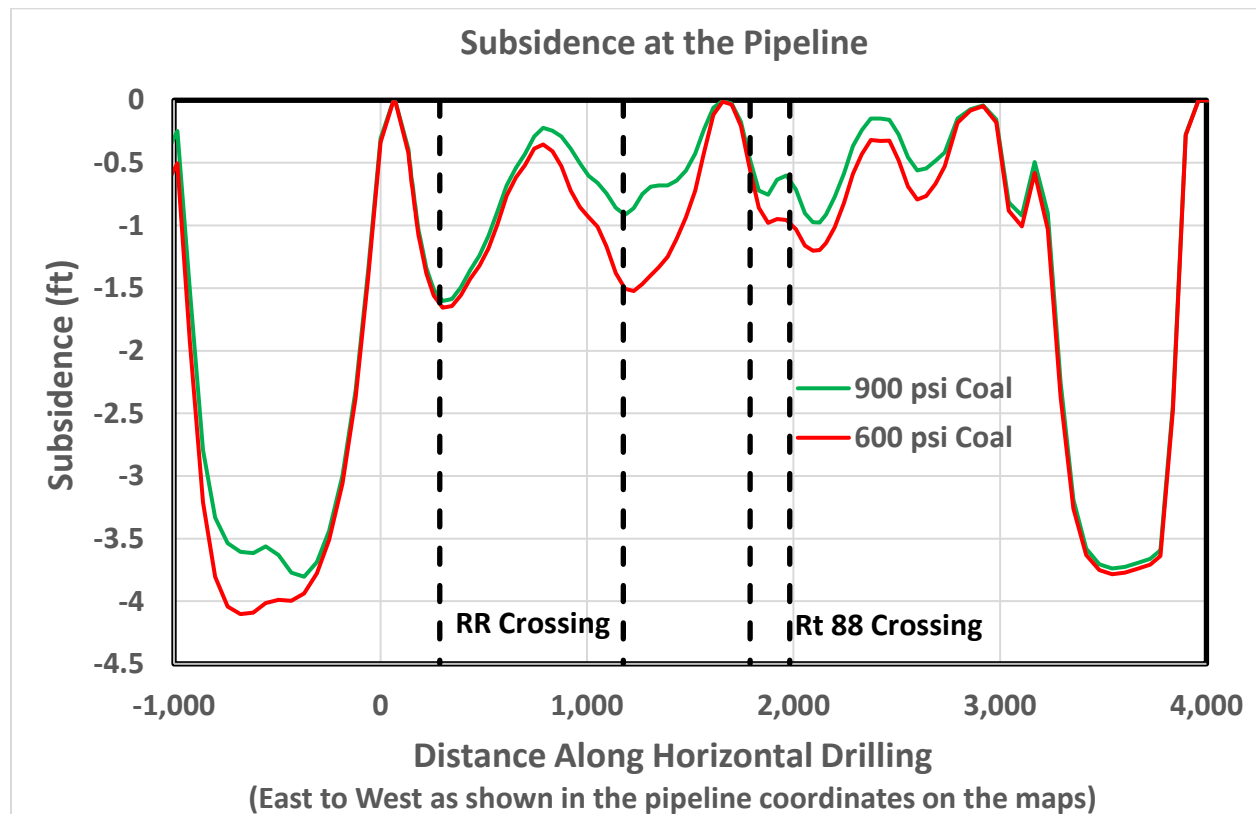
Figure 6. Subsidence prediction along the pipeline alignment at different coal strengths.

To examine the details of the previous subsidence along the pipeline alignment, the subsidence in the near surface overburden above the seam has been interpolated from the output shown in Figure 5 directly to the pipeline coordinates, as shown in Figure 6. In this plot, the subsidence under the pipeline as it crosses over the edge of the adjacent gob areas is clearly visible.

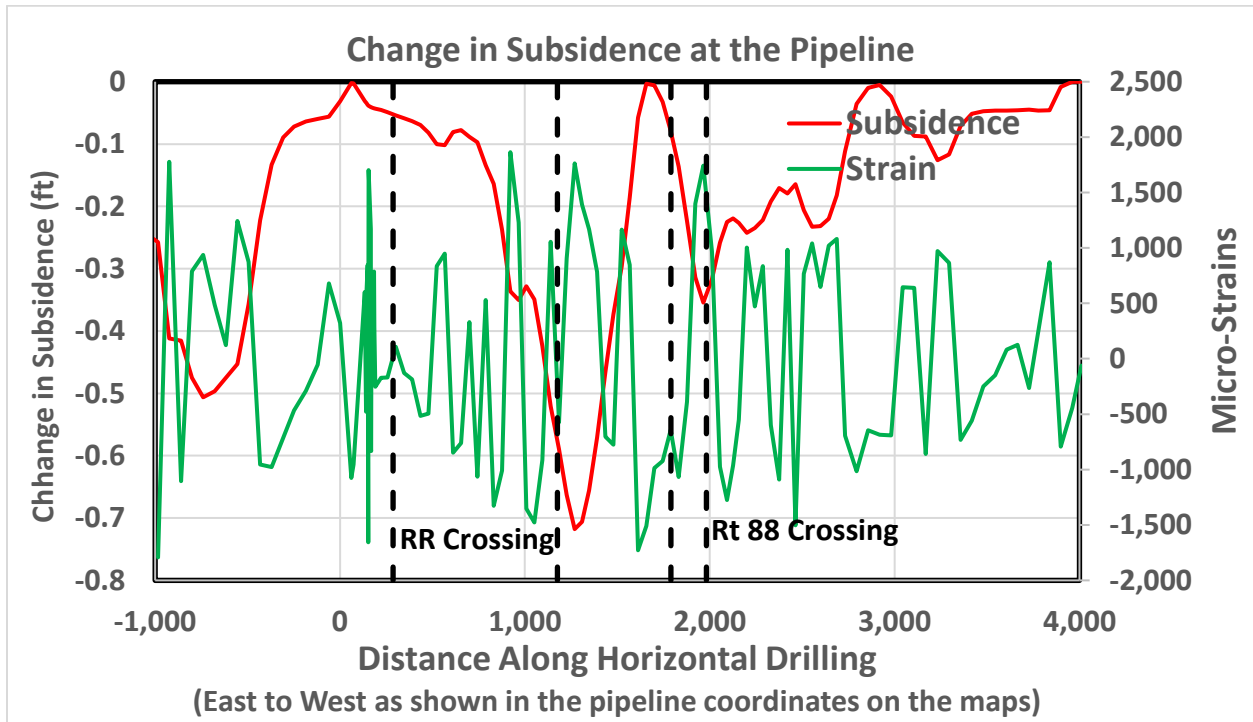
Figure 9. Predicted worst case subsidence and associated strains (tension is negative).

tight within the horizontal borehole due to the drilling mud confining the pipe or collapse of the borehole, then it may be assumed that the pipe will experience the full ground strain as shown in Figure 9. If the pipeline is simply lying in the open horizontal borehole and can easily slide, then areas of tension or compression in the ground can be reasonably canceled by sliding of the pipe between adjacent areas of the opposite strain.
