# Report of Findings (As-built Information)

Toboyne Township, Perry County  
Schaeffer Run  
Back Hollow Bridge TBT-3 Inspection  
Bridge Key: 29744

Project #212IC-BF-00037  
January 11, 2018

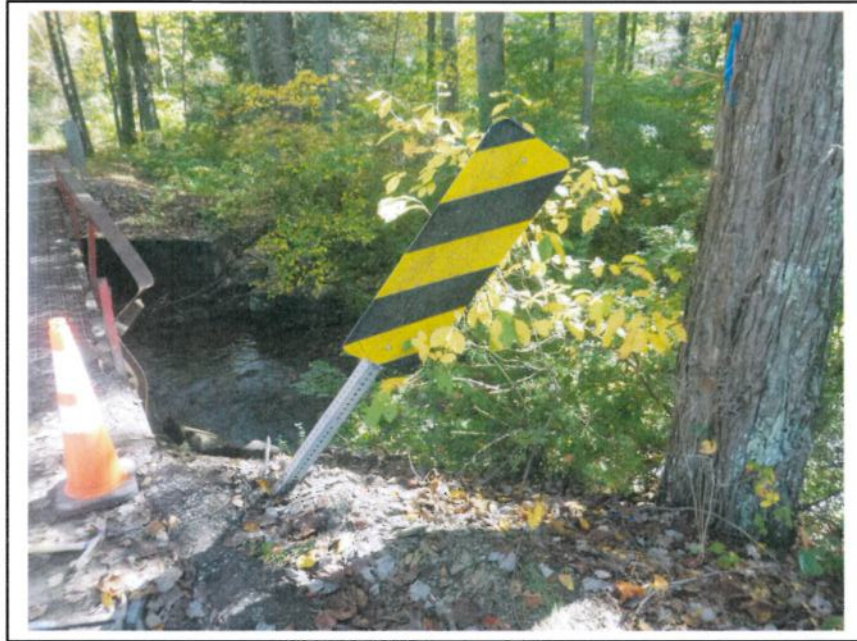
Photo No. 15: Near Right Leaning Hazard Clearance Sign

The bridge is posted for 13 Tons, Except Combinations 28 Tons. The approach weight posting signs are >25' from bridge but provide visibility across structure due to road alignment. All weight posting signs are in satisfactory condition. Weathering noted on several of the advance sign panels (See Photo Nos. 9 & 10). The far advanced supplemental weight posting sign at the township line is missing due to construction of a pipeline, however this sign is not required, the far advanced sign is in place. One lane bridge signs are in place, the far post is slightly loose, stable. Both one lane bridge signs are dirty, the far sign is very dirty (See Photo Nos. 13 & 14). Additionally, there are hazard clearance signs present, the near left post and panel are bent with scrapes, stable, need repaired. The post at the near right is very loose and leans (See Photo No. 15). All four are placed at improper height.

6.	Railing – Structure Mounted 73 LF <i>Install standard structure mounted guide rail.</i>	\$150 per LF	\$10,950	1 Deferred
7.	Approach Roadway – Clearance Signs 2 EA <i>Reset loose hazard clearance sign post at near right. Reset near and far right hazard clearance signs to proper height.</i>	\$200 per EA	\$400	2

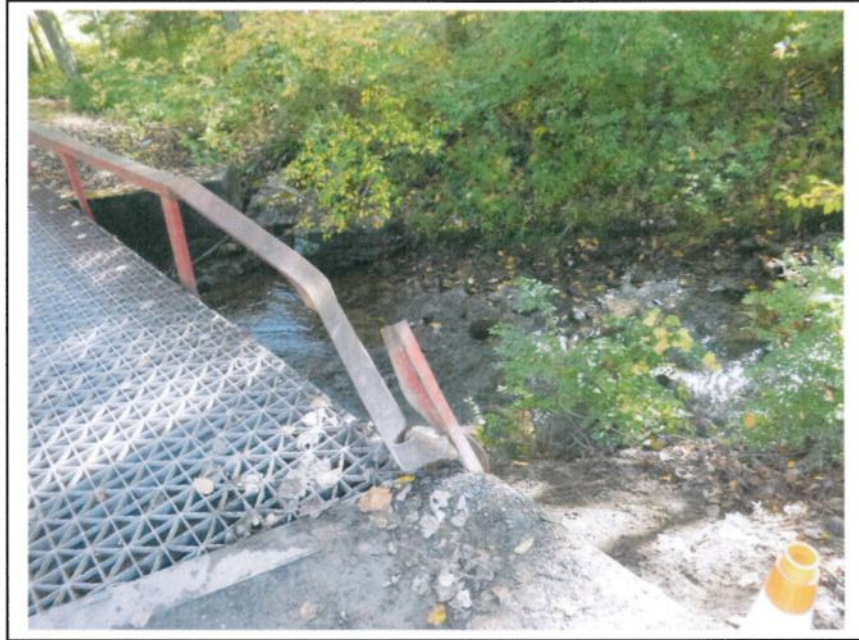
Photo No. 17: Near Right Railing Damage

- Moderate damage at far left, three bent posts, end post bent out 5", all secure.
- Painted on top and inside face with freckled corrosion, remainder exhibits corrosion and minor pitting. A few scrape marks and minor isolated paint peel on inside face.
- Right railing exhibits outward lean at top (outward lean 2" max. to 1/4" min., old condition)
- Severe impact damage at the near right. The top channel is no longer connected to the first post and the turndown is no longer present. The post is no longer connected to the beam at the top and is barely attached at the bottom of the beam. (See Photo No. 17)

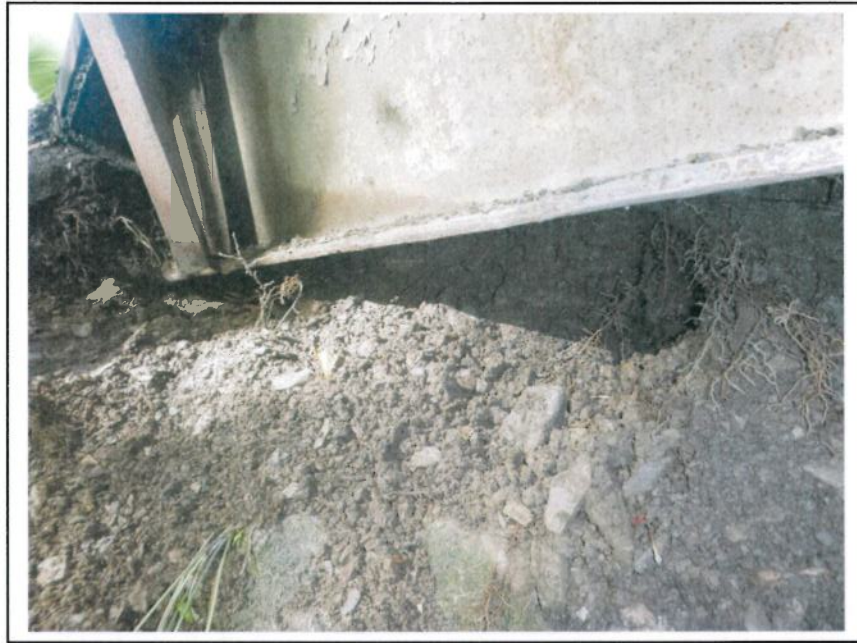
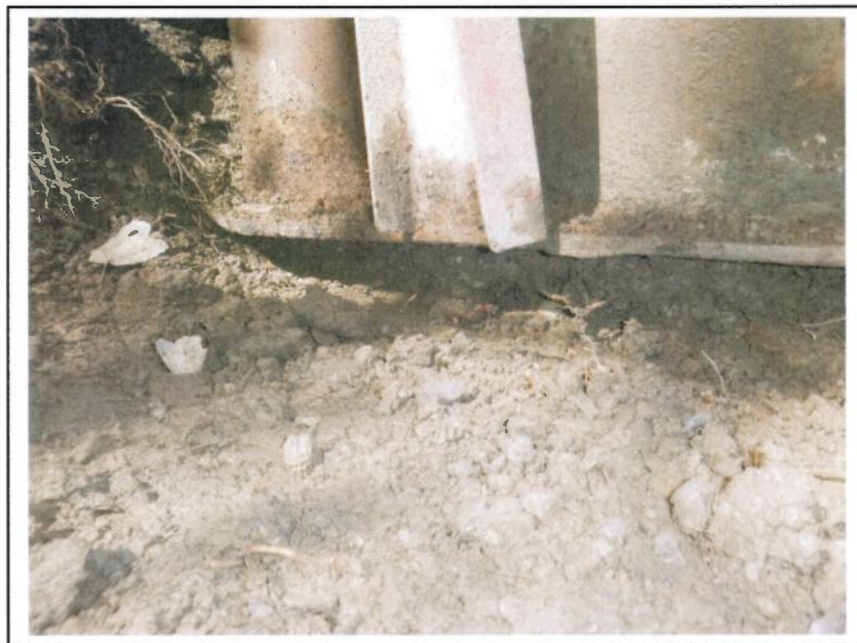
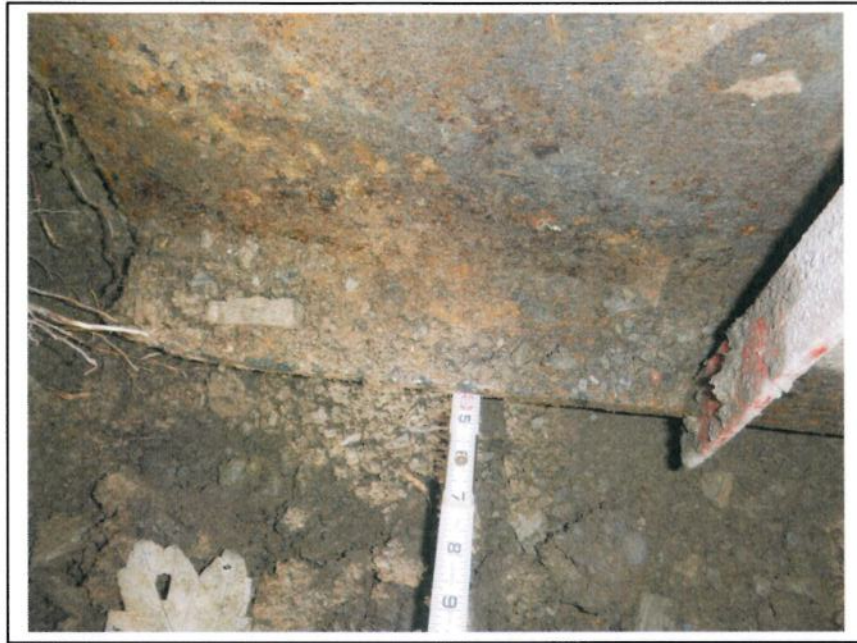
- Moderate to heavy paint peel, surface corrosion with pitting, some moderate pitting on top flanges.
- No significant section loss noted.
- One minor gouge and two moderate gouges noted on downstream (left) fascia web, 1/8" deep +/-.
- Upstream (right) fascia bent laterally at far end 6' (old condition, deck welded to top flange no cracks) with minor gouges along bottom flange.
- Heavy accumulation of gravel and dirt on top flanges, minor on bottom.
- Beam 4 at the near end exhibits extensive bearing loss/deterioration (over 80%). Beam 4 visibly deflected under live load, this deflection also caused movement of the remaining bearing material. This deficiency warranted immediate closure of the structure. (See Photo Nos. 25-27)

Photo No. 25: Beam 4 Loss of Bearing at Near Abutment

The bridge is in critical condition overall. This is primarily driven by the condition of the bearing area under beam 4 at the near abutment; the bridge was closed at the time of inspection due to this deficiency. The substructures are also a concern because the beams do not appear to rest on any formal substructure and appear to rest on compacted shale. Additionally the traffic safety features at this structure are damaged and do not provide proper vehicular safety to travelers. The recommended maintenance items outlined in this report should be implemented in a timely manner to abate further deterioration and to improve vehicular safety.

9.	Bearings – Pedestal/Seat 1 EA <i>Repair the bearing area under beam 4 at the near abutment.</i>	\$2,500 per EA	\$2,500	1 Deferred
<b>Total Cost of All Maintenance Items:</b>			<b><u>\$ 24,350</u></b>

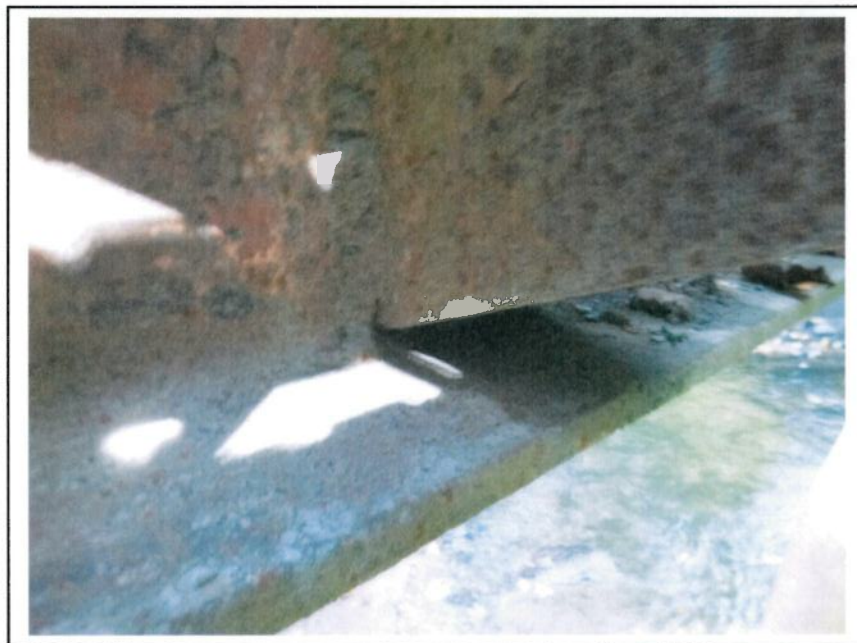
- Four cracked welds noted at connection to beam web locations.
  - o Beam 1 bottom angle connection, 3/8" long fine crack in weld (right face of web) (See Photo No. 28).
  - o Beam 2 (center bay) bottom angle connection of beam 2 web 4" long (full height) crack in weld on near side (right face of web) (See Photo No. 29).
  - o Beam 3 bottom angle connection, 3/8" long fine crack in weld (left face of web).
  - o Beam 4 (upstream. fascia) top & bottom angle connection 11/16" gap at bottom connection, 1/8" gap at top with slight misalignment (left face of web) (See Photo No. 30).

Photo No. 28: Bay 1 Intermediate Diaphragm Cracked Weld at Beam 1

2.	Clean/Flush – Steel – Horizontal Surfaces 1 EB <i>Clean horizontal surfaces.</i>	\$1,000 per EB	\$1,000	3
3.	Steel – Diaphragm/Lateral Bracing 5 EA <i>Repair welds at X-bracing diaphragm.</i>	\$250 per EA	\$1,250	3

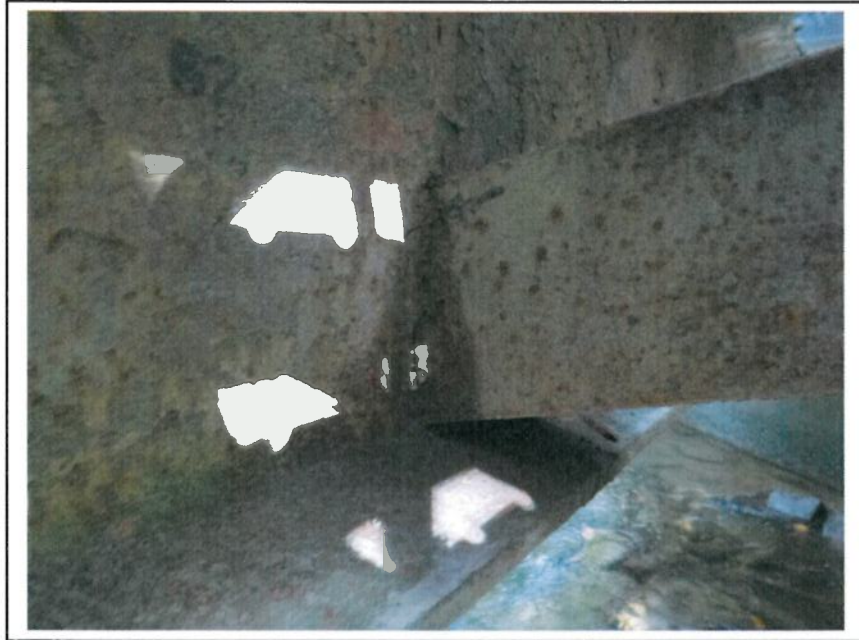
Photo No. 29: Bay 2 Cracked Weld at Beam 2

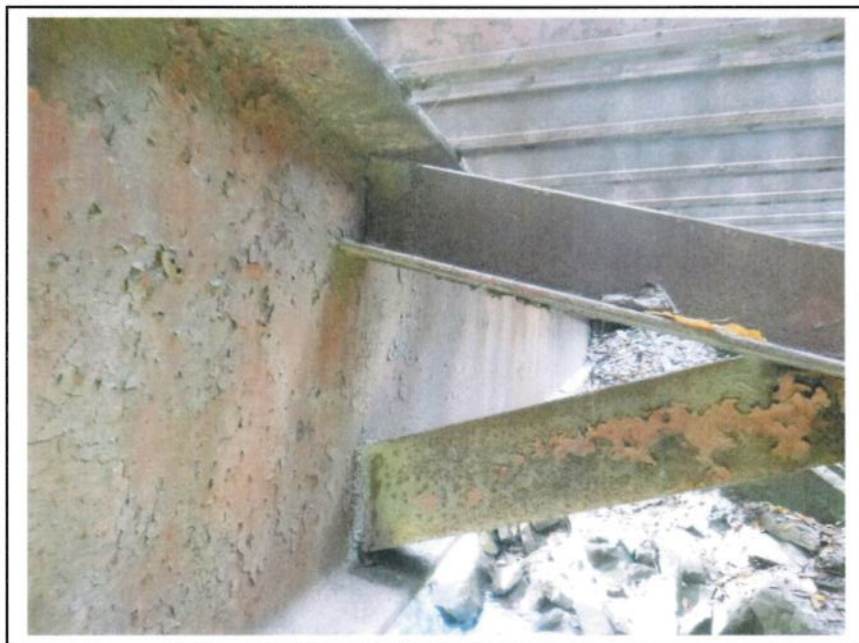
Photo No. 30: Bay 3 Intermediate Diaphragm Gap in Connection

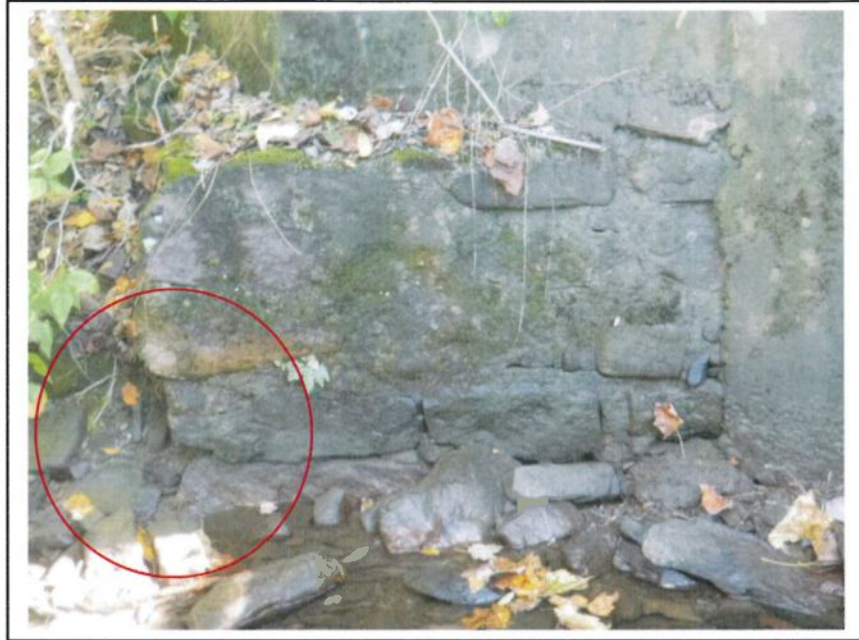
- Far left masonry some minor deterioration at end 1' long x 0.5' vertical x 2' under void (See Photo No. 37).
- Joints mostly sound.
- Concrete sound, similar to abutment.

Photo No. 37: Far Left Wing Void

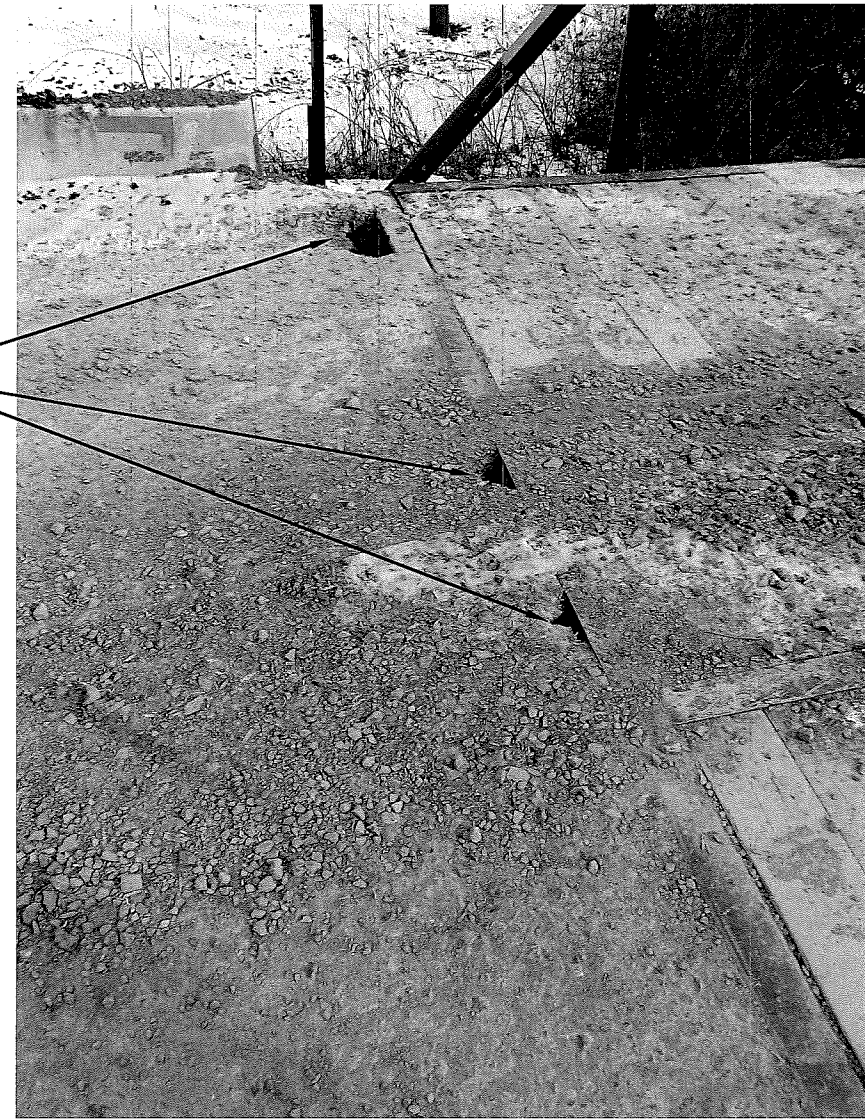
SECTION E-E  
DWG S-002

DIRT AND GRAVEL SLUFFING DOWN UNDER AIR BRIDGE ON NORTHWESTERN APPROACH RAMP

3. To prevent soil from sluffing under the bridge at each approach, it is our recommendation to add two (2) 3/8” plates across the full width of the “Air Bridge” as shown in the Modification at Approaches Detail on Tt Dwg. S-004.

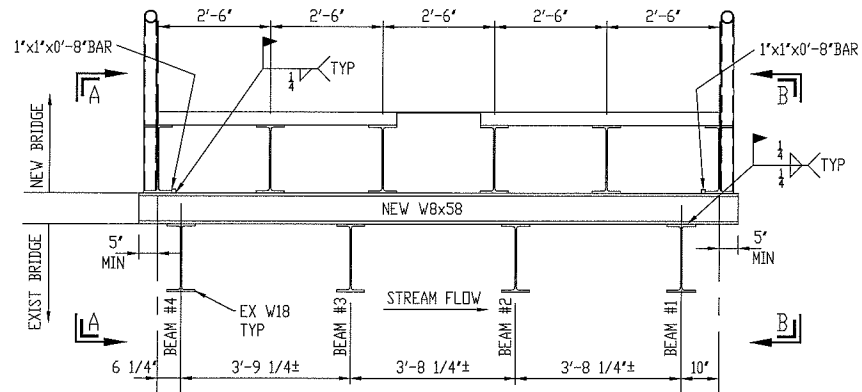
REPAIR AT NORTHWEST END  
HOUSE SIDE

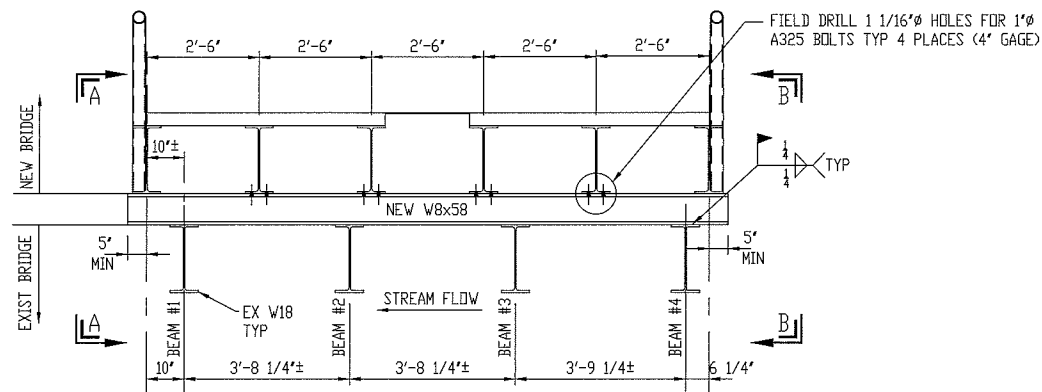
REPAIR AT SOUTHEAST END
