Historic Resource Survey Form

HISTORIC NAME Duffy Farm; Greenawalt Farm

CURRENT/COMMON NAME Lower Farm Ruin (Site 36Da235)

Organization/Company Heberling Associates, Inc.

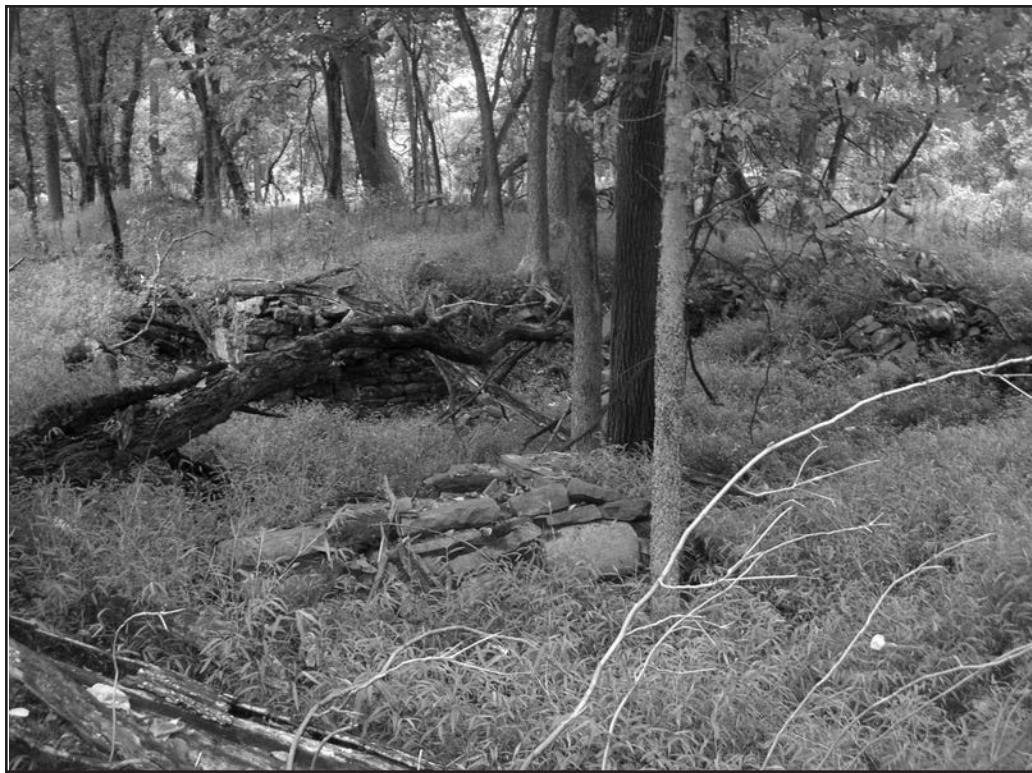
Photo 1: Duffy Farm; Greenawalt Farm, Middletown, Londonderry Twp., Dauphin County. View of the house foundation, facing north.

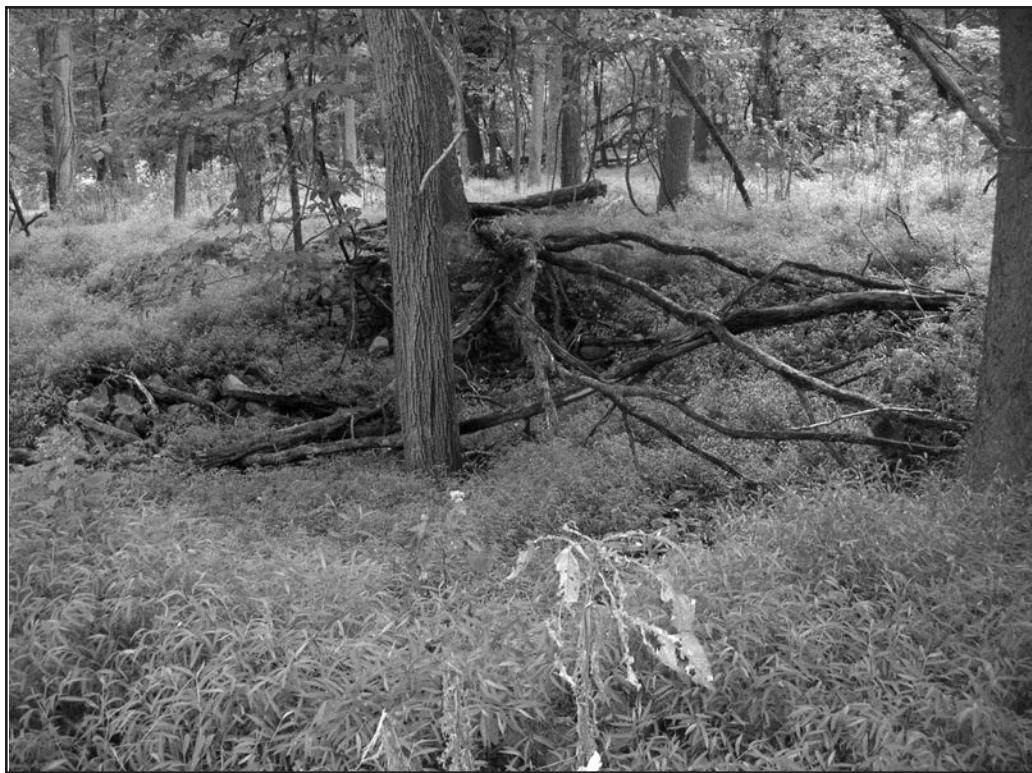
Photo 2: Duffy Farm; Greenawalt Farm, Middletown, Londonderry Twp., Dauphin County. View of the house foundation, facing south.

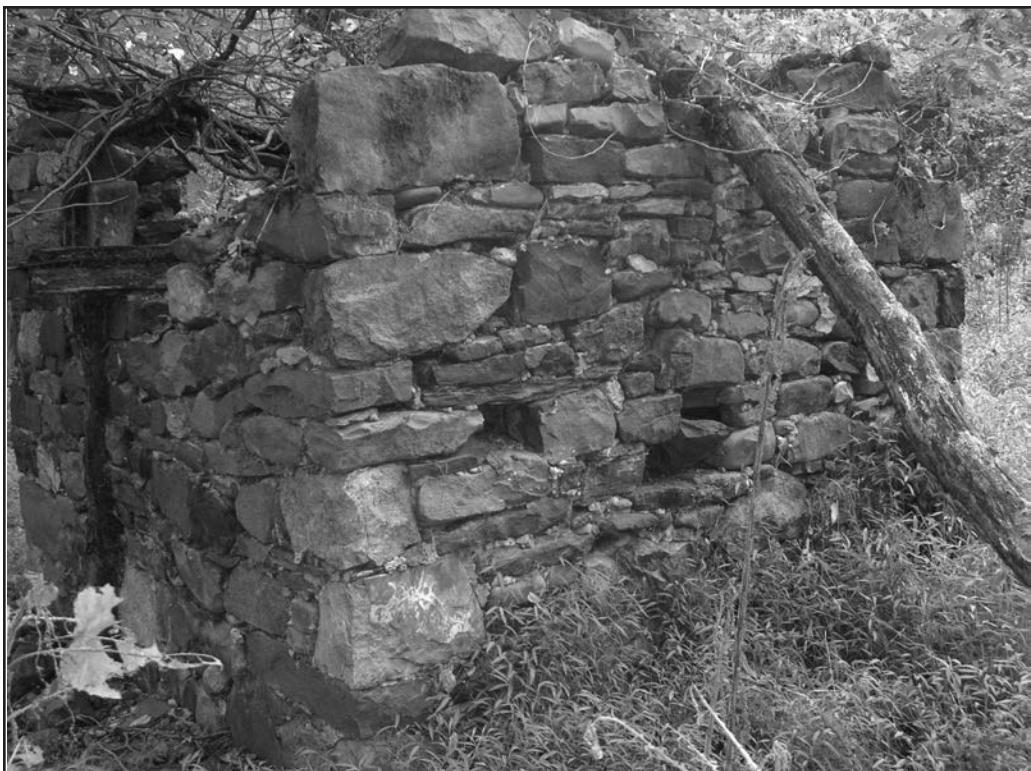
The ruins of a stone smokehouse are located at the western edge of what was the house yard (Photo 6). The 9.3 ft square structure was, like the other buildings, constructed of an array of cobblestone, with cut stone lining the 3 ft wide central portal and small flue portal on the rear (western) elevation (Photo 7). The walls, 1.5 ft thick, extend approximately 7 ft from ground level. Decayed and collapsed roof joists that once supported a gable front roof rest on the top of the extant walls. A second major element, the ruins of a washhouse, is located at the northern edge of the house yard (Photo 8). The ruined structure, filled with rubble, features a 1.5 ft wide stone foundation that is 10.5 ft long, 7.4 ft deep, and opens on the south side (Photo 9). A ruin of undetermined function is located in the center of the house yard. The roughly 6 ft square pile of stone, soil, and other fill is located between the ruins of the smokehouse, well, and washhouse.

Photo 6: Duffy Farm; Greenawalt Farm, Middletown, Londonderry Twp., Dauphin County. View of the smokehouse, facing east.

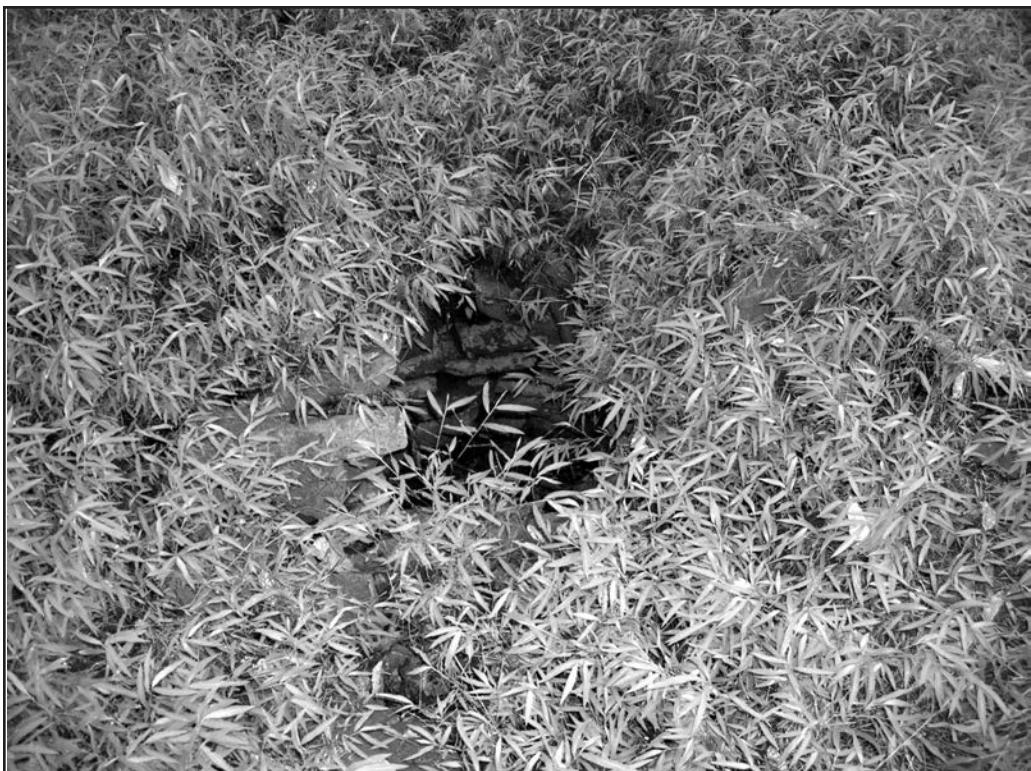
A collapsed well depression is located immediately (10 ft) to the north of the smokehouse (Photo 10). This well is 8 ft in diameter and lined with 8 courses of flat stone. The depression is 3.8 inches deep at its center, and inset with a single 1-inch metal pipe, entering into the well from the northeast. A second well is located to the southeast of the house yard. Smaller than the other wells on the site, the depression is 4.5 ft in diameter and 4 ft deep (Photo 11). This well site is not lined with stone or brick, and there is no evidence of piping.

Photo 10: Duffy Farm; Greenawalt Farm, Middletown, Londonderry Twp., Dauphin County. View of the house yard well, facing northwest.

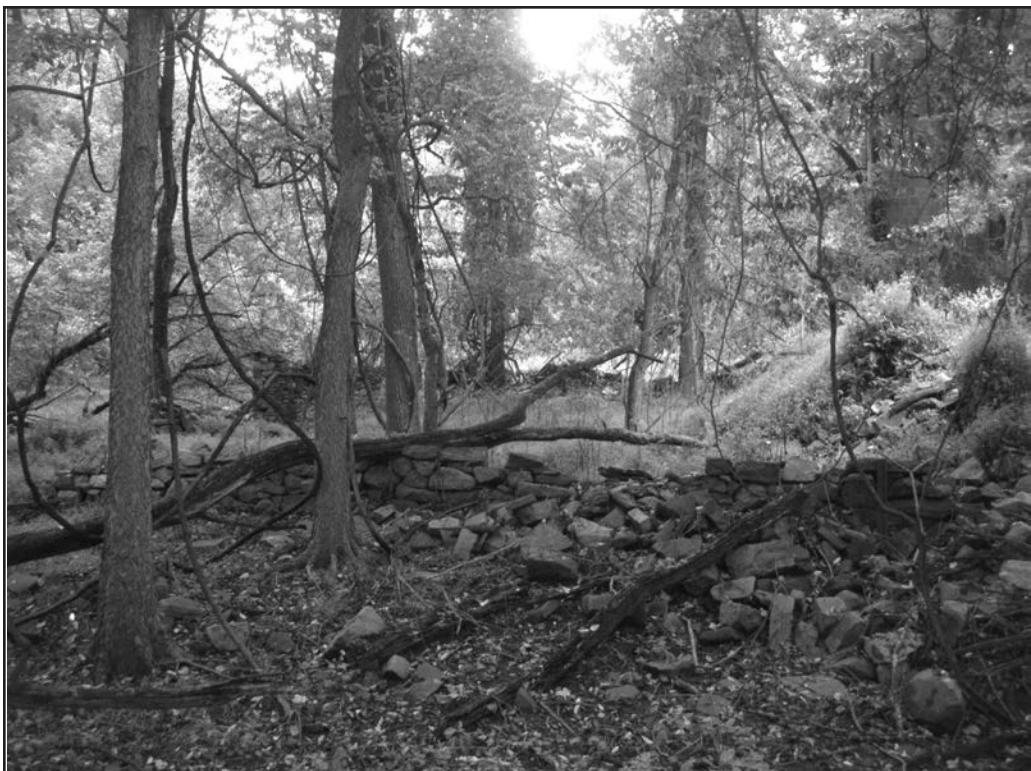
The ruins of the barn show that the structure was a bank barn, likely a standard Pennsylvania barn, with a large basement space and a pair of out sheds flanking the broad (40ft wide) earthen ramp (Photos 16-17). The foundation reveals that the basement of the barn was 81 ft wide and 53 ft deep including the out bin granary foundations. The pattern of rubble suggests the northern exterior wall once was a “stone ender,” a wall of structural stone that supported the roof. The distance from the front of the foundation to the bank face is 47 ft., and the depth of the foundation at that face is 7.5 ft. The barn superstructure was larger, extending and overshot at least 6 ft over the foundation on the barn’s face. The front (eastern) face of the foundation, opposite the bank, was inset with four bays that served as cattle doors, including a large central bay opening into a large recessed barnyard that spanned the width of both the principal barn and the adjoining barn to the south (Photo 18).

Photo 16: Duffy Farm; Greenawalt Farm, Middletown, Londonderry Twp., Dauphin County. View of the Pennsylvania Barn, facing south.

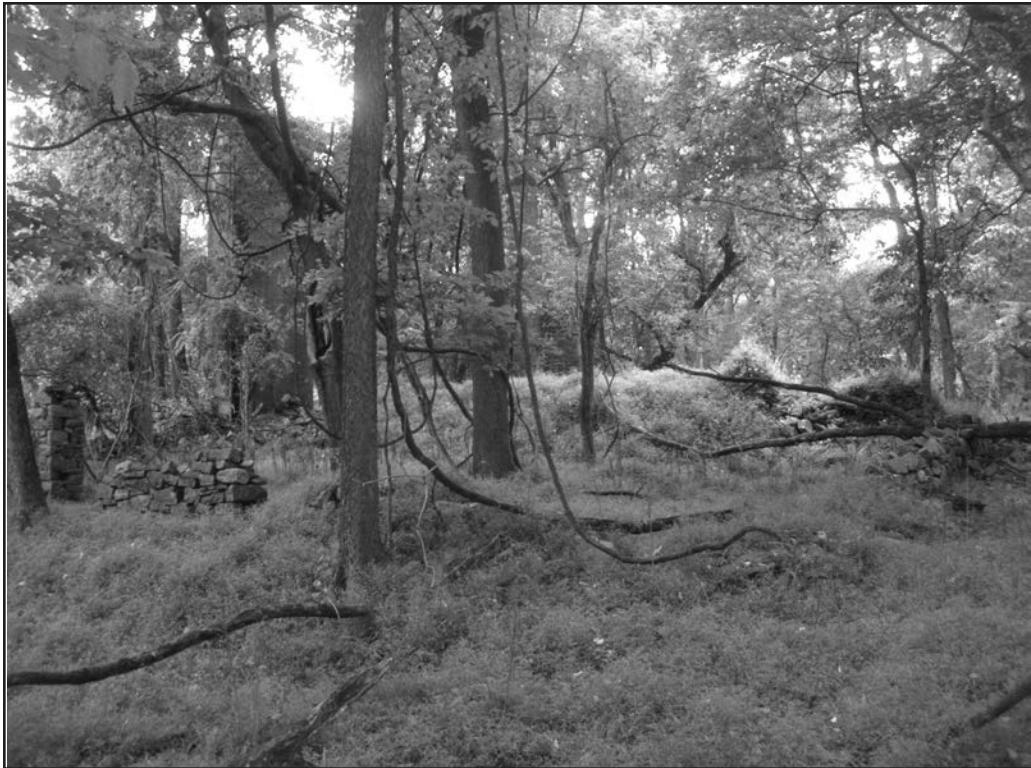
Photo 17: Duffy Farm; Greenawalt Farm, Middletown, Londonderry Twp., Dauphin County. View of the Pennsylvania Barn, facing west.

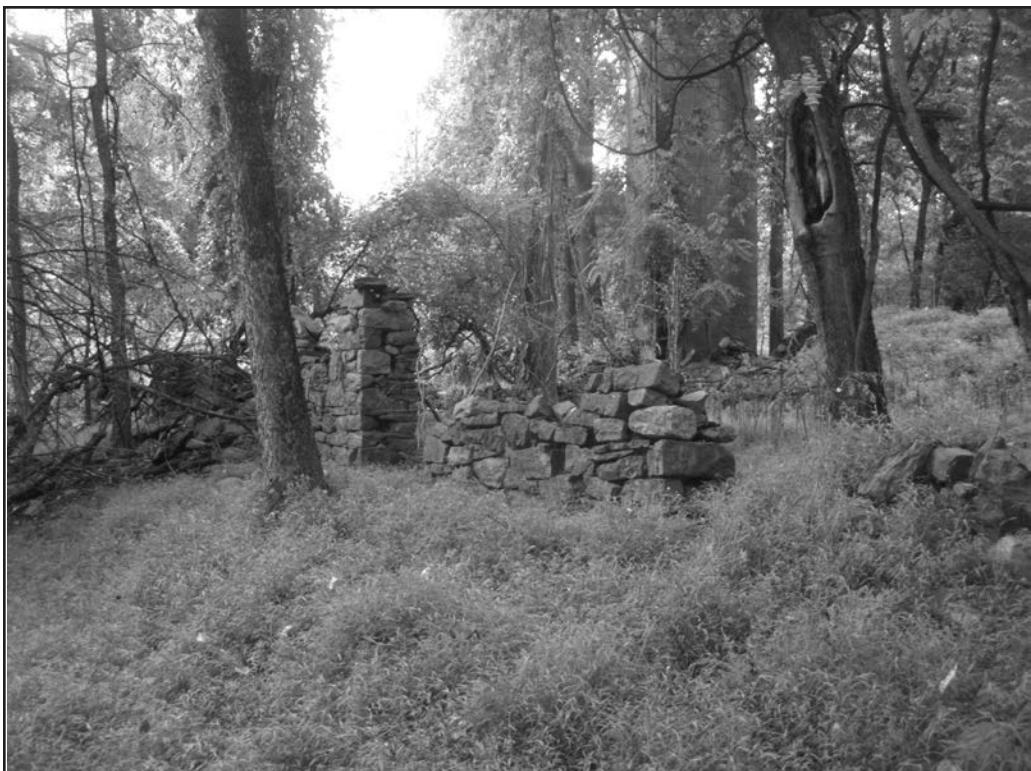
Photo 18: Duffy Farm; Greenawalt Farm, Middletown, Londonderry Twp., Dauphin County. View of the Pennsylvania Barn, facing southwest.

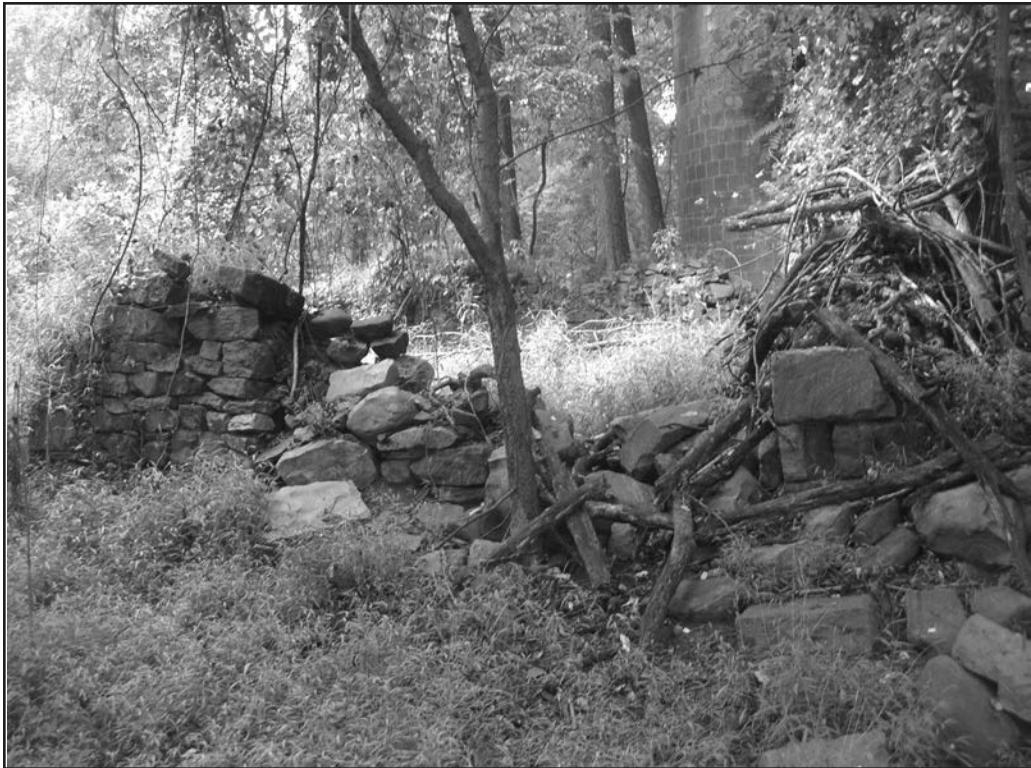
A second structure, a small basement barn, was set back 8.5 ft to the east from the rear of the principal barn (Photos 19-20). The structure, with some extant foundation walls that average approximately 5.4 ft tall, is 44 ft deep and 50 ft wide. Condition of the foundation is irregular, particularly on the south side, which was pierced at its center with a 10 ft wide runway bay that ran parallel to the roofline. The rear (eastern) face was inset with several cattle doors. The interior of the foundation walls was unfinished and unlined, with no evidence of any poured concrete or sanitary stucco, suggesting the absence of a dairying function. This barn was likely constructed in relationship to the principal barn, with which it shared a common southern wall, and the other elements of the complex. Currently, the modern silo was built in relation to this structure, its outflow facing a doorway built into the west basement foundation, immediately north of the large earthen bank.

Photo 19: Duffy Farm; Greenawalt Farm, Middletown, Londonderry Twp., Dauphin County. View of the basement barn, facing west.

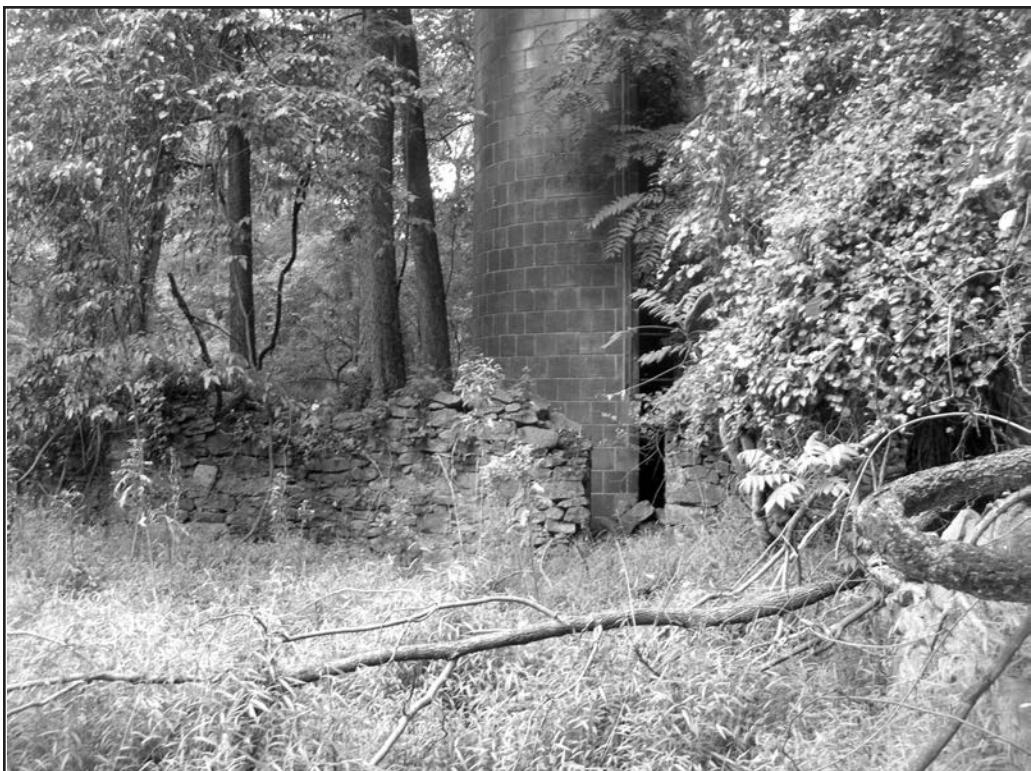
Photo 20: Duffy Farm; Greenawalt Farm, Middletown, Londonderry Twp., Dauphin County. View of the basement barn interior, facing southwest.

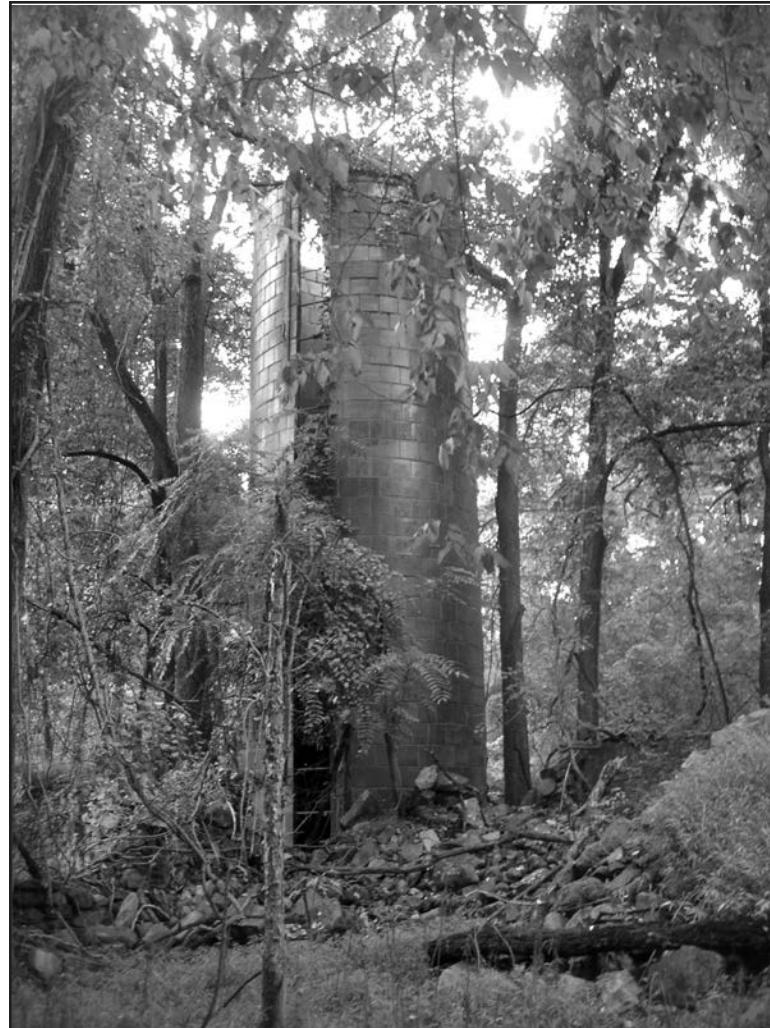
The large tile silo, 13 ft in diameter, was sold as a prefabricated kit patented in 1911 and thought to have been built on the site c. 1930 (Rider c. 1980; Photo 21). Like the other structures, the silo was fitted with an outflow pipe inset into its base. A recessed 18 ft wide roadway, located immediately north of the principal barn, is flanked by two parallel layers of stone, each 2 ft wide. A cut and rough stone foundation with some concrete inset with a pebble aggregate is located off the northeast corner of the principal barn. Located north of a recessed roadway, this structure may have been a retaining wall, shed foundation, or loading platform.

Photo 21: Duffy Farm; Greenawalt Farm, Middletown, Londonderry Twp., Dauphin County. View of the silo, facing southwest.

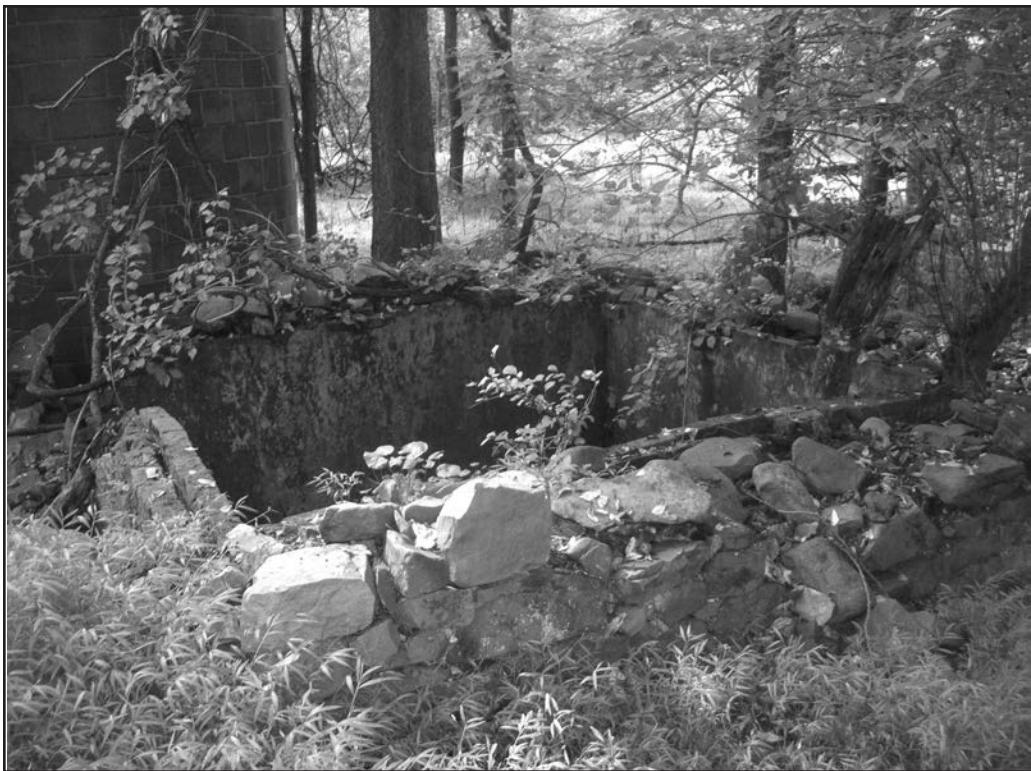
The cistern is a 14.9 ft square structure excavated into the ground between the barn and the mill (Photos 22-23). Constructed of two courses of the familiar cut stone and cobble (with a brick section on the eastern elevation), the interior is lined with two bands of common bond bricks covered with cement stucco. The stonework features a more careful dressing than on the adjacent engine house and mill. The extant foundation wall extends 3.2 ft. above the ground surface, and the walls are 2 ft wide. A 3-inch-diameter glazed terra cotta outflow pipe is inset in the southwest corner of the structure approximately 6 ft above the current bottom. A second outflow pipe is inset on the east side, 4 ft above the bottom. An outflow sluice is cut into the southeastern corner of the exposed brick face. The 7.7 ft deep interior of the cistern is filled with debris, including a 12 ft long section of 3-inch metal pipe.

Photo 22: Duffy Farm; Greenawalt Farm, Middletown, Londonderry Twp., Dauphin County. View of the cistern, facing south.

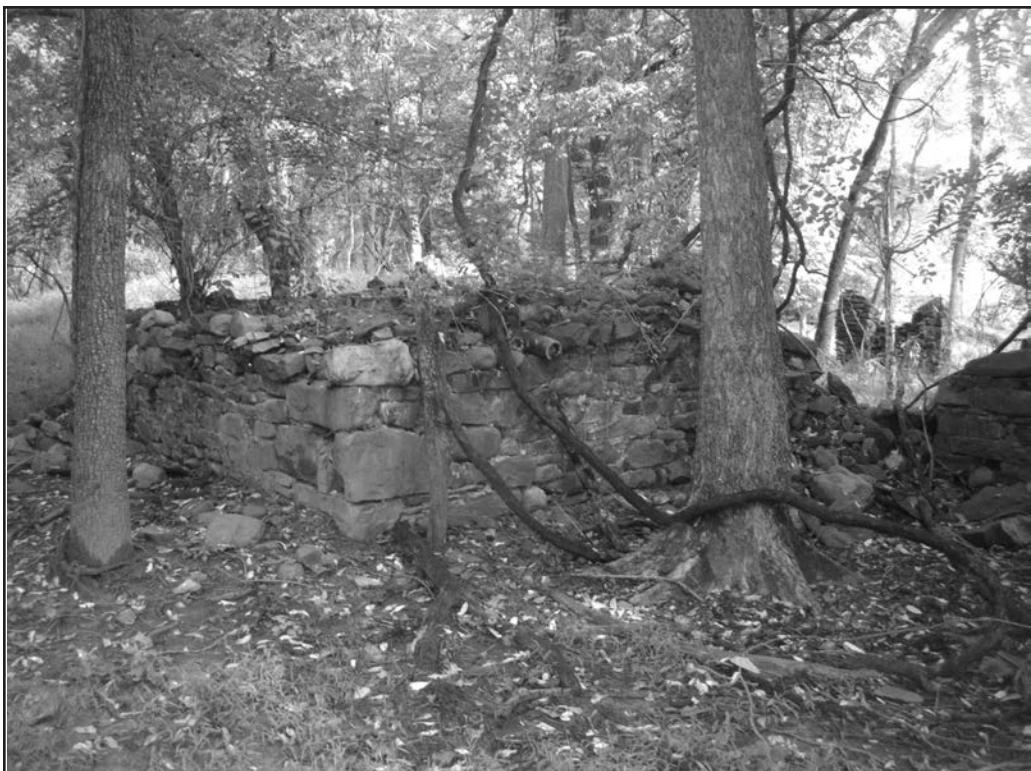
Photo 23: Duffy Farm; Greenawalt Farm, Middletown, Londonderry Twp., Dauphin County. View of the cistern, facing northwest.

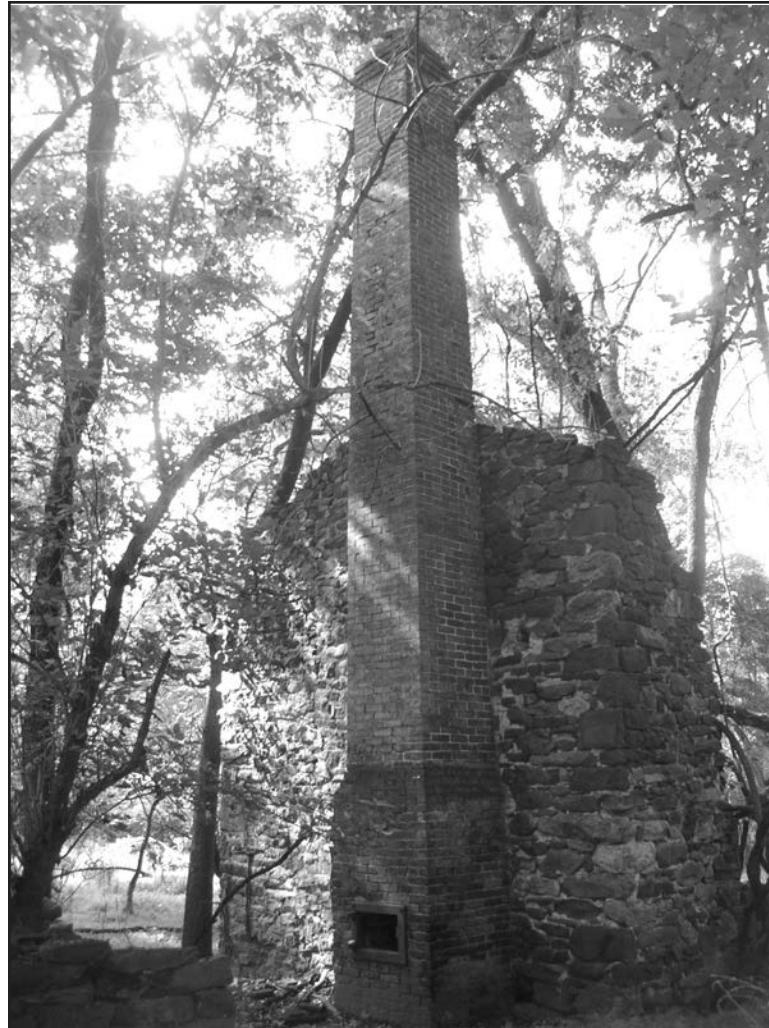
The adjoining brick chimney (3.3 ft x 3.5 ft x app. 40 ft) is offset slightly to the north (Photo 27). The chimney is constructed of heavy machined glazed brick (7 in x 3 in x 1.5 in) set within a heavy cement mortar. The chimney tapers slightly at a point 6 ft from the ground level and is corbelled at the top. A metal stove door enters into the face of the chimney on the east side, suggesting that it may have been once covered with a structure.

Photo 27: Duffy Farm; Greenawalt Farm, Middletown, Londonderry Twp., Dauphin County. View of the engine house and chimney, facing southwest.

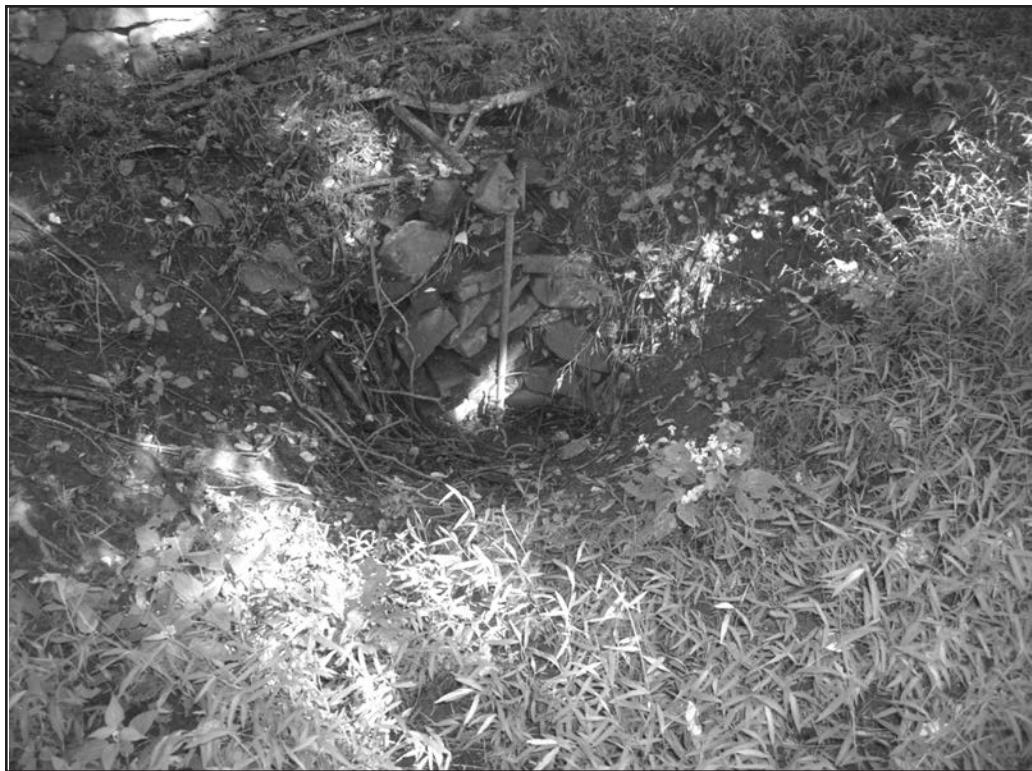
Although the most of the walls of the adjacent well have collapsed, the approximately 6.3 ft deep depression is roughly 12 ft in diameter (Photo 28). The northern portion of the interior is ringed with five courses of stone and some bricks and is inset with a 1-inch modern metal pipe, which extends three feet from the northern edge of the depression. A second 4 ft tall pipe extends from the center of the bottom of the well.

Photo 28: Duffy Farm; Greenawalt Farm, Middletown, Londonderry Twp., Dauphin County. View of the barnyard well, facing northeast.

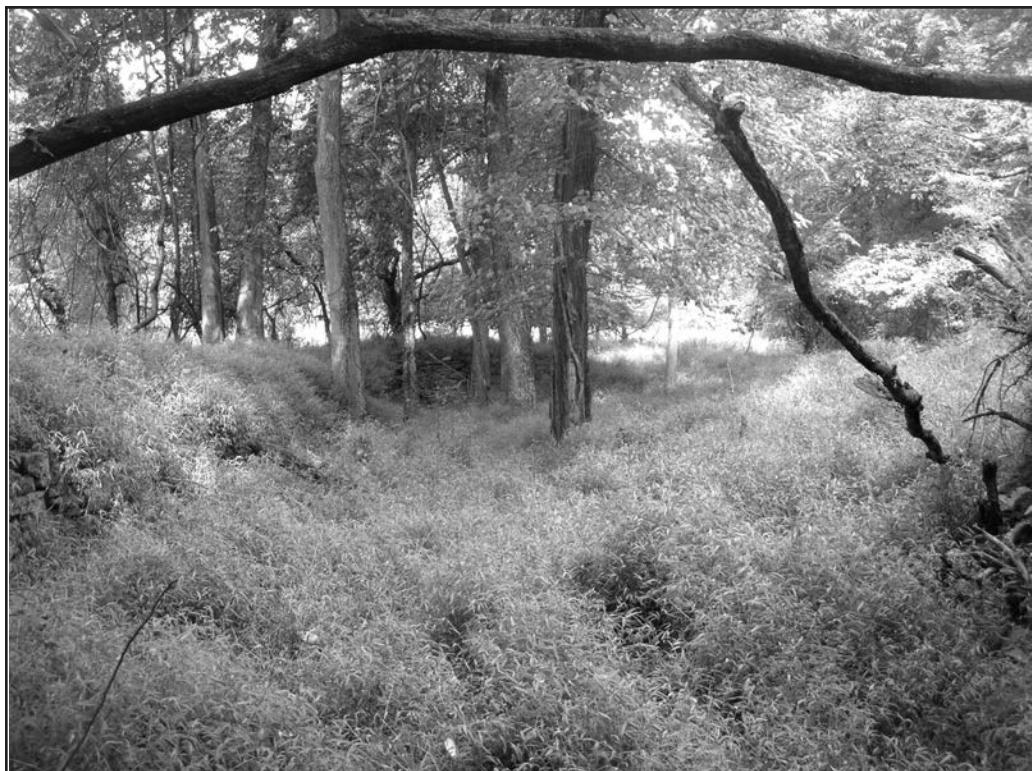
Of the three known tobacco sheds on the property, only the ruin of the massive “cellar barn” remains, located well to the north of the house and barnyard (Photo 29). Excavated into a slope west of a compacted earthen levee and the original eastern channel, this massive structure is open on the river side (east). The ruin consists of three basement walls, all 1.5 ft wide and constructed of

Photo 29: Duffy Farm; Greenawalt Farm, Middletown, Londonderry Twp., Dauphin County. View of the cellar tobacco barn, facing north.

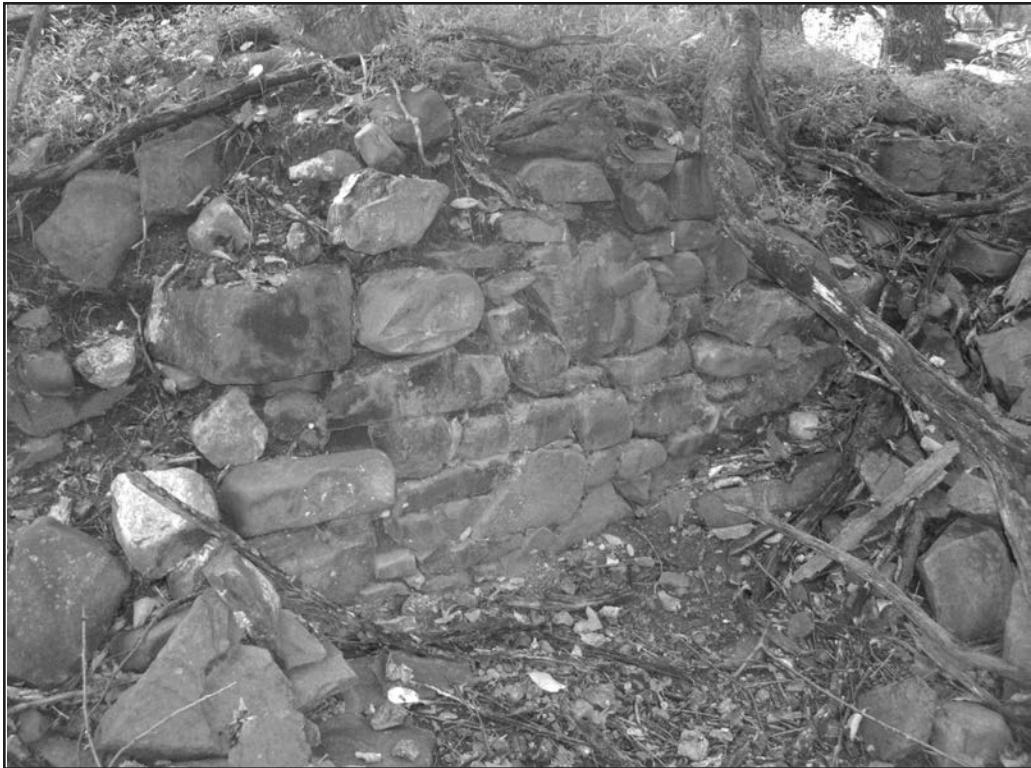
the cut stone and cobble mix (Photo 30). The outline of the structure is truly massive, 106 ft in overall length with southern and northern wing walls extending east for 17 ft and 16 ft respectively (Photo 31). A wall extends at a right angle from the southern wing wall for 13 ft to the south. The wall is 6 ft tall at its greatest depth in the southwestern corner, although stone, earth, and debris have filled much of the cellar.

Photo 30: Duffy Farm; Greenawalt Farm, Middletown, Londonderry Twp., Dauphin County. View of the cellar tobacco barn, facing northwest.
