CHAPTER 102 INSPECTION REPORT

PA Department of Environmental Protection

Permit No.: PAD510225Report No.: 22

Project/Site Name:	<u>Alliance 51st Street, Philadelphia</u>	Permit Issuance Date:	<u>9/5/2023</u>
Site Address:	<u>1656 S. 51st St.</u>	Permit Expiration Date:	<u>9/4/2028</u>
Site City, State, ZIP:	<u>Philadelphia, PA 19143</u>	Permit Type:	<u>NPDES IP</u>
RP/Permittee Name:	<u>Eric Carlson</u>	Site Municipality(ies):	<u>Philadelphia</u>
RP/Permittee Address:	<u>40 Morris Ave., Suite 230</u>	Site County(ies):	<u>Philadelphia</u>
RP/Permittee City, State, ZIP:	<u>Bryn Mawr, PA 19010</u>	Earth Disturbance:	<u>11.54</u> acres
RP/Permittee Email:	<u>ecarlson@alliancehp.com</u>	Site Latitude:	<u>39.935278</u>
Surface Water(s):	<u>Schuylkill River</u>	Site Longitude:	<u>-75.209236</u>
Special Protection?	<input type="checkbox"/> Yes <input checked="" type="checkbox"/> No	Complaint Inspection?	<input checked="" type="checkbox"/> Yes <input type="checkbox"/> No
Construction Stage:	<u>Inactive</u>	Activity:	<u>Construction ≥ 1 ac.</u>

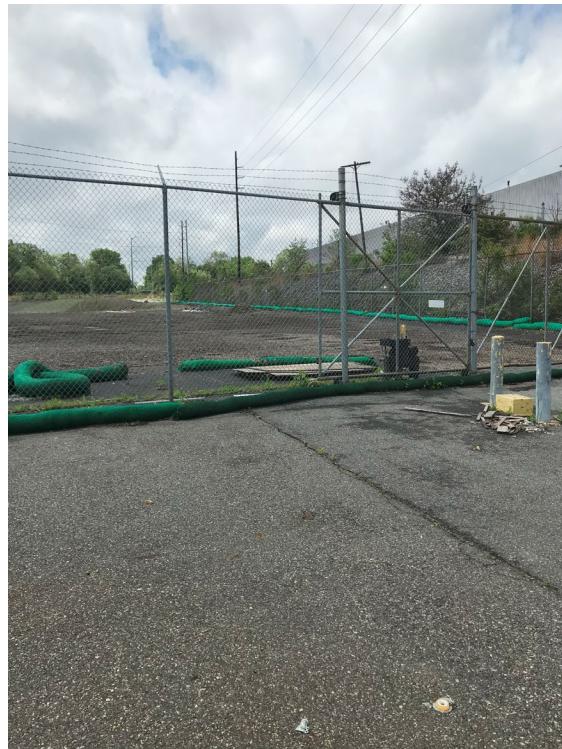
We noted that the filter sock along both 51st St. gates to the site were in proper position and in good operating condition. Mulching on the site appeared to remain relatively uniform. I observed some germination in the upslope far end of the site (along the railroad tracks). Some earthwork appeared to have recently taken place in the upslope far end of the site.

Most upslope gate and filter sock.

1. In accordance with DEP's Erosion and Sediment Pollution Control Program Manual, Technical Guidance No. 363-2134-008 (March 2012), Page 65, inspect filter socks weekly and after each runoff event. In addition, DEP requests that damaged socks be repaired according to manufacturer's specifications or replaced within 24 hours of inspection.
2. Maintaining filtersock areas, to prevent any overtopping condition, is recommended.
3. It is recommended to investigate the addition of a storage BMP (i.e., a sediment basin) in the downslope portion of the site.
4. Since the growing season is under way as of the time of this inspection, DEP recommends considering strategies for further site stabilization at this time.
5. Repair of the erosion control matting in the interior bend of the large fill dirt stockpile is recommended.

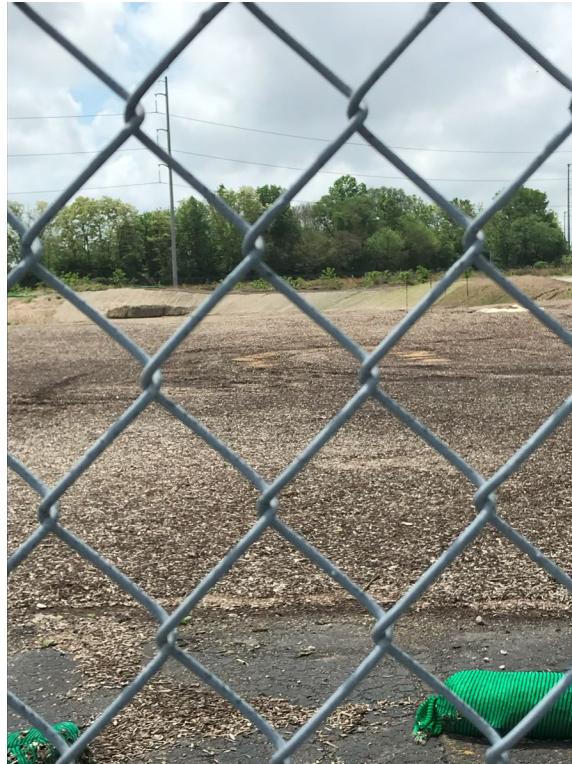
Upslope portion of site with some germination in distance.

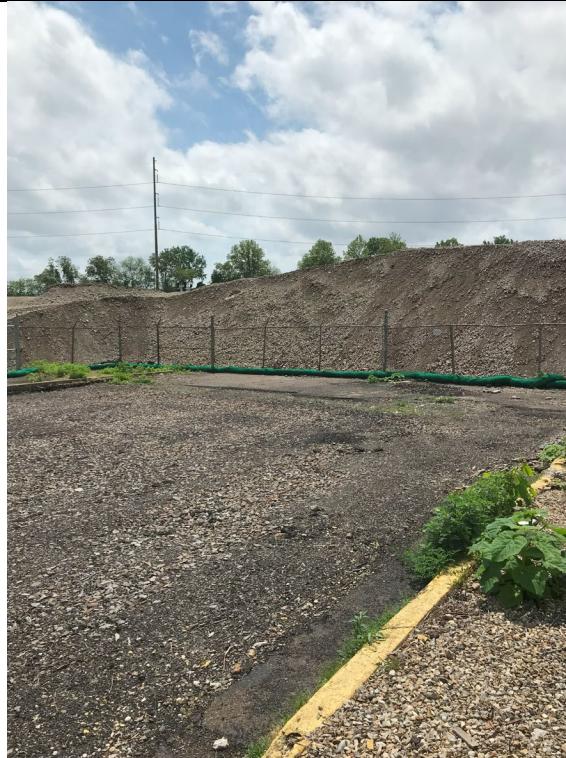
The stone stockpile near the 51st St. midslope site boundary appeared unchanged from the previous inspection. The "For Lease" signage remains in place. We noted some germination in midslope areas of the site.

Stone stockpile and midslope filter sock.

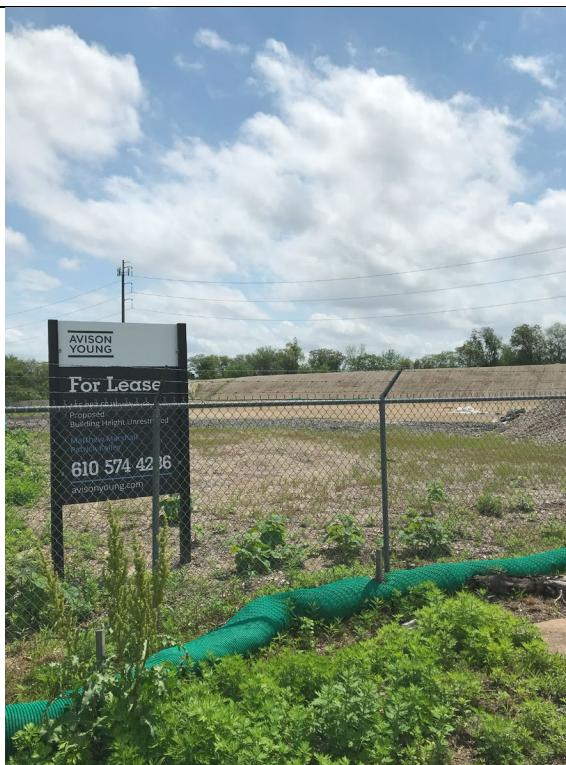
“For Lease” signage and midslope portion of site showing some germination.

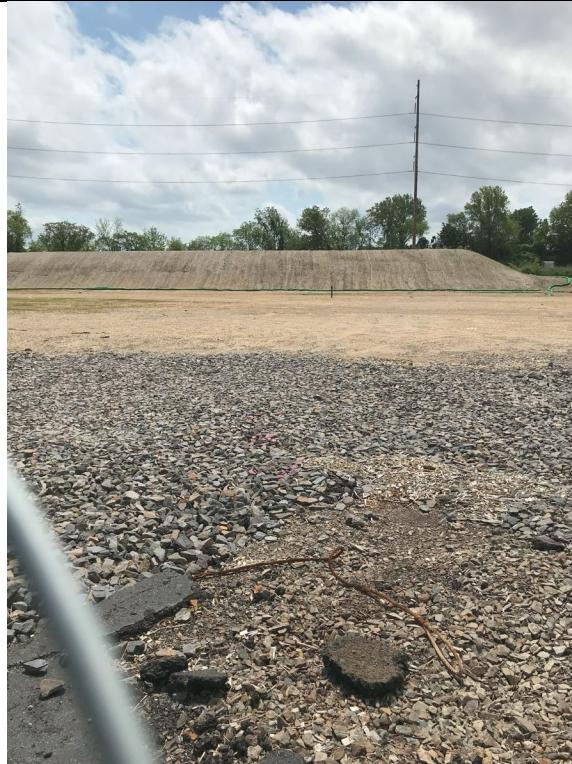
Large fill dirt stockpile in distance beyond midslope portions of site.

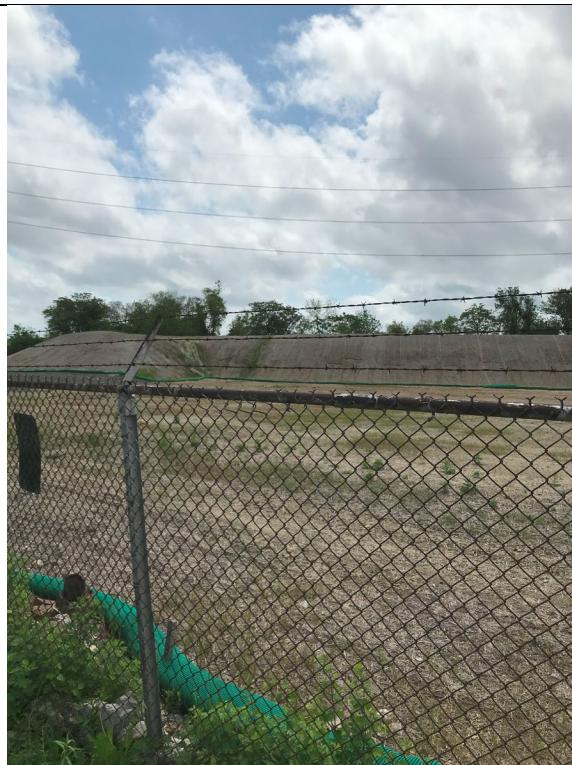
Erosion control matting remained in place at the interior bend of the large fill dirt stockpile, and on the most downslope side. However, we noted that some of the erosion control matting had slipped and rolled up towards the bottom of the interior bend of the stockpile. There were some areas of germination on this stockpile, including on the back side (adjacent to the railroad tracks).

Interior bend of large fill dirt stockpile in distance with some germination present.

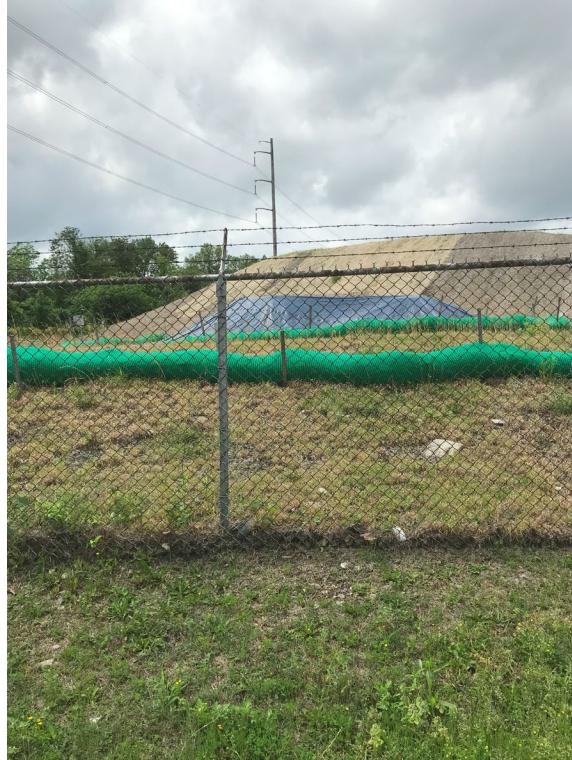
We observed that some short stretches of filtersock along the downslope boundary of the site were nearing an overtopping condition by collected mulch from upslope areas.

A new tarp covering the small pile of contaminated soil downslope of the large fill dirt stockpile was intact and fully covered the soil.

Downslope filtersock (foreground); contaminated fill dirt stockpile with tarp (at center); downslope end of large fill dirt stockpile with erosion matting (background).

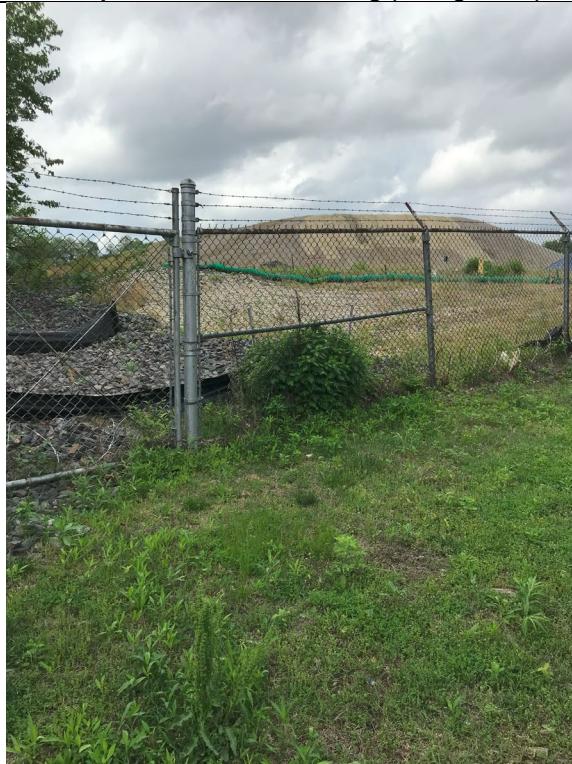
Silt fence along rocked swale, and back side of large fill dirt stockpile.

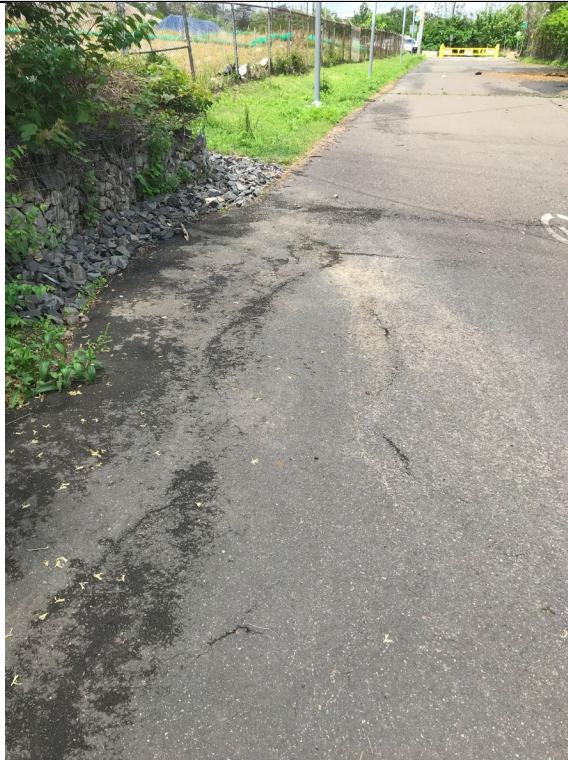
We did not observe any change to the sediment staining on the Bartram's Garden trail downslope of the site.

**Sediment staining on Bartram's Garden trail.
End of photo log.**
