Date(s) of Inspection: **10/11/22** TV  PA  SM  GP  NM  MEGA  Permit #(s): \_\_\_\_\_ Expiration Date: \_\_\_\_\_ Case #: \_\_\_\_\_ PF ID #: **851121**

Company Name: **Hanson Aggregates LLC** Municipality: **East Rockhill Twp** County: **Bucks**

Plant Name: **East Rockhill Quarry** Physical Location: **2105 N. Rockhill Rd, Sellersville, PA 18960** Federal ID - Plant Code #: \_\_\_\_\_

**10/11/22 Hanson East Rockhill Quarry AQ Sampling Photos**

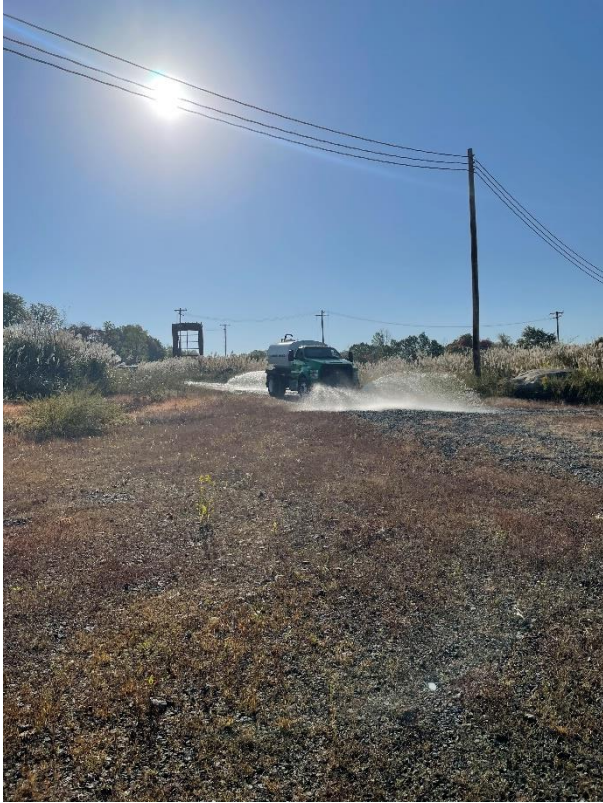
Water truck in operation - 10/11/22, 9:39 AM

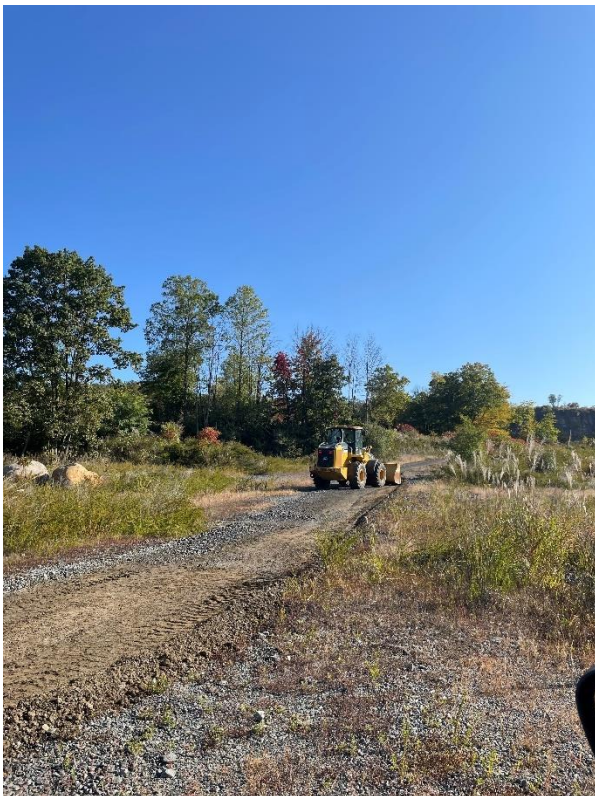
Front-end loader leveling road - 10/11/22, 9:56 AM
