NARRATIVE REPORT FORM

Facility Name: Glenwood Drive & Walker Road

Primary Facility ID: 881609

Inspection Purpose: Oversight of monitoring well 7S and 8D installations. MW-7S is located on Walker Road in the roadway north of the properties at 121 and 123 Walker Road, Washington Crossing, PA 18977. MW-8D is located on Spencer Road near the southern driveway of the property at 128 Glenwood Drive, Washington Crossing, PA 18977 (see Photo #1 for both locations).				
Weather: Sunny, 80s °F				
PADEP Staff Present: Dustin Lipik, P.G. (DL)				
Narrative: <p>DL arrived at the monitoring well 7D/7S drilling area at 11:15. Upon arrival DL spoke with Chris Embry (CE) of Sunoco Pipeline, LP (SPLP). CE informs DL that Summit Drilling, LLC (Summit) had just finished the drilling and installation of monitoring well 7S and was in the process of demobilizing from the well and moving their drilling equipment to the borehole for monitoring well 8D. CE indicated that there was no visual or olfactory evidence of contamination during drilling of MW-7S and all photoionization detector (PID) readings were equal to or less than background concentrations (Photo #2). CE indicates that there were no visits

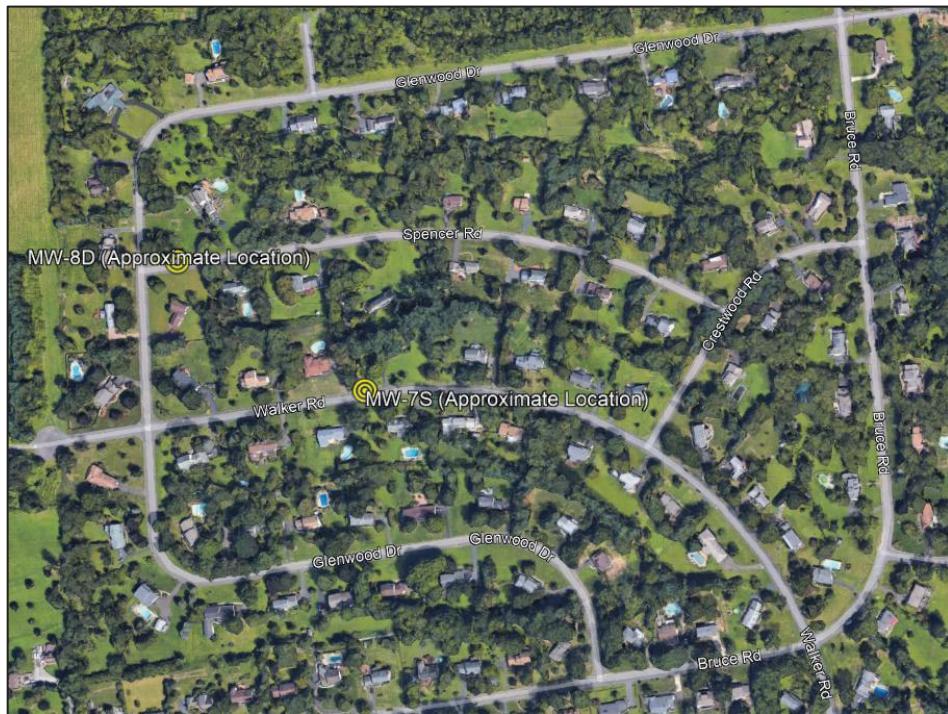
Photo #1
 Monitoring wells 7S and 8D installation locations, Washington Crossing, PA

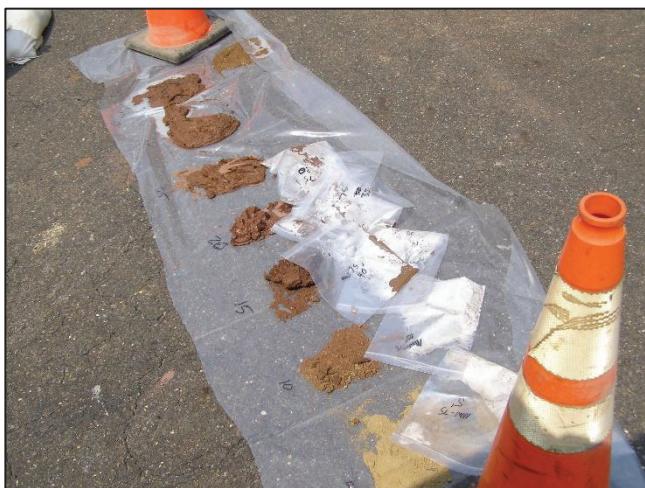
At 11:47, DL speaks with Brian Hale (BH) of Groundwater & Environmental Services, Inc (GES), the geologist overseeing drilling activities. BH confirms CE's statements regarding visual and olfactory evidence of contamination and PID readings from the borehole at MW-7S. BH tells DL that MW-7S was constructed as a 2-inch, schedule 40, polyvinyl chloride (PVC) permanent well with a 0.020-inch screen from 40 to 15 feet (ft) below ground surface (bgs) and riser from 15 ft bgs to ground surface. A #2 Morie sand pack was emplaced around the screen from 40 to 13 ft bgs (2 ft above well screen). Hydrated bentonite chips were emplaced from 13 to 11 ft bgs, and grout was emplaced from 11 ft bgs to ground surface. Surface completion will be flush mount with a well vault and concrete pad.

Photo #2
 Monitoring well 7S drill cuttings.
 8/7/2025 @ 11:26

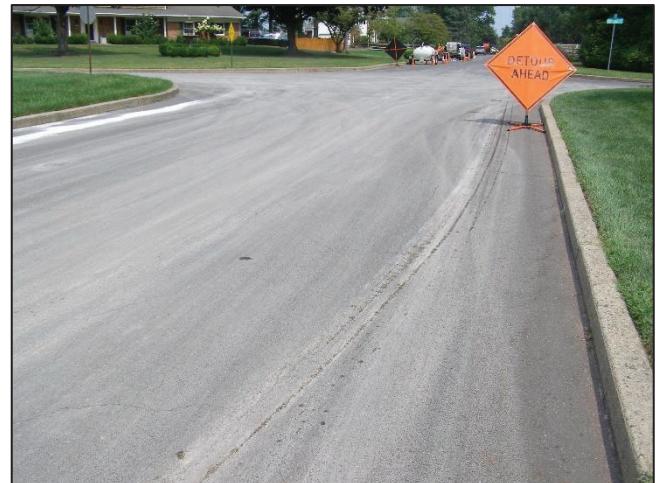
Photo #3
 Asphalt staining looking north on Glenwood Drive toward intersection with Walker Road.
 8/7/2025 @ 11:32

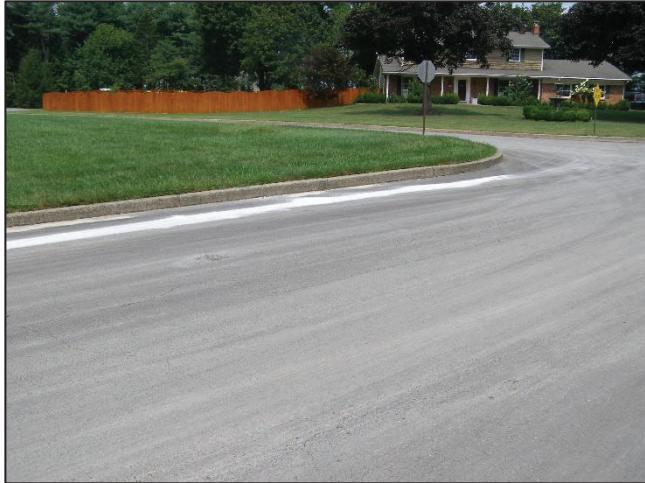
Photo #4
Oil-dry power overlying stained asphalt looking northeast on Walker Road toward intersection with Glenwood Drive.
8/7/2025 @ 11:32

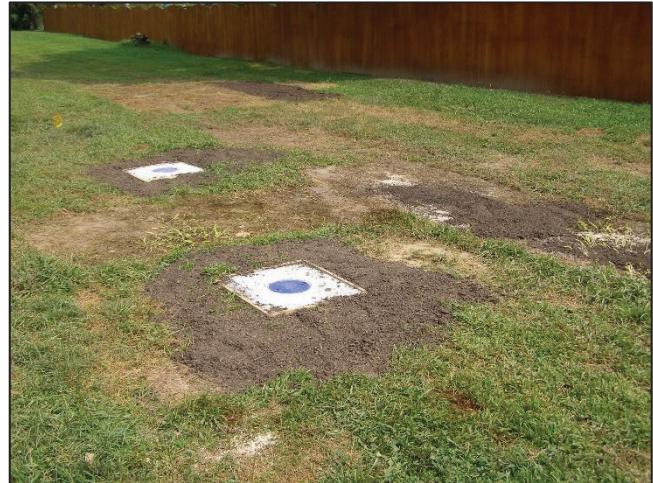
Photo #5
Final restored surface completion at MW-2S and 2D.
8/7/2025 @ 11:38

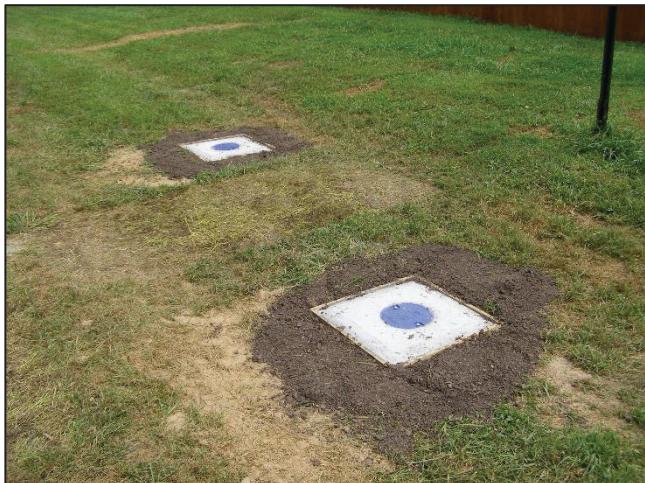
Photo #6
Final restored surface completion at MW-1S and 1D.
8/7/2025 @ 11:39

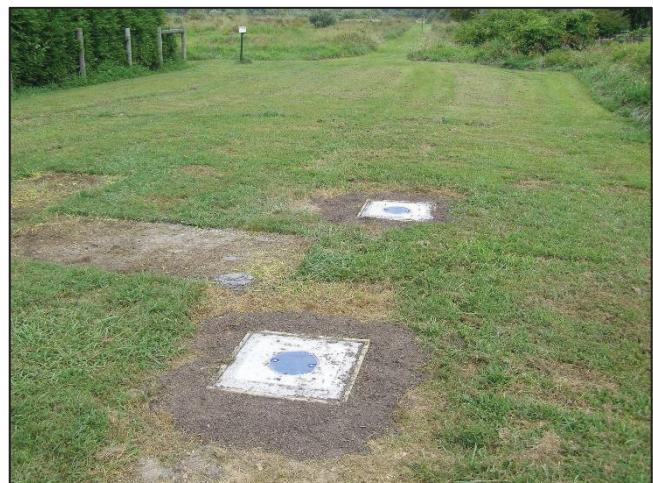
Photo #7
Final restored surface completion at MW-3S and 3D.
8/7/2025 @ 11:40

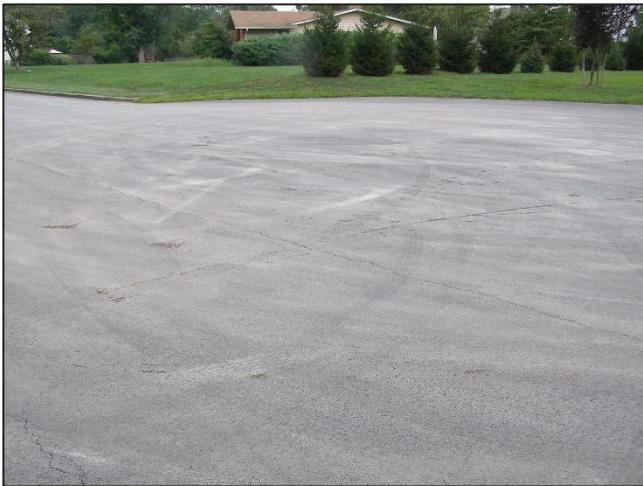
Photo #8
 Asphalt staining in cul-de-sac of Walker Road, west of Glenwood Drive.
 8/7/2025 @ 14:44

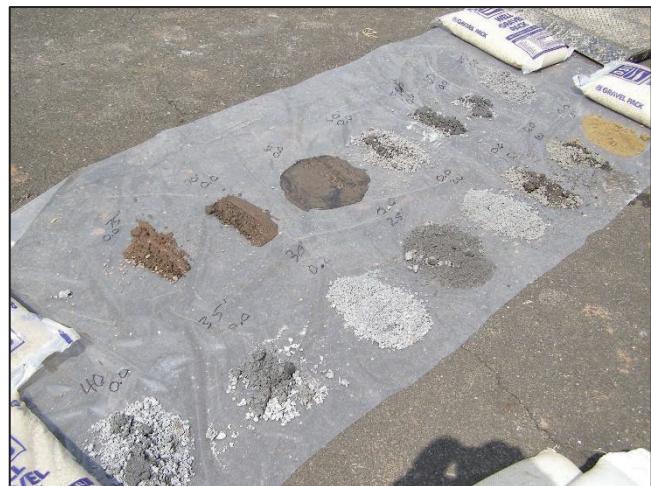
At 14:45, DL returns to the MW-8D drilling area. CE indicates that borehole terminal depth of 75 ft bgs has been reached and Summit is beginning preparation for construction of the monitoring well. PID readings collected from soil cuttings every 5 ft were equal to or less than background concentrations (Photo #9) GES indicated that the well would be constructed as a 2-inch, schedule 40, polyvinyl chloride (PVC) permanent well with a 0.020-inch screen from 75 to 50 ft bgs and riser from 50 ft bgs to ground surface. A #2 Morie sand pack would be emplaced around the screen from 75 to 48 ft bgs (2 ft above well screen). Hydrated bentonite chips would be emplaced from 48 to 46 ft bgs, and grout would be emplaced from 46 ft bgs to ground surface. Surface completion will be flush mount with a well vault and concrete pad.

Photo #9
 Soil cuttings from monitoring well 8D.
 8/7/2025 @ 14:50
