**NARRATIVE REPORT FORM**
Facility Name: Glenwood Drive & Walker RoadPrimary Facility ID: 881609

Inspection Date: 11/17/2025	Inspection Time: 9:18-10:52	Lat/Long:	
Program:	<input type="checkbox"/> Storage Tanks	<input type="checkbox"/> HSCA	<input checked="" type="checkbox"/> LRP
Owner Name: Energy Transfer		Inspection ID:	Site ID:
<b>Facility Location (911) Address:</b> Glenwood Drive, Walker Road, and Spencer Road Washington Crossing, PA 18977		<b>Municipality:</b> Upper Makefield Township	
		<b>County:</b> Bucks County	
<b>Responsible Official Name:</b> Bradford Fish  <b>Title:</b> Senior Environmental Specialist Emergency Response & Remediation		<b>Responsible Official Address:</b> 100 Green Street Marcus Hook, PA 19061	
<b>Responsible Official Telephone:</b> 610.859.6297  <b>Email Address:</b> Bradford.fish@energytransfer.com

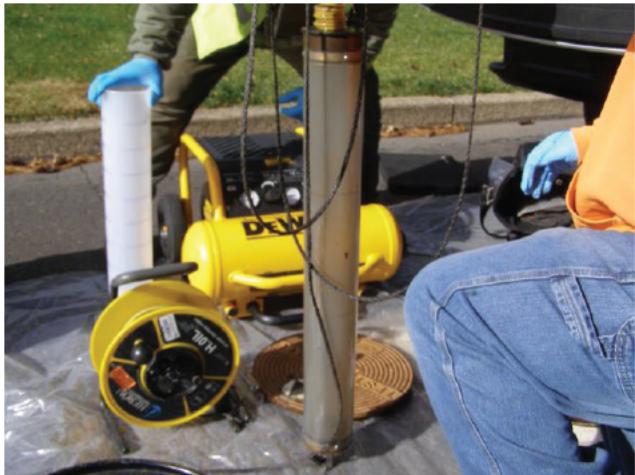
Photo 1: RW-2 Skimmer  
 Source: Olivia Budnovitch, 11/17/2025, 10:40

The skimmer from RW-2 can be seen in Photo 1. There was no fuel or water recovered into the chamber of the skimmer. There was 0.01 feet of fuel in the well around the skimmer prior to being removed.

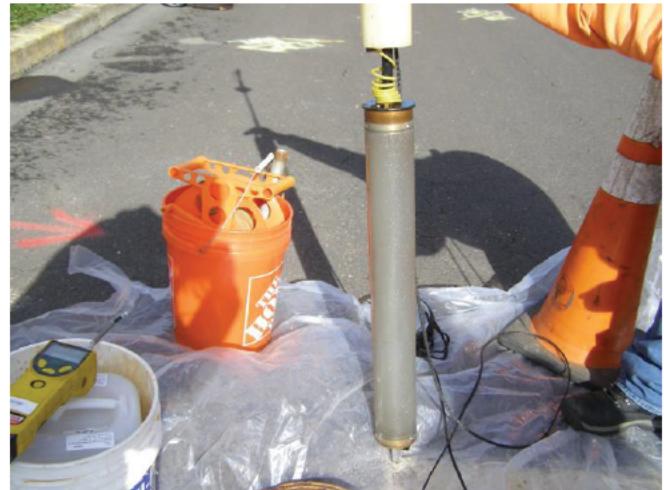
Photo 2: RW-3 Skimmer  
 Source: Olivia Budnovitch, 11/17/2025, 10:46

The Skimmer from RW-3 can be seen in Photo 2. There was approximately 100 mL of a product and water mixture in the skimmer. The mixture was transferred to a large, graduated cylinder for measurement and sample collection. A sample of the product was collected by GES.
