Appendix 1

Exhibit 6

September 19, 2023

Subject: **Quarry Pit Discharge Level**
NEW HOPE CRUSHED STONE & LIME COMPANY, INC. (NHCS)

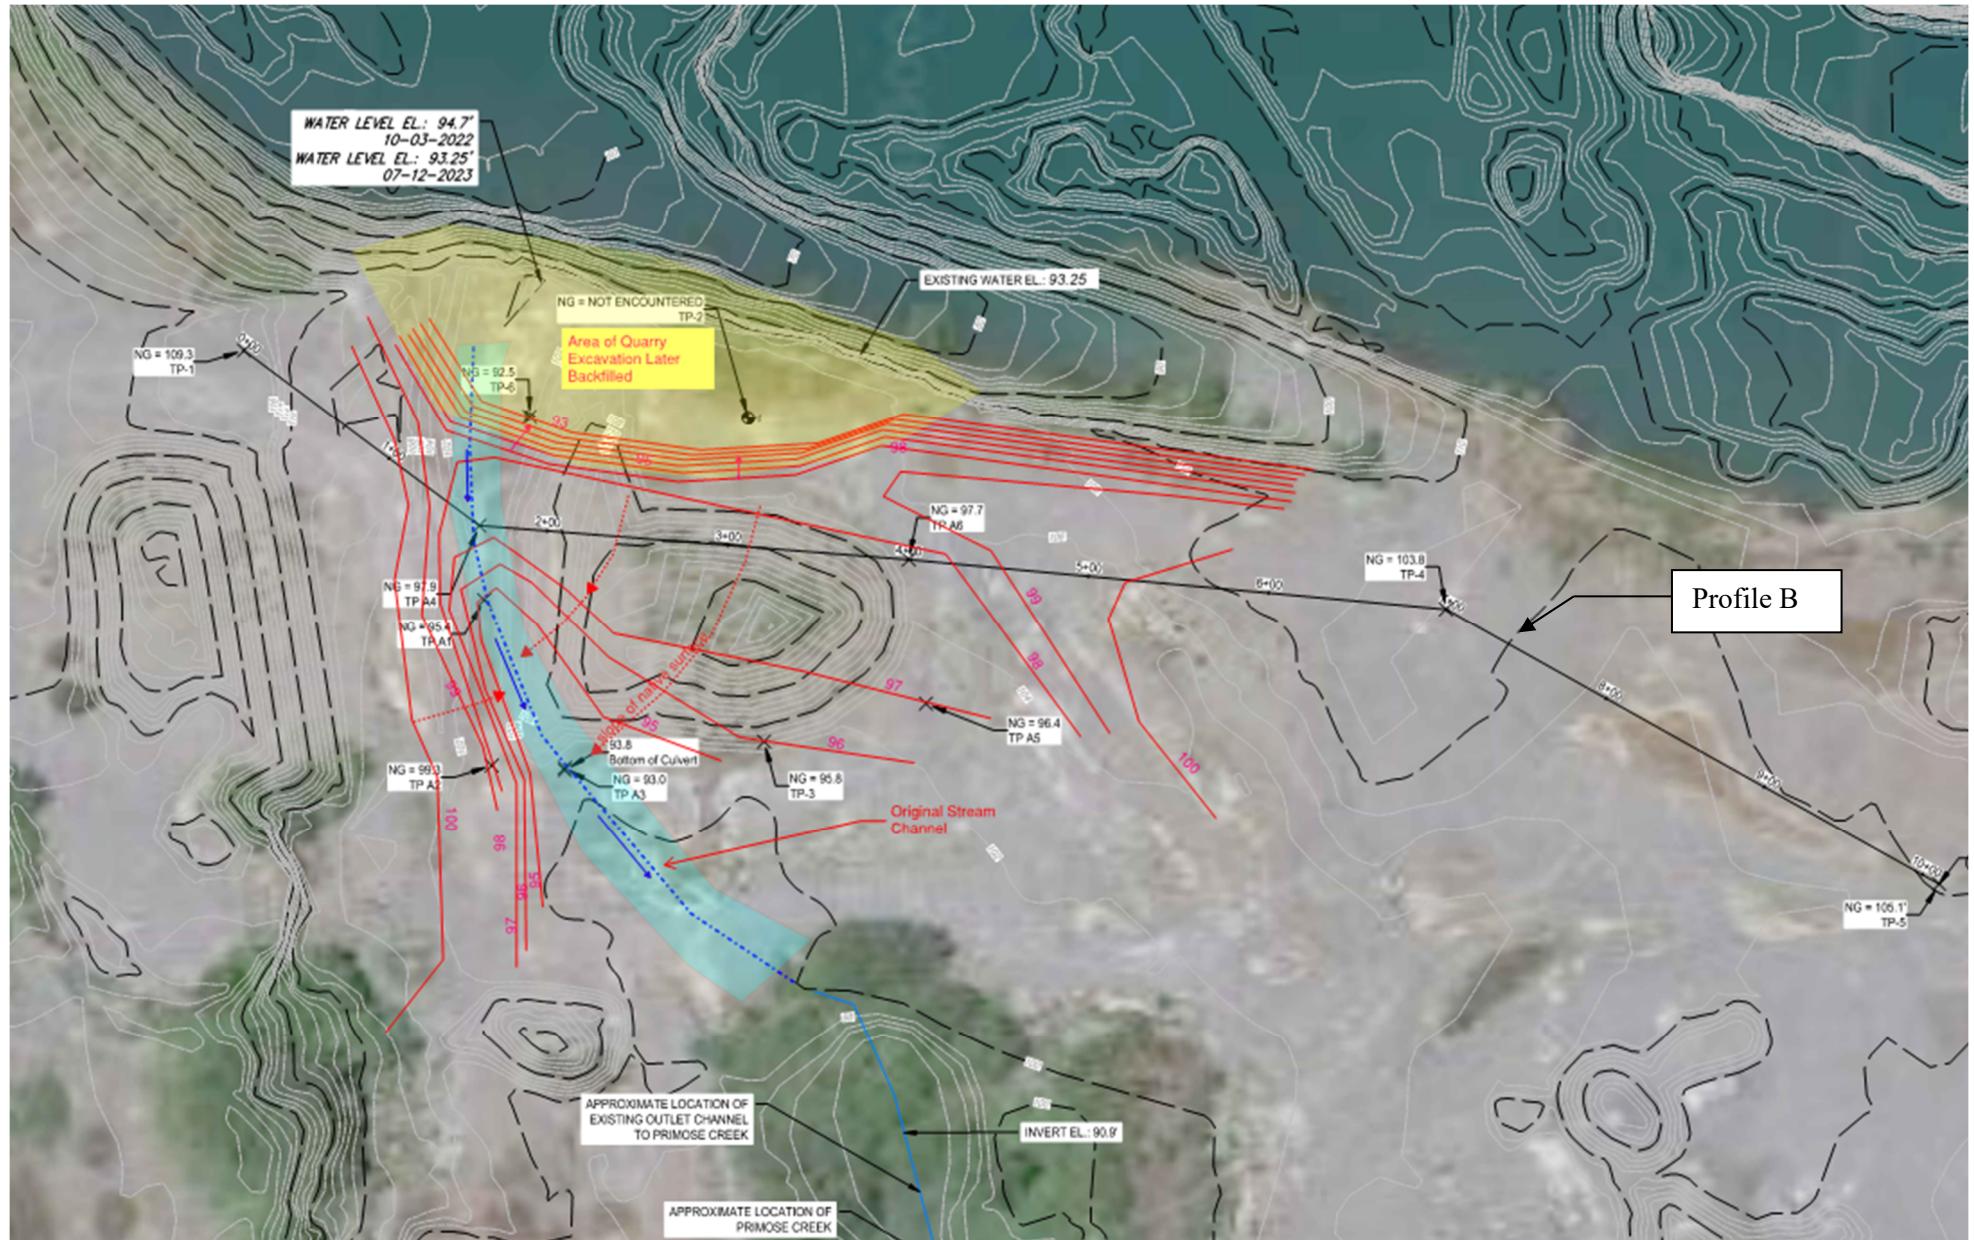
Figure 1 – Topographic Interpretation of Native Surface

Figure 1 attached to this letter presents a topographic depiction of the native surface elevations based on the test pit data. It clearly demonstrates that the native surface elevations encountered in the test pits are consistent with the record of mining indicated by the aerial images. Test Pit A3 encountered a buried culvert. The location and elevation of this culvert is consistent with the alignment of the stream and roadway that would have crossed it (Figure 2). All of the data are consistent with the topographic contours indicated in Figure 1. The original natural ground, and stream channel slope downward from the west to

east, the original direction of flow in Primrose Creek. It is clear that there had been excavations and fill placement west of the line toward the present apparent rim of the quarry pit, however, those areas should be considered part of the pit and levels determined there should not be used in setting the discharge level. The only levels that would control are those that form the natural rim, which are at or near elevation 98' NGVD88 as depicted by Profile B.

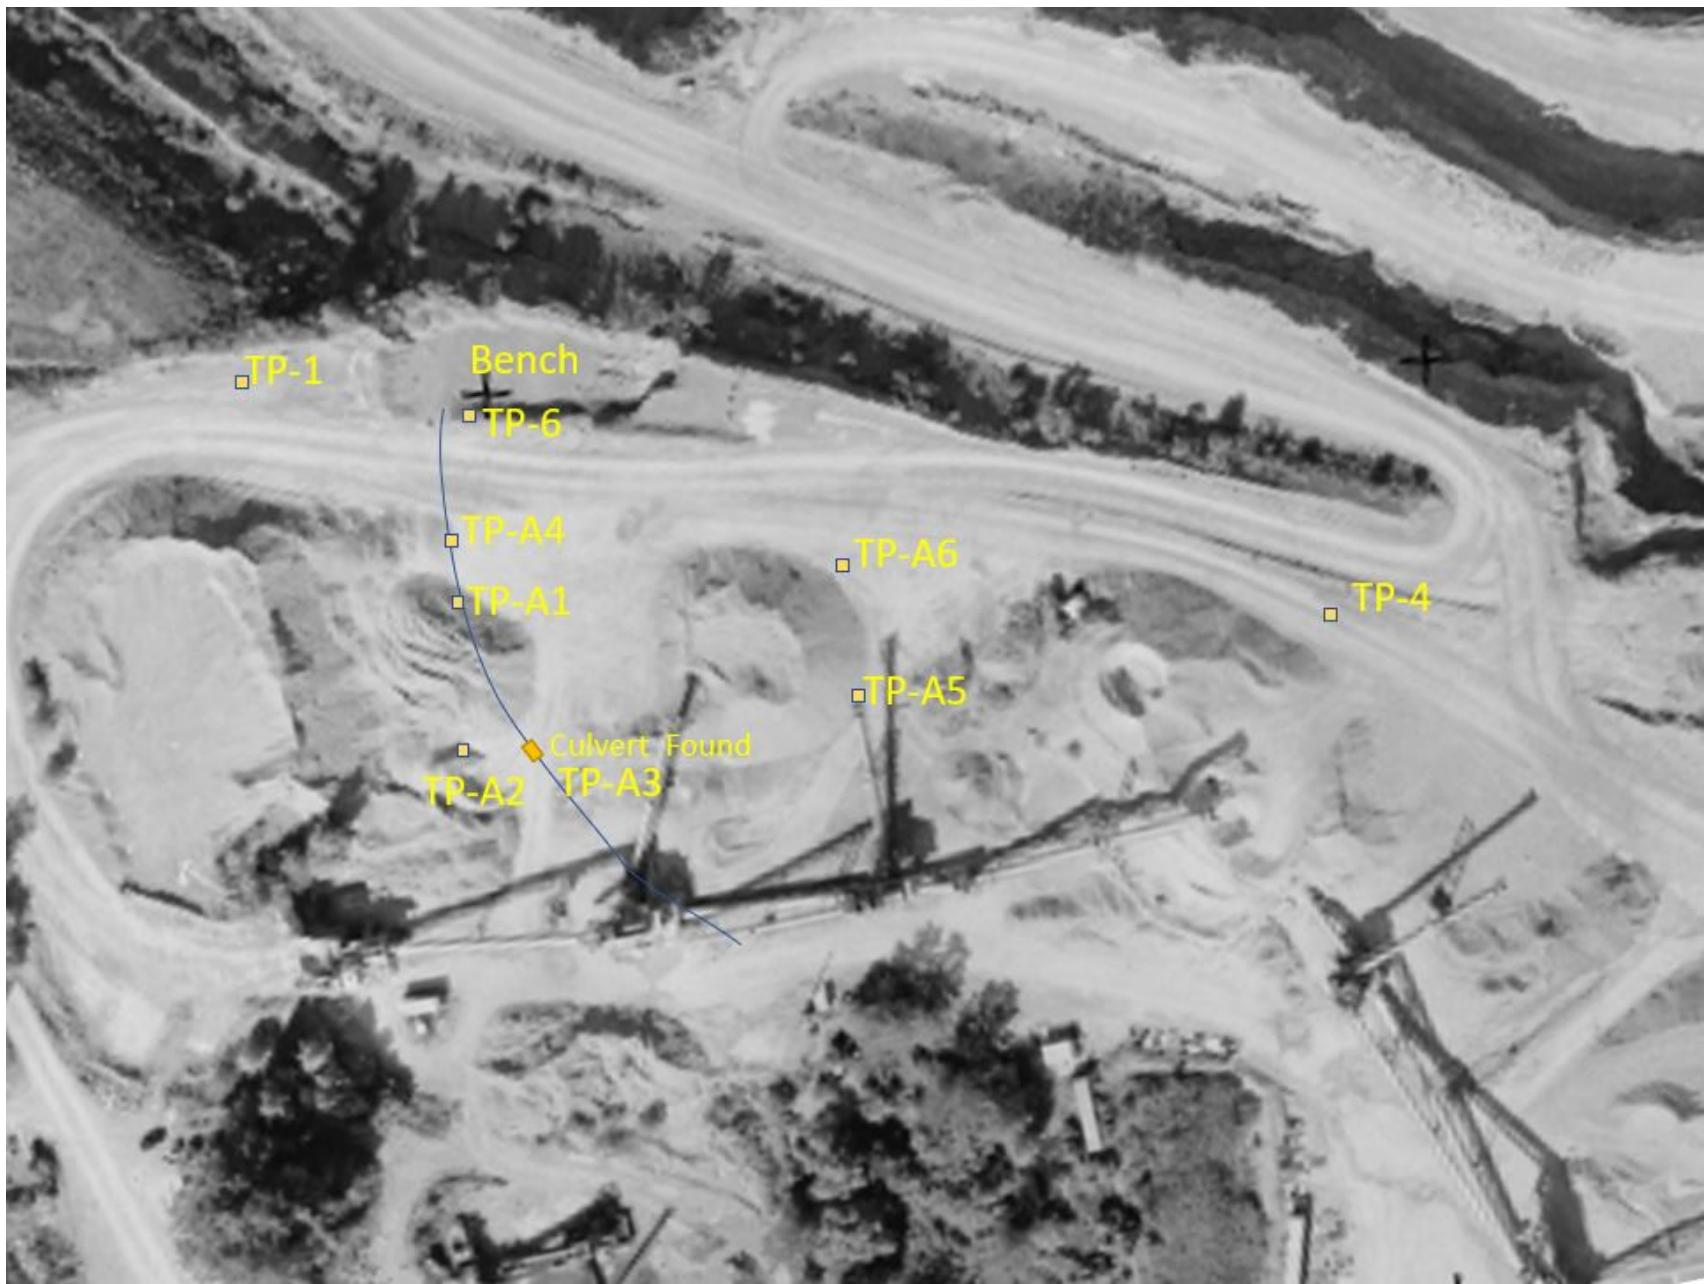
Figure 2 – Test Pits and Culvert on 2014 Aerial Image (9-26-2014)

In addition to the field data, previous surveys and aerial imagery inform the location of the historic stream and limits of mining. Specifically, aerial imagery indicating the presence of a bench that was later backfilled in the area of TP-6 was presented in the meeting between Solebury School and DEP representatives on March 3, 2023. The aerial survey was flown for Solebury School, by Tetra Tech on September 26, 2014 (copy attached). The former alignment of Primrose Creek and locations of watercress farming based on earlier aerial photos were also provided in that meeting.

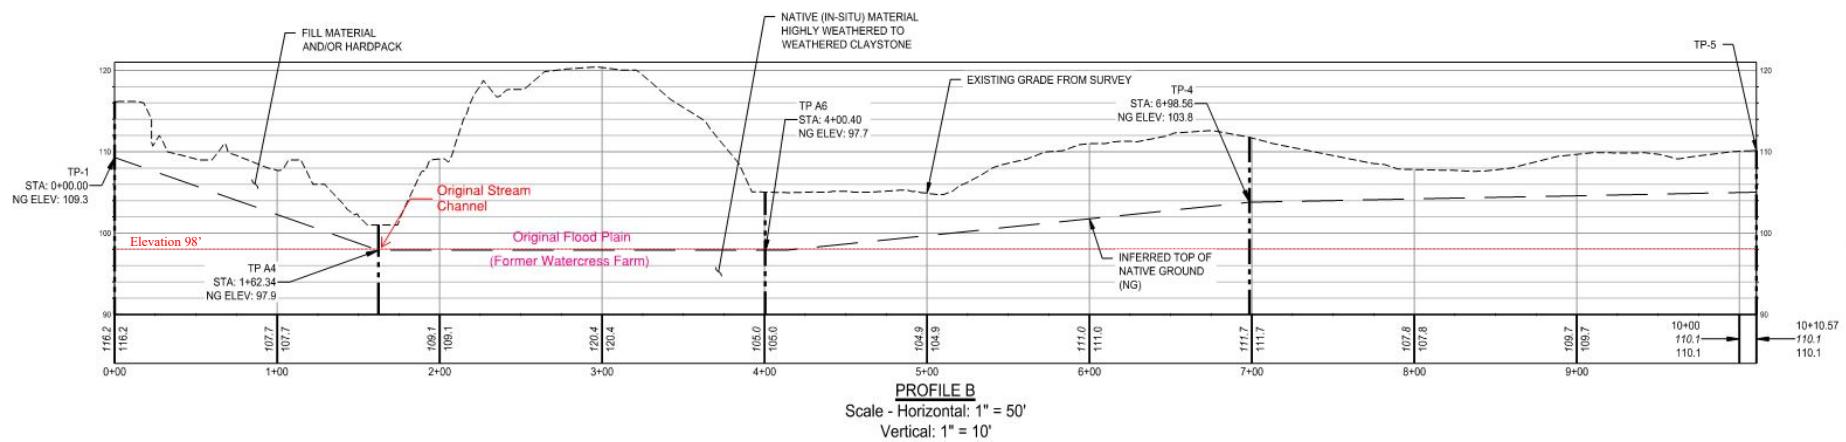
Figure 3 – Annotated Profile B

Accordingly, the native surface line shown on Profile B represents an accurate depiction of the native ground surface that should be used for setting the minimum elevation based on the regulatory dam classification criterion. The Profile B location shown in Figure 1 should be taken as the hypothetical dam alignment and Profile B should be taken as the stream valley cross section for the purposes of setting the invert elevation for the quarry discharge to avoid the need for a dam. This is a conservative representation of the native ground elevation that would limit water flowing from the quarry pit. This profile is annotated and included here as Figure 3.
