New Hope Crushed Stone

Monthly Update

September 2016

STATUS AS OF:	September 30, 2016	
PROJECT	New Hope Crushed Stone (NHCS) Quarry Reclamation and Stream Restoration	
START DATE	Reclamation: January 29, 2016 Stream Restoration: January 29, 2016	
ANTICIPATED COMPLETION DATE	Reclamation: March 2019 Stream Restoration: March 2019	
CURRENT STATUS	Quarry Reclamation	Behind
	Stream Restoration	On Schedule

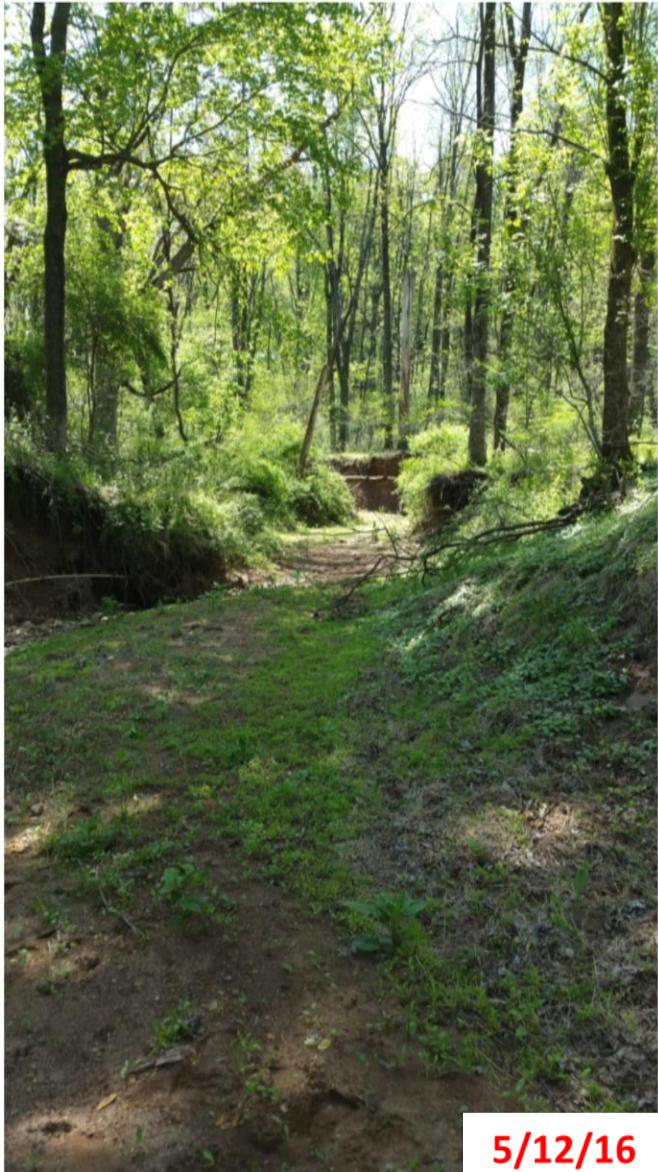
West, Looking East - Restoration

The GP-104 and GP-105 permits were issued on August 10. Recent activity on the stream has been some general repair work. Pictures will be updated when more progress is made.

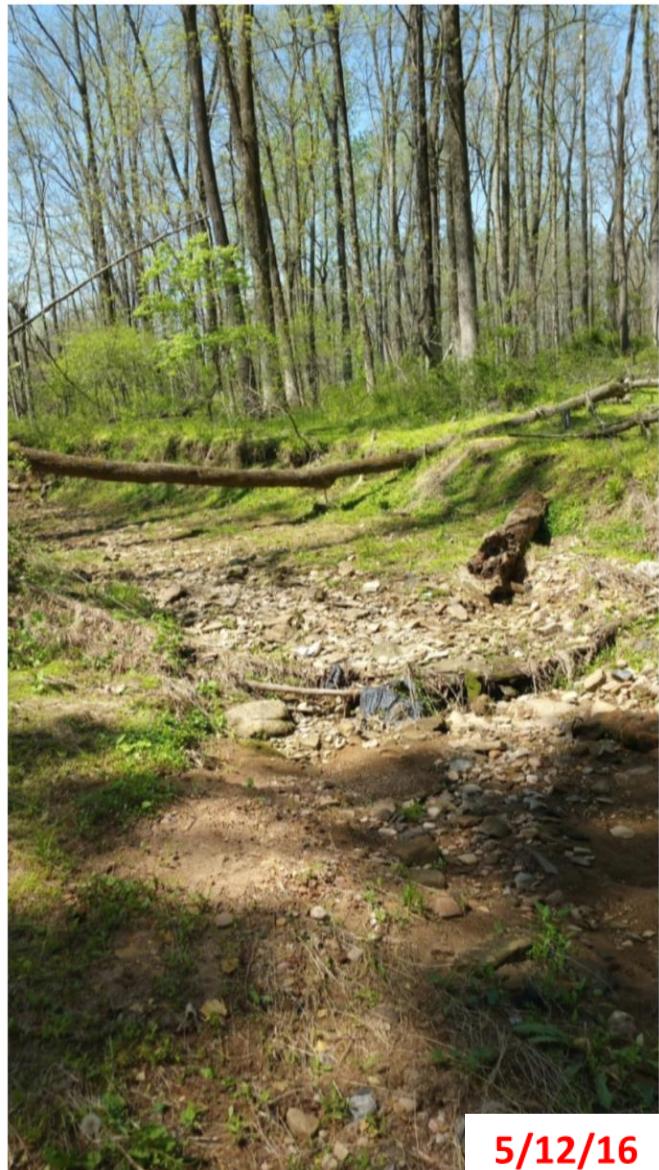
West, Looking West - Restoration

The GP-104 and GP-105 permits were issued on August 10. Recent activity on the stream has been some general repair work. Pictures will be updated when more progress is made.

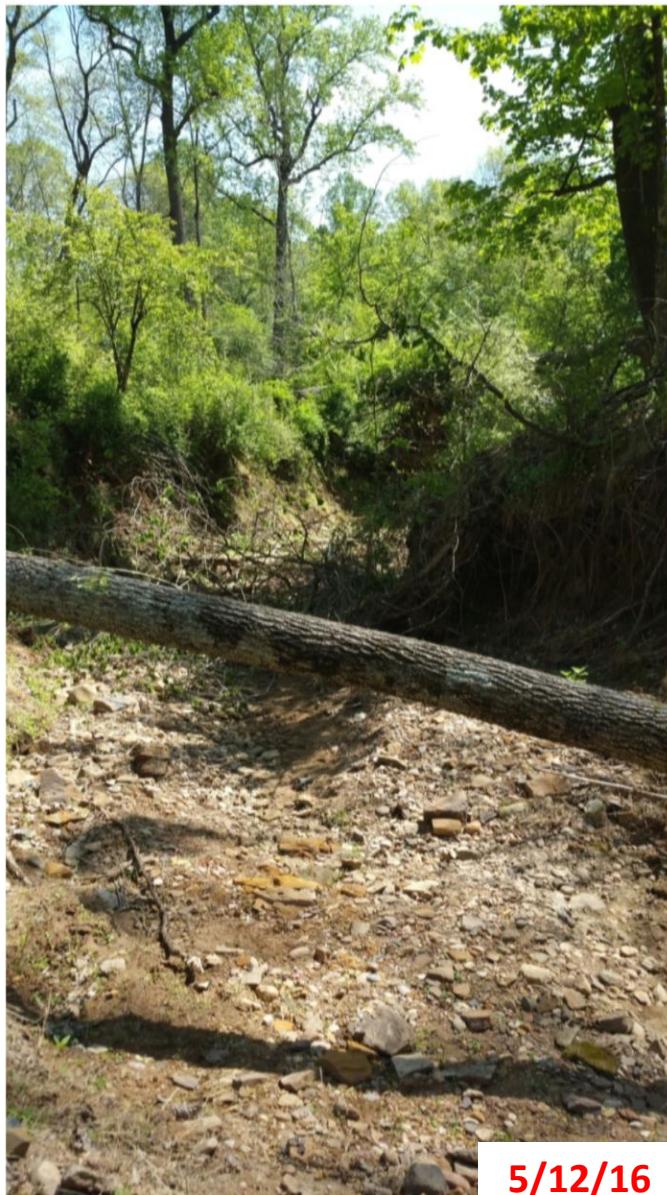
East, Looking East - Restoration

The GP-104 and GP-105 permits were issued on August 10. Recent activity on the stream has been some general repair work. Pictures will be updated when more progress is made.

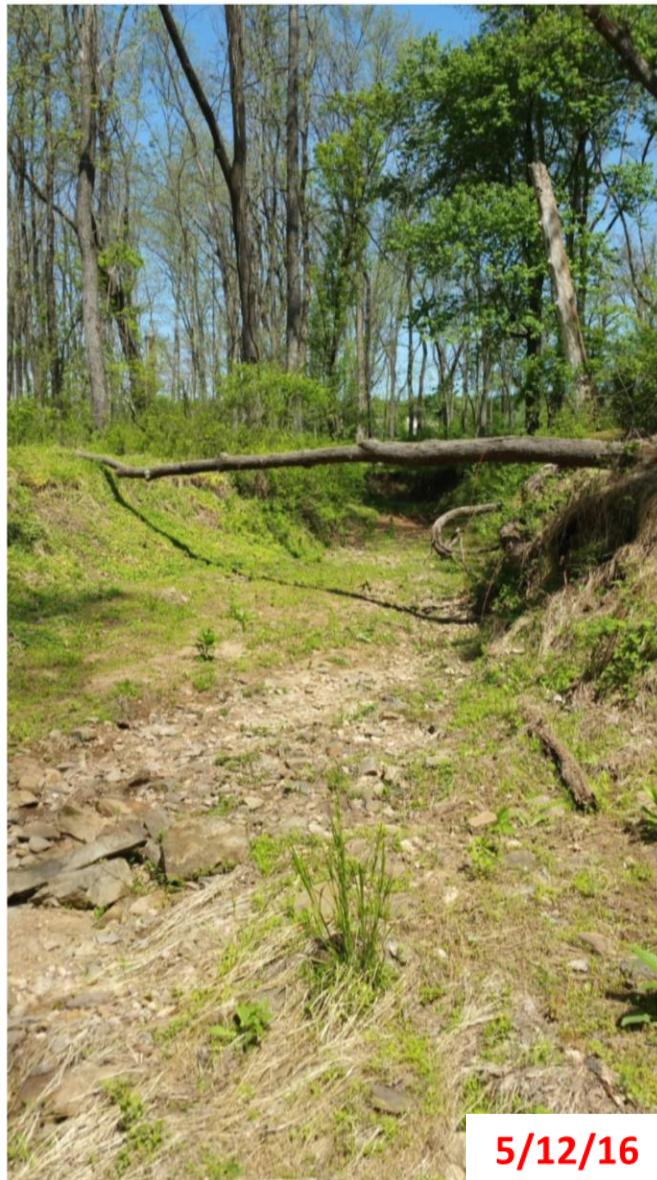
East, Looking West - Restoration

The GP-104 and GP-105 permits were issued on August 10. Recent activity on the stream has been some general repair work. Pictures will be updated when more progress is made.

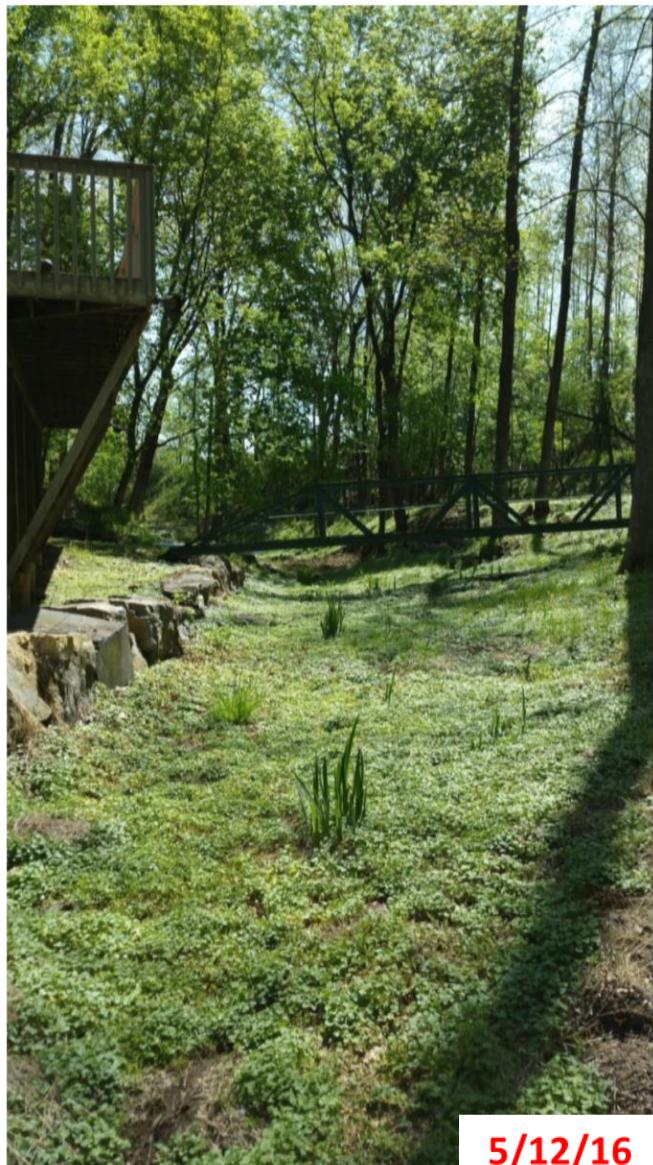
Mehok, Looking East - Restoration

The GP-104 and GP-105 permits were issued on August 10. Recent activity on the stream has been some general repair work. Pictures will be updated when more progress is made.

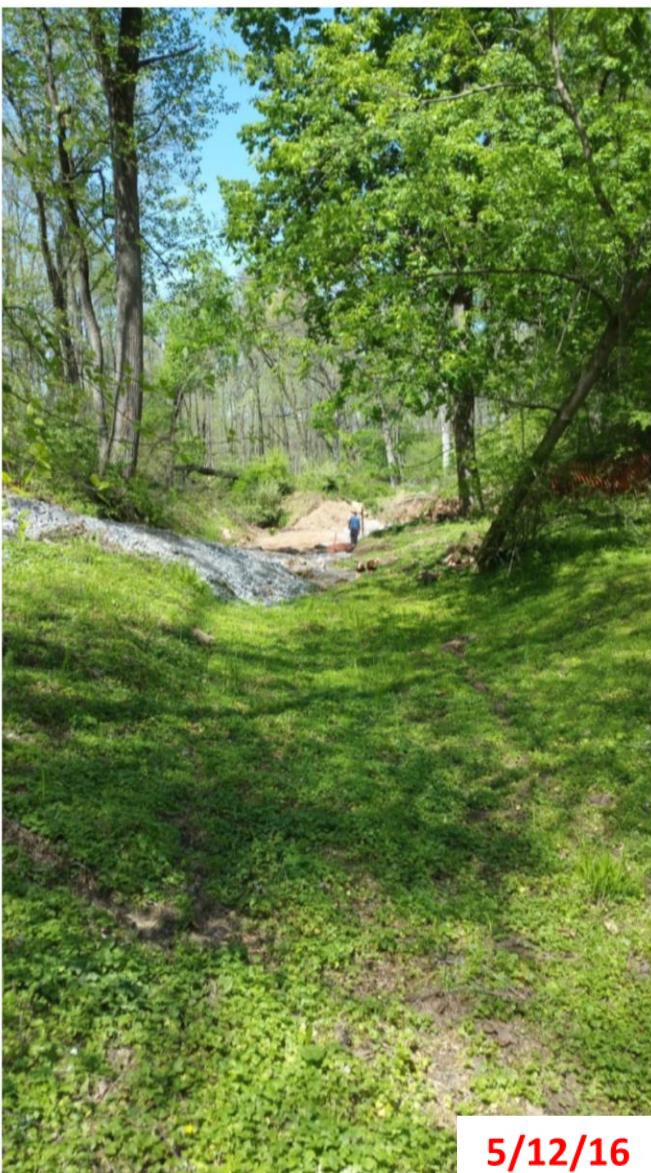
Mehok, Looking West - Restoration

The GP-104 and GP-105 were issued on August 10. Recent activity on the stream has been some general repair work. Pictures will be updated when more progress is made.

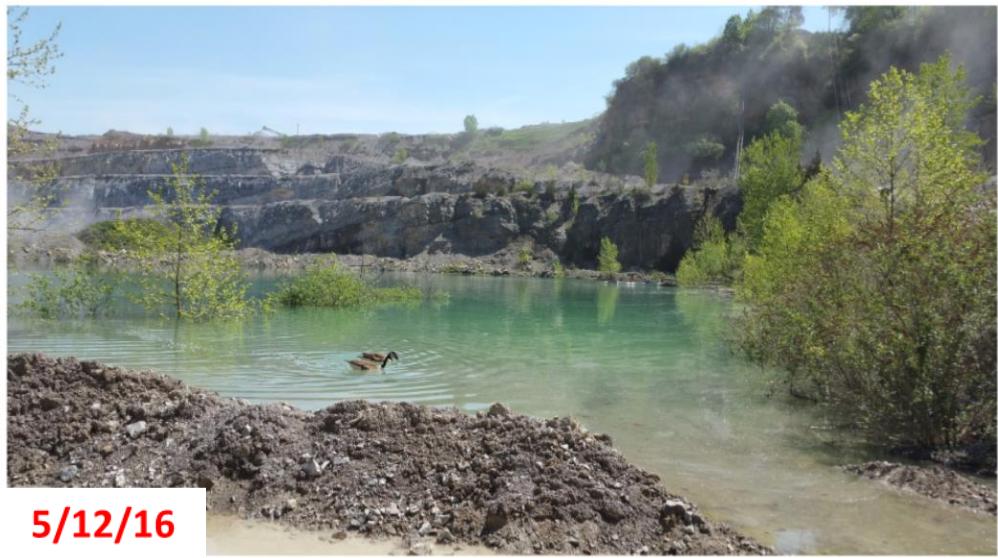
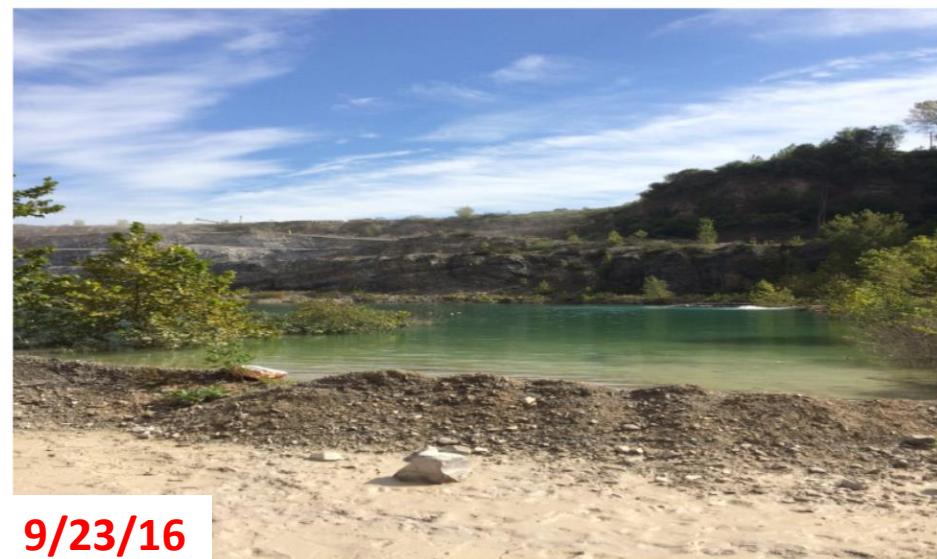
Sump - Reclamation

By months end, no change in water level. Water pumped from the pit area to sump area because of dry conditions to maintain 500,000 GPD rate.

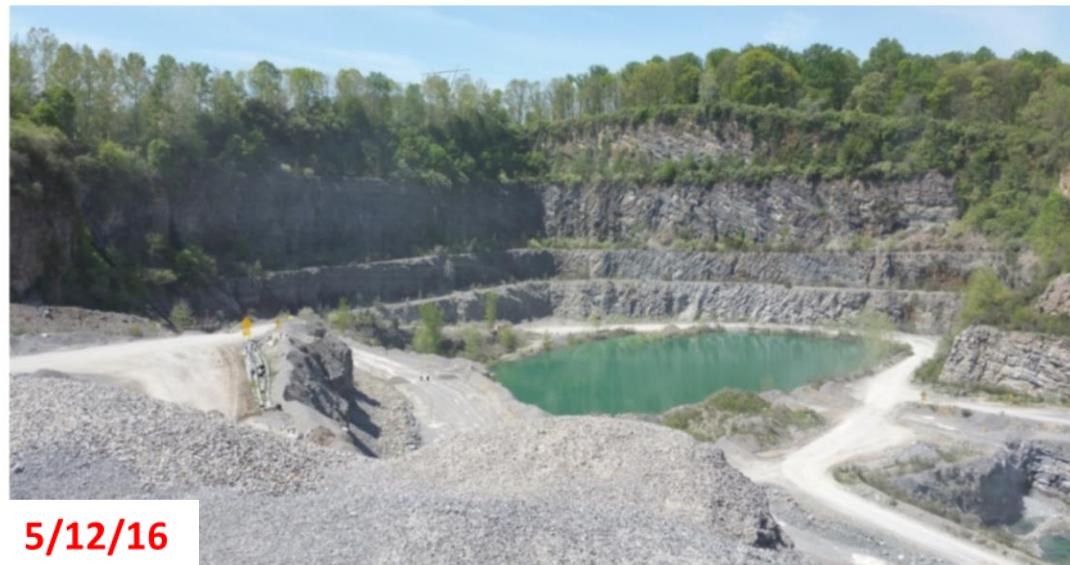
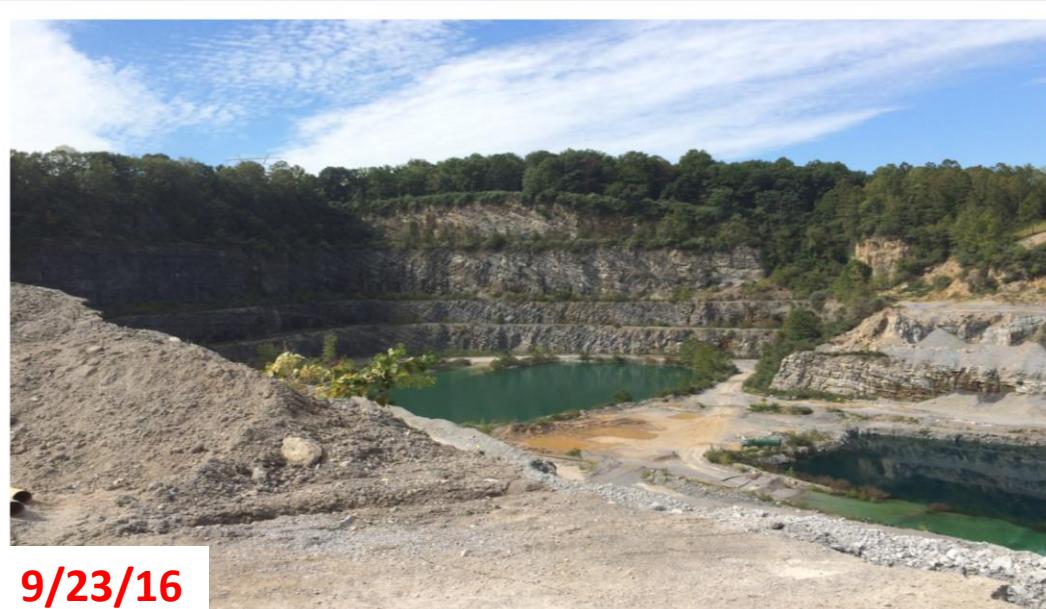
Ramp, Looking South - Reclamation

Sump area unchanged. Pit area to the right is up to about -110 MSL, or 10 feet above the floor.

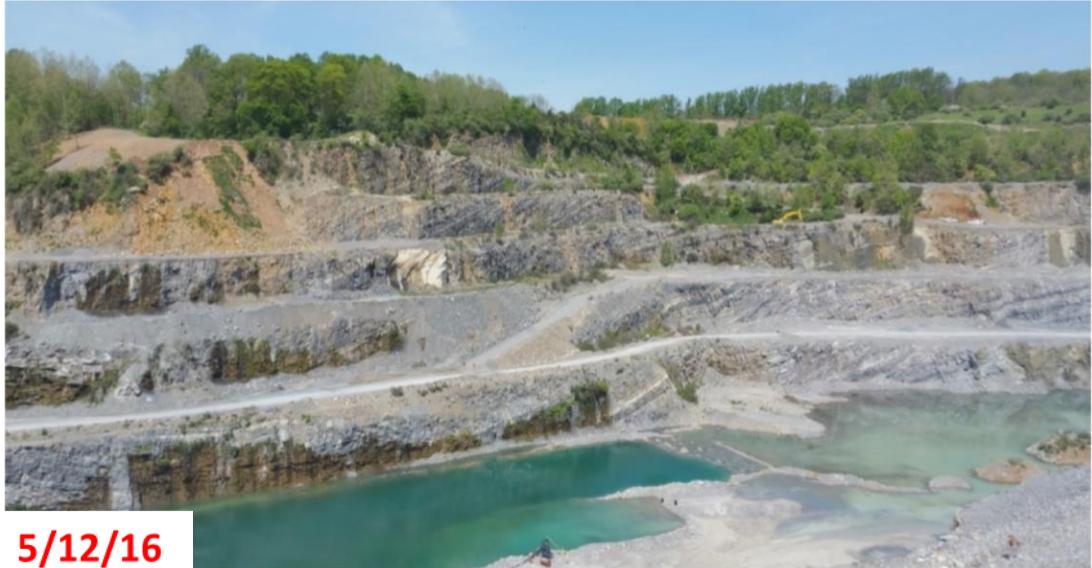
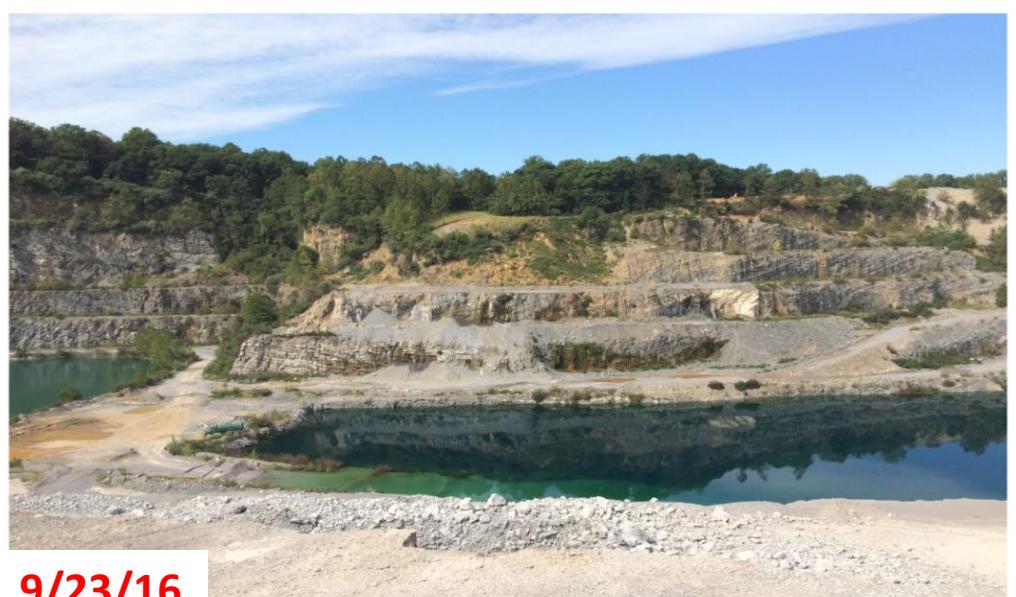
Ramp, Looking West - Reclamation

Pit area water is at the -110 MSL level, or 10 feet above the floor. Mining continues on the third and fourth benches.

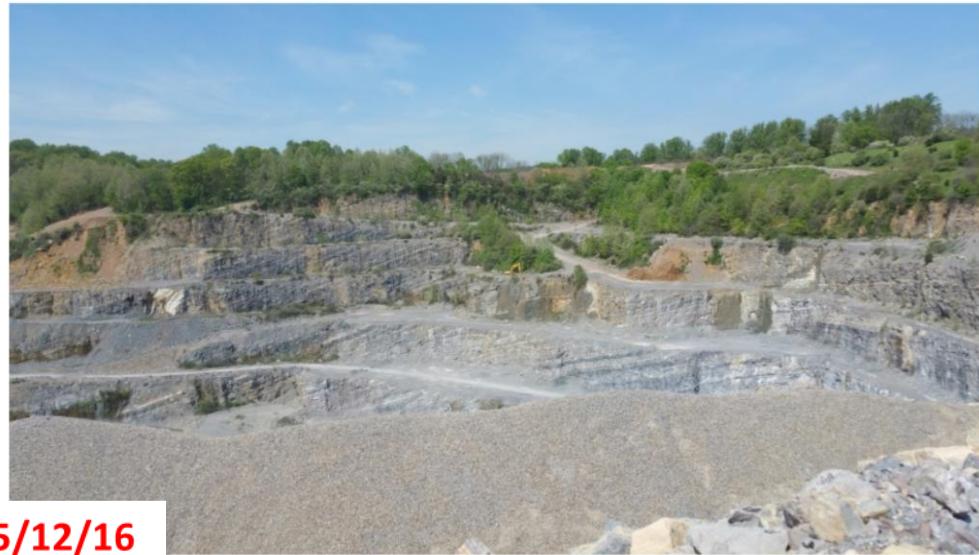
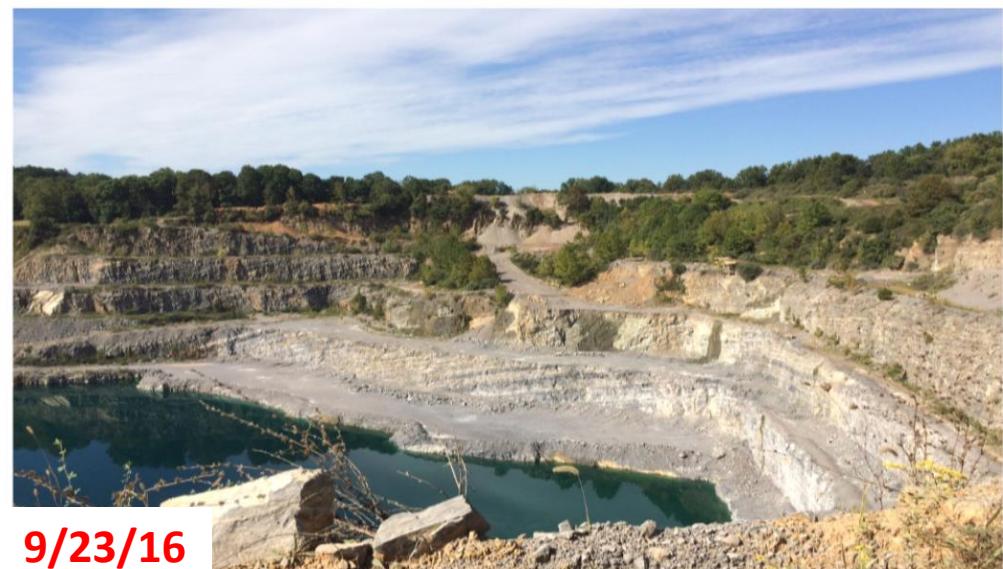
Garage, Looking North - Reclamation

Reclamation work continues in the NW corner.

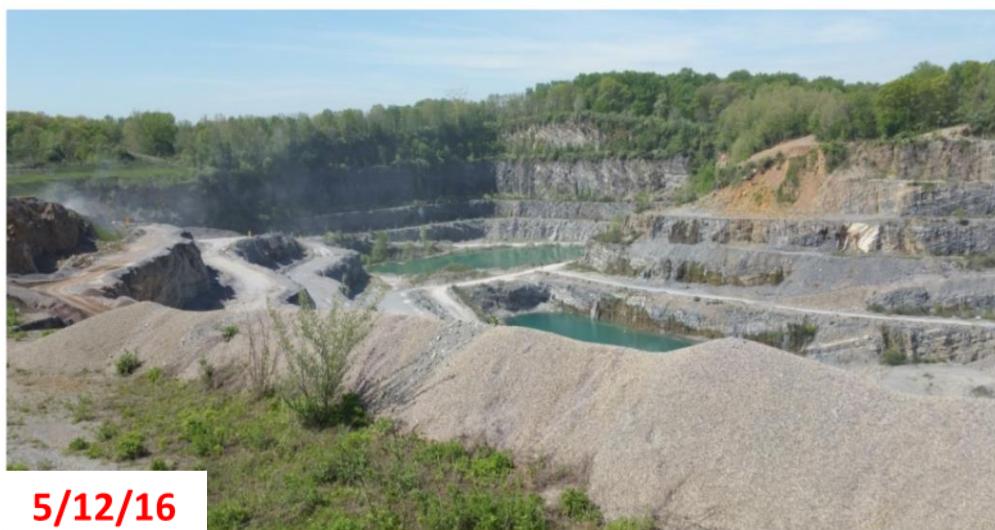
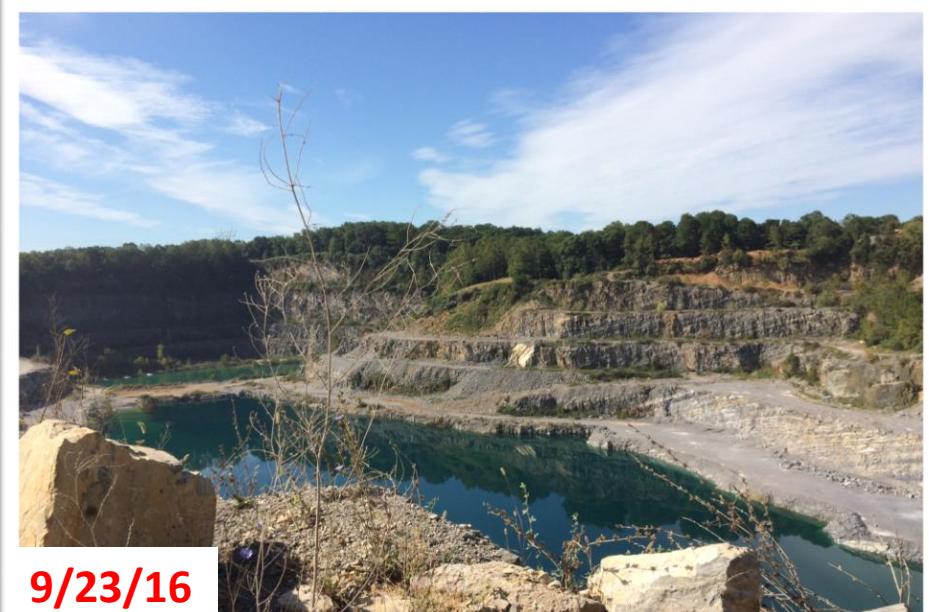
Garage, Looking South - Reclamation

Water levels continue to rise in the pit area. Reclamation work to the top right.
