Shell Chemical Appalachia LLC  
300 Frankfort Rd  
Monaca, PA 15061

August 9, 2023

**RE: PA-04-00740C Ethylene Manufacturing Line (Source ID 201), HP Ground Flares (Source IDs C205A and C205B), and HP Elevated Flare (Source ID C205C) Visible and Excess Emissions Malfunction Report**

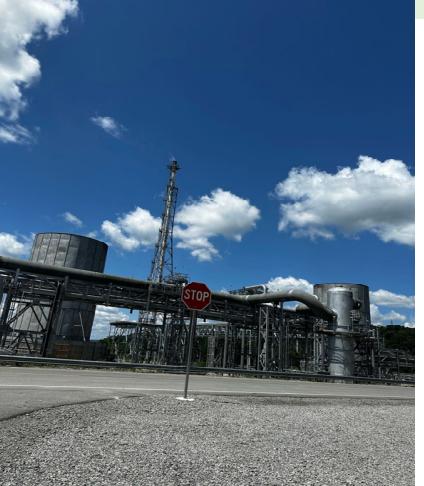
Observations				
Begin	7/10/2023 11:00	Clock Time 11:00	Observation Period (when you are actually looking at stack)  Every 5 Minutes	Emissions Observed (when you actually see smoke)  0:00:00 0:00:00 0:00:00 0:00:00 0:00:00 0:00:00 0:00:00 0:00:00 0:00:00 0:00:00
End	13:00	13:00		
Compliant? (Y/N)	YES		Y	
General Notes				
No Emission Observed between 7/10/2023 11:00 and 13:00. Per camera footage, the HP Elevated flare smoking ended at 9:12:50.
