APPENDIX D STREAM CORRIDOR ASSESSMENT

DEP staff conducted a walking survey of portions of Walnut Creek, using the Stream Corridor Assessment (SCA) survey protocols, developed by the State of Maryland - Department of Natural Resources, as a guide. These protocols are intended as a rapid assessment tool to identify potential environmental problems, such as:

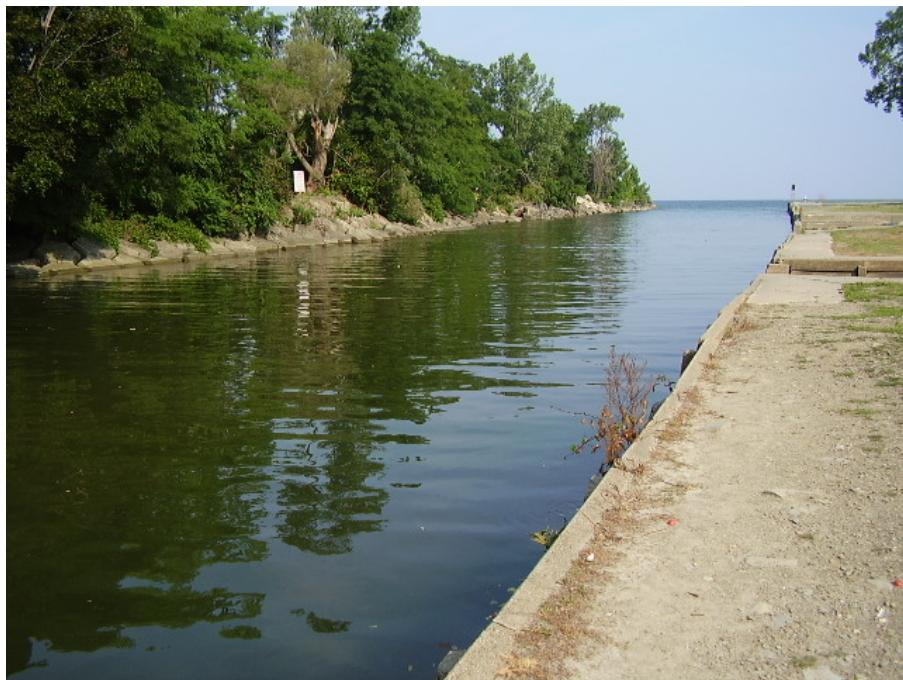
Photo 1 – Channel Alteration / Inadequate Buffer at the mouth of Walnut Creek

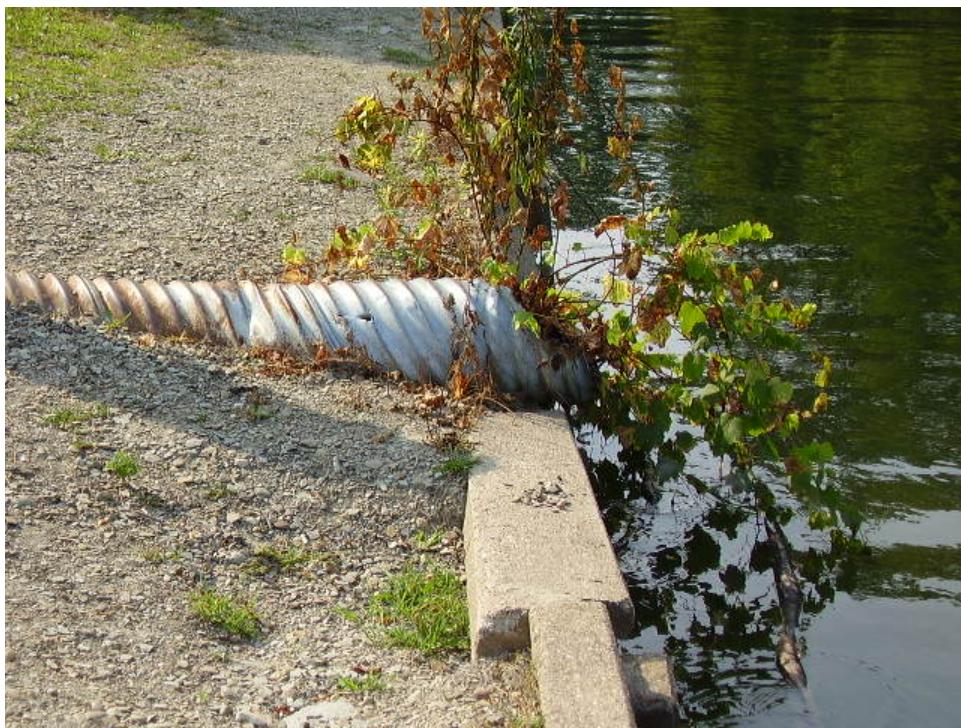
Photo 2 – Exposed Pipe, PFBC Manchester Facility

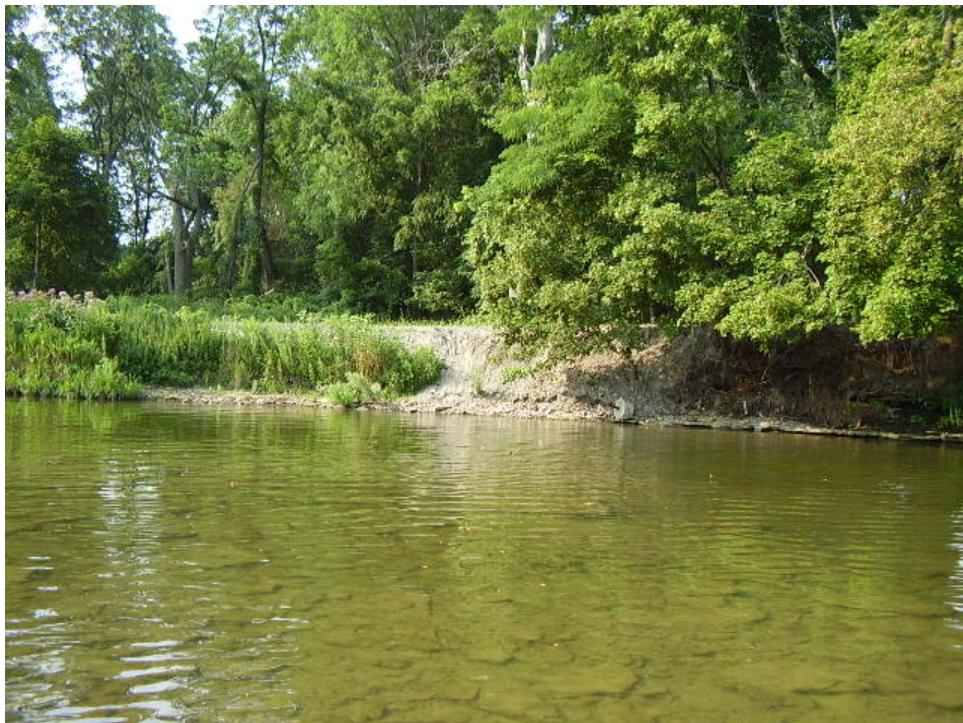
Photo 3 – Erosion Site, PFBC Manchester Facility

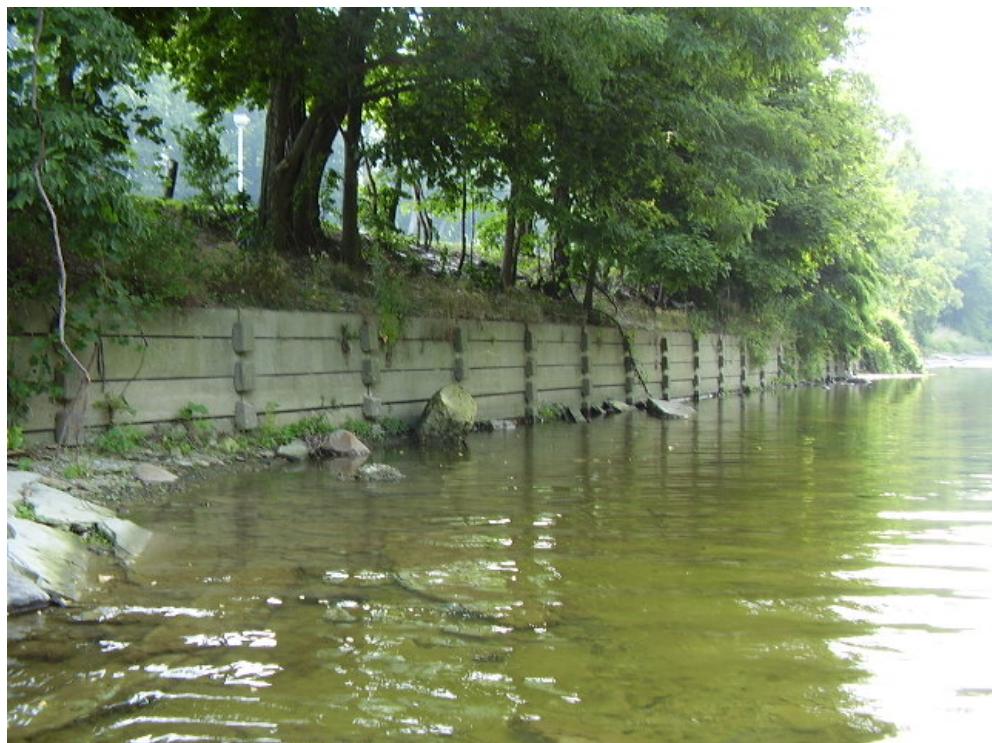
Photo 4 – Channel Alteration at 24 WC

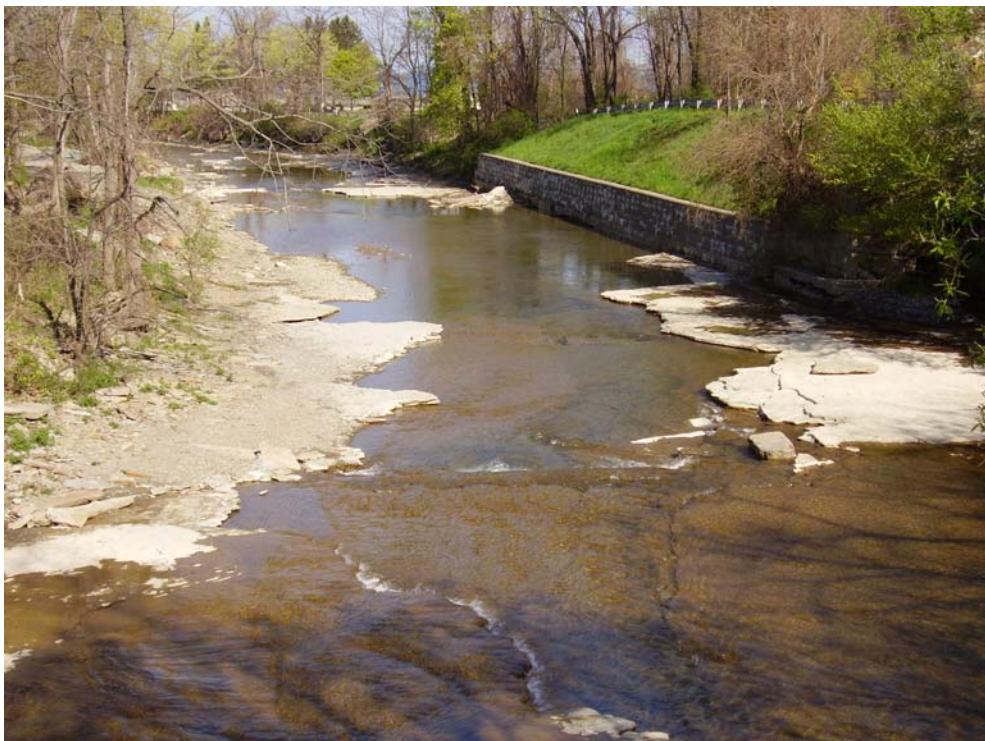
Photo 7 – Channel Alteration, Downstream Manchester Road Bridge

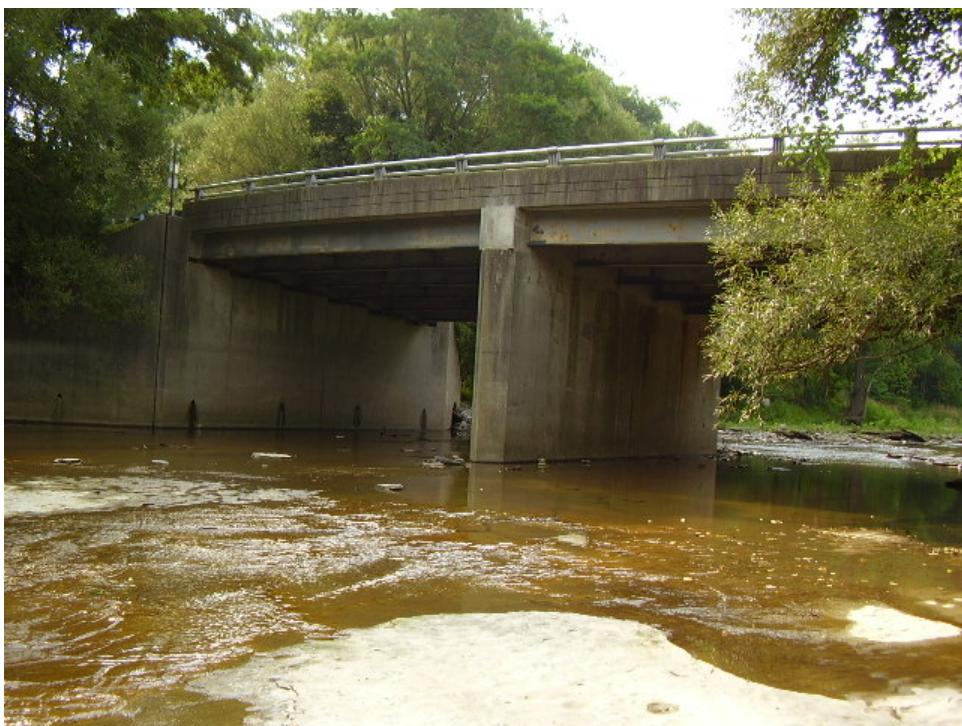
Photo 8 – Channel Alteration, Manchester Road Bridge

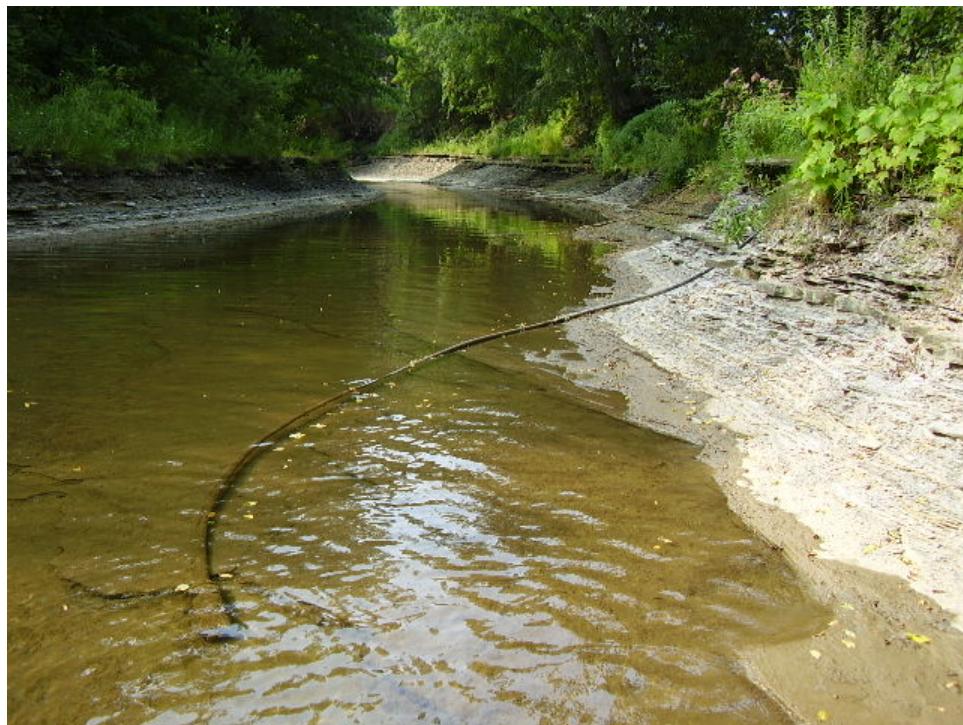
Photo 11 – Water Withdrawals / Encroachments , Upstream Manchester Rd. Bridge

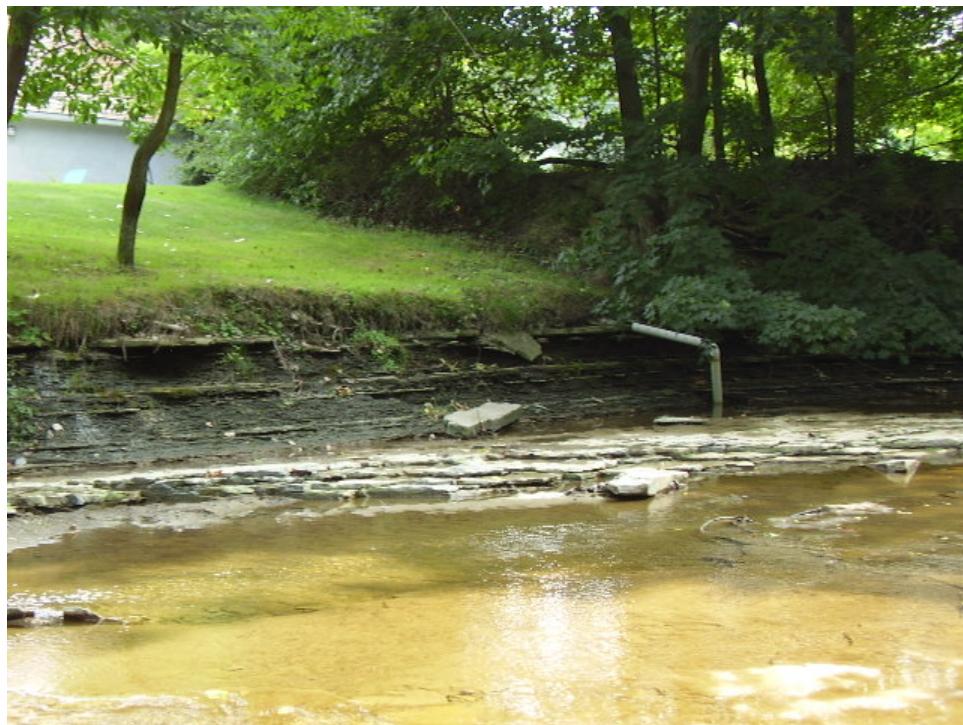
Photo 12 – Water Withdrawal/Inadequate Buffer, Upstream Manchester Rd. Bridge

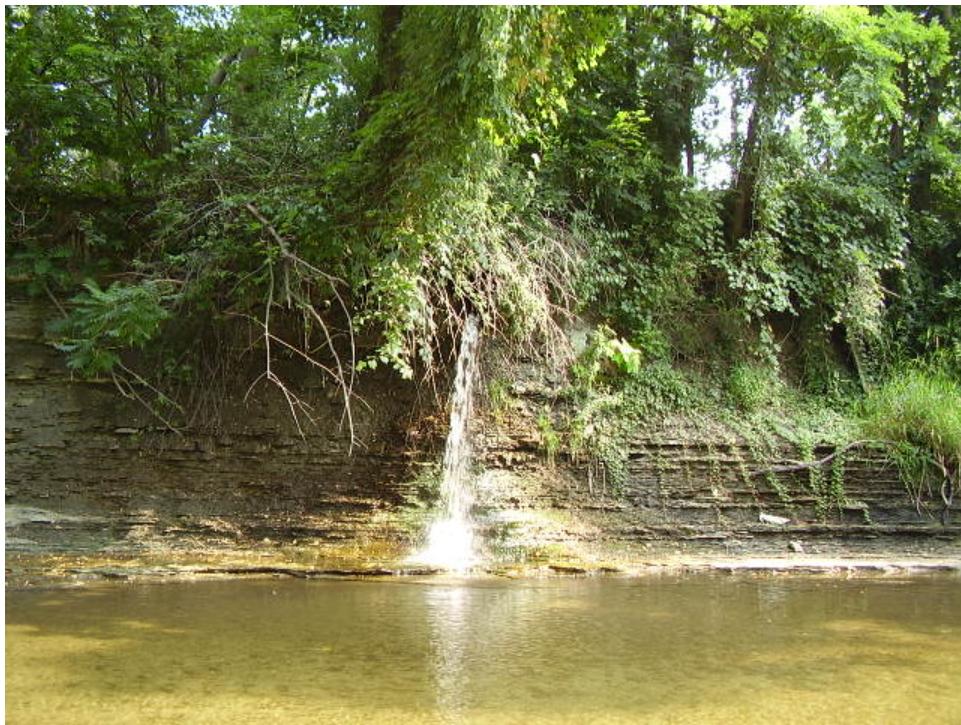
Photo 13 – Pipe Outfall, Upstream Manchester Rd. Bridge

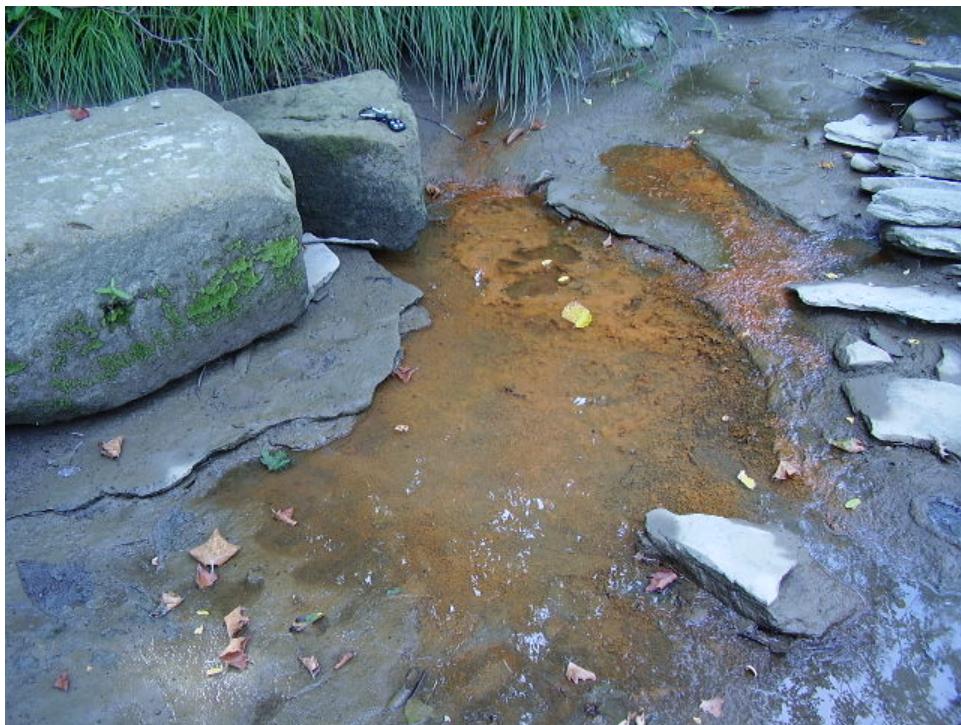
Photo 14 – Unusual Condition / Unidentified Seep, Upstream Manchester Rd. Bridge

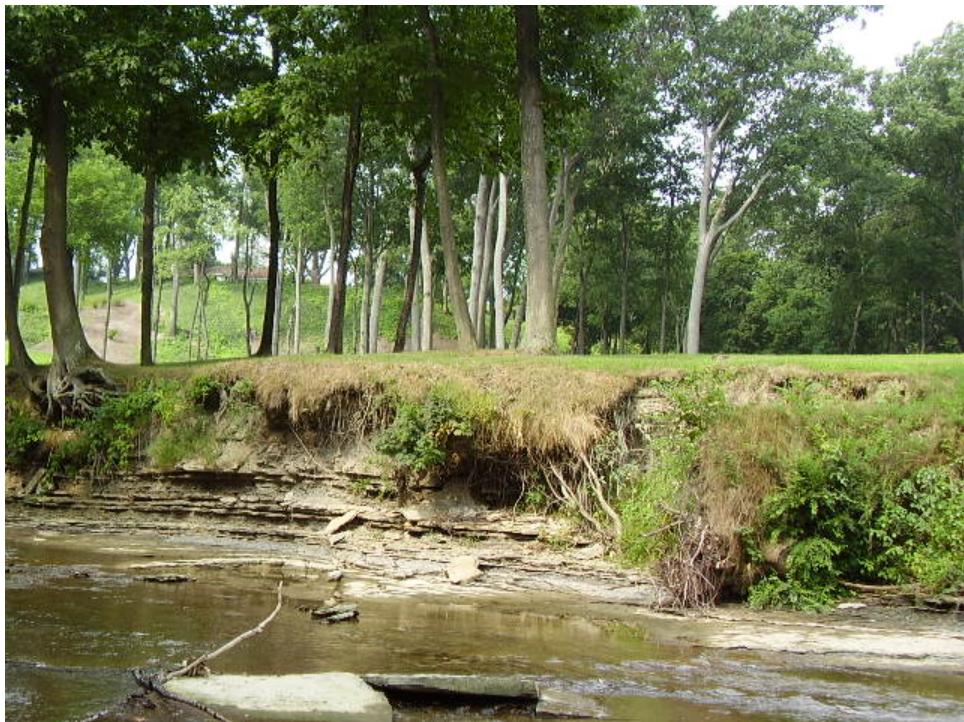
Photo 15 – Inadequate Buffer, Upstream Manchester Rd. Bridge

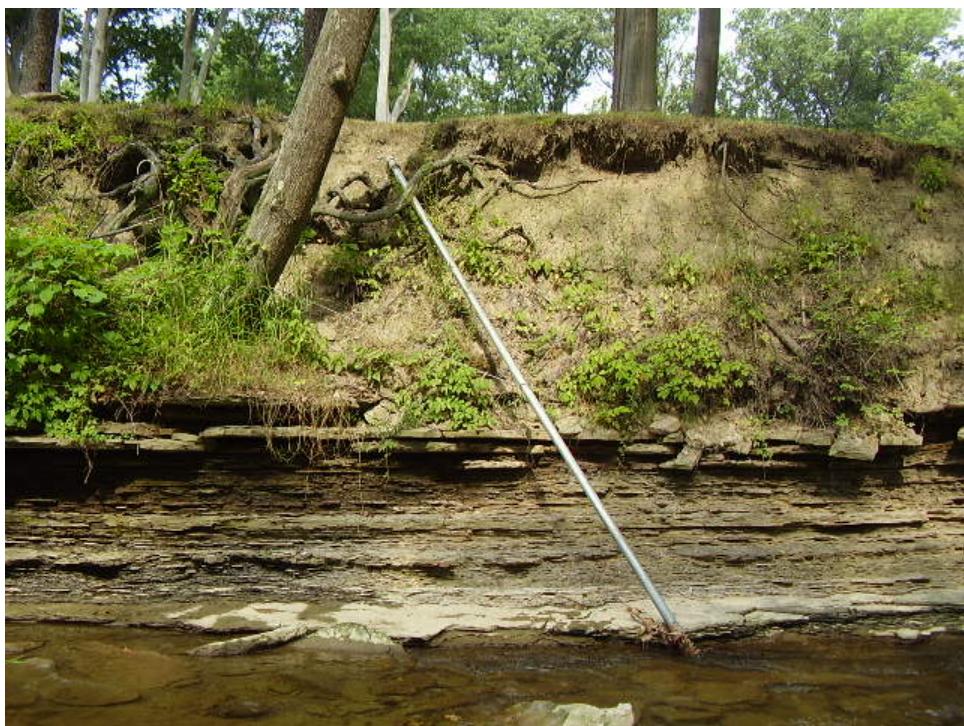
Photo 16 – Water Withdrawal / Inadequate Buffer Upstream Manchester Rd. Bridge

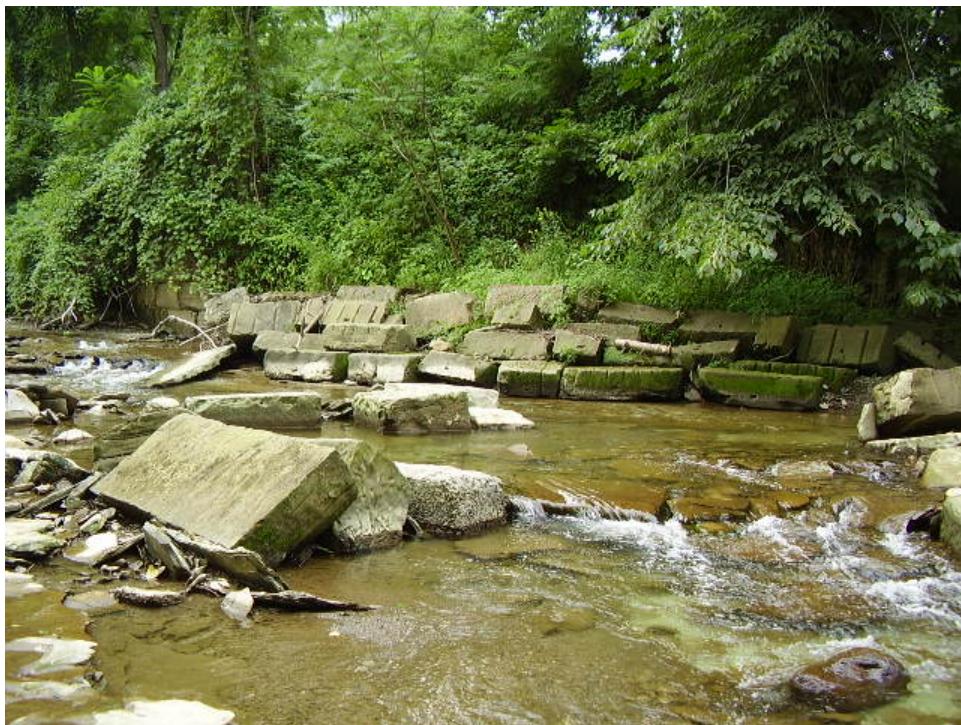
Photo 17 – Channel Alteration, Upstream Manchester Rd. Bridge

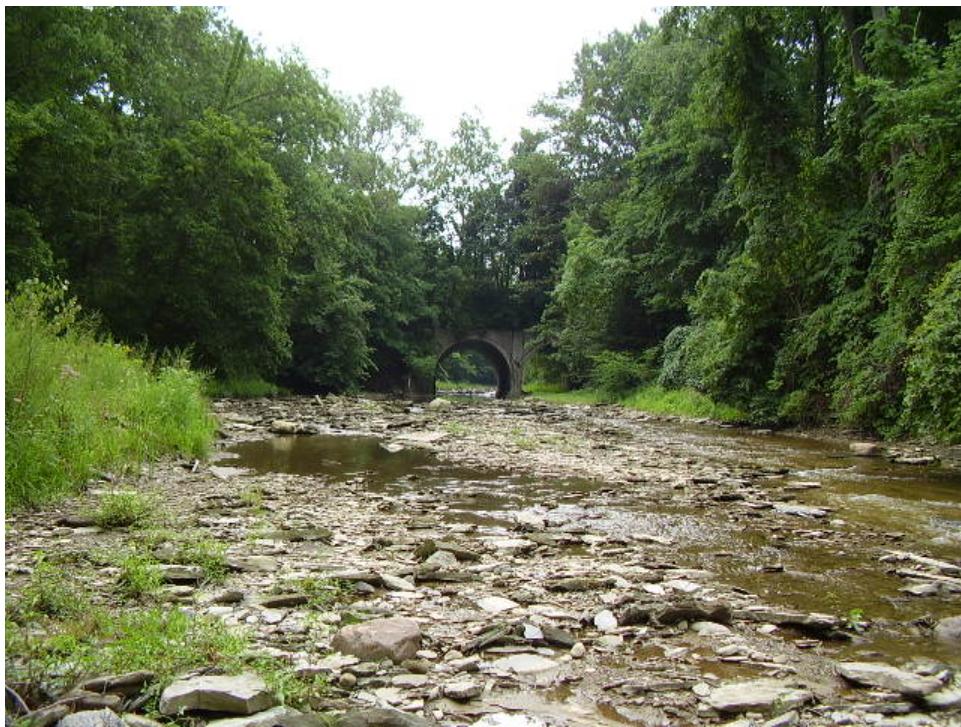
Photo 18 – Sedimentation, Downstream U.S. Highway 5 Bridge

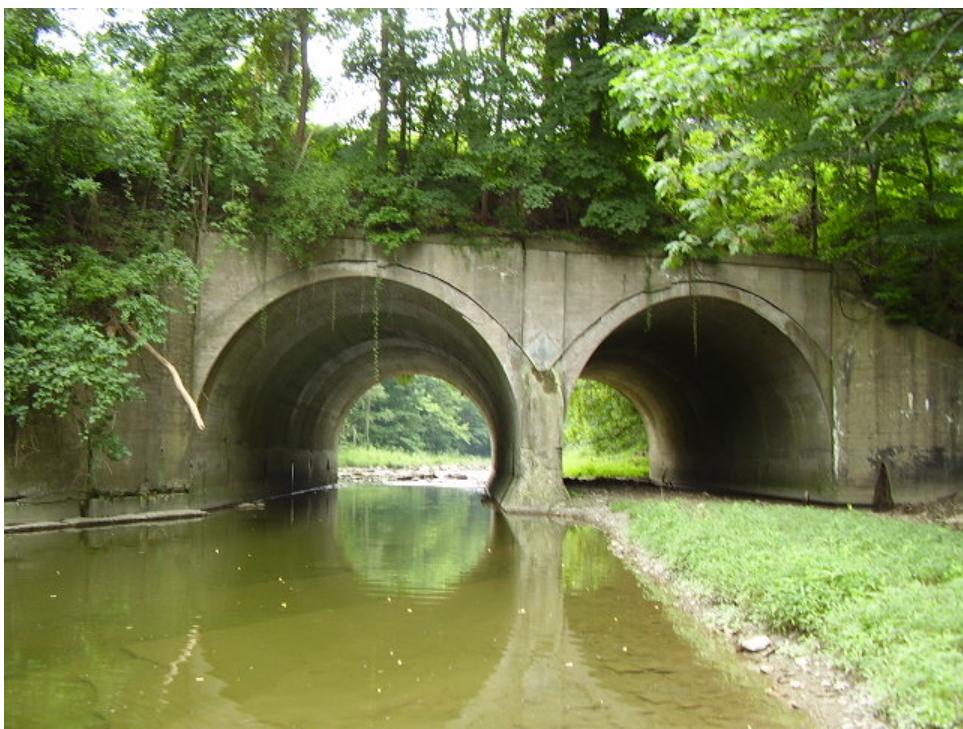
Photo 19 – Channel Alteration / Sedimentation, Downstream U.S. Highway 5 Bridge

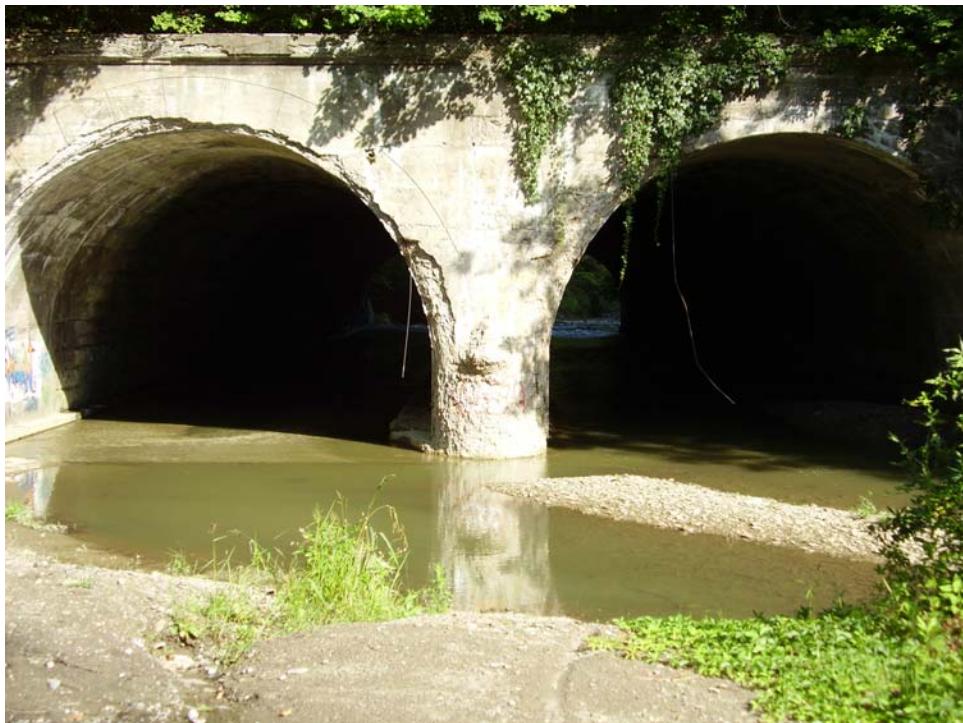
Photo 20 – Channel Alteration / Sedimentation, Downstream CSXT RR Bridge

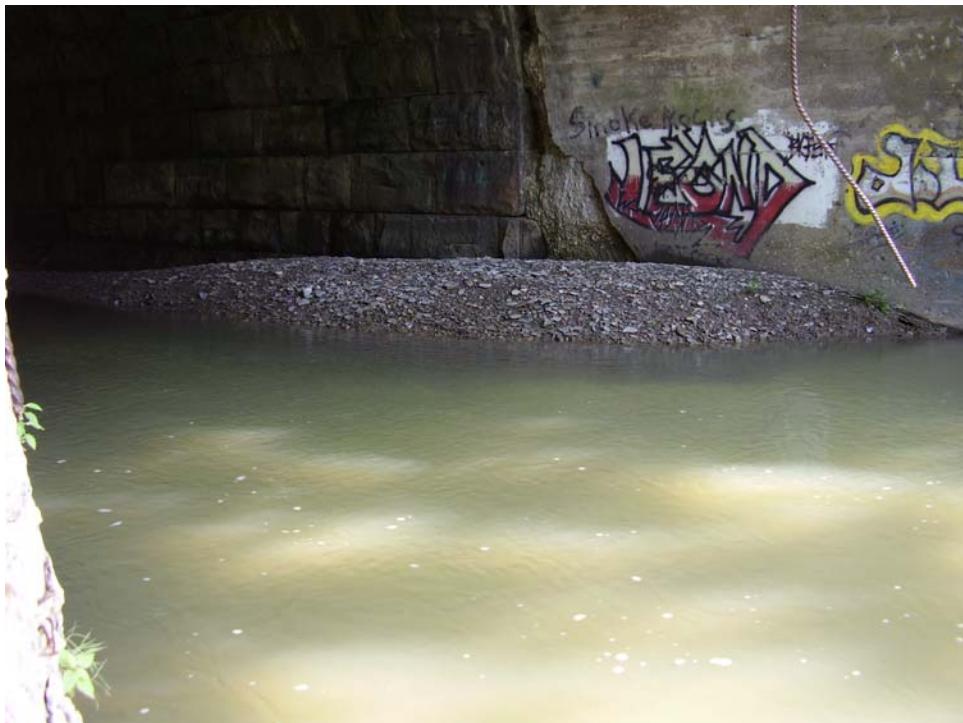
Photo 22 – Sedimentation, Downstream CSXT RR Bridge

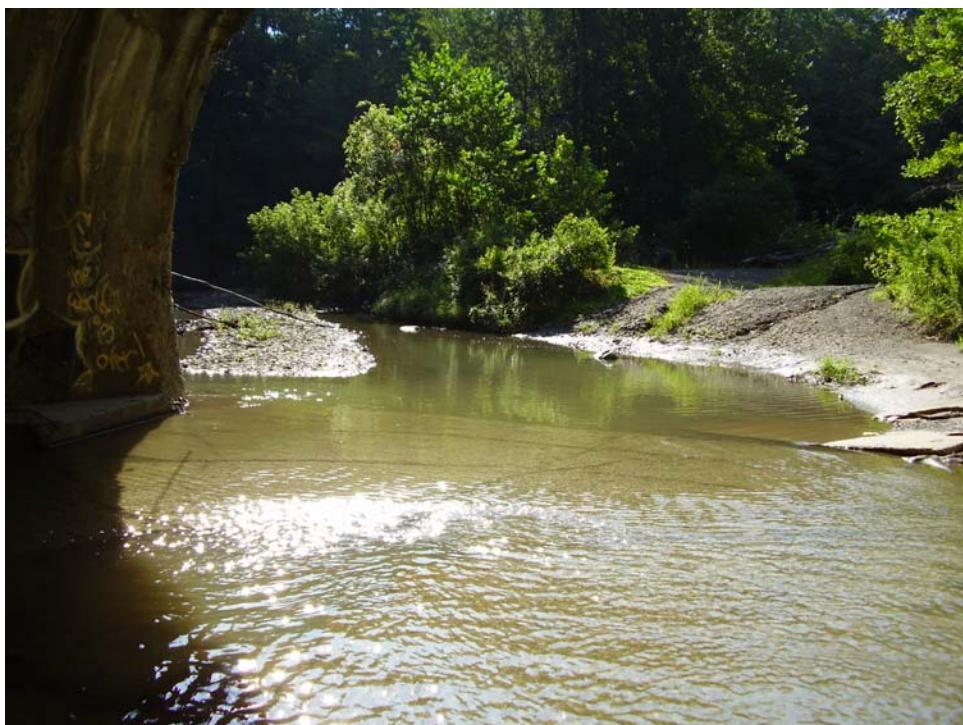
Photo 23 – Sedimentation, Downstream CSXT RR Bridge

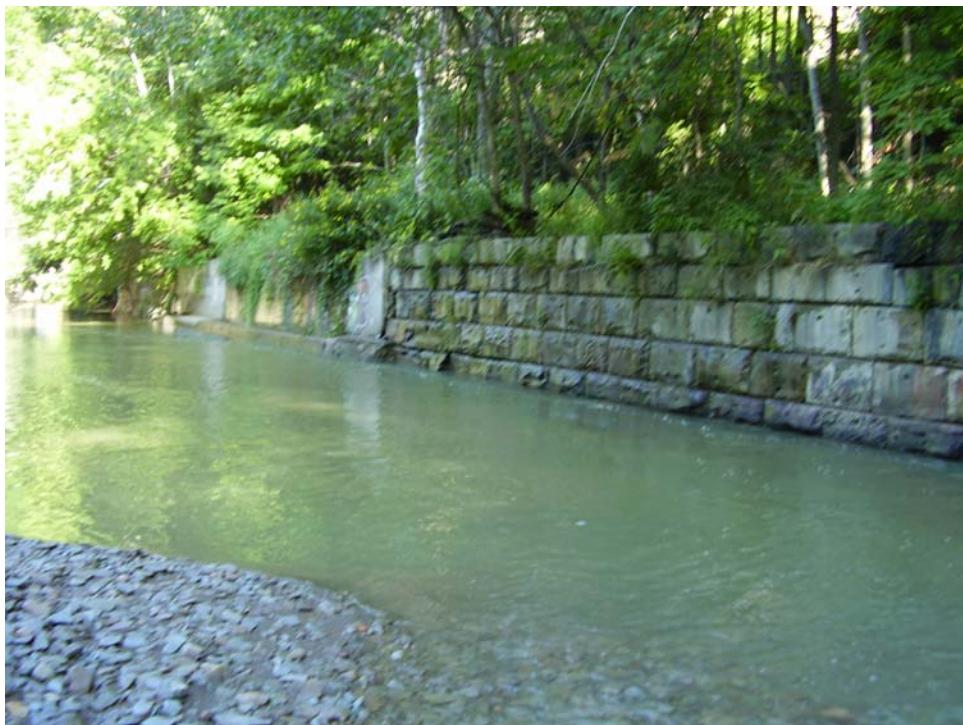
Photo 24 – Channel Alteration / Sedimentation, Downstream CSXT RR Bridge

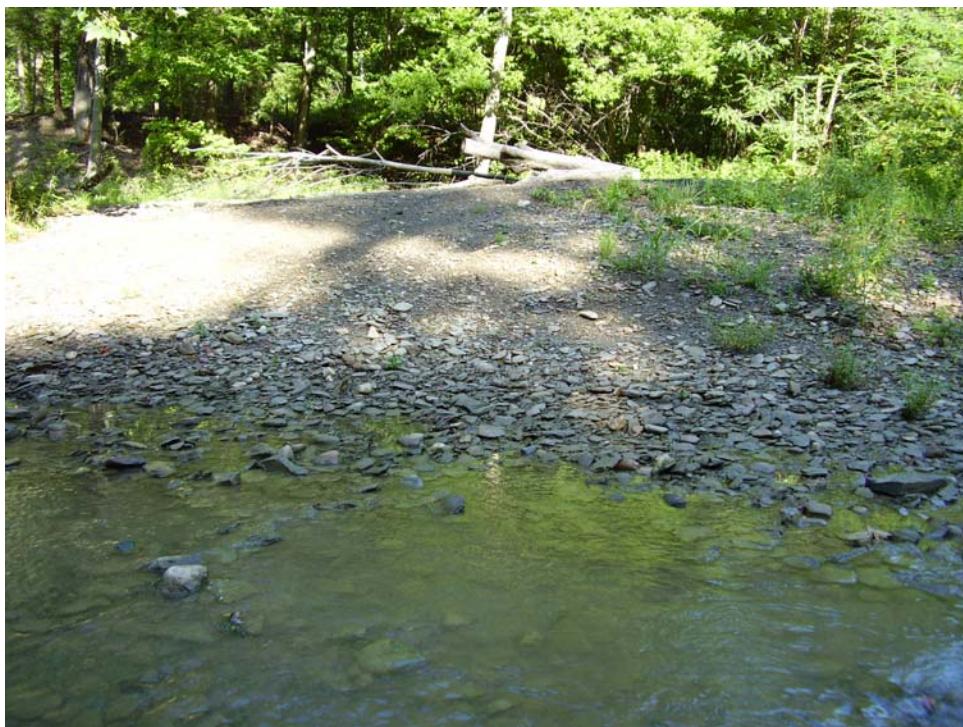
Photo 25 – Erosion / Sedimentation, Downstream CSXT RR Bridge

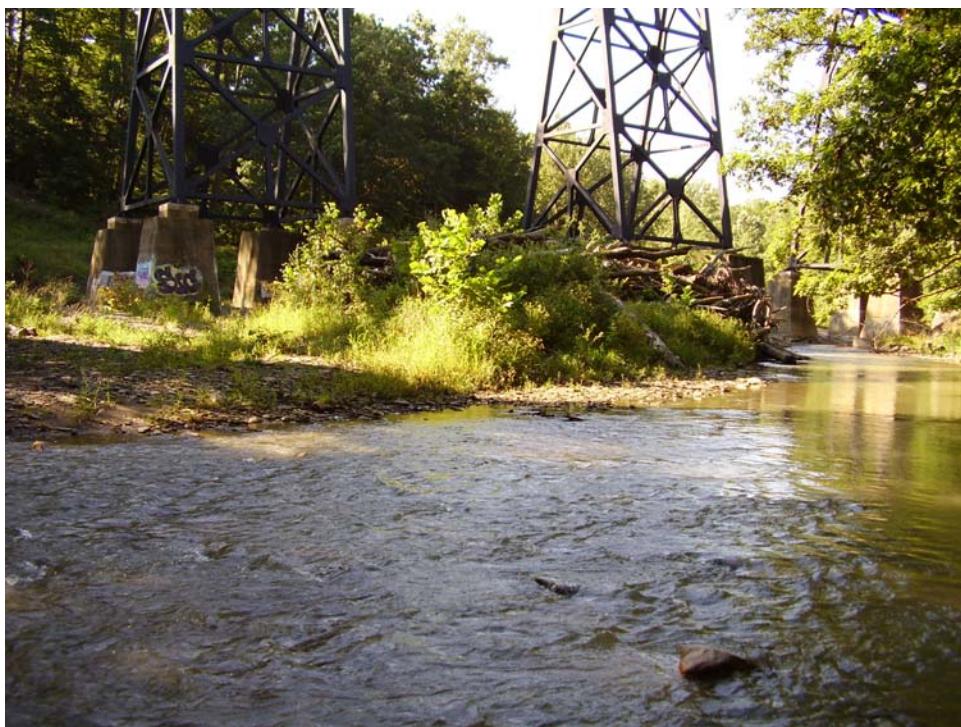
Photo 26- Sedimentation, Downstream Elevated CSXT RR Bridge

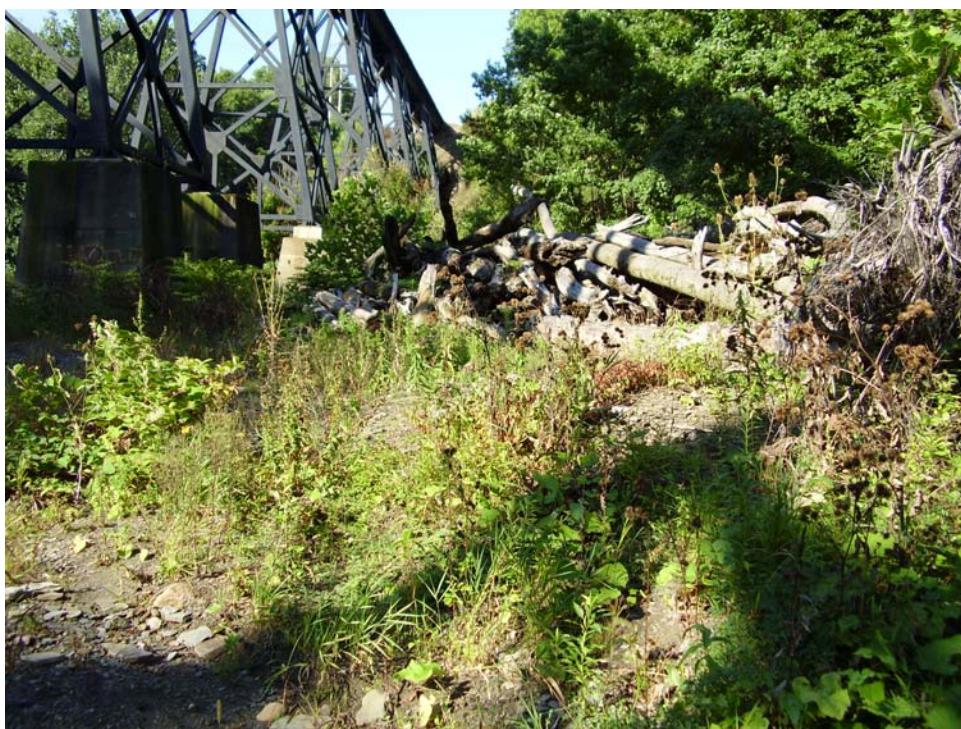
Photo 27 – Sedimentation / Debris Jam, Downstream Elevated CSXT RR Bridge

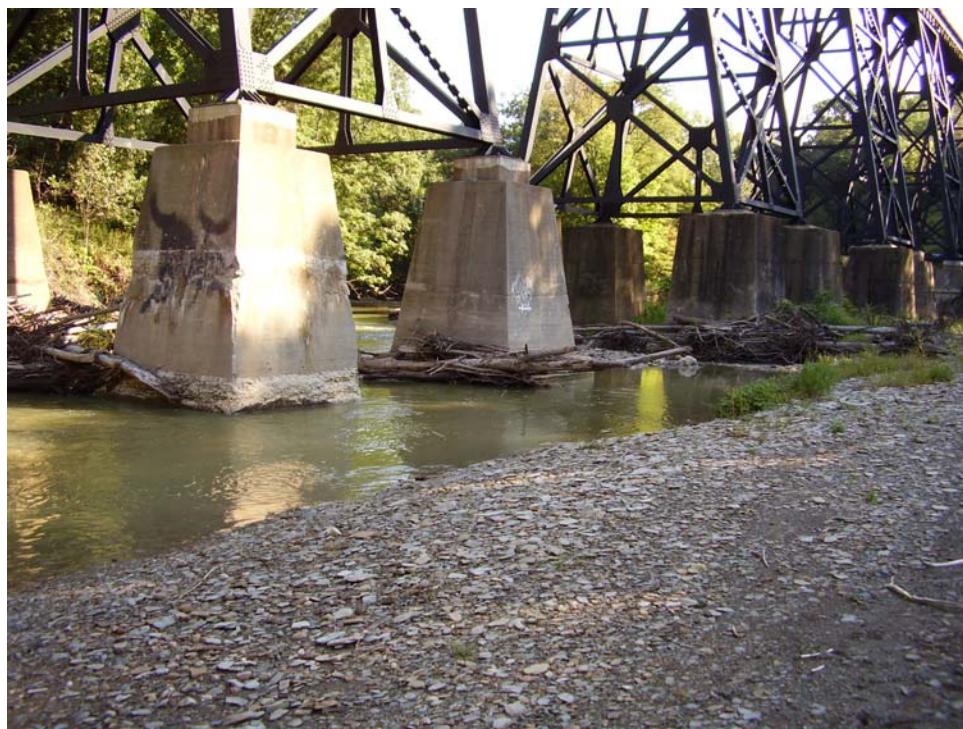
Photo 28 - Sedimentation/Debris Jam, Upstream Elevated CSXT RR Bridge

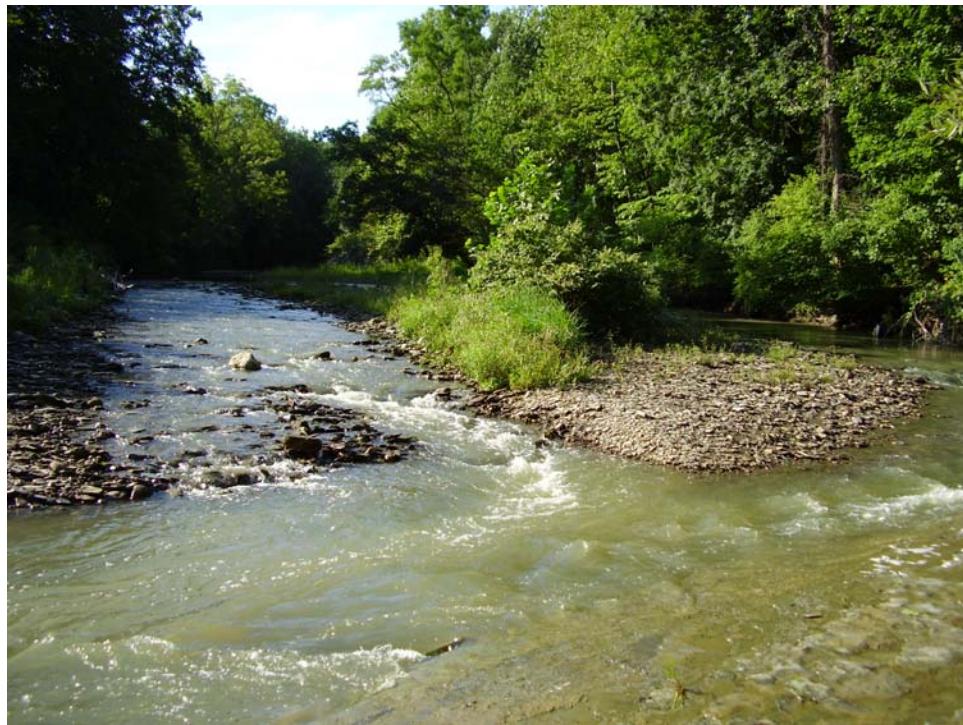
Photo 29 – Sedimentation, Upstream Elevated CSXT RR Bridge

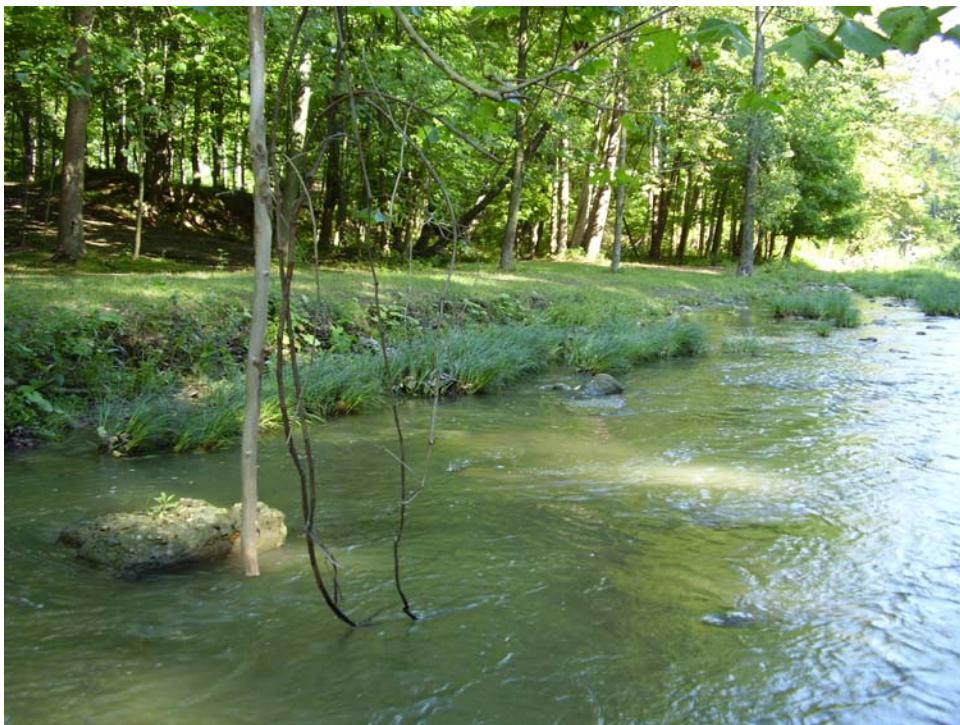
Photo 30 – Inadequate Buffer, Upstream Elevated CSXT RR Bridge

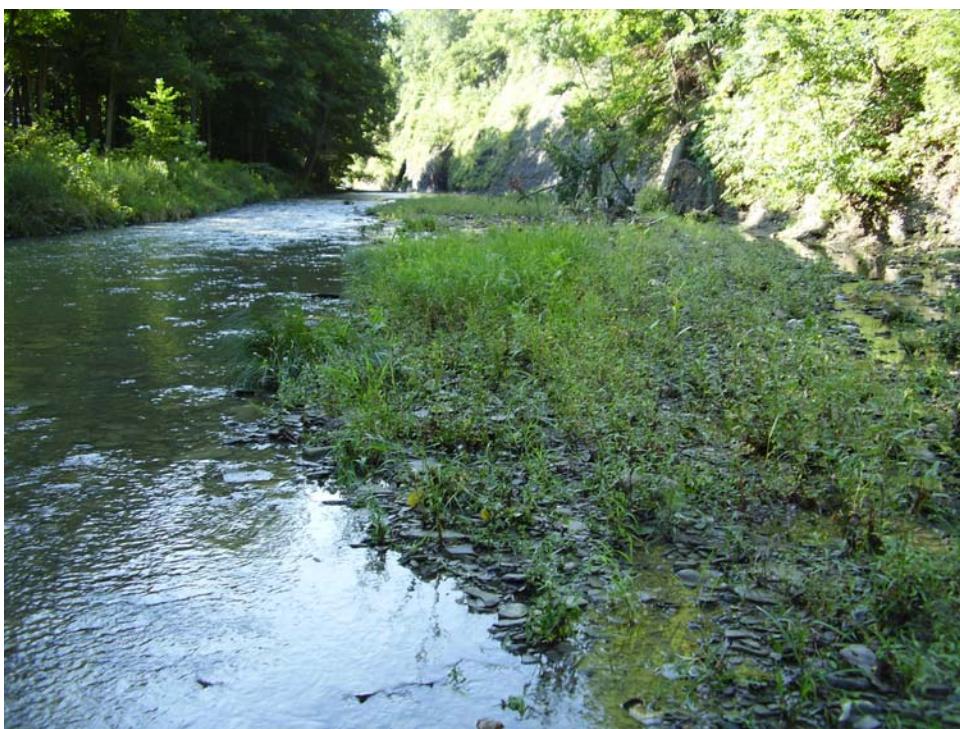
Photo 31 – Sedimentation, Upstream Elevated CSXT RR Bridge

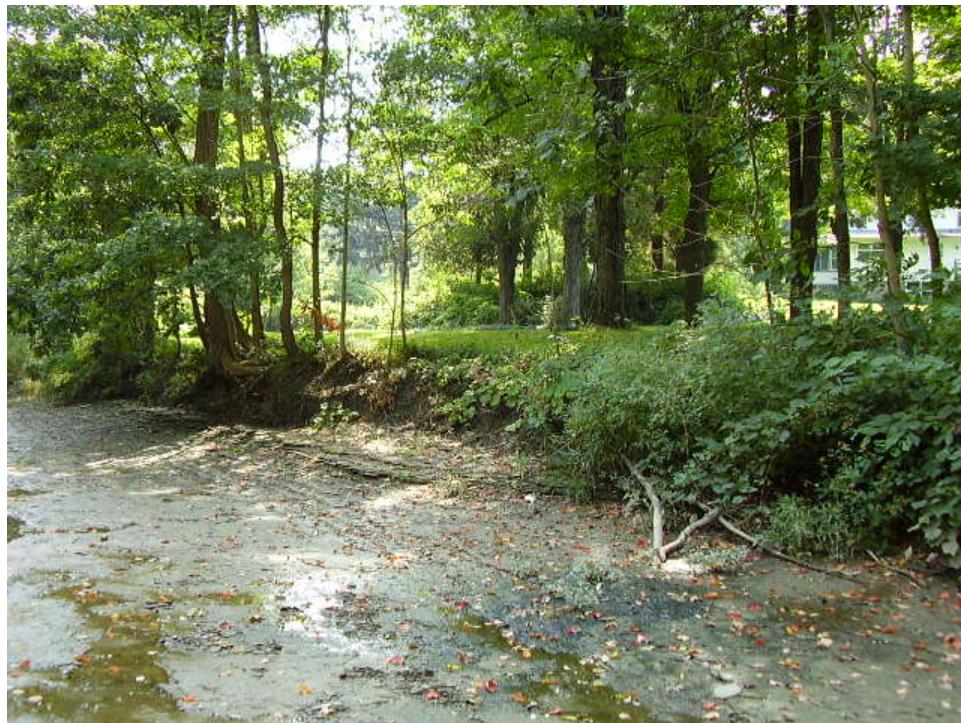
Photo 32 – Inadequate Buffer, Downstream Millfair Road Bridge

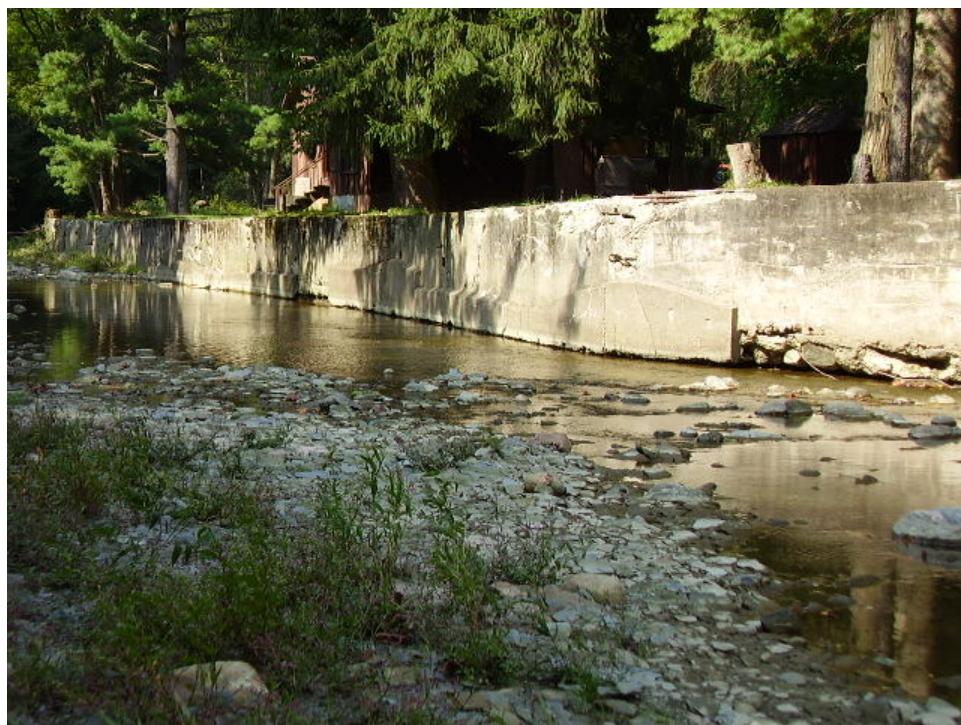
Photo 33 – Channel Alteration, Downstream Millfair Road Bridge

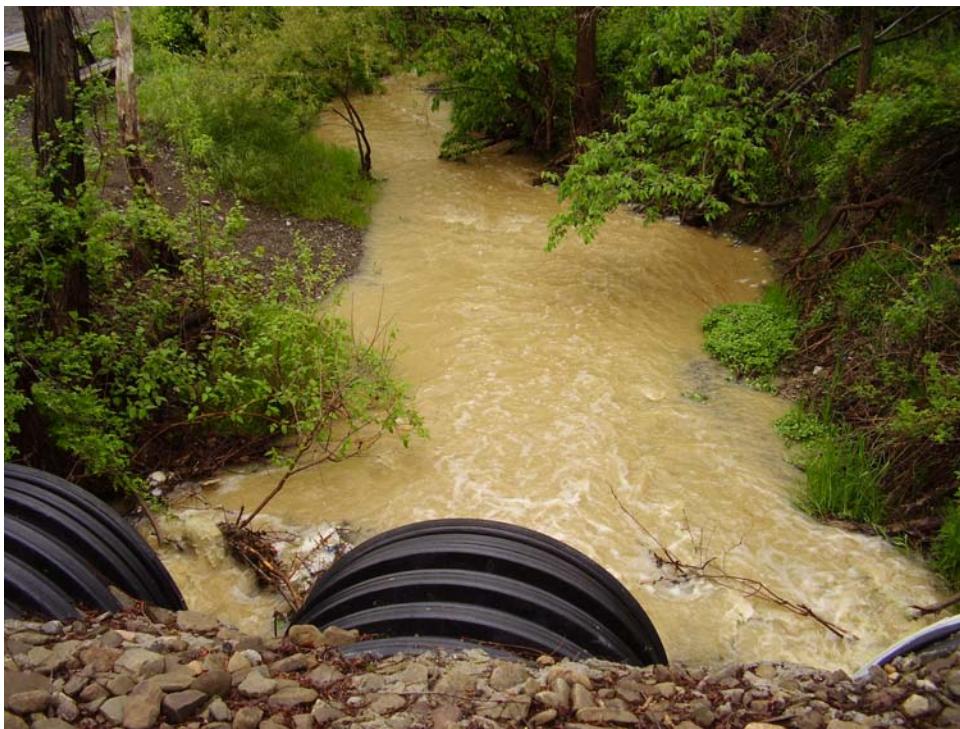
Photo 34 – Channel Alteration 20UNT

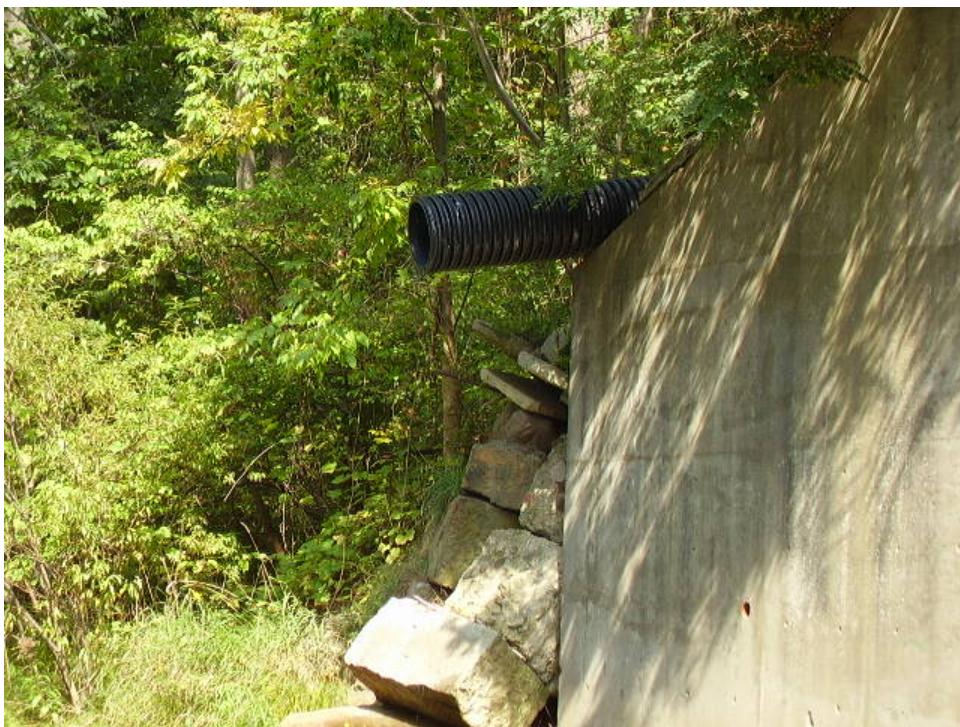
Photo 35 – Channel Alteration / Pipe Outfall, Downstream Millfair Road Bridge

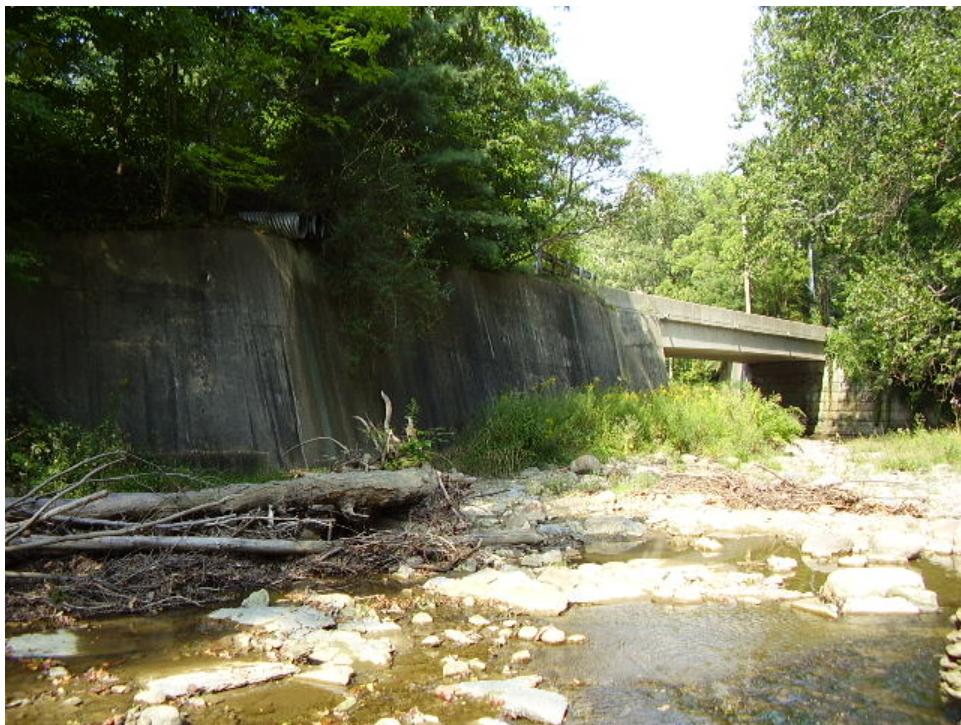
Photo 36 – Channel Alteration, Upstream Millfair Road Bridge

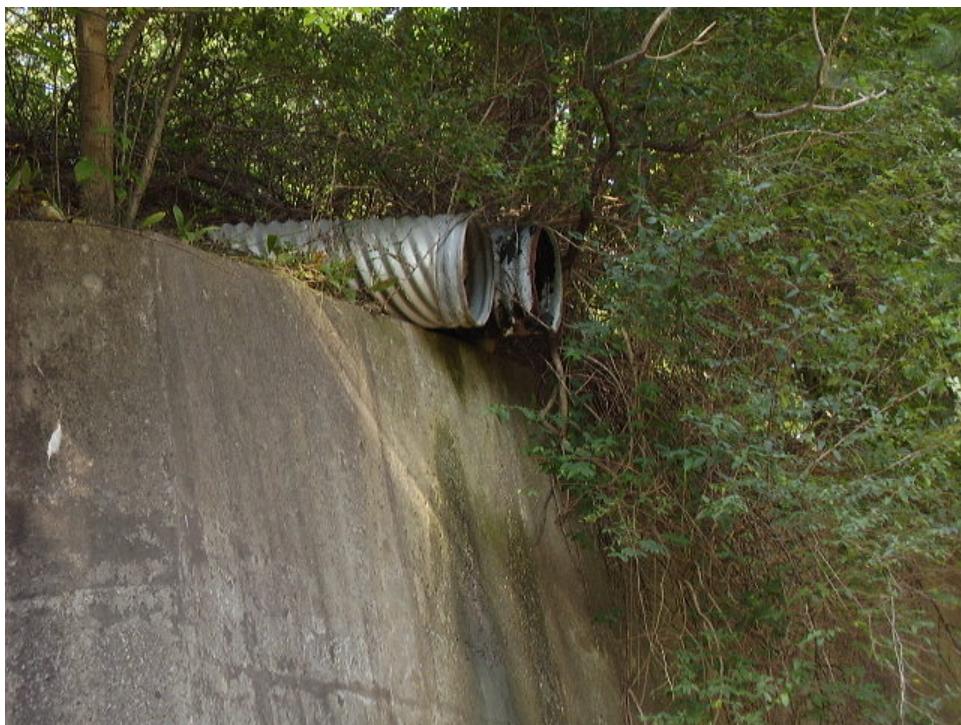
Photo 37 – Pipe Outfall, Upstream Millfair Road Bridge
