APPENDIX D STREAM CORRIDOR ASSESSMENT

DEP staff conducted a walking survey of portions of Walnut Creek, using the Stream Corridor Assessment (SCA) survey protocols, developed by the State of Maryland - Department of Natural Resources, as a guide. These protocols are intended as a rapid assessment tool to identify potential environmental problems, such as:

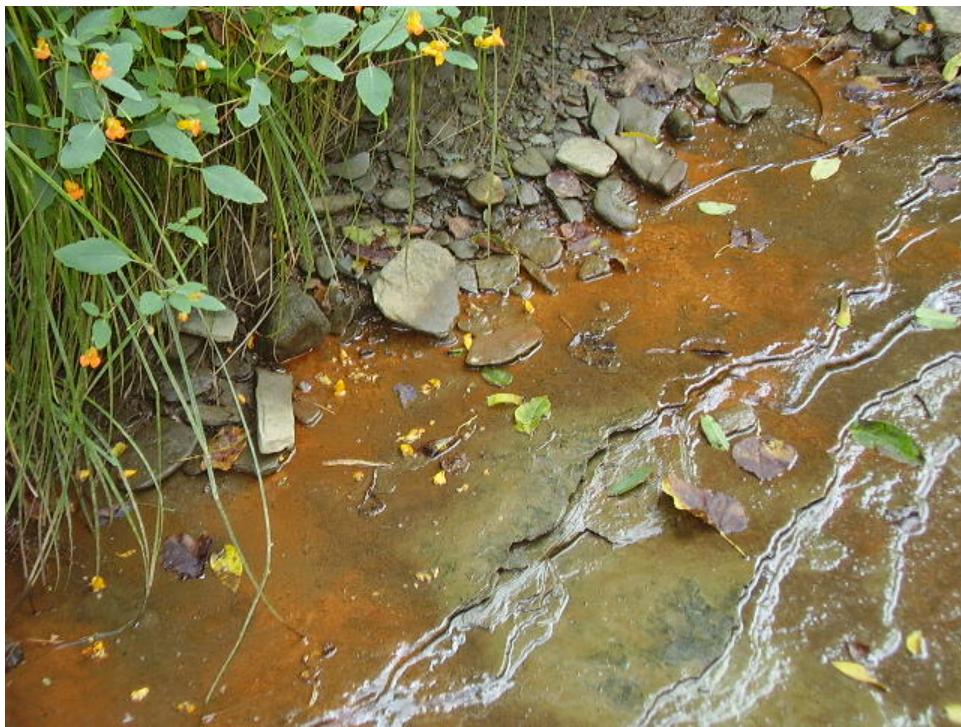
Photo 38 – Unusual Condition / Unidentified Seep, Upstream Millfair Road Bridge

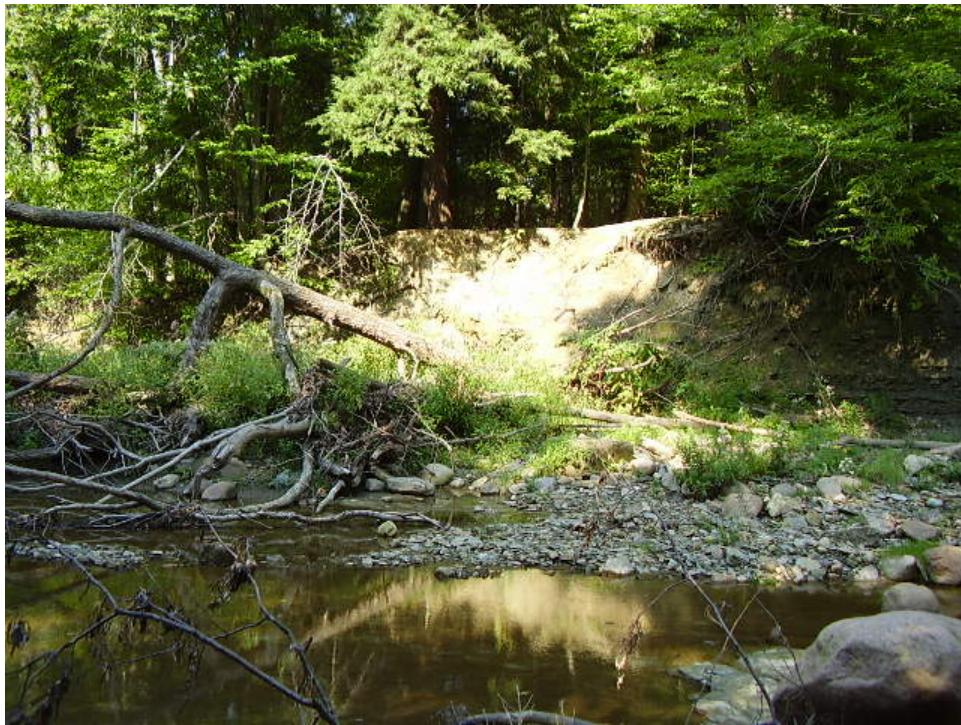
Photo 39 Erosion Site, Upstream Millfair Road Bridge

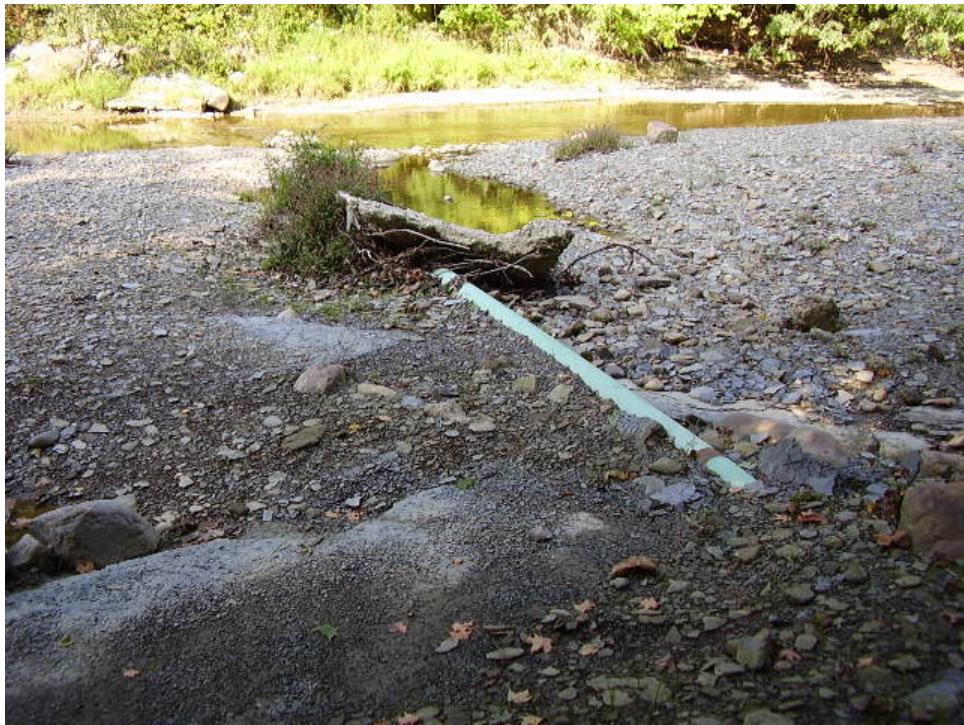
Photo 40 – Exposed Pipe, Upstream Millfair Road Bridge

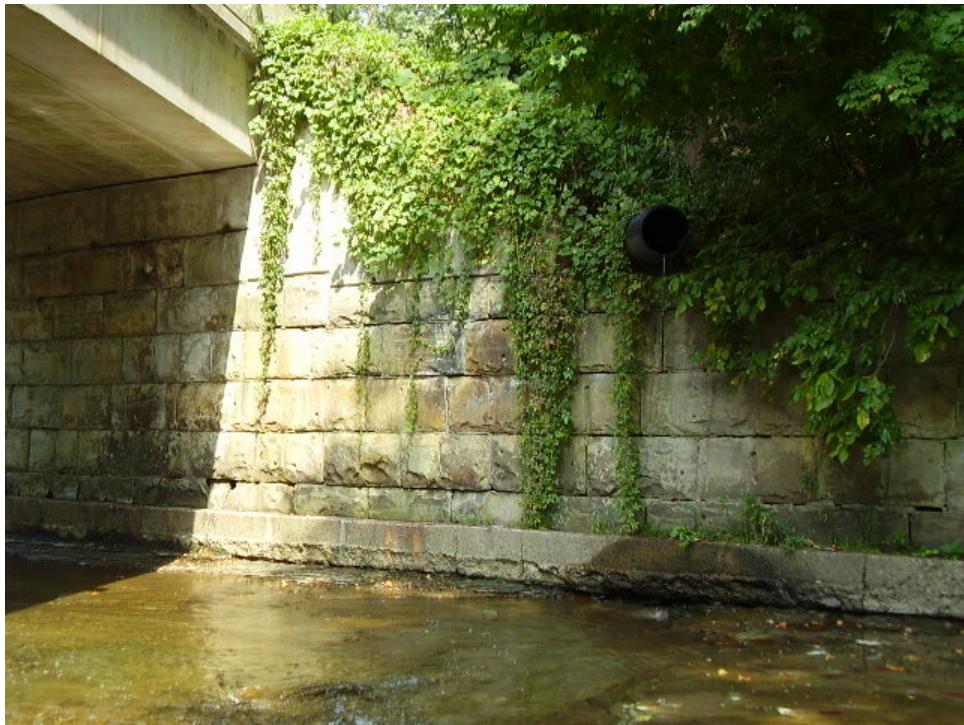
Photo 41 – Channel Alteration, Upstream Millfair Road Bridge

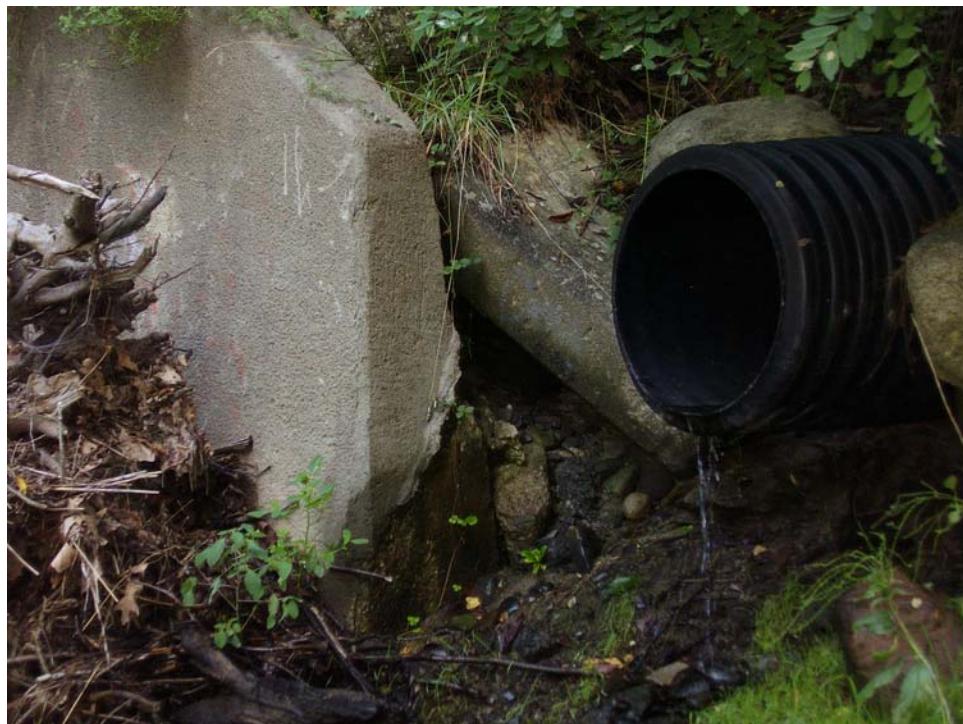
Photo 43 – Pipe Outfall, Upstream Old Sterritania Road Bridge

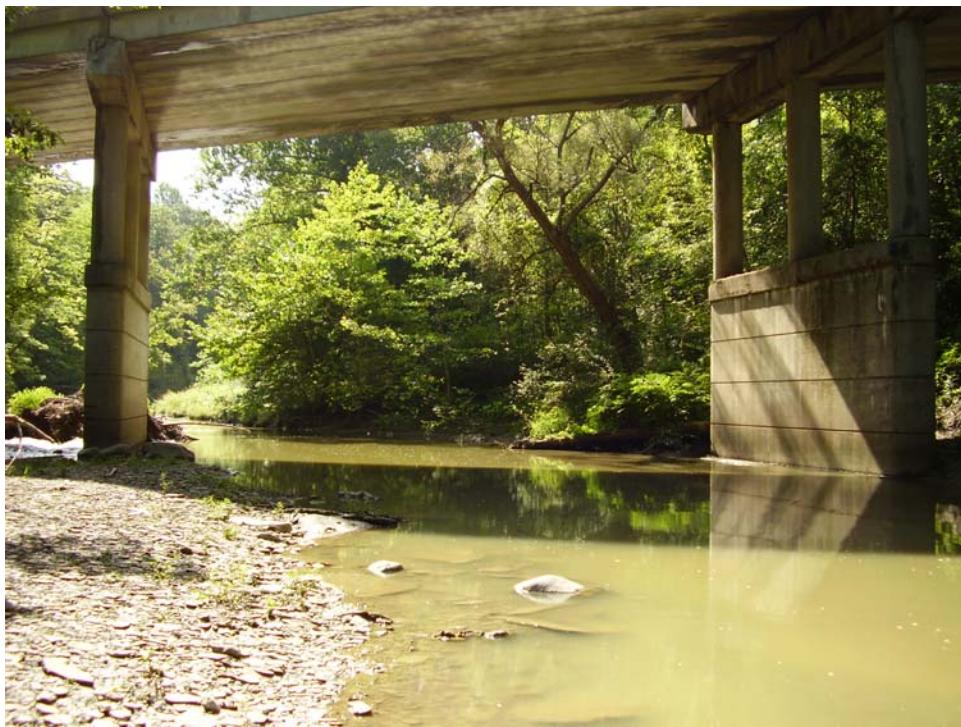
Photo 44 Channel Alteration, Upstream Old Sterritania Road Bridge

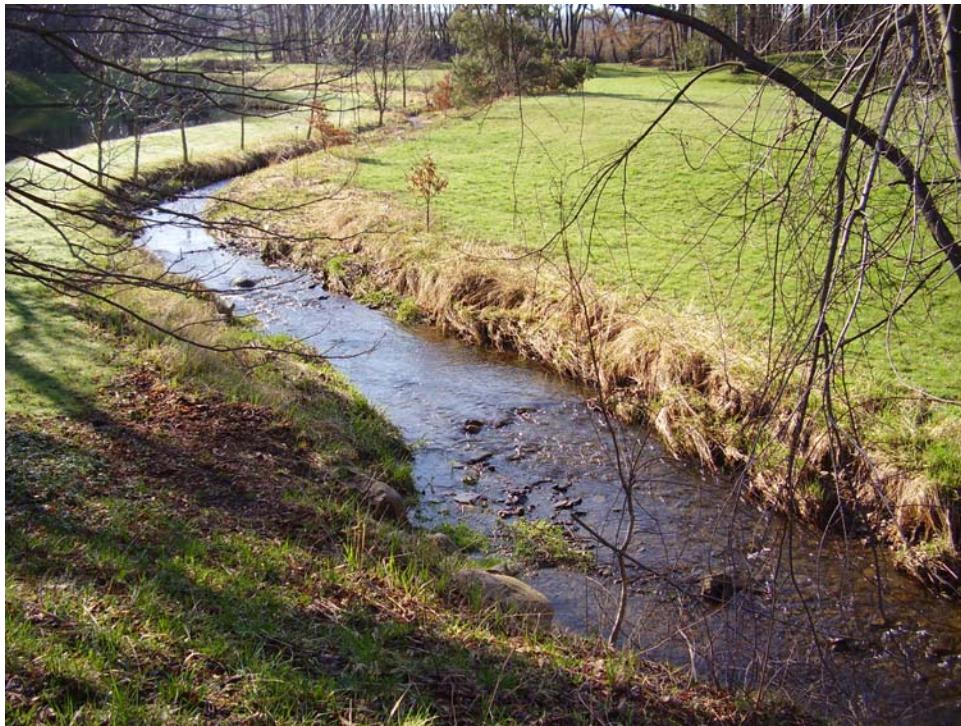
Photo 45 Lake of Riparian Buffer at 17TR

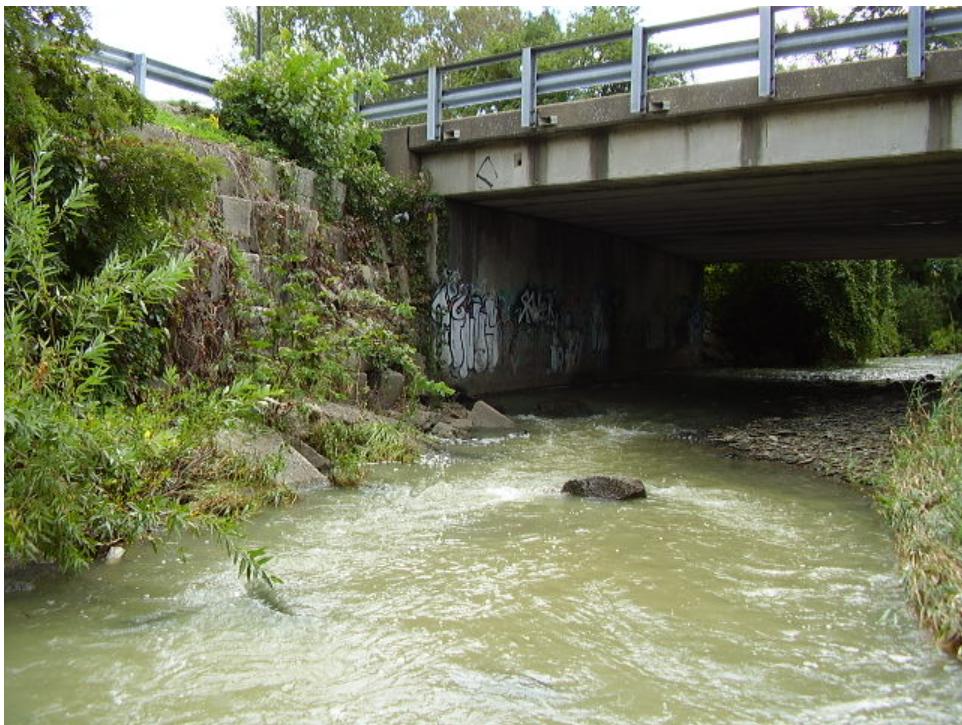
Photo 46 – Channel Alteration, Downstream Peach Street Bridge Crossing

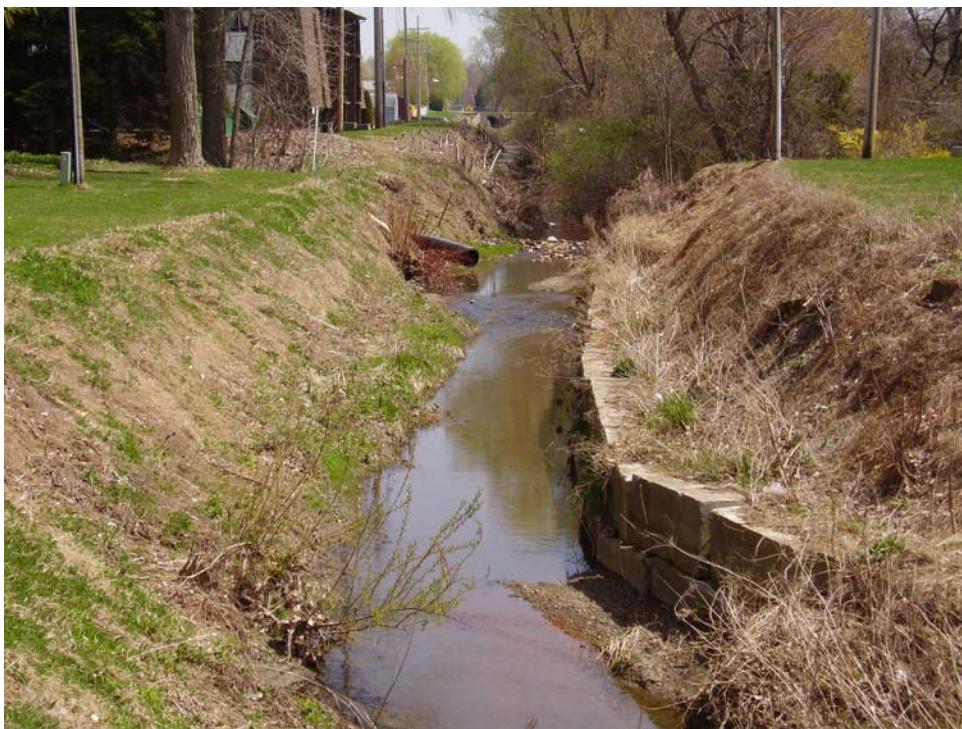
Photo 47 – Channel Modification/No buffer (12UNT)

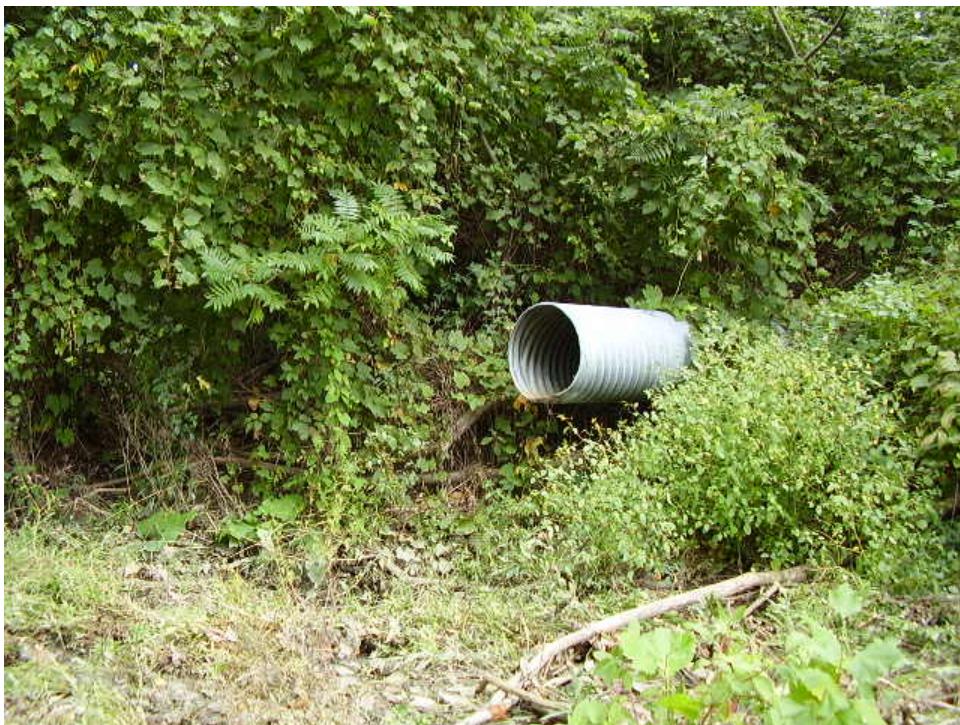
Photo 48 – Pipe Outfall, Downstream Peach Street Bridge Crossing

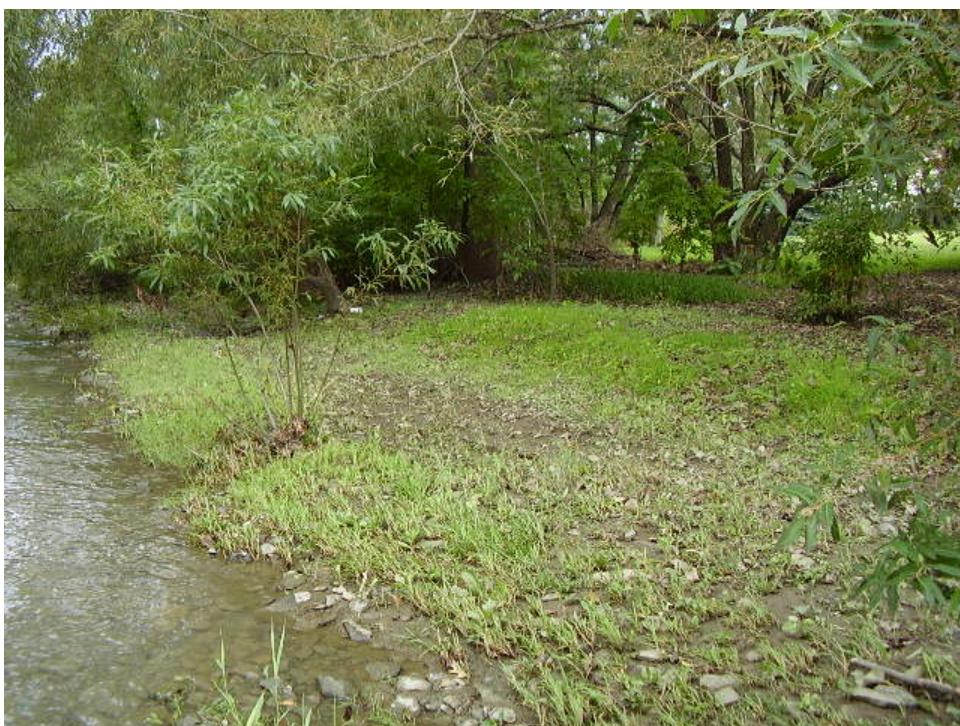
Photo 49 – Inadequate Buffer, Downstream Peach Street Bridge Crossing

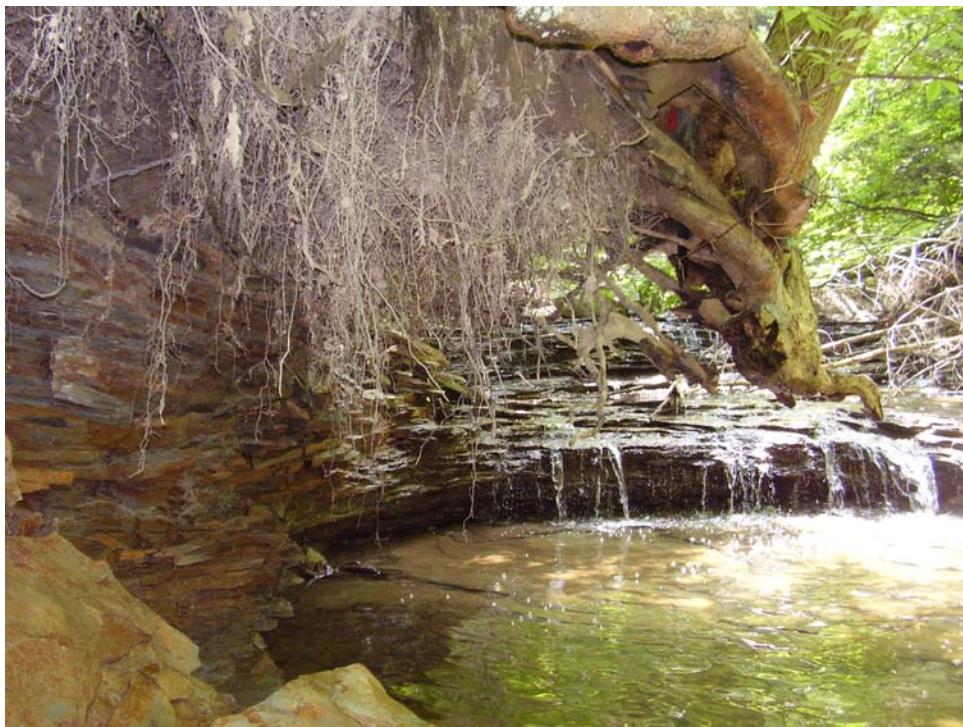
Photo 52 Erosion site 9UNT

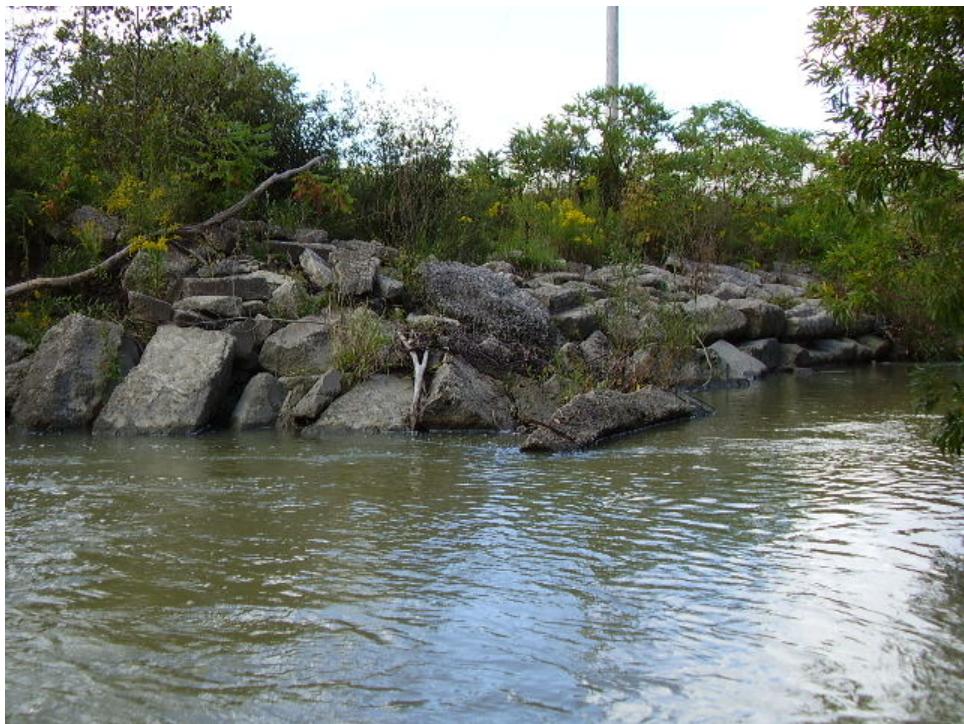
Photo 53 – Channel Alteration, Downstream Peach Street Bridge Crossing

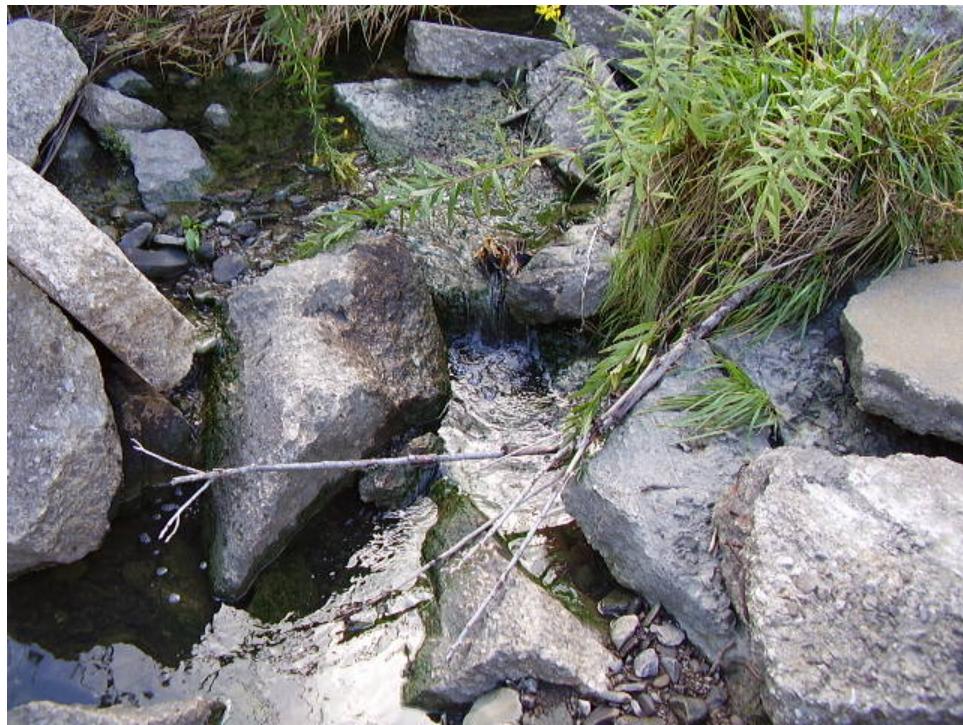
Photo 54 – Fill Material, Downstream Peach Street Bridge Crossing

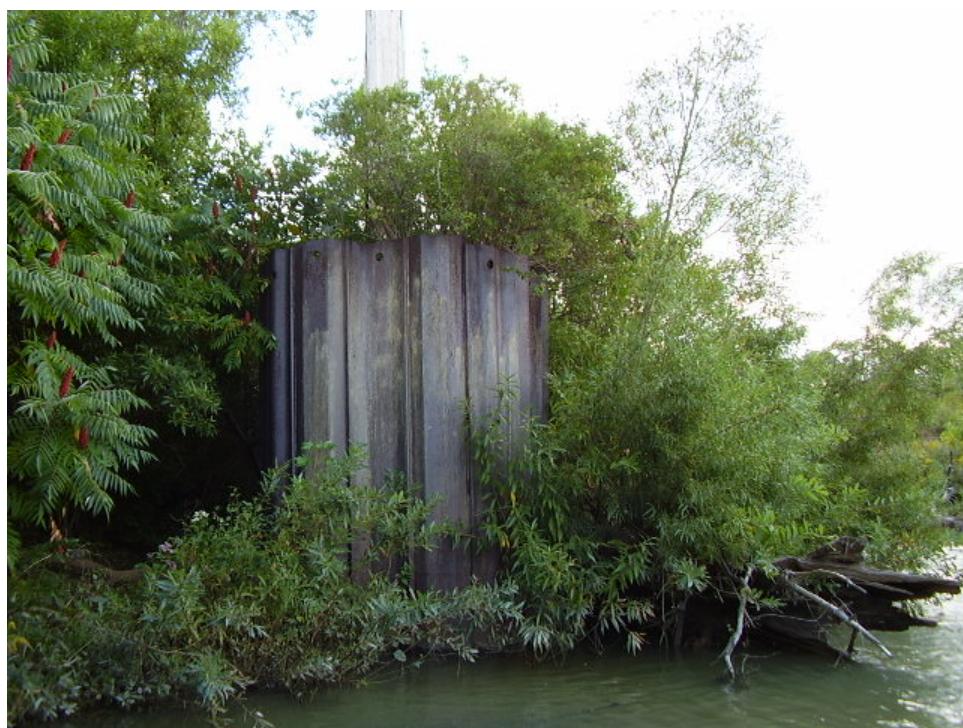
Photo 55 – Channel Alteration, Downstream Peach Street Bridge Crossing

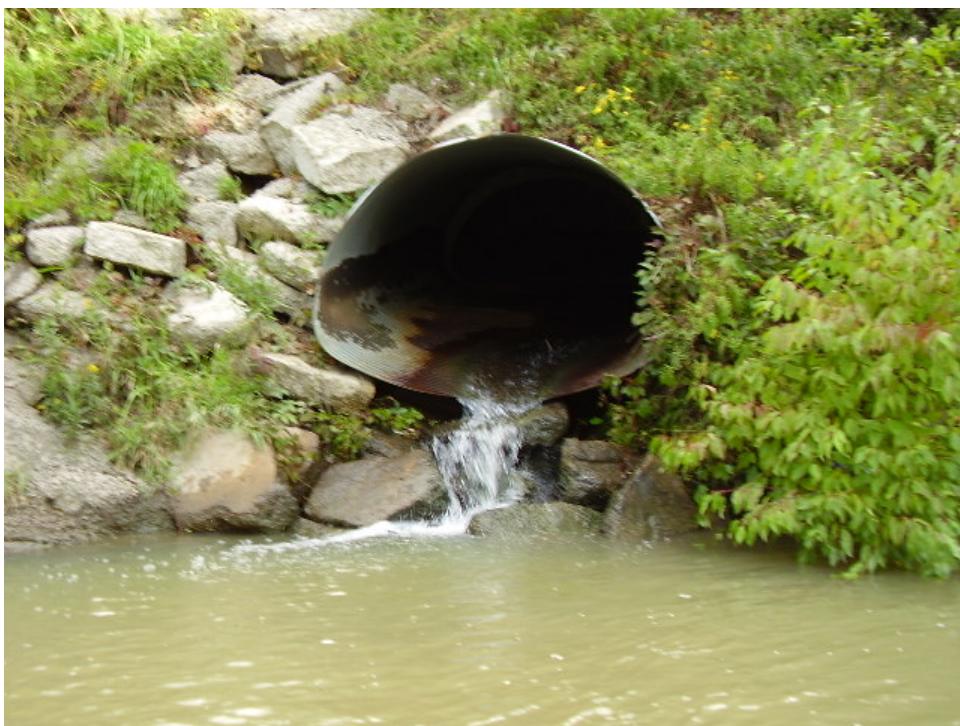
Photo 59 – Pipe Outfall, Downstream Peach Street Bridge Crossing

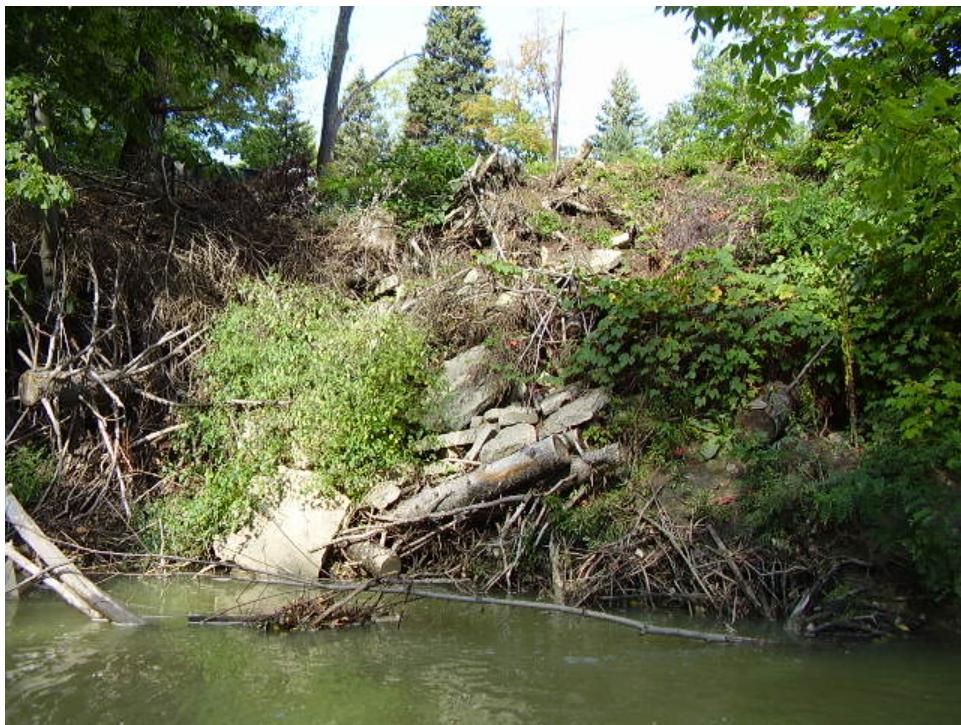
Photo 60 – Fill, Downstream Peach Street Bridge Crossing

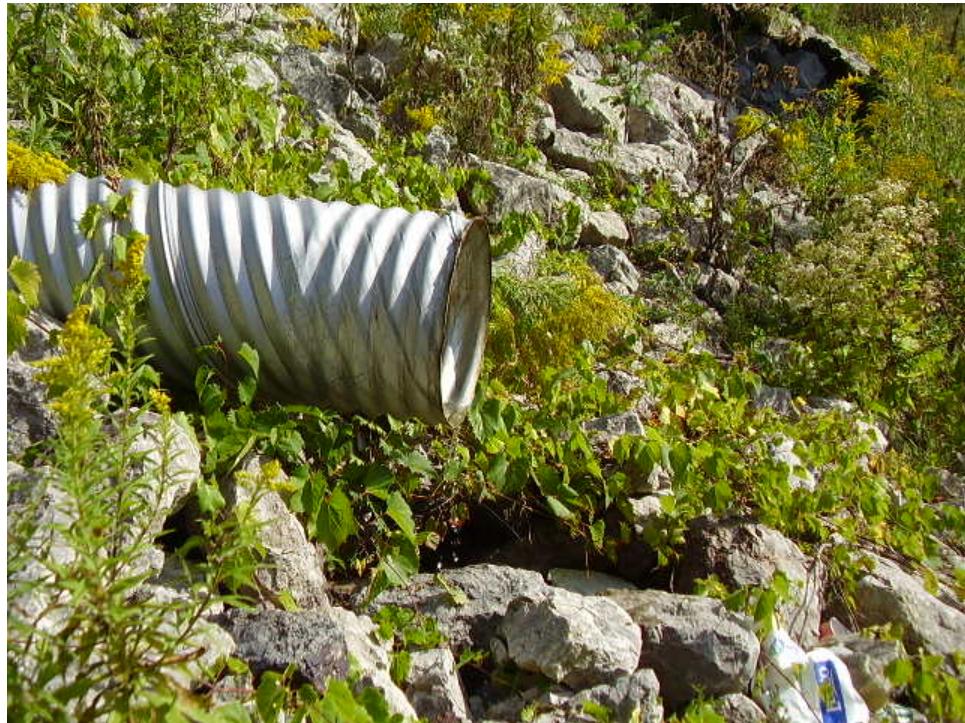
Photo 62 – Pipe Outfall, Interstate 79 Bridge Crossing

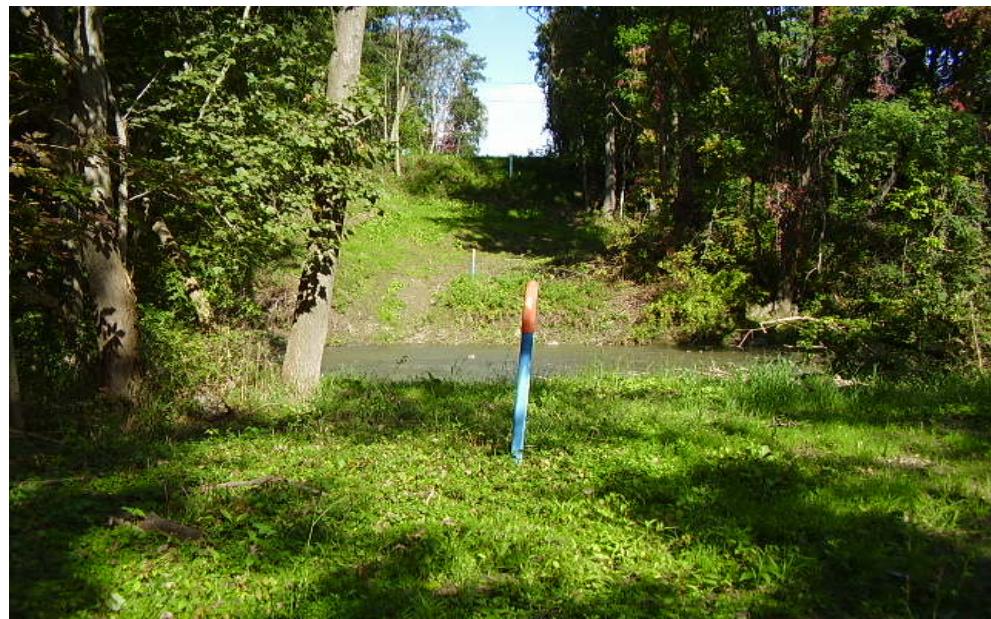
Photo 63 – Inadequate Buffer / Erosion Site, Downstream Interstate 79 Bridge Crossing

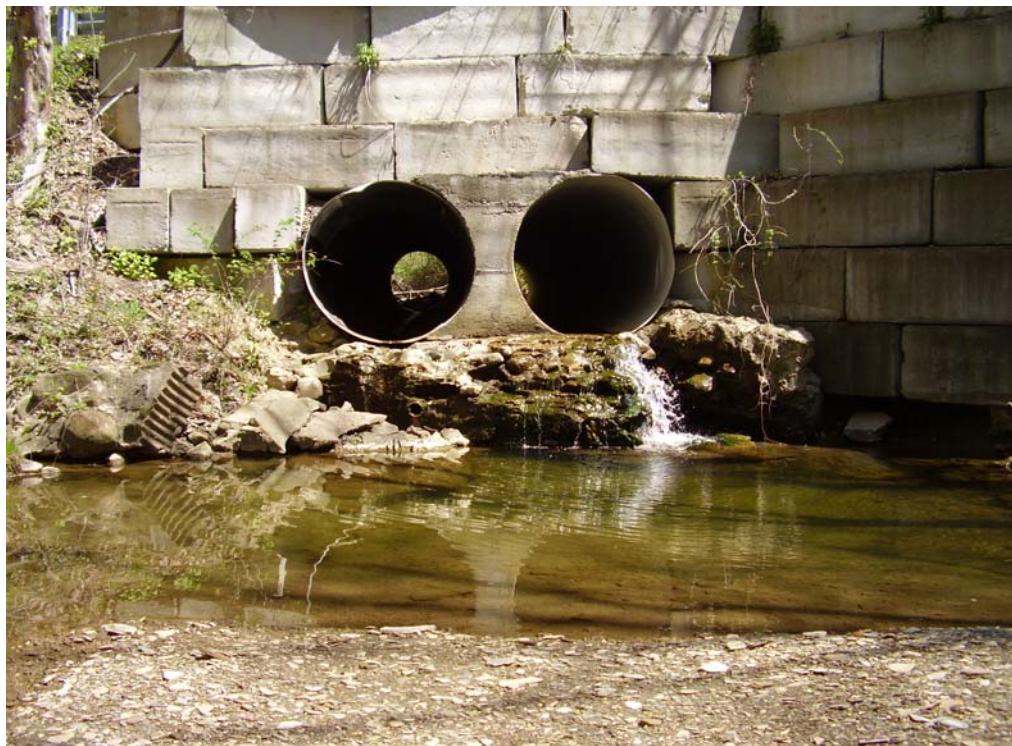
Photo 64 - Obstructions to Fish Passage (15UNT).

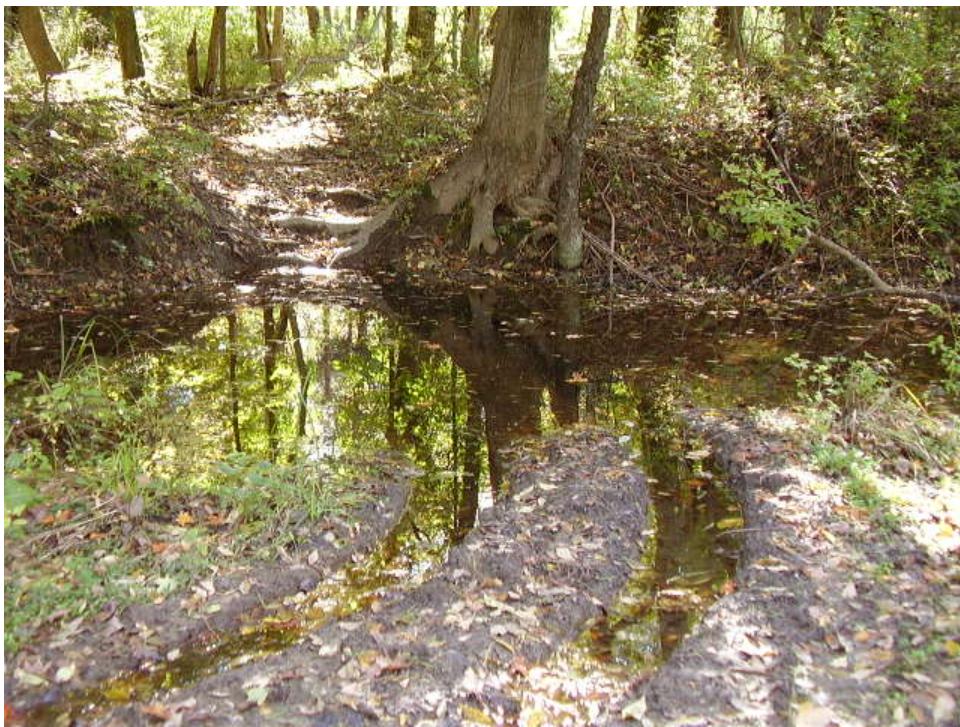
Photo 65 – Erosion Site / ATV Crossing

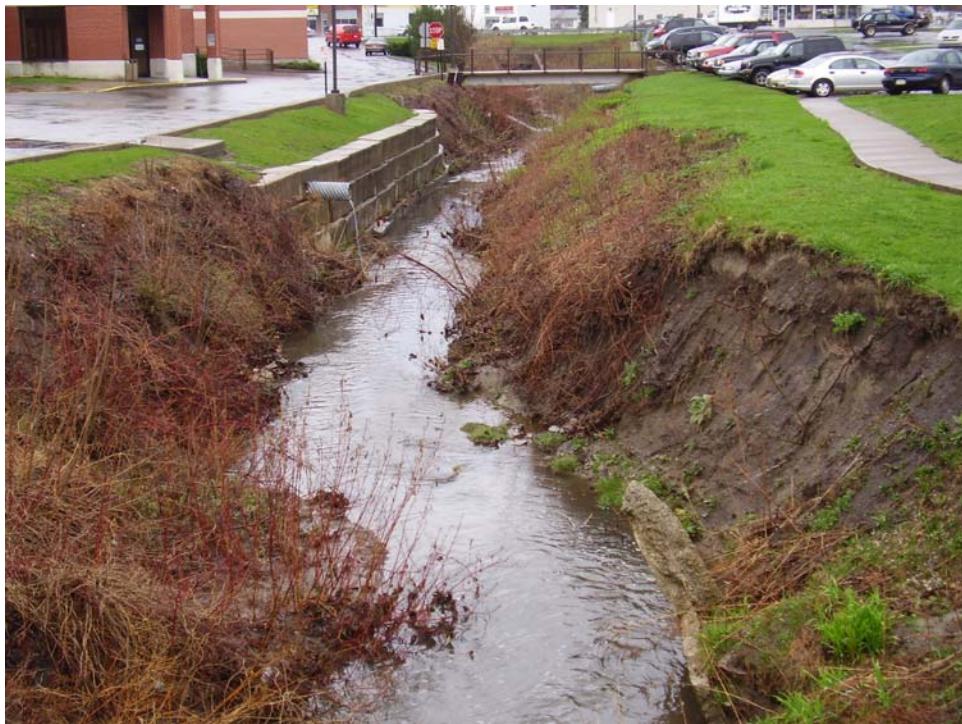
Photo 67 - Loss of Riparian Habitat / Stream Channelization (12UNT)

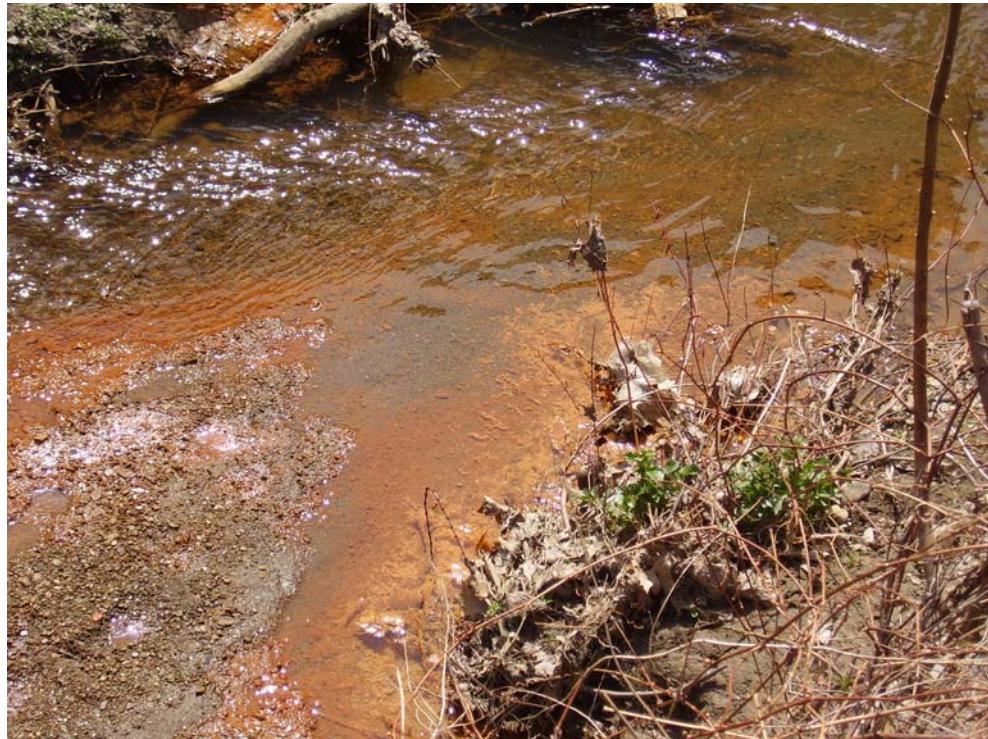
Photo 68 – Unusual Condition – iron staining within Walnut Creek tributary (12UNT)

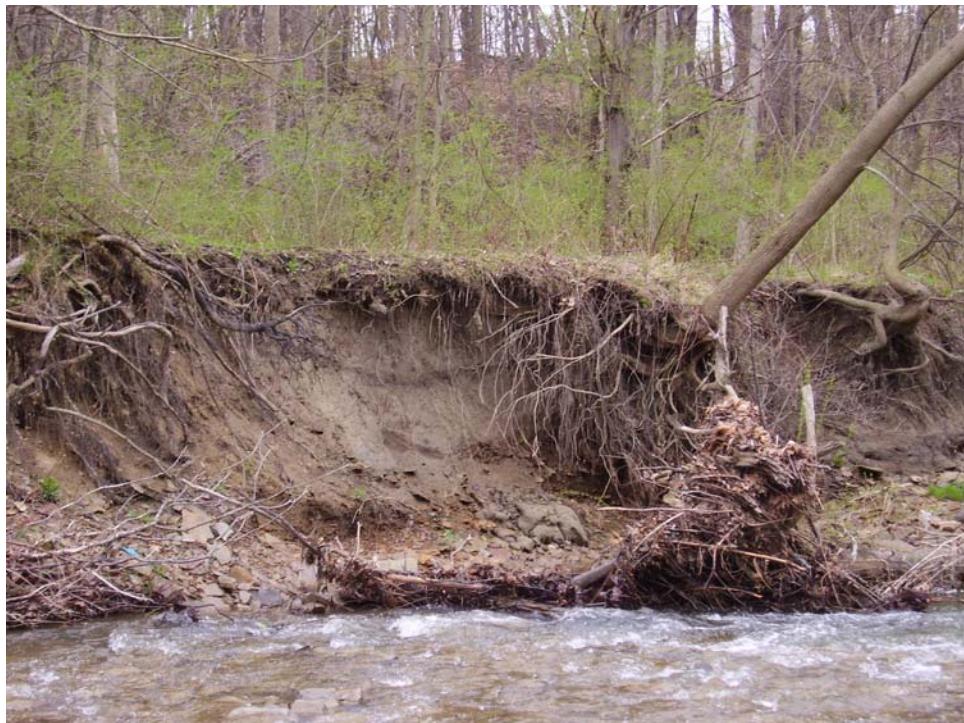
Photo 69 Erosion site at 13WC

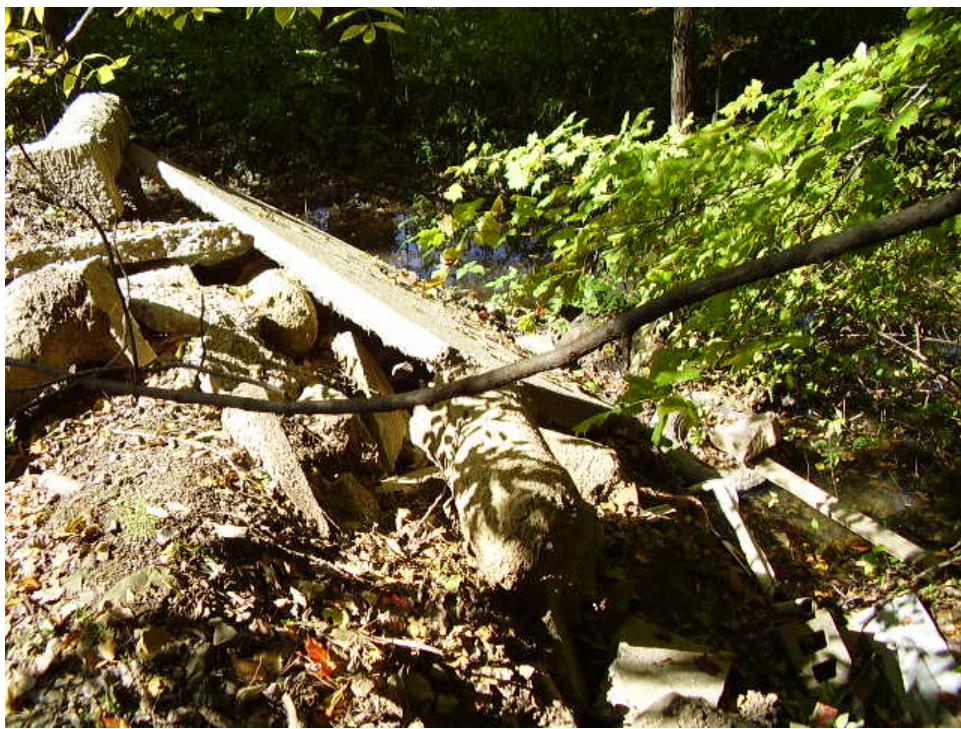
Photo 70 – Fill / Debris

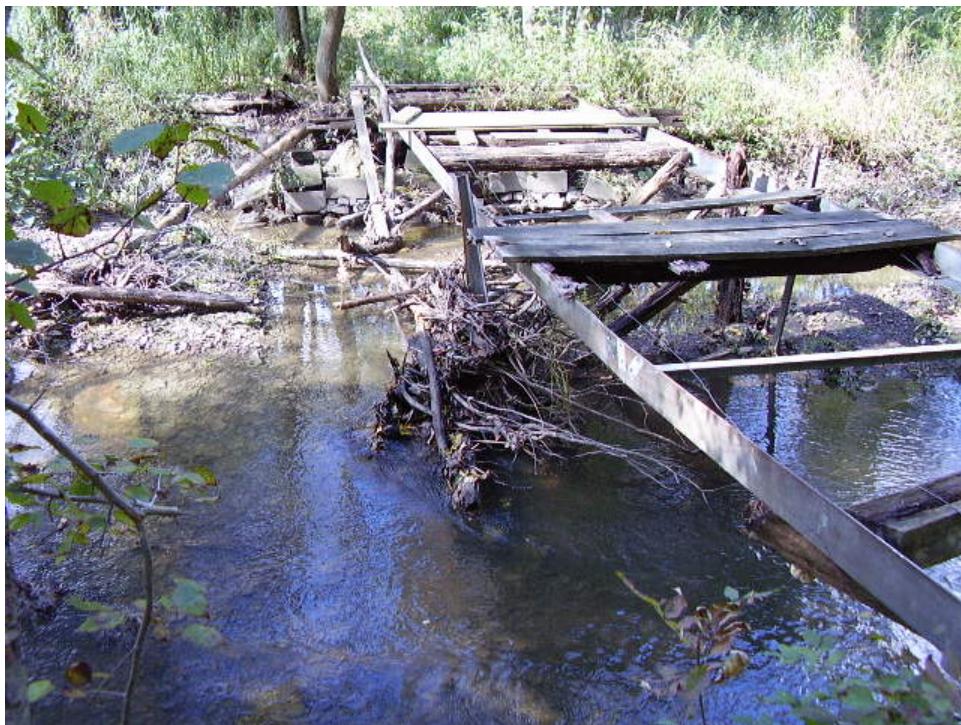
Photo 71 – Channel Alteration

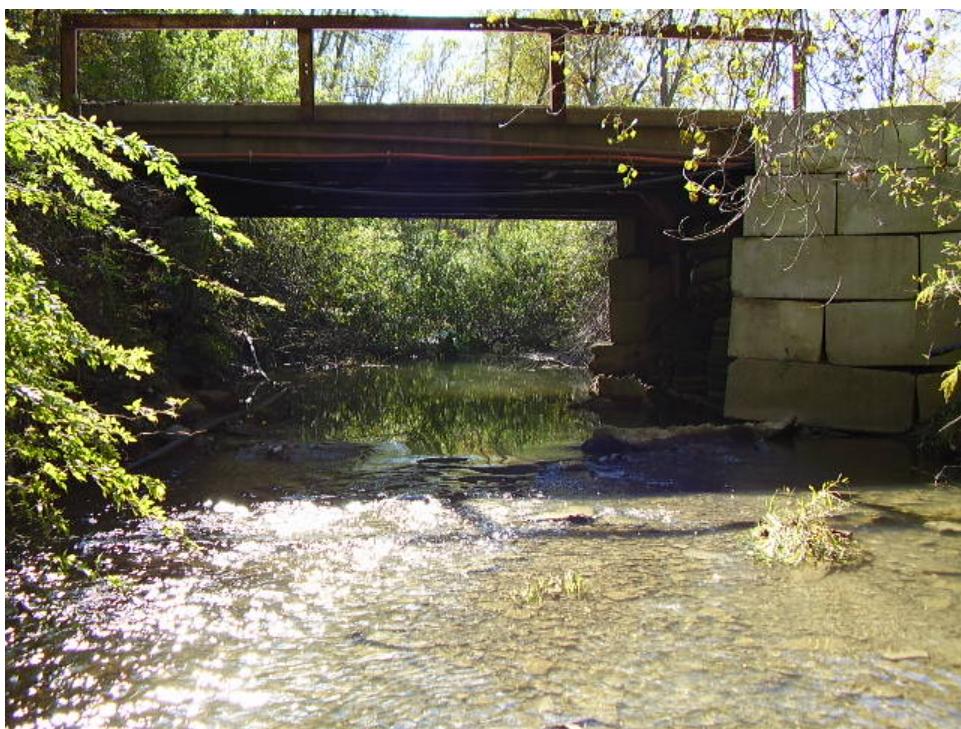
Photo 72 - Channel Alteration

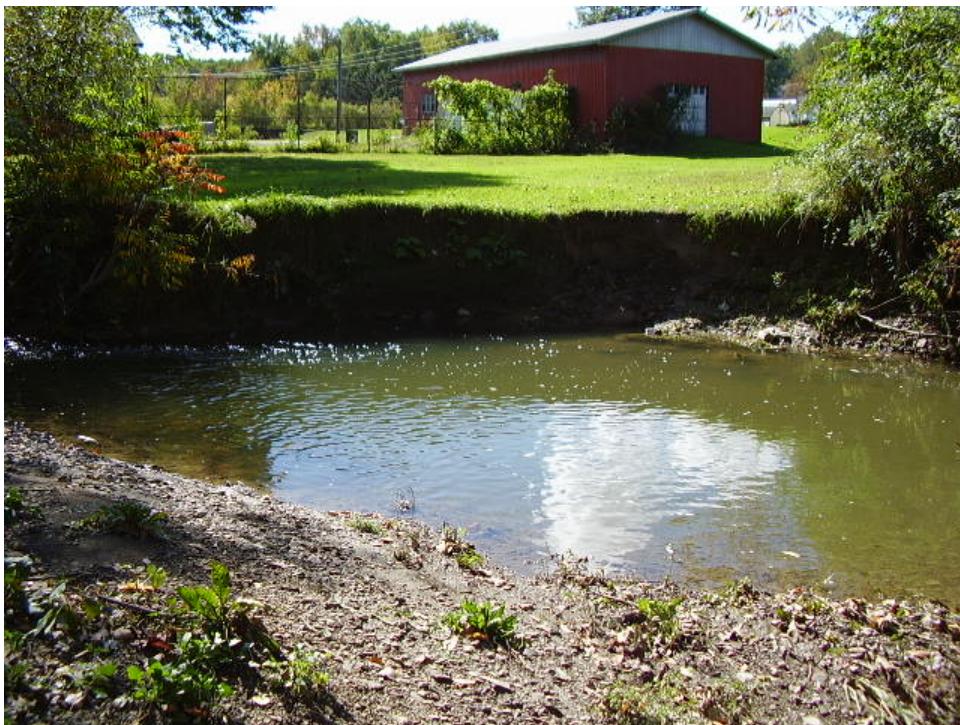
Photo 73 – Inadequate Buffer / Erosion Site

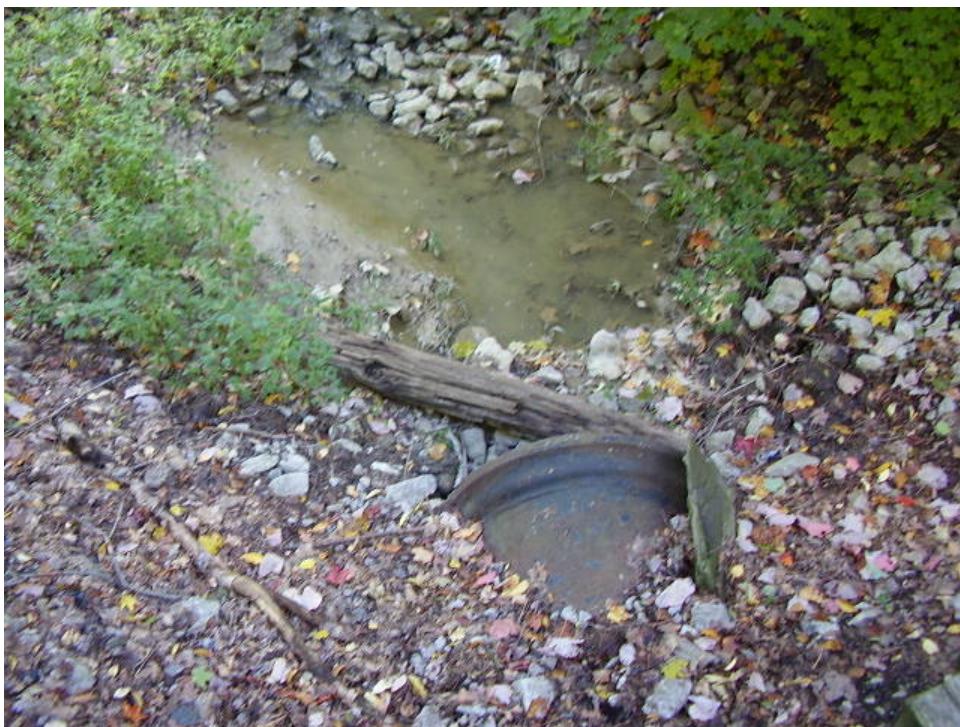
Photo 74 – Pipe Outfall

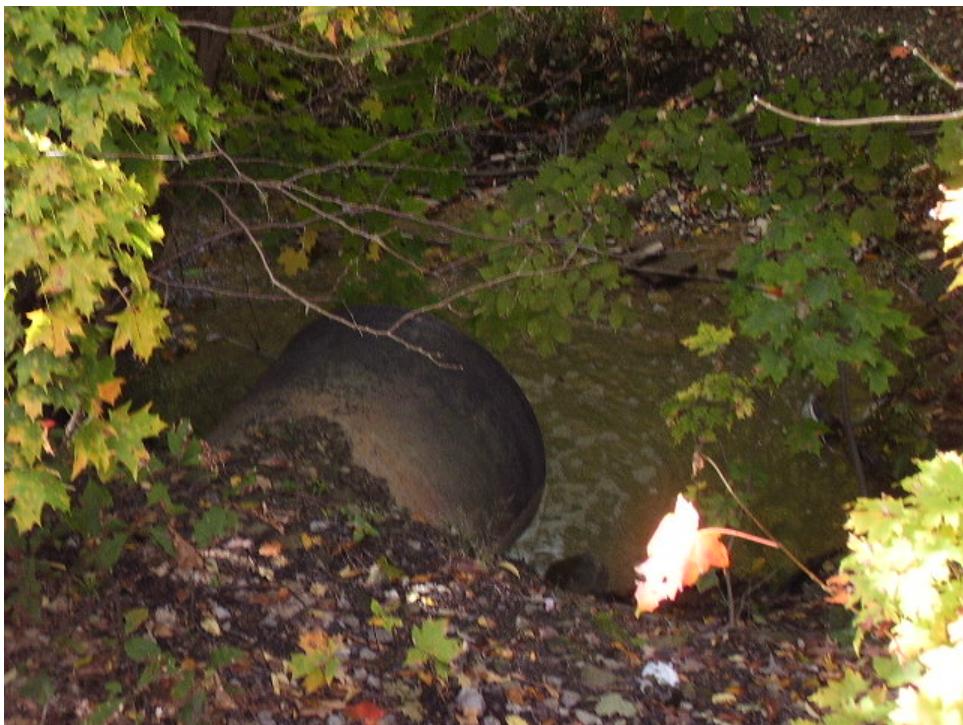
Photo 75 – Pipe Outfall

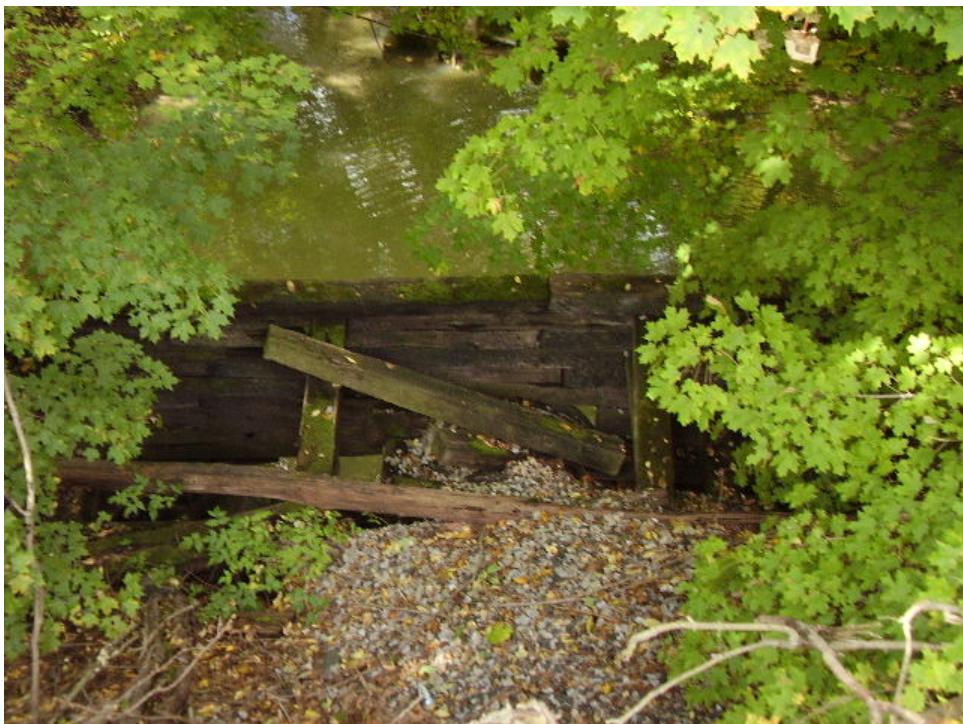
Photo 76 – Pipe Outfall

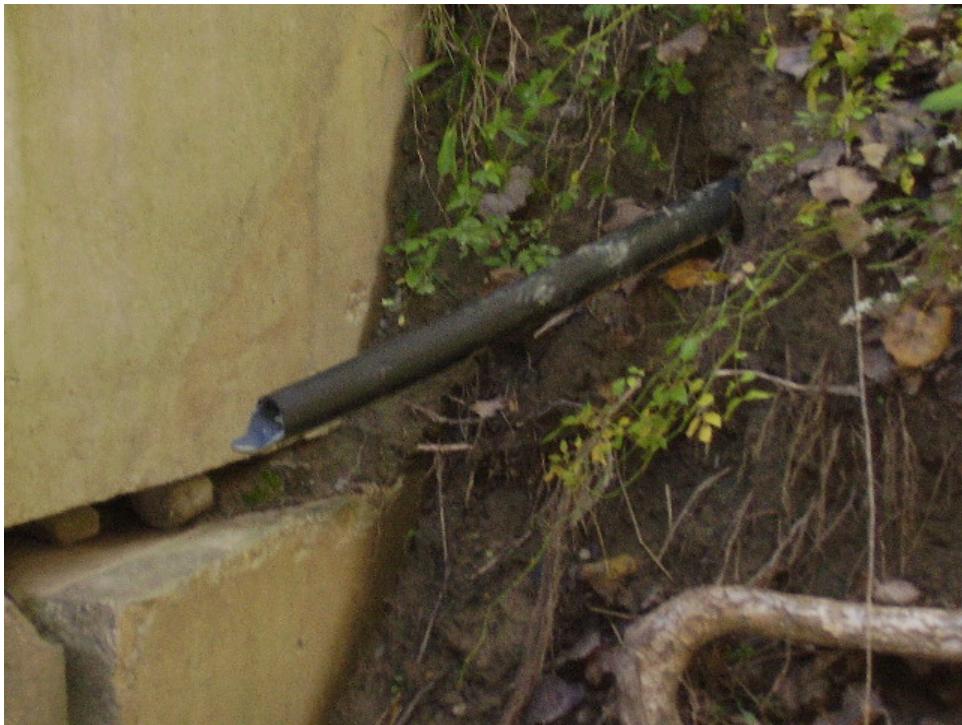
Photo 77 – Exposed Pipe
