APPENDIX D STREAM CORRIDOR ASSESSMENT

DEP staff conducted a walking survey of portions of Walnut Creek, using the Stream Corridor Assessment (SCA) survey protocols, developed by the State of Maryland - Department of Natural Resources, as a guide. These protocols are intended as a rapid assessment tool to identify potential environmental problems, such as:

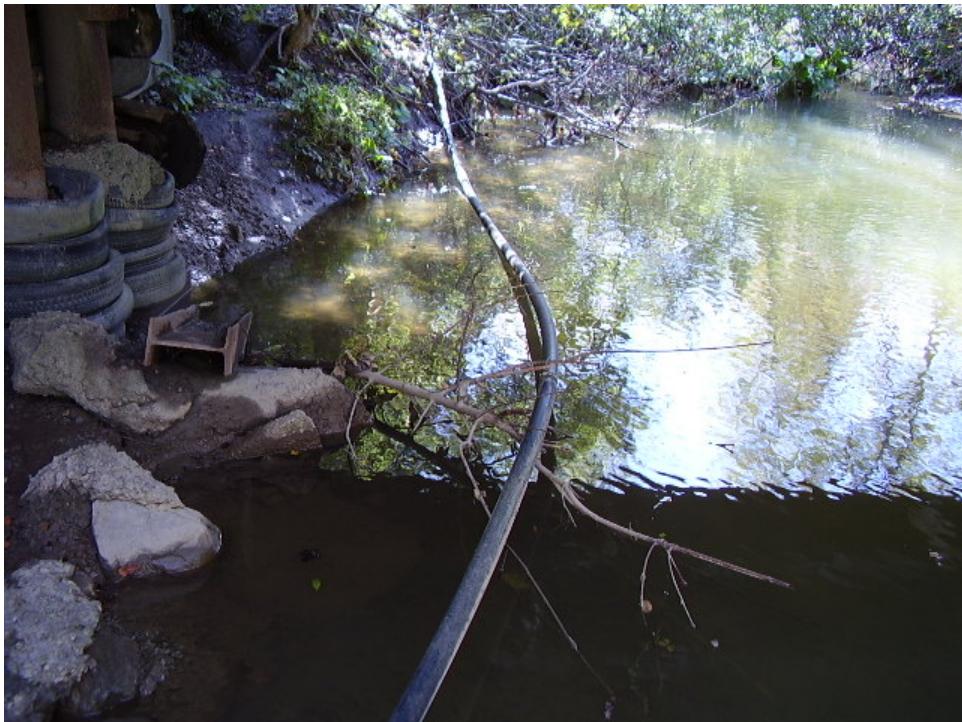
Photo 78 – Exposed Pipe / Channel Alteration

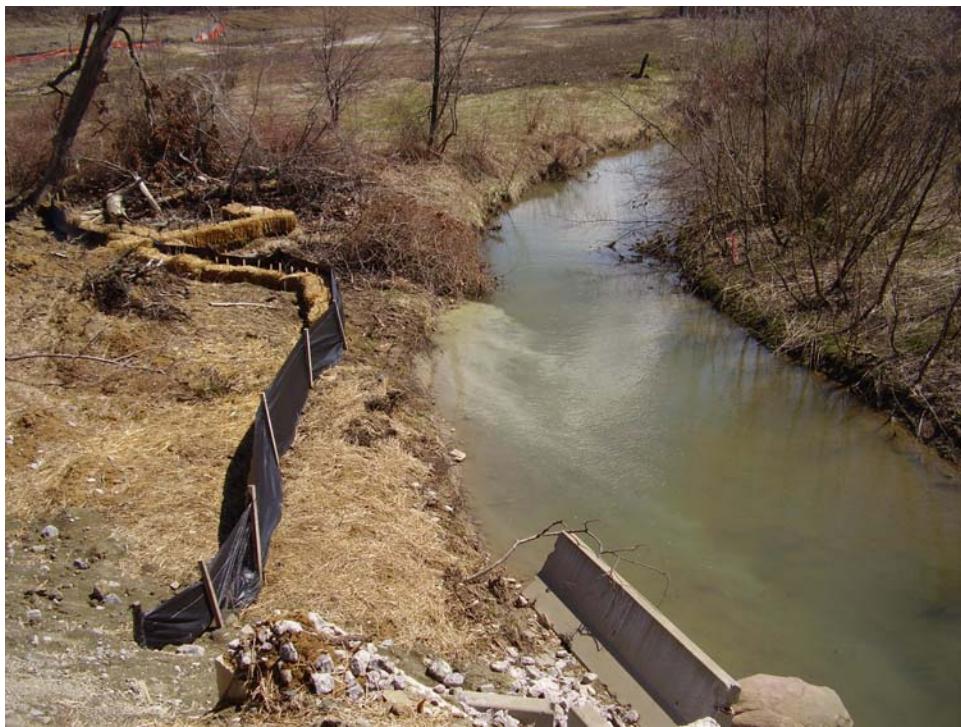
Photo 79 – Channel Alteration / Inadequate Buffer

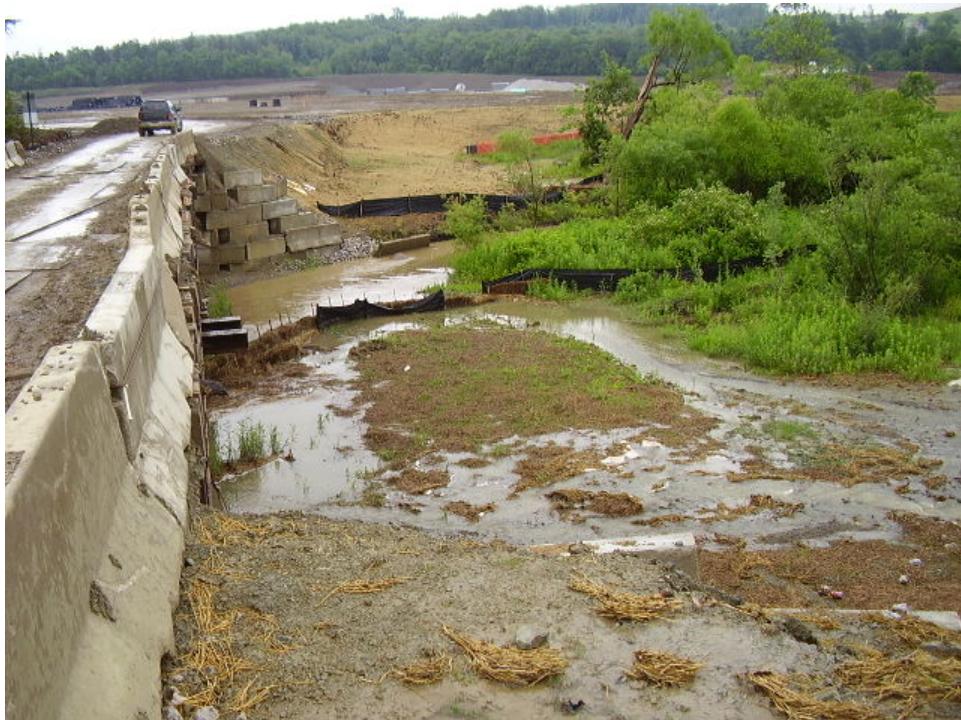
Photo 80 – Channel Alteration / Inadequate Buffer
