Building Inspection Results

Client: Environmental Assurance Co., Inc.
 Project: Homer City Power Plant – Coal Silos
 Job Number: EACI-25-27

Date: June 2, 2025
 Inspector: Edgar King
 License Number: **030716**

LIMITED ASBESTOS-CONTAINING BUILDING MATERIALS INSPECTION
HOMER CITY GENERATING STATION SILOS ROOFING

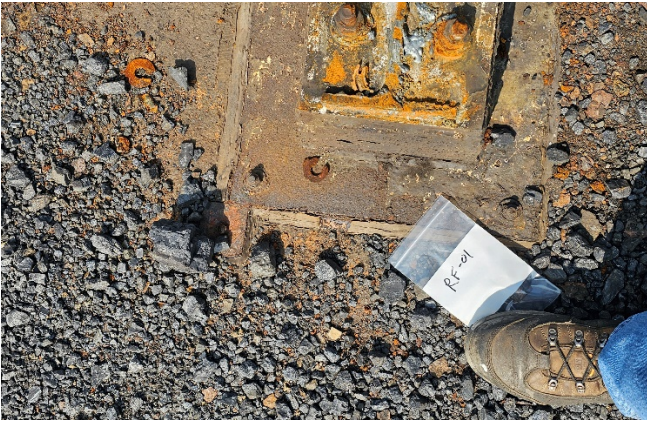
Photo 3: SAMPLE RF-01 CAULKING SILO 1

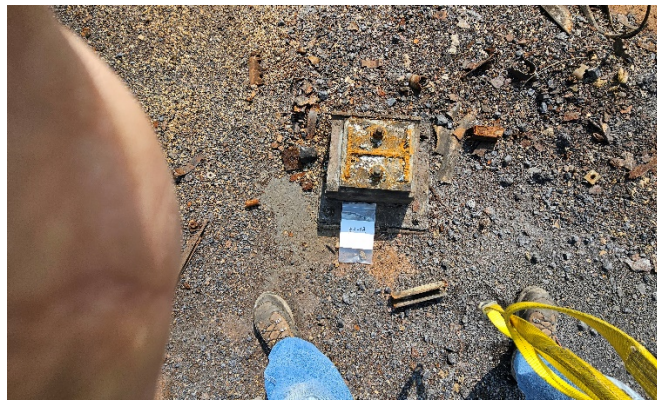
Photo 4: SAMPLE RF-02 CAULKING SILO 1

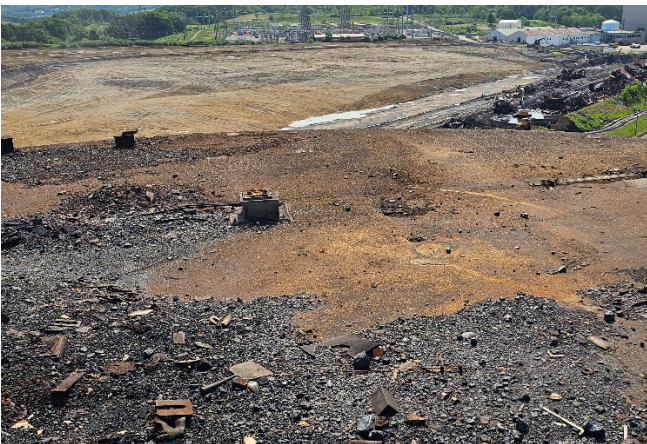
Photo 5: TOP OF SILO 2 NO VISIBLE SUSPECT
ACMS

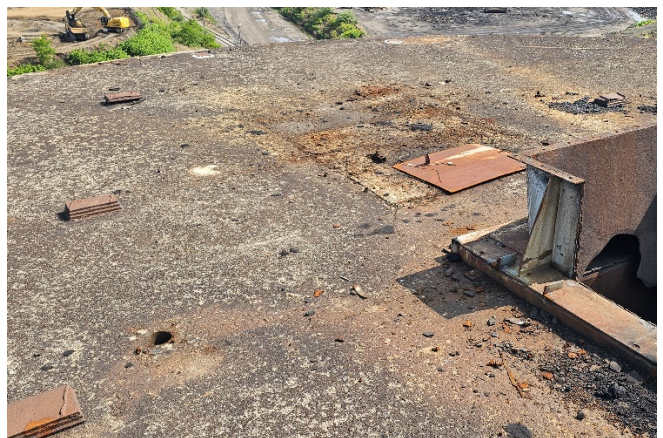
Photo 6: TOP OF SILO 3 NO VISIBLE SUSPECT
ACMS

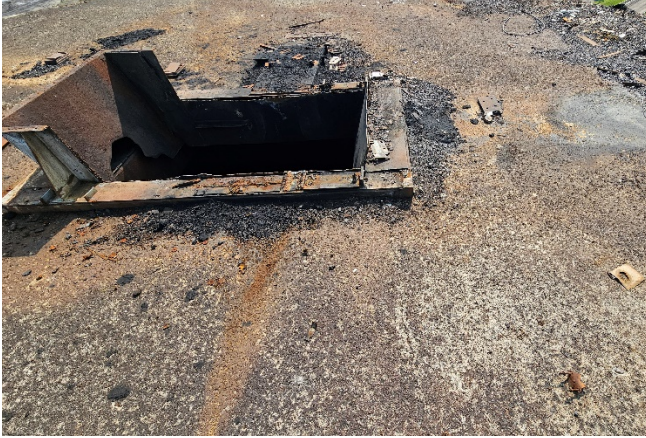
Photo 7: TOP OF SILO 3 NO VISIBLE SUSPECT
ACMS

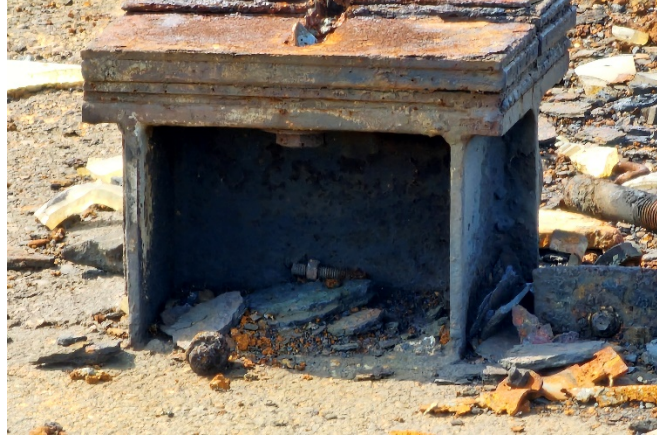
Photo 8: TOP OF SILO 4 NO VISIBLE SUSPECT
ACMS

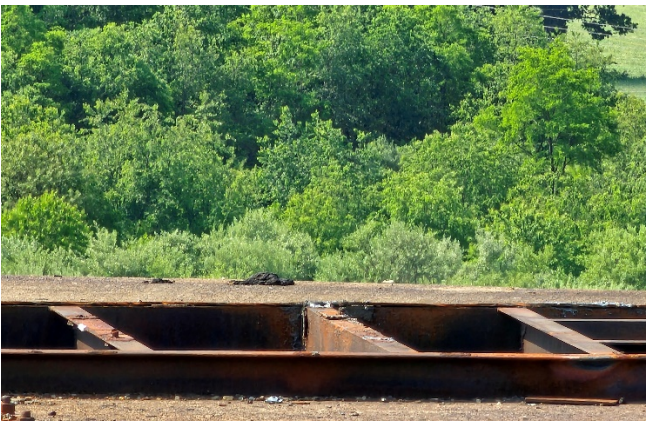
Photo 9: TOP OF SILO 4 NO VISIBLE SUSPECT
ACMS

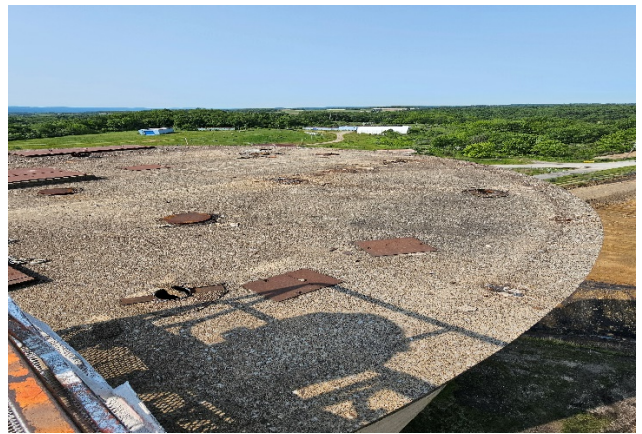
Photo 10: TOP OF SILO 5 NO VISIBLE SUSPECT
ACMS

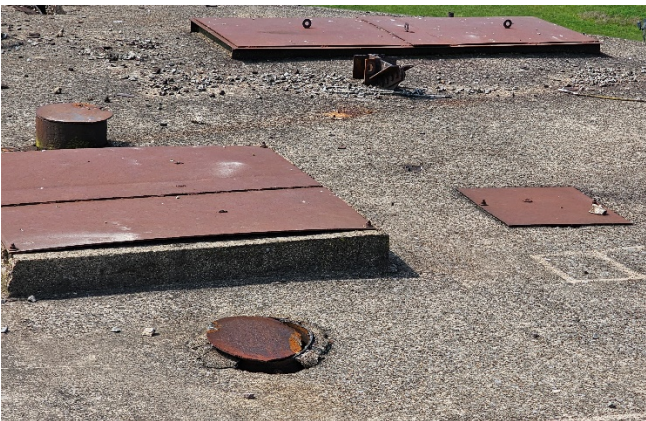
Photo 11: TOP OF SILO 5 NO VISIBLE SUSPECT
ACMS

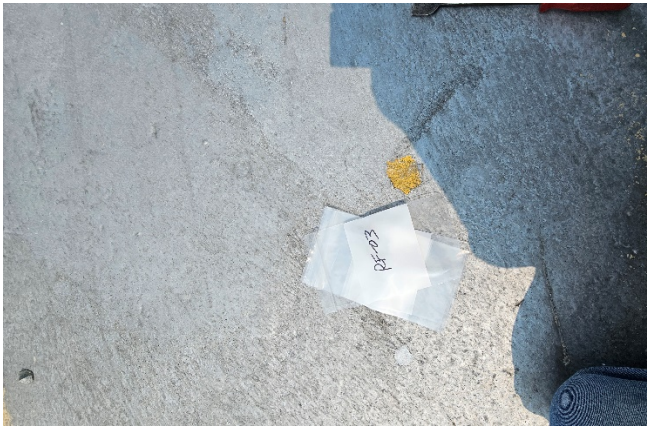
Photo 13: SAMPLE RF-03 LIME SILOS 1&2 A&B ROOFING

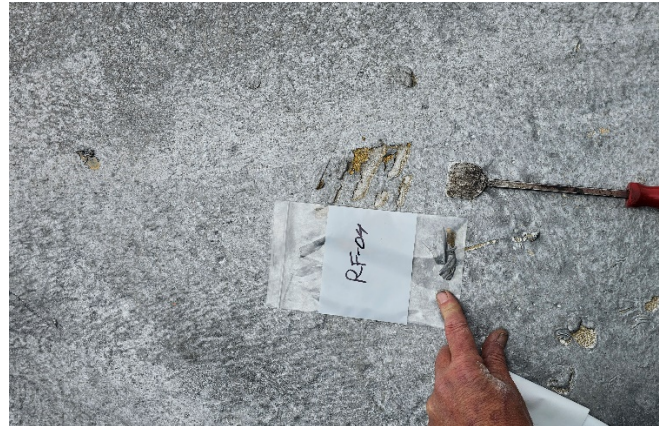
Photo 14: SAMPLE RF-04 LIME SILOS 1&2 A&B ROOFING

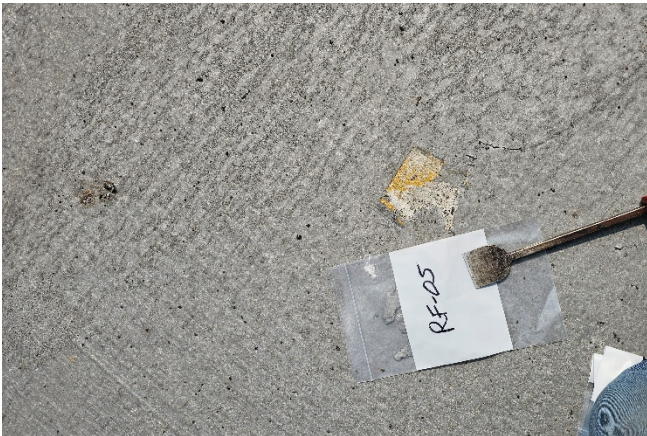
Photo 15: SAMPLE RF-05 LIME SILOS 1&2 A&B ROOFING

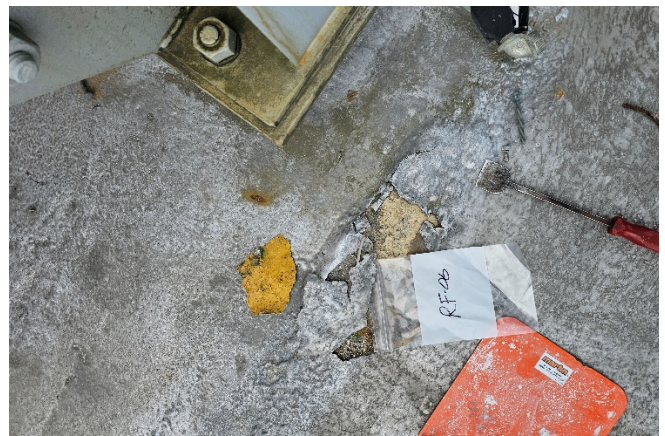
Photo 16: SAMPLE RF-06 BYPRODUCT SILOS 1&2 ROOFING

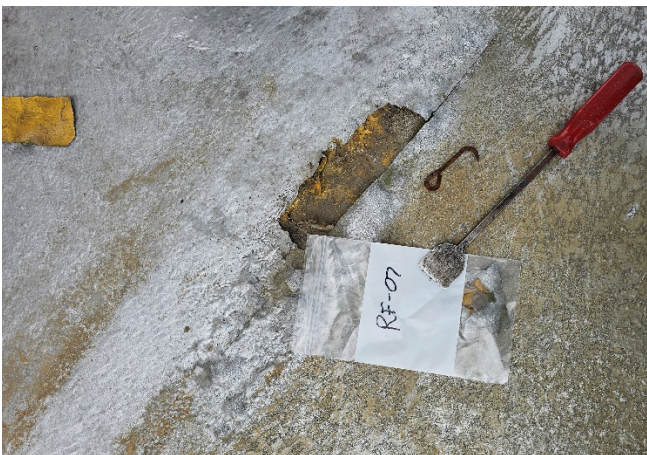
Photo 17: SAMPLE RF-07 BYPRODUCT SILOS 1&2 ROOFING

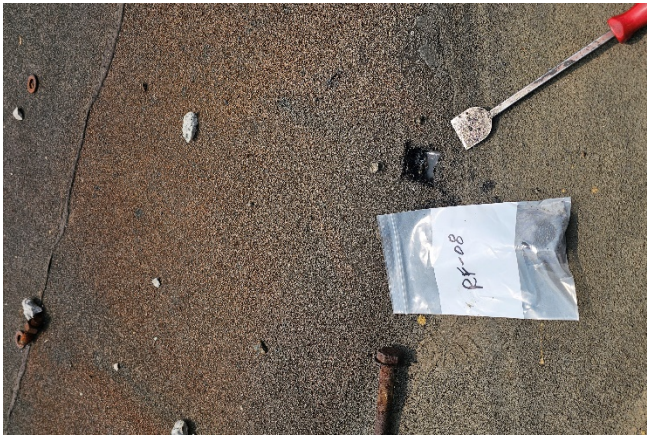
Photo 19: SAMPLE RF-08 UNIT #1 TOP ASH SILO ROOFING

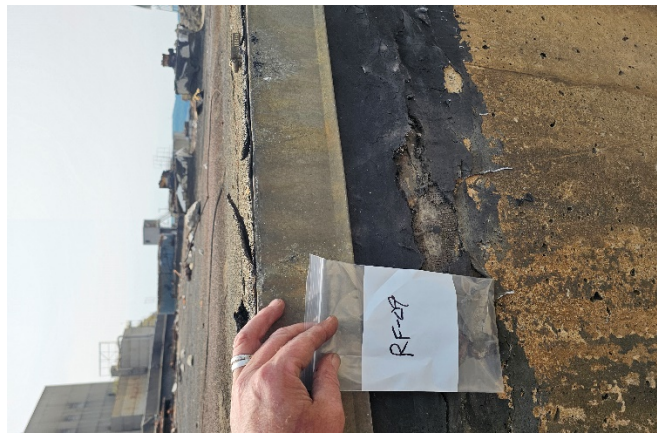
RF-09	Unit 1 – Top Ash Silo Around Sides	Grey / Brown Flashing	Not Quantified	Poor	High	None

Photo 20: SAMPLE RF-09 UNIT #1 TOP ASH SILO FLASHING

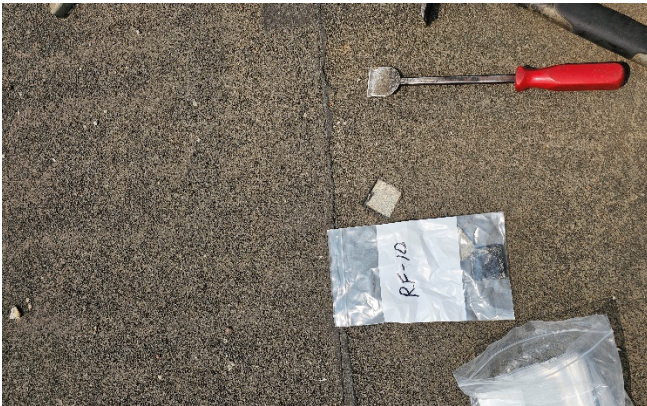
Photo 21: SAMPLE RF-10 UNIT #1 TOP ASH SILO ROOFING

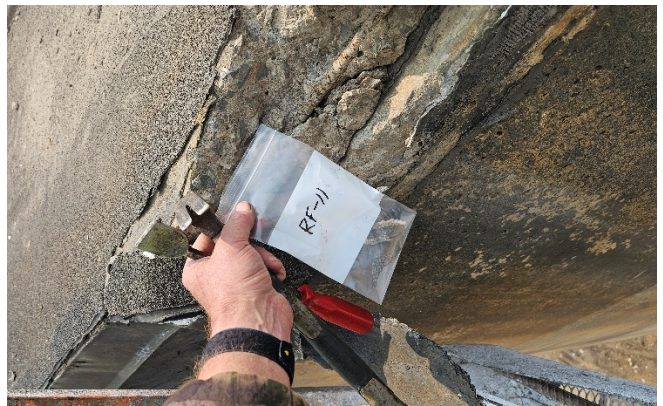
Photo 22: SAMPLE RF-11 UNIT #1 TOP ASH SILO FLASHING

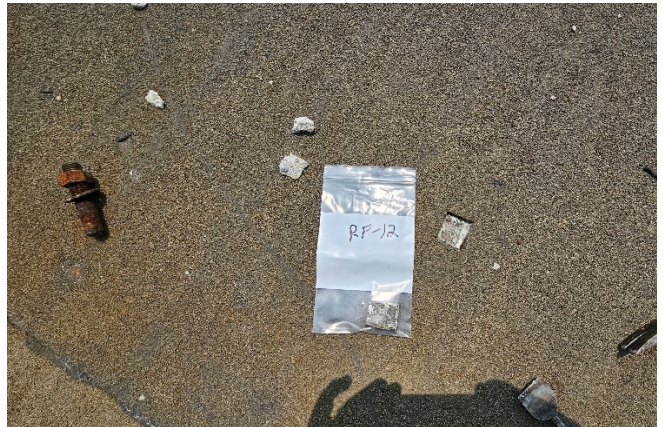
Photo 24: SAMPLE RF-12 UNIT #2 TOP ASH SILO ROOFING

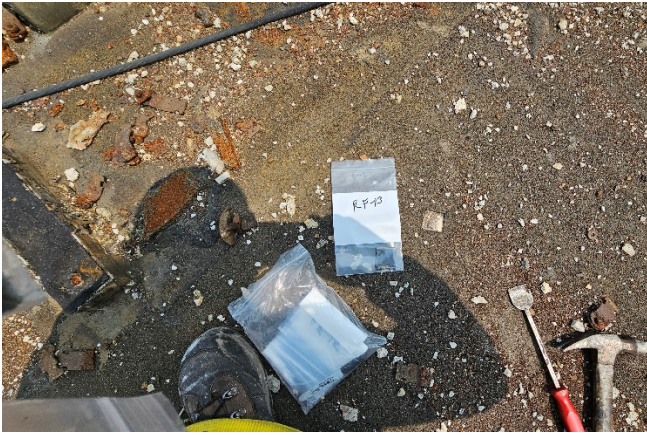
Photo 25: SAMPLE RF-13 UNIT #2 TOP ASH SILO ROOFING

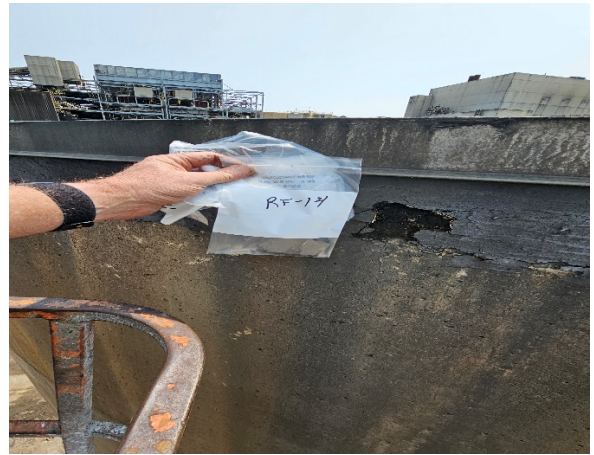
Photo 26: SAMPLE RF-14 UNIT #2 TOP ASH SILO FLASHING

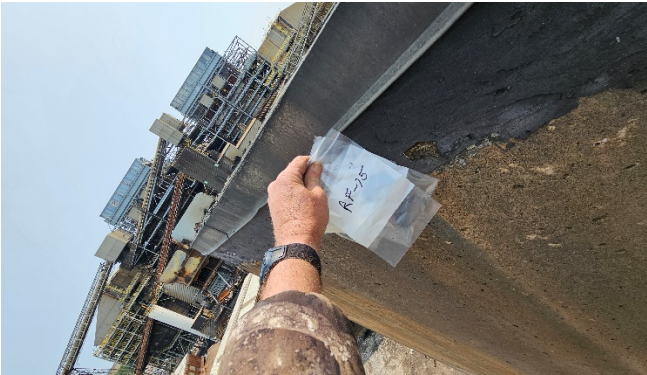
Photo 27: SAMPLE RF-15 UNIT #2 TOP ASH SILO FLASHING

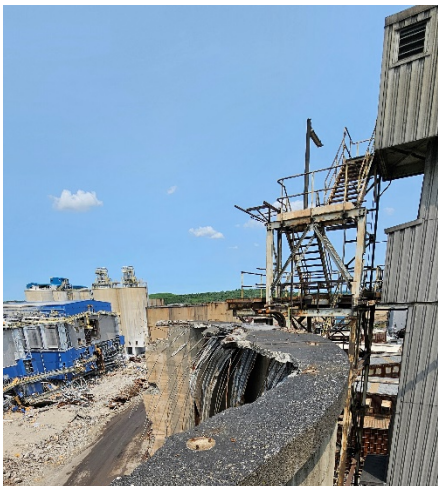
Photo 29: UNIT #3 TOP ASH SILO NO VISIBLE ACMS

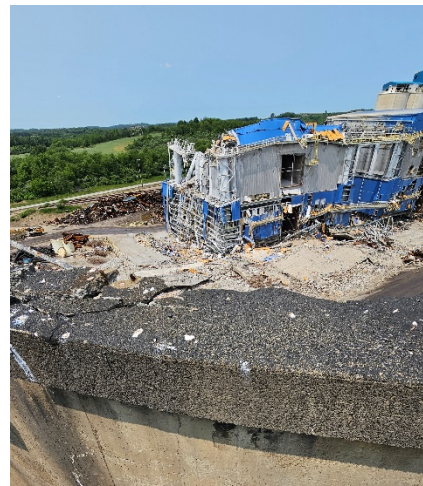
Photo 30: UNIT #3 TOP ASH SILO NO VISIBLE ACMS
