Administrative Record

September 7, 1988

SUBJECT: Vanport Township Municipal Authority Water Supply
Groundwater Assessment and Investigation
Vanport Township
Beaver County

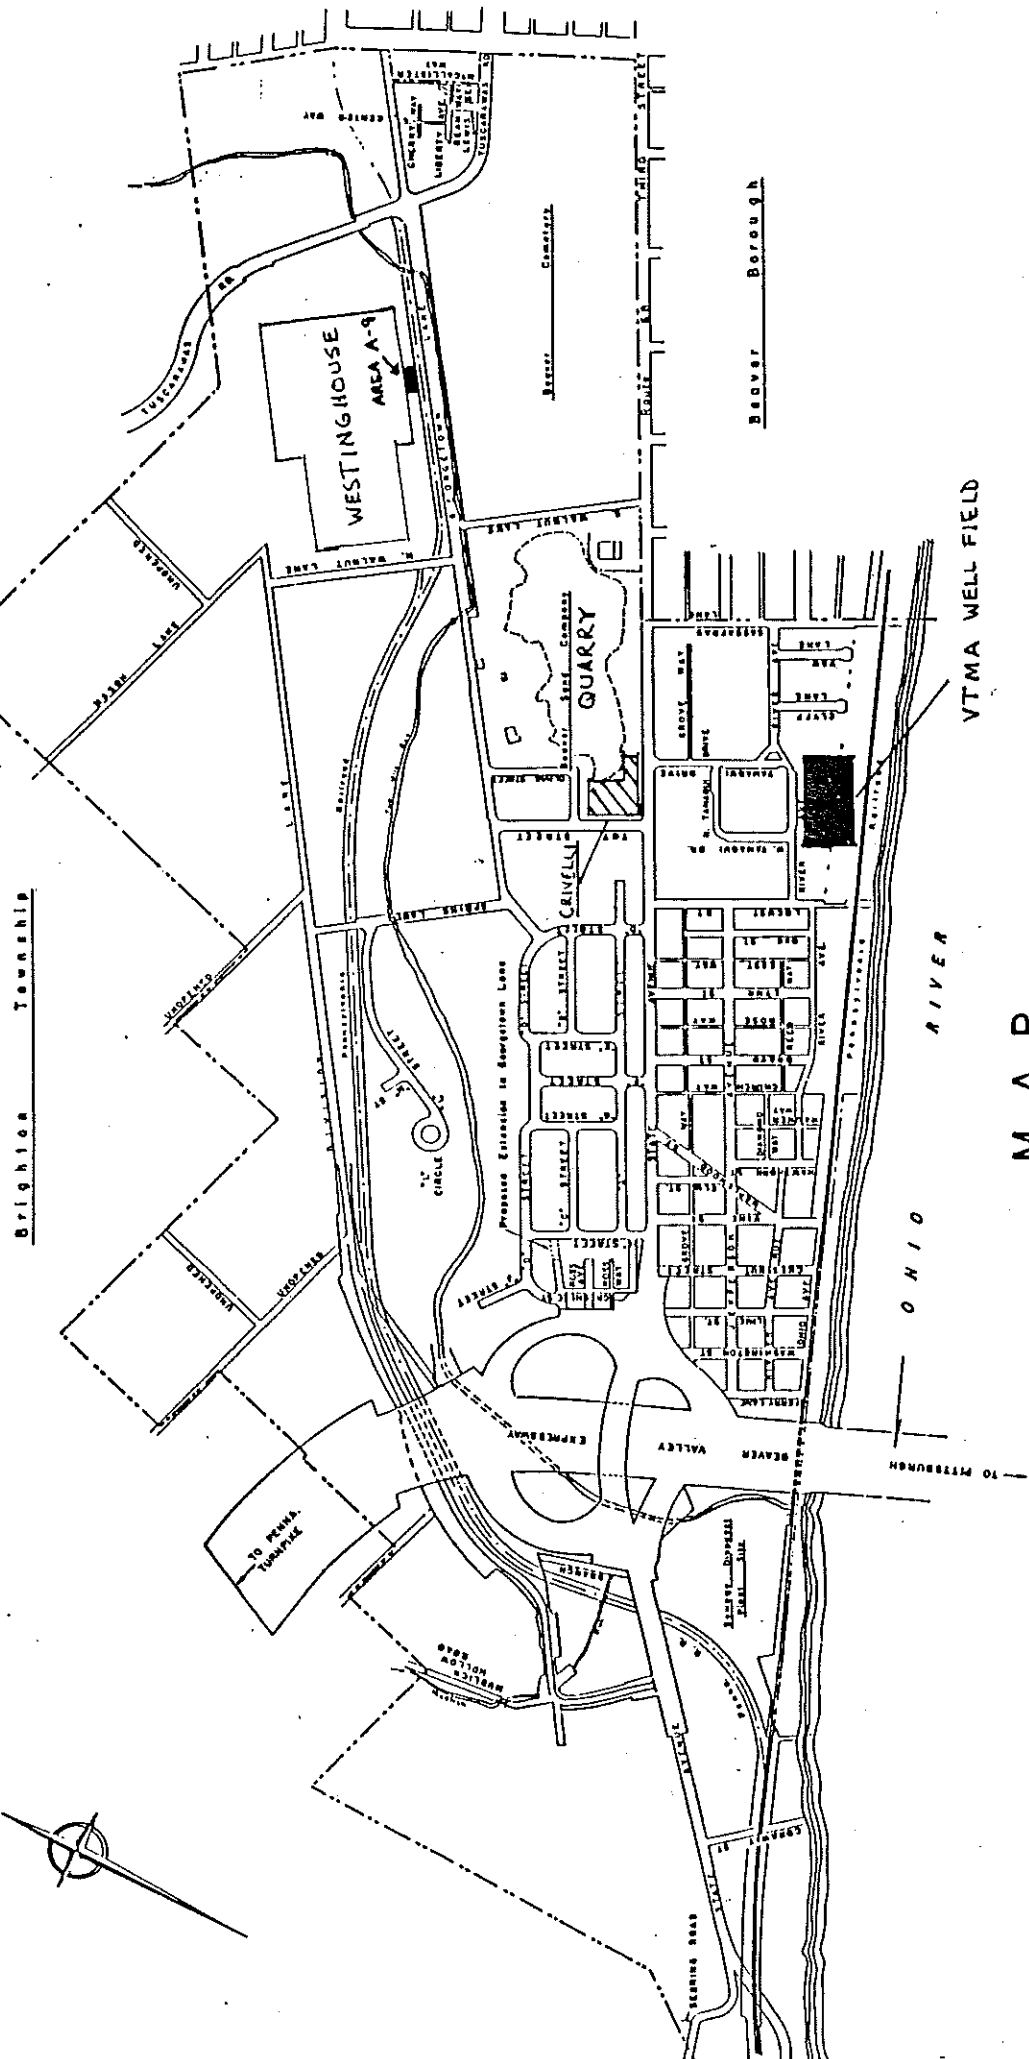
FIGURE - 1

Westinghouse's Beaver plant is located approximately 2,500' to the northeast of VTMA's water supply well field (see Figure 1).

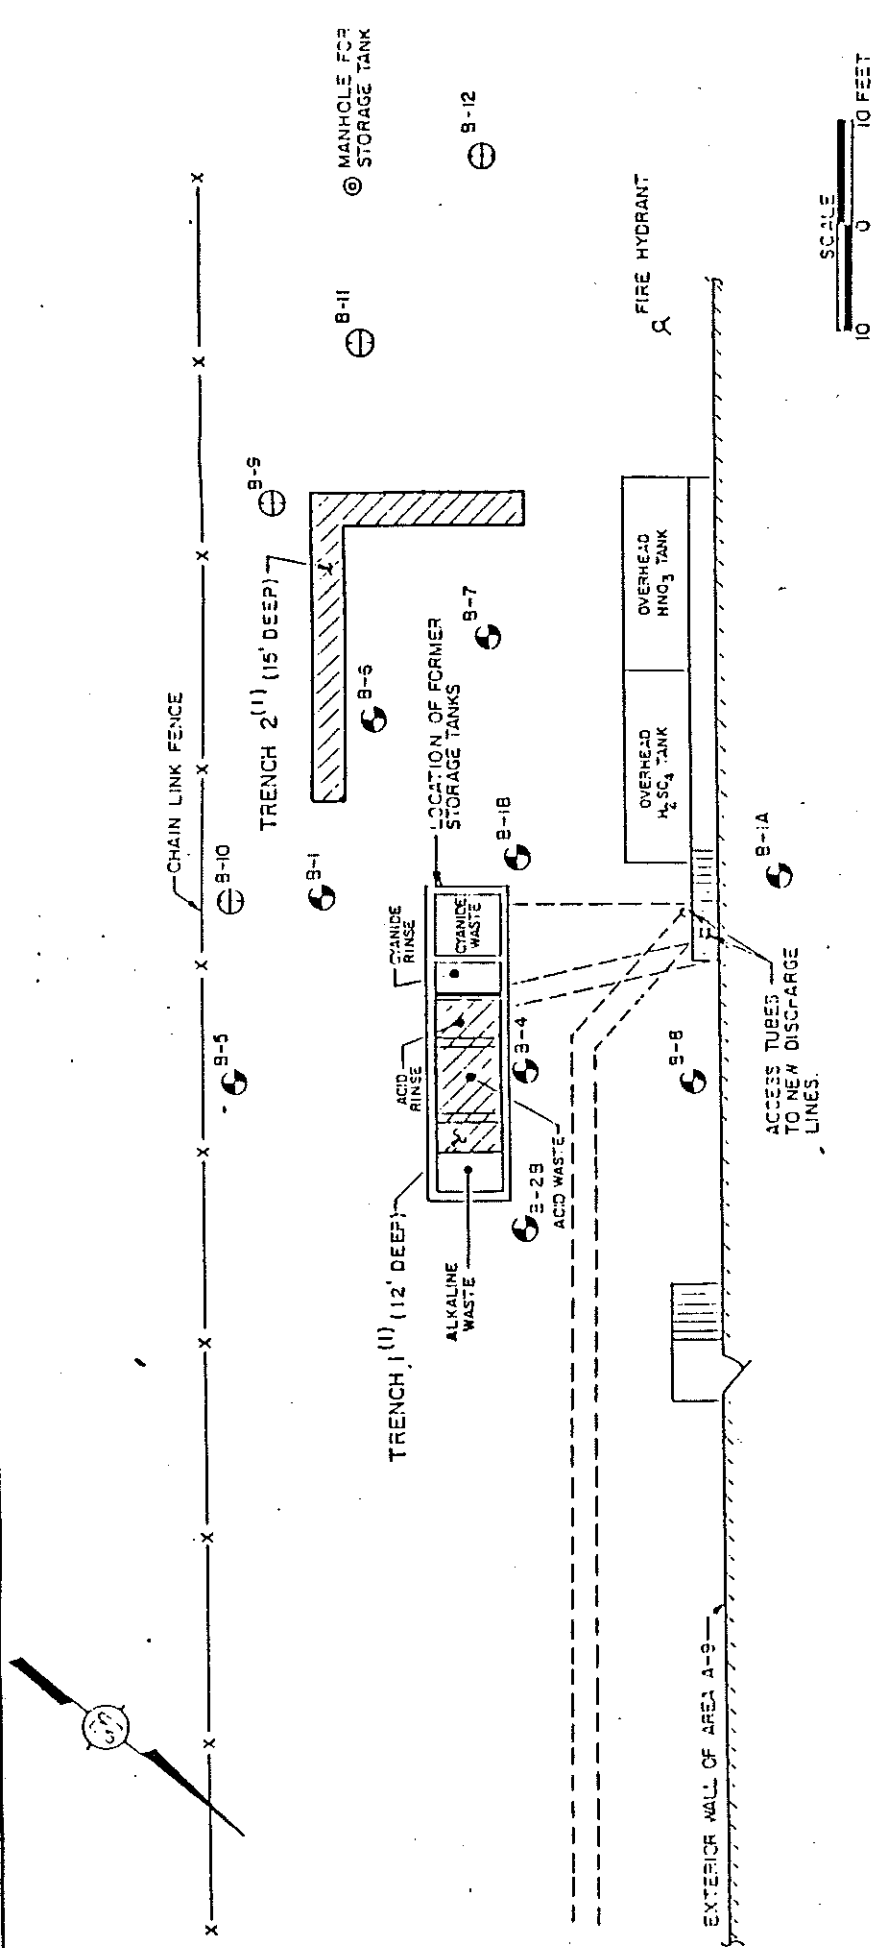
FIGURE - 2

Westinghouse has been addressing an existing contamination problem at their Beaver plant. Westinghouse operates the plant as a manufacturing facility which, at one time, included electroplating operations. The electroplating operation utilized a series of inground dip tanks that contained a variety of chemicals in both acid and basic solutions. Waste tanks were also used. These tanks are located in Area A-9 (see Figure 2).
