Shell Chemical Appalachia LLC
300 Frankfort Rd
Monaca, PA 15061

August 10, 2023

RE: PA-04-00740C LP Multipoint Ground Flare Visible and Excess Emissions Malfunction Report

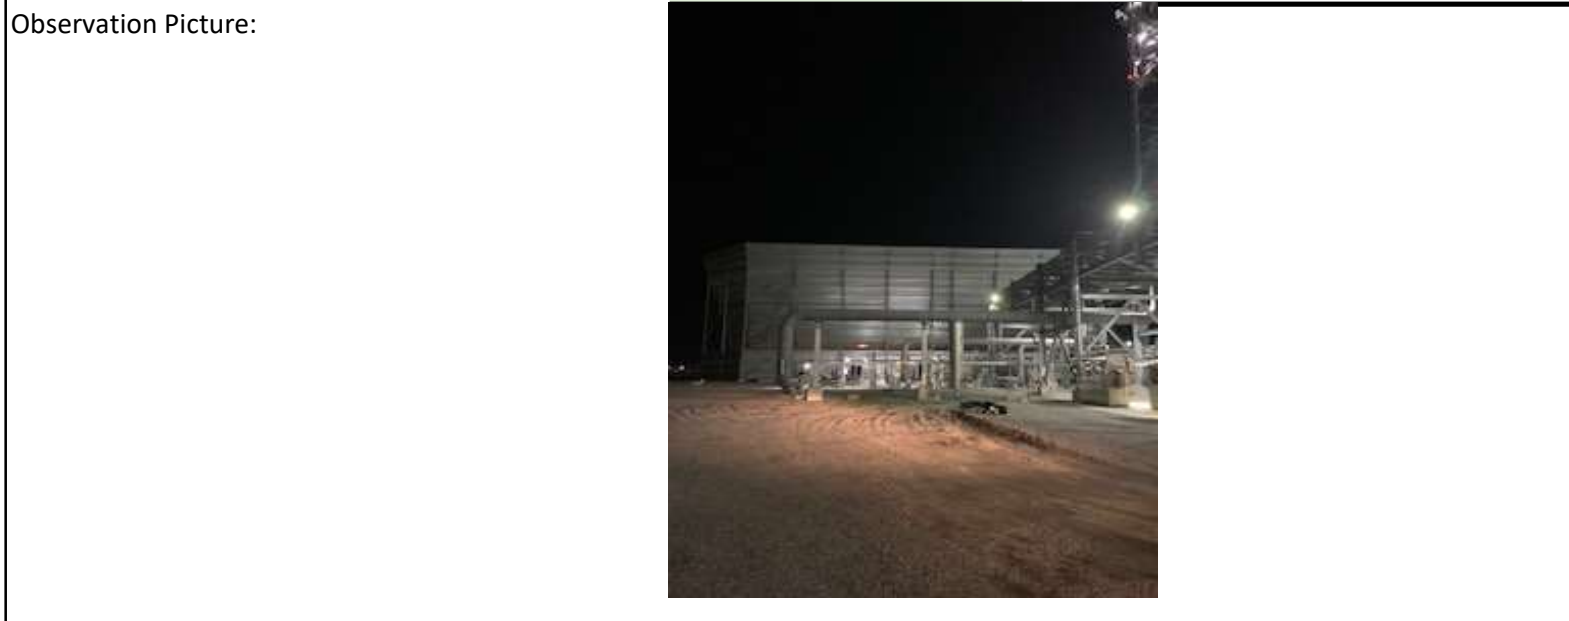
No Emissions Observed between 7/10/2023 17:25 and 19:25. The picture above was taken later in the shift. Per camera footage, the smoking end at 17:23:42.
