WEEDVILLE

Abandoned Mine Reclamation Project

Contract No. OSM 24(0515)101.1

FACT SHEET

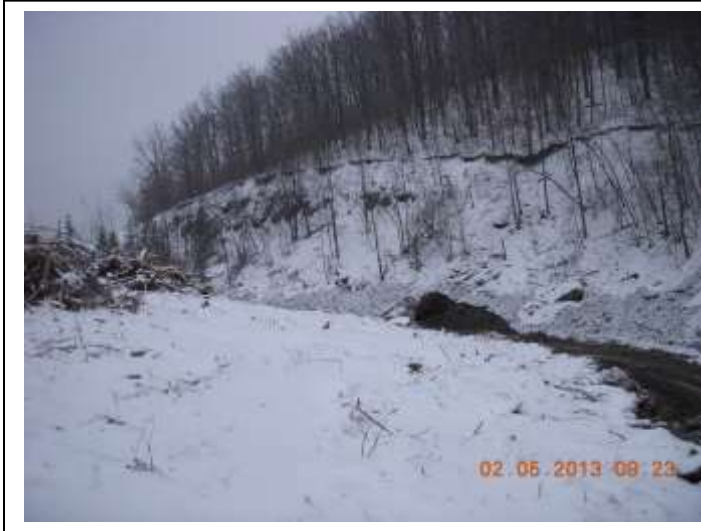
The highwall and pit floor.

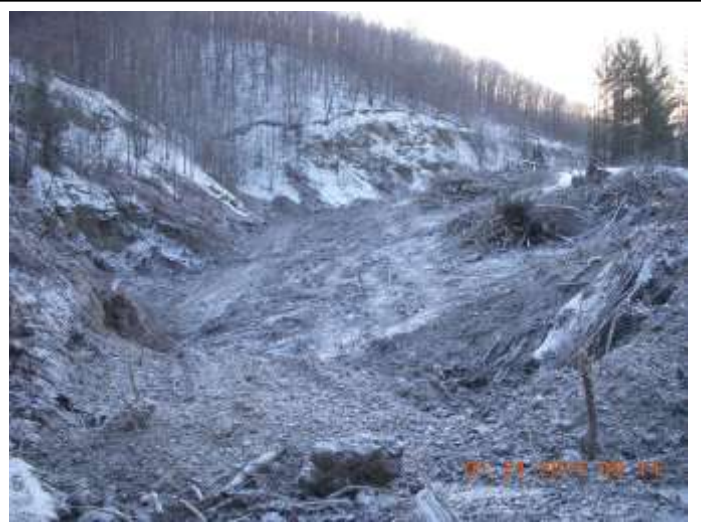
The highwall and pit floor.

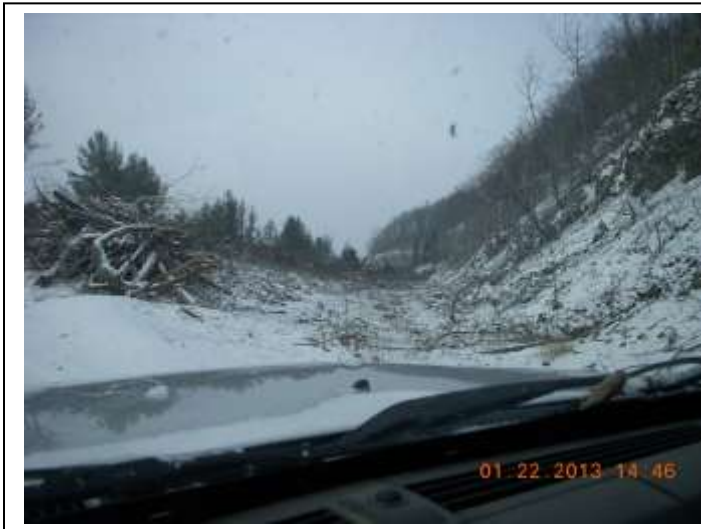
The highwall and pit floor.

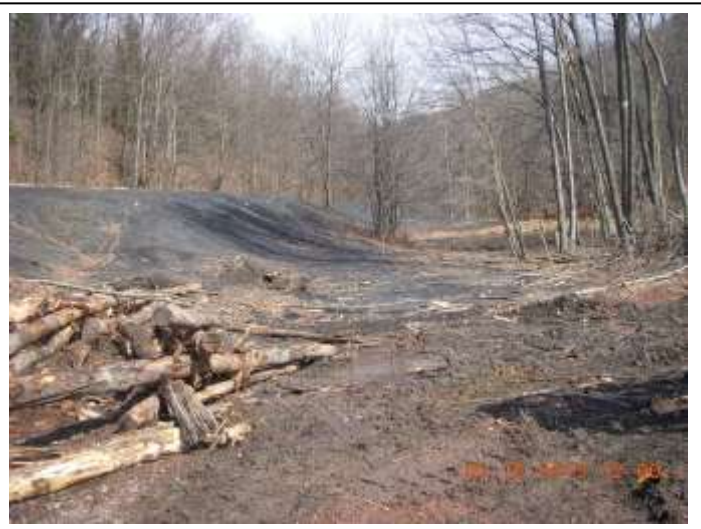
Coal Refuse Pile No. 2.

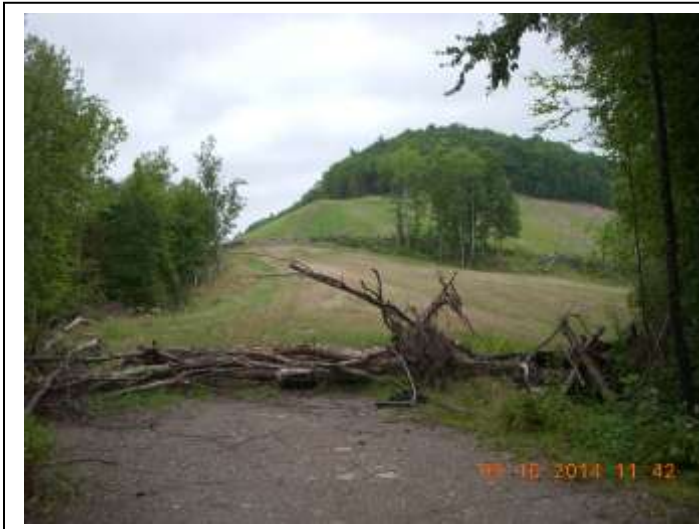
View of the main grading area and Coal Refuse Pile No. 2.

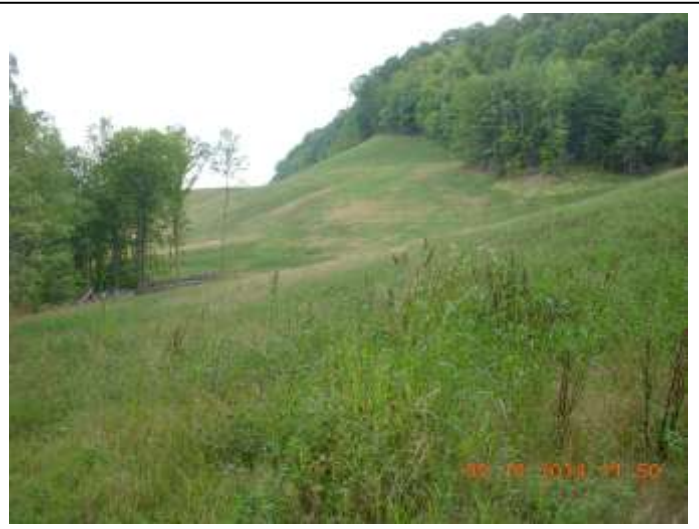
View of the main grading area from Apple Street.

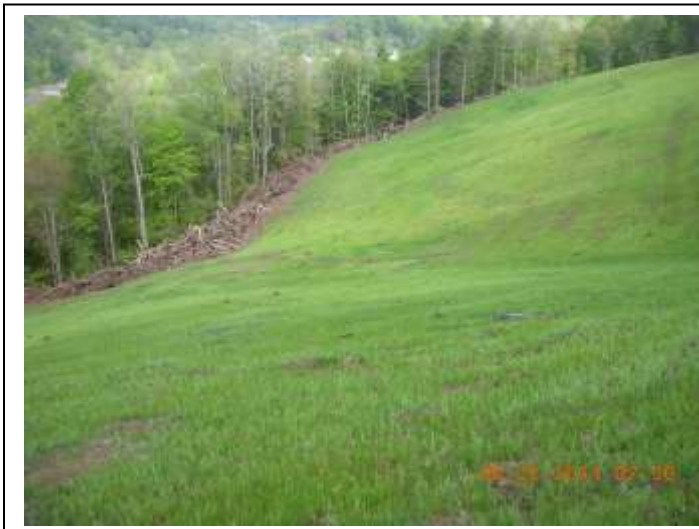
View of the grading area and Swale No. 1, above Berndale.

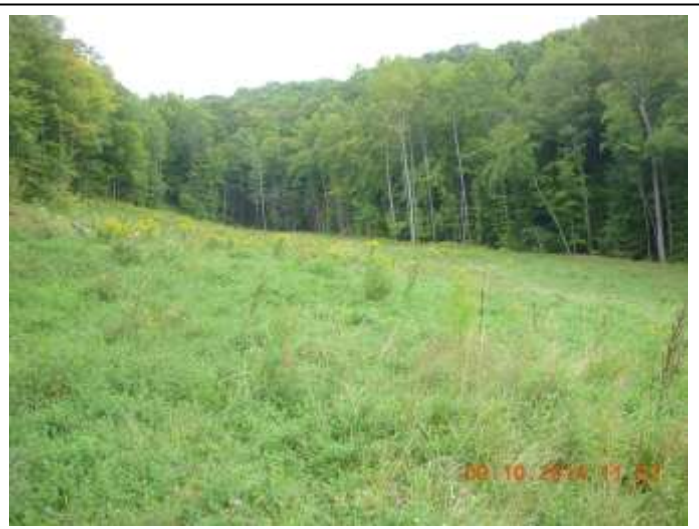
View of the small grading area east of Apple Street.
