Re: Comments on Report for HDD PA-WM1-0023.0000-RD

Comments on HDD PA-WM1-0023.0000-RD

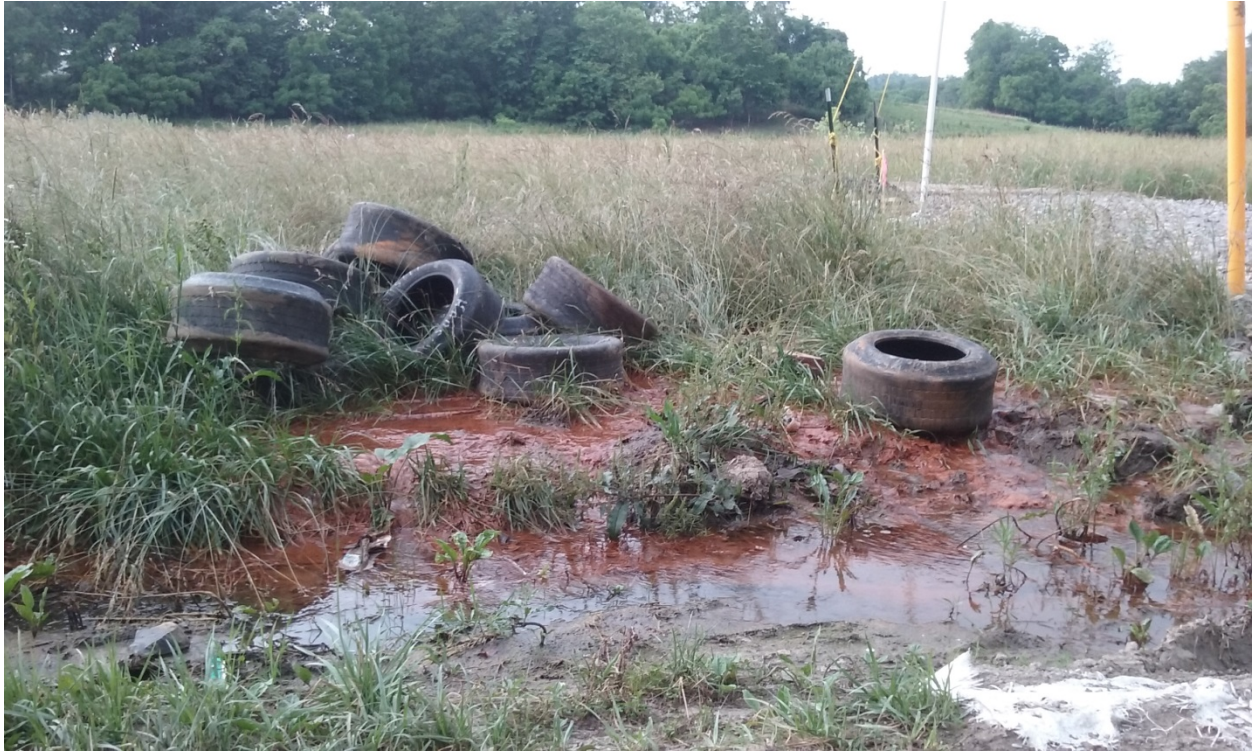
Attachment A

Sunoco's ME II Sewickley Creek HDD site is roughly 0.3 miles from the Hildenbrand Rd. HDD site. In June of 2017, a Mountain Watershed Member documented a discharge of reddish water at the Sewickley Creek Site. (See photo included as "Attachment A"). Because this area is so thoroughly undermined, it is likely that the water's reddish tinge was caused by exposure to minerals from the underground mine before it was forced to the surface as a result of either construction activity or inadvertent returns which occurred during HDD activity.

Photo taken by Mountain Watershed Association member on June 14, 2017 from Angelcyk Rd. of Sewickley Creek HDD site.
