# **Filter Self-Assessment**

# **Example Report**

XYZ Water Treatment Plant was required to perform a filter self-assessment on filter #1 as a result of elevated turbidities over the past 3 months. IESWTR and LT1ESWTR require that a filter self-assessment be conducted for any individual filter that has a measured turbidity level greater than 1.0 nephelometric turbidity units (NTU) in two consecutive measurements taken 15 minutes apart in each of 3 consecutive months. This report summarizes the findings of our self-assessment on filter #1 and shows our plans to correct the problems that we found.

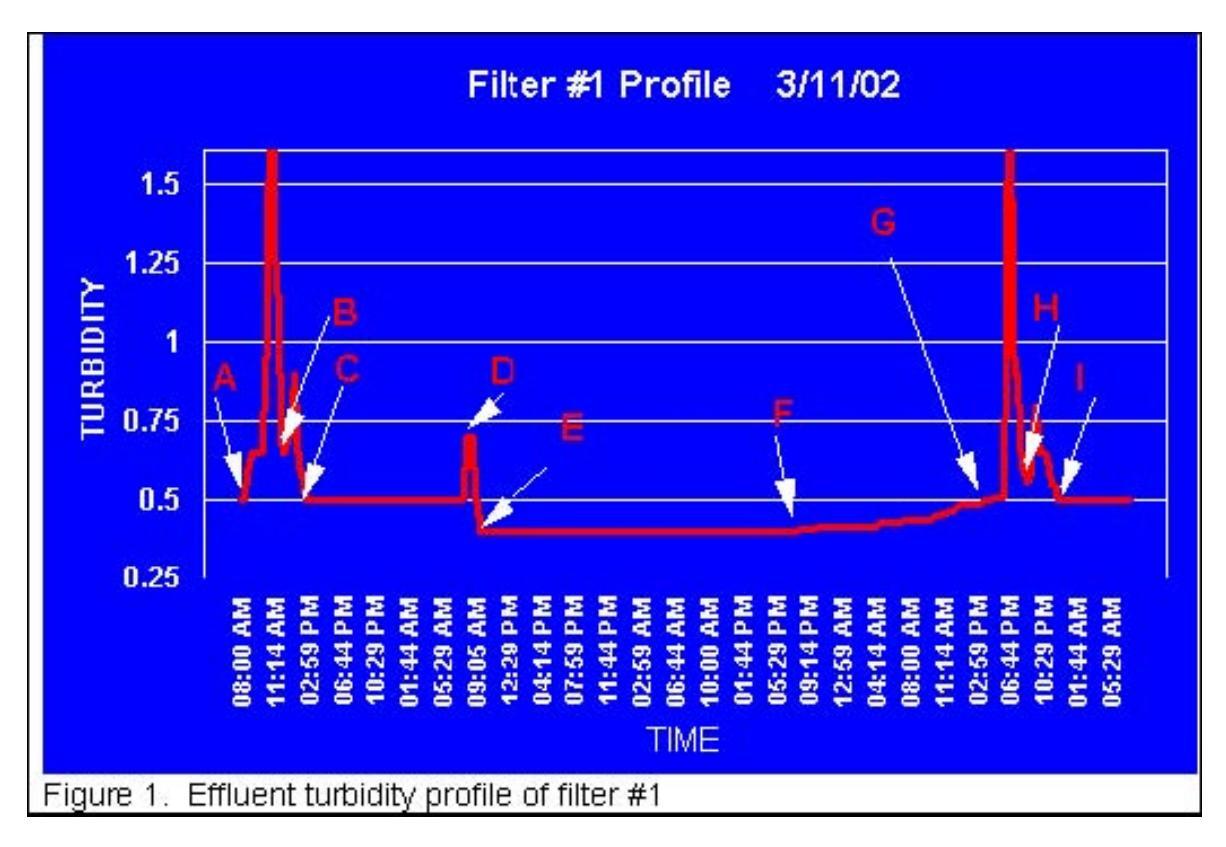
Figure 1 below shows a turbidity profile for filter #1. The filter run ended at 80 hours of run time. The filter was then backwashed and placed into service with a turbidity of about 2 NTU. Filter #1 then recovered to a turbidity of approximately

0.5 NTU within 15 minutes. This is not typical of the other three filters at the XYZ Water Treatment Plant. The other filters typically recover to <0.1 NTU within 15 minutes. This is an indication that the problem is within filter #1 and not a result of poor pre-treatment.

- A. 10:30 AM Day 1 filter #1 backwashed @ 0.65 NTU
- B. 12:29 PM Day 1 filter # 1 placed into service @ 0.65 NTU
- C. 2:59 PM Day 1 filter #1 recovers @ 0.5 NTU
- D. 8:45 AM Day 2 filter #3 backwashes

E. 9:30 AM Day 2 performance of filter #1 improves because filter #3 has been washed which reduces the loading on filter #1

- F. 8:29 PM Day 2 performance of filter #1 begins to degrade
- G. 6:59 PM Day 3 filter #1 backwashed @ 0.51 NTU
- H. 8:44 PM Day 3 filter #1 placed into service @ 0.56 NTU
- I. 12:14 AM Day 4 filter #1 recovers @ 0.5 NTU

- Significant turbidity spike when placing filter #1 into service following backwash.
- Filter #1 recovers to 0.5 NTU after backwash while other filters recover to 0.1 NTU.
- Filter #1 turbidity increases when filter #3 is backwashed.

**Applicability of Corrections:** Unfortunately, our plant was designed without filter-to-waste capabilities or we would be able to send this spike to waste. While reading some filter optimization literature we found a couple of special procedures for placing a filter into service after backwashing. The first two that we plan to try immediately are:

- Allow the filter to rest for 1 hour before placing it into service; and
- Ramp valves open slowly when placing the filter on-line.

If these two procedures do not reduce our turbidity spike when placing a filter in service, we will then try using a filter aid polymer.

The addition of filter-to-waste piping has been budgeted into our 3-year plan.

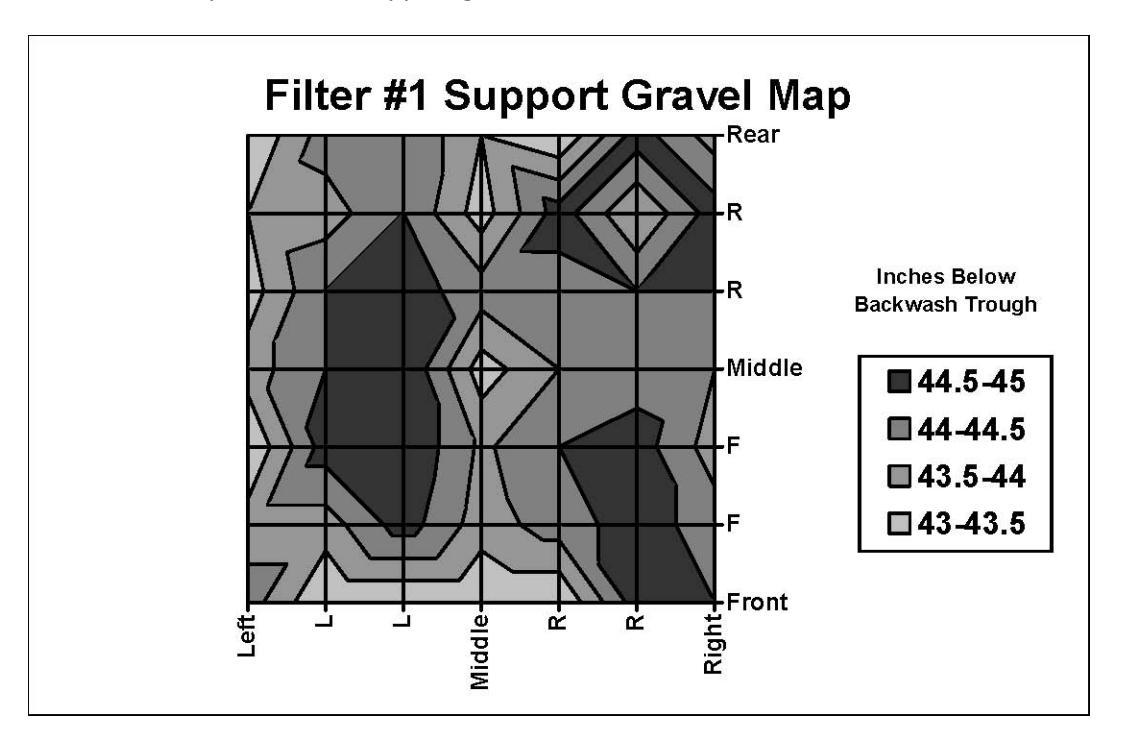
Figure 2. Map of filter #1 support gravel in inches below the backwash trough.

Our operators mapped the gravel layer using a ½-inch steel rod as described in an AWWA Filter Surveillance video that we purchased for operator training. They found that the gravel layer was within 2 inches of variance. According to Chapter 5 of EPA's Guidance Manual for Compliance with the Interim Enhanced Surface Water Treatment Rule: Turbidity Provisions, the gravel layer should not deviate more than 2 inches. The operators also discovered that we only have a total of 25 inches of filter media. This was verified by digging a test hole and measuring the depth to the gravel layer. Please see figure 2 below for a map of filter #1 support gravel.

In addition, no media was found in the clearwell, no air boiling was observed during the backwash and no vortexing was seen while the filter was draining.

We suspect that our underdrains may have some manganese dioxide fouling. As a result, a more indepth inspection of the underdrains will be conducted when the filters are rebuilt.

• The underdrains may be fouled.
