CROWN/TYLERSBURG
Abandoned Mine Reclamation
Contract No. OSM 16(0886,3316)101.1

**CROWN/TYLERSBURG
ABANDONED MINE RECLAMATION
CONTRACT NO. OSM 16(0886,3316)101.1
FACT SHEET**

Location: Farmington Township, Clarion County

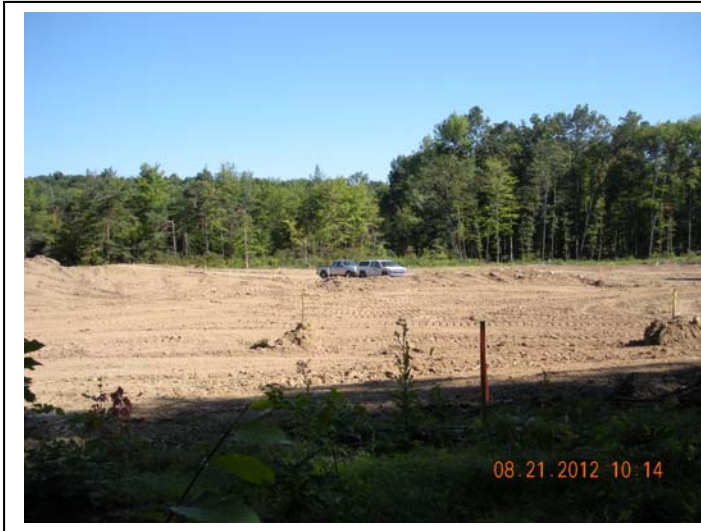
Site A, looking north, fill at west end of site (east end of fill).

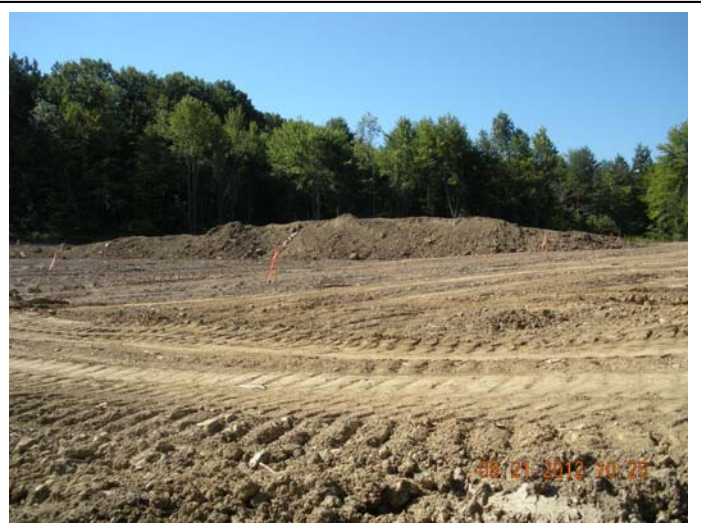
Site A, looking south, fill at west end of site (west end of fill).

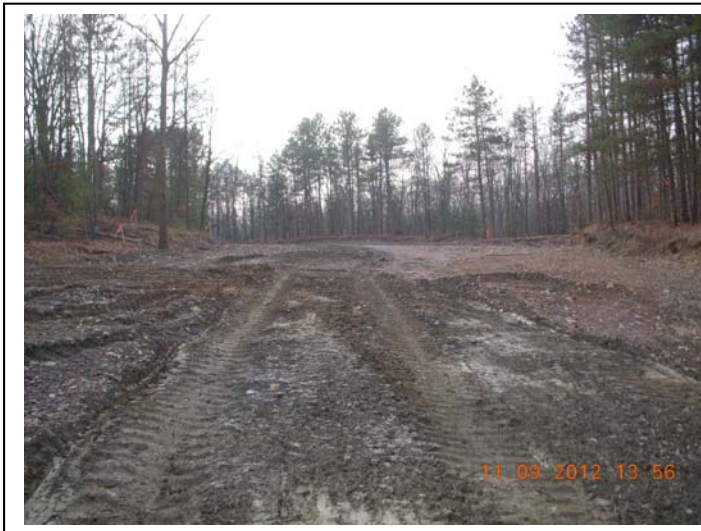
View of site grading looking along western dogleg on Site B.

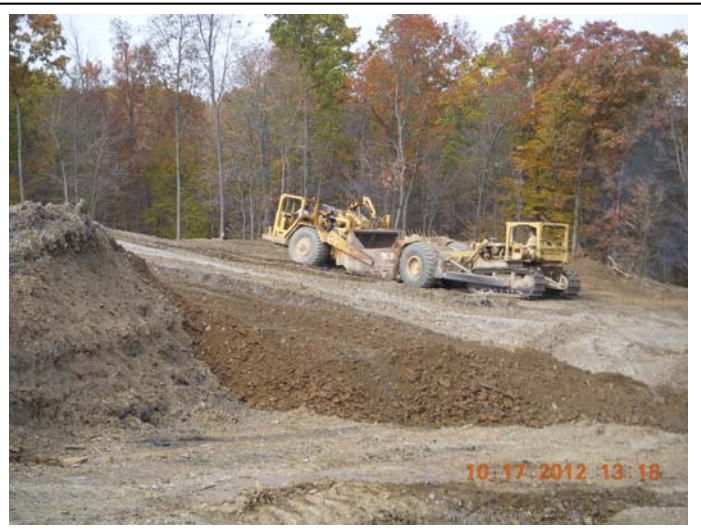
View of grading along north and east boundaries of Site B.

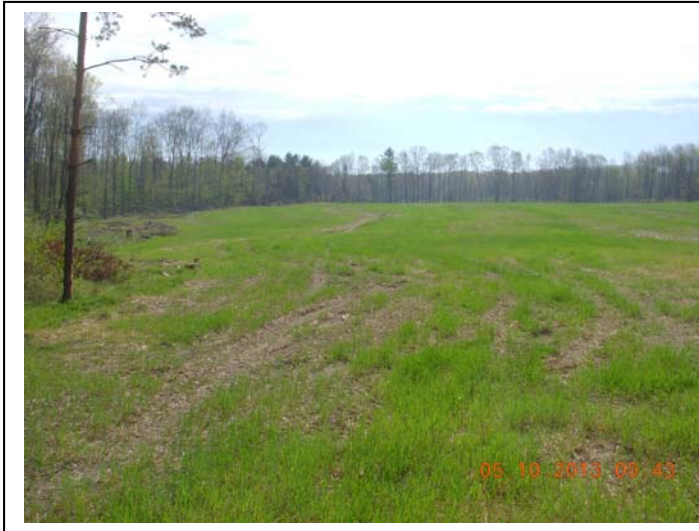
View of grass growing on Site A, looking east.

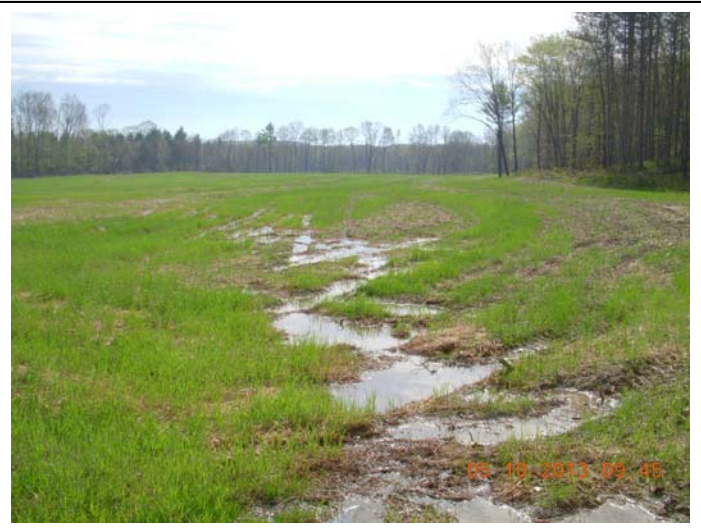
View of grass growing and water running along Site A, looking east.

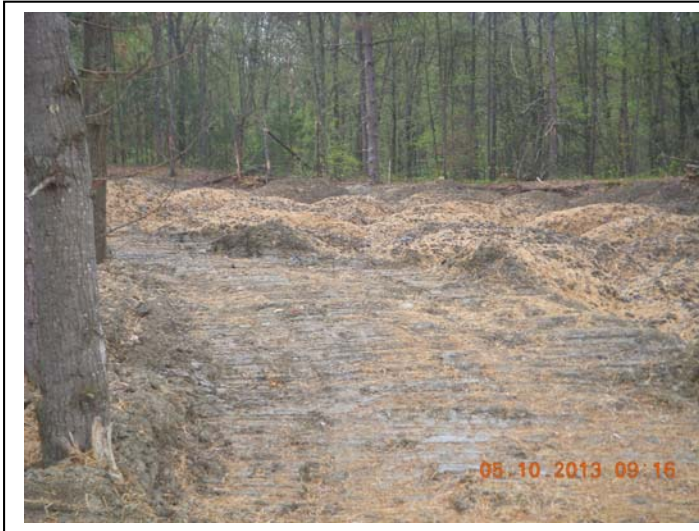
View of completed ARRI grading looking along western dogleg on Site B.

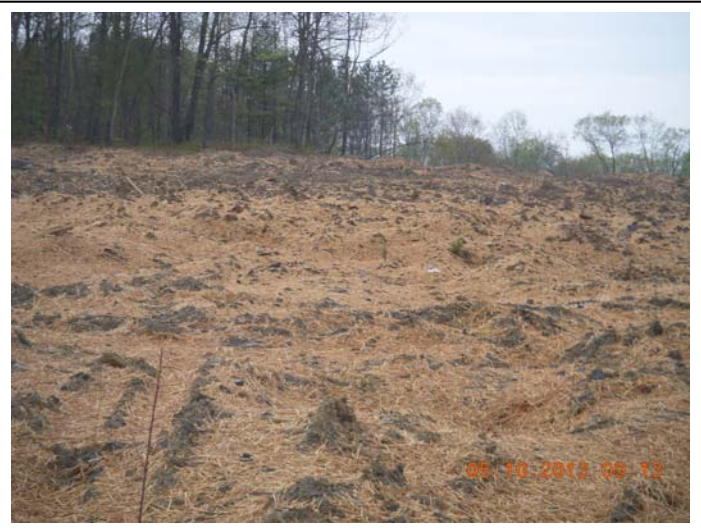
View of ARRI grading on Site B, looking west.
