NEWTOWN SOUTH 2
Abandoned Mine Reclamation
Contract No. OSM 54(3649)102.1

**NEWTOWN SOUTH 2
ABANDONED MINE RECLAMATION
CONTRACT NO. OSM 54(3649) 102.1**

FACT SHEET

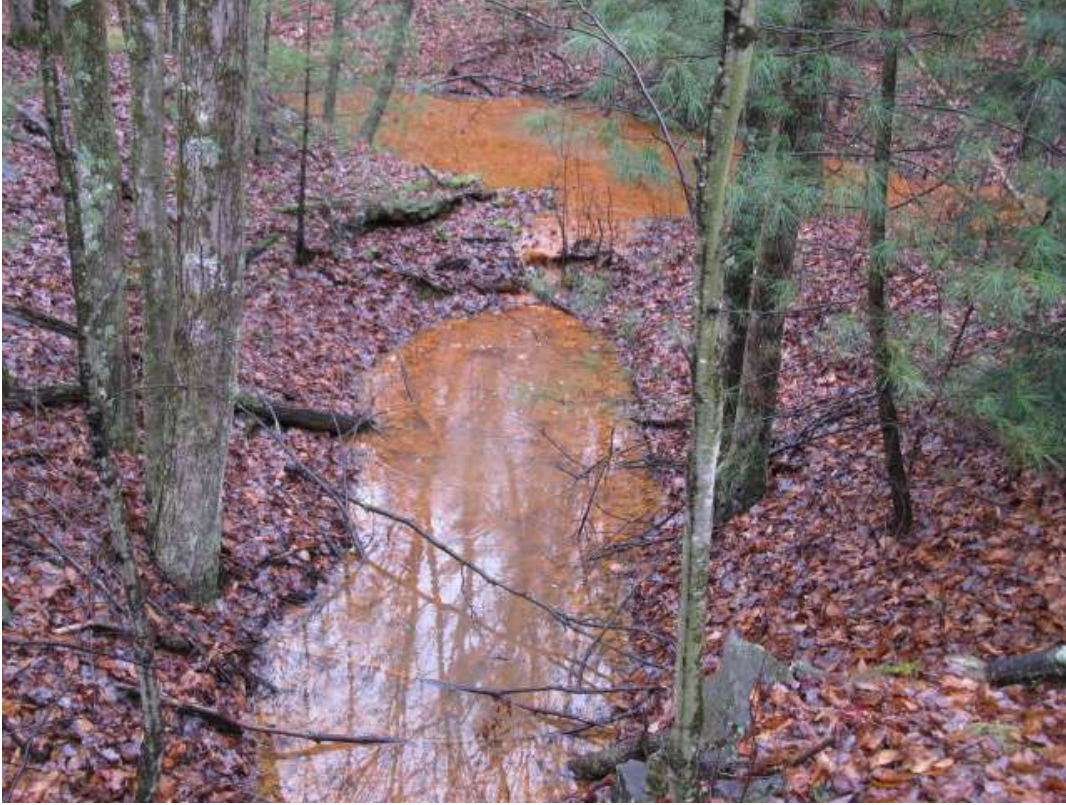
Pre Construction Photo of mine discharge

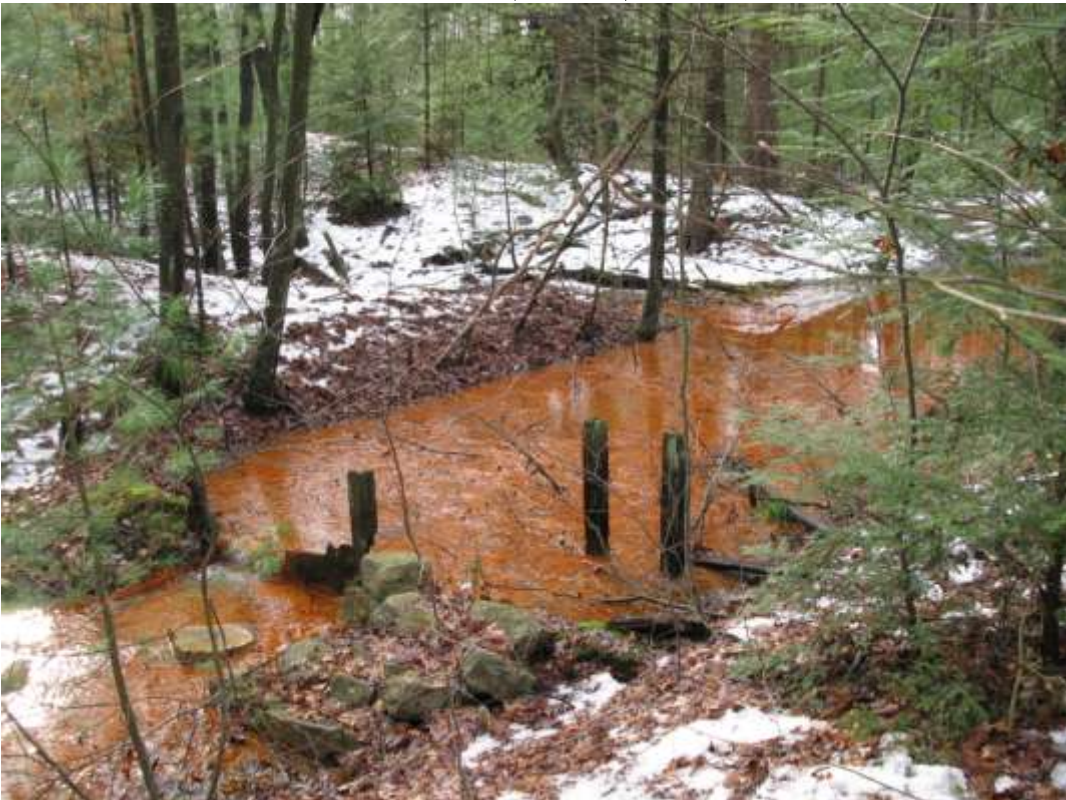
Pre Construction Photo of mine discharge

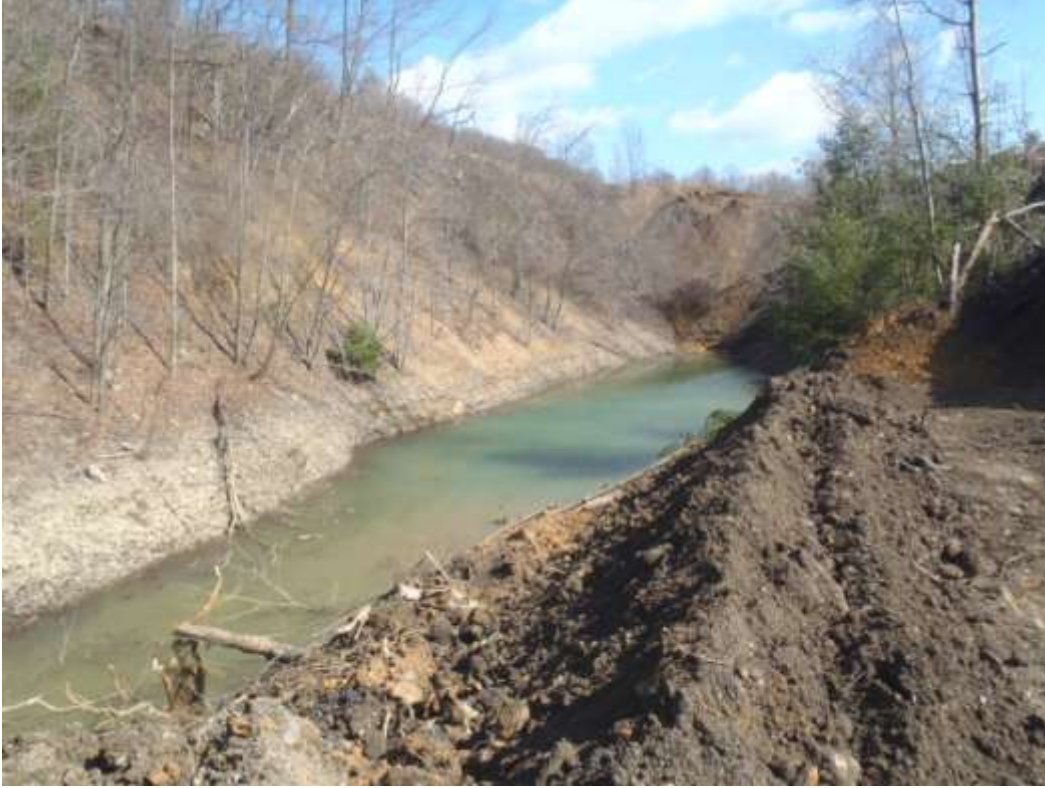
Impoundment 'A' before being dewatered

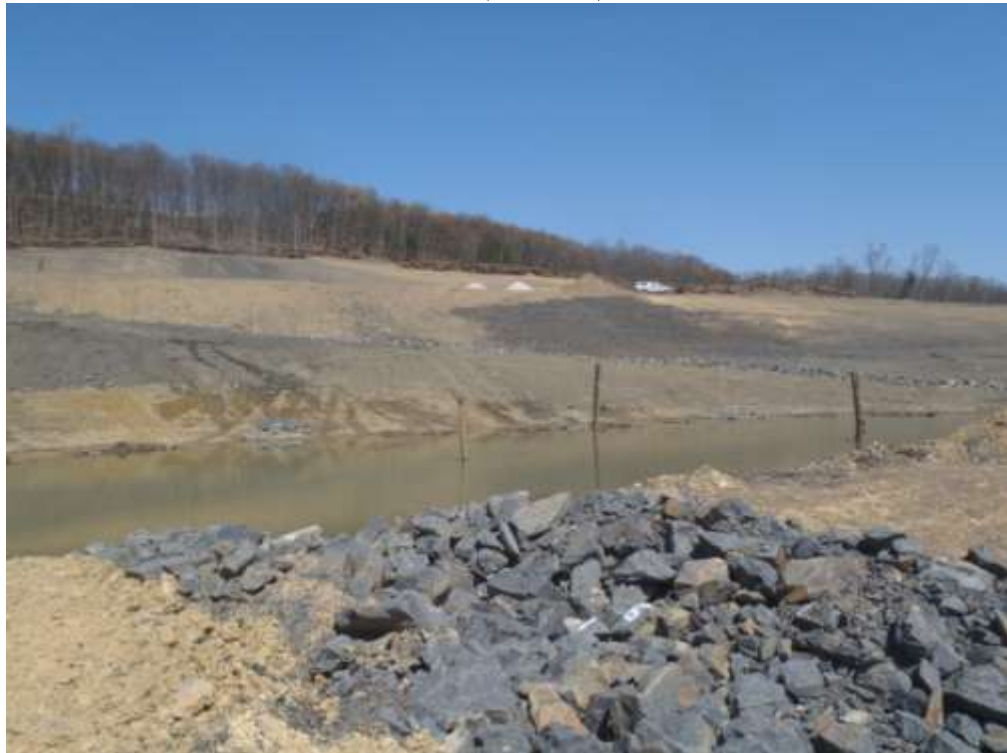
Grading Area 'D' during construction

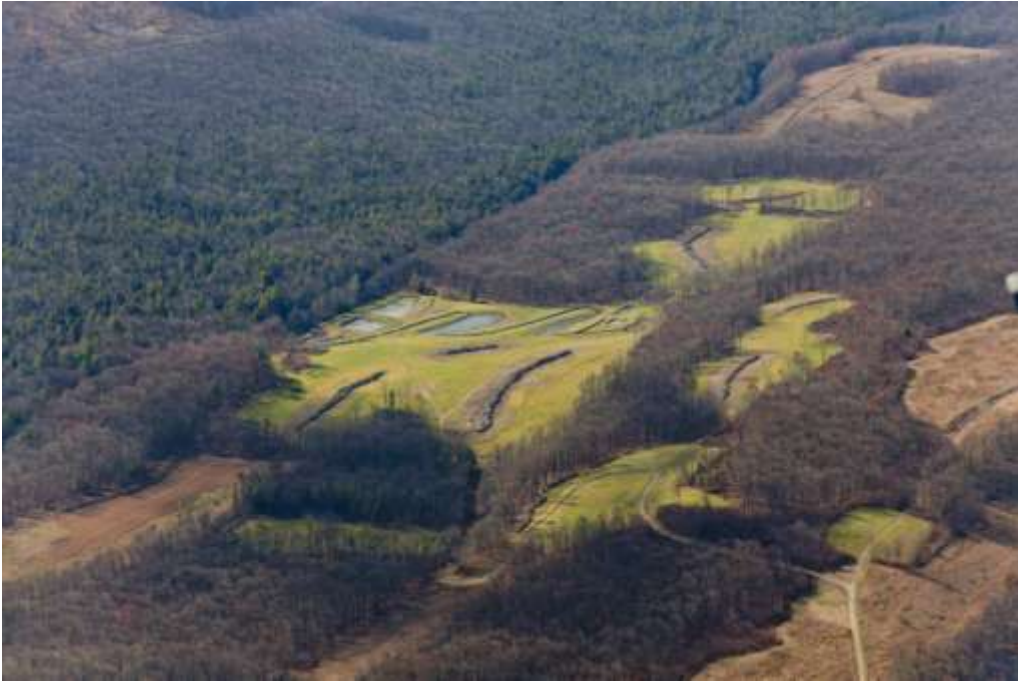
Oblique showing completed job first fall.

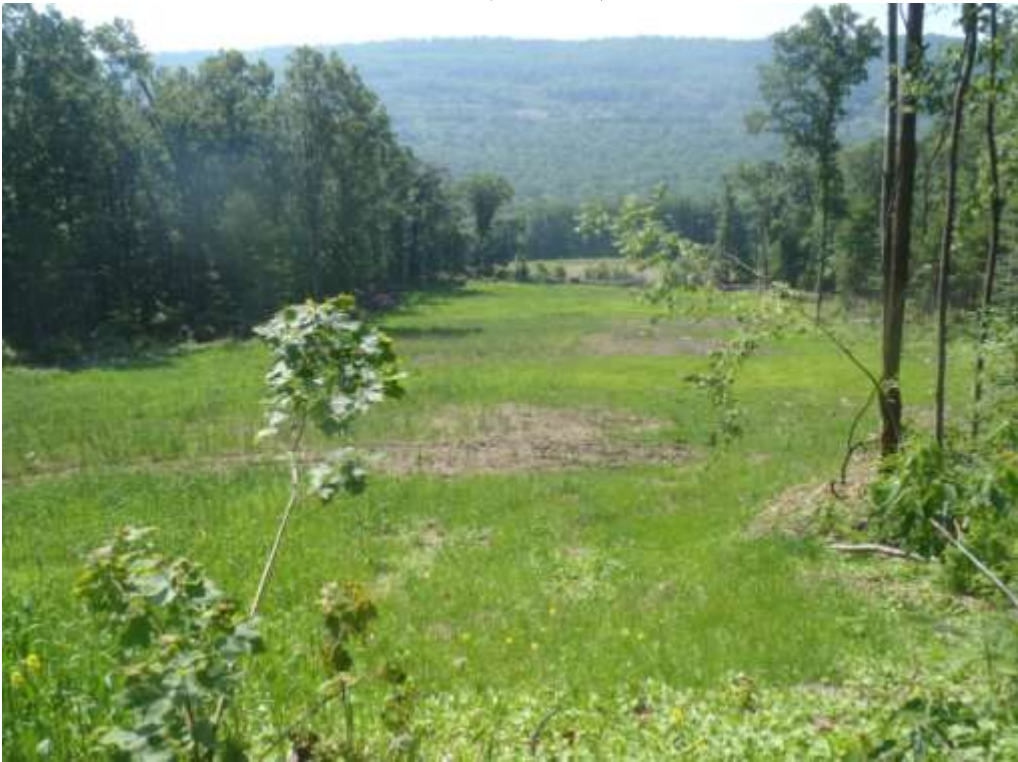
Completed job during first growing season
