BLACK DOG HOLLOW
Abandoned Mine Reclamation Project
Contract No. OSM 63(0618)104.1

**BLACK DOG HOLLOW
ABANDONED MINE RECLAMATION PROJECT
CONTRACT NO. OSM 63(0618)104.1**

FACT SHEET

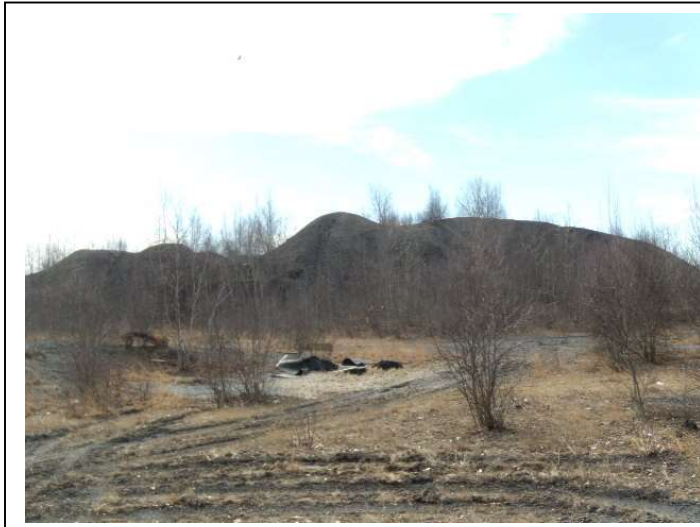
Site A No. 2 West Side

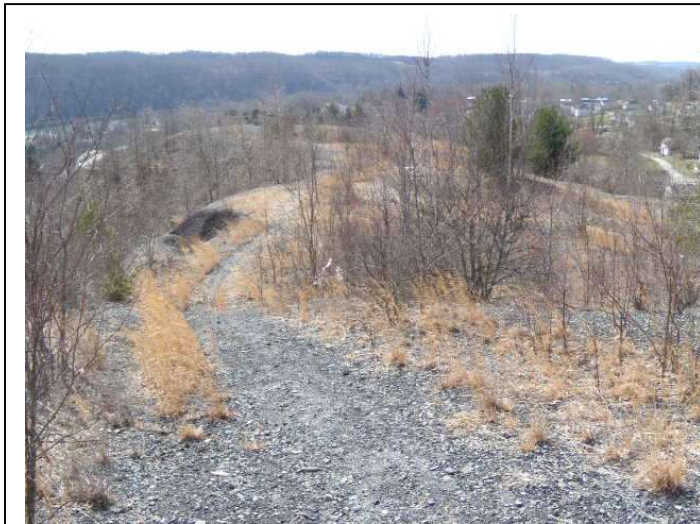
Site No. 2 Looking Toward the North End of the Project

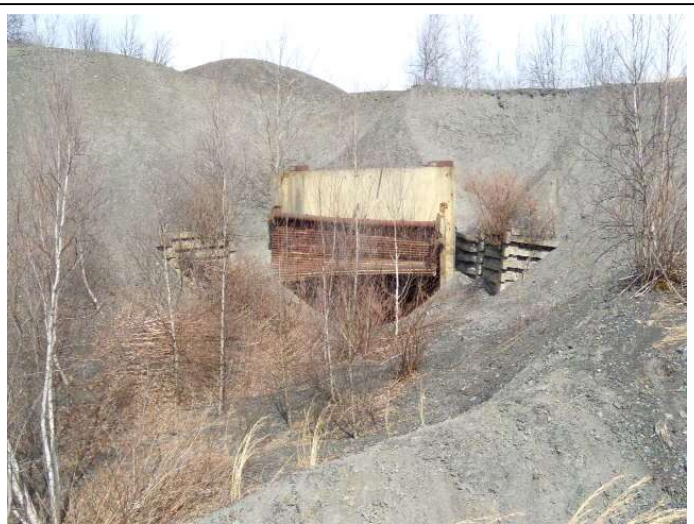
Site No. 2 East Side of the Project
