June 27, 2025

RE: Northern Red-bellied Cooter Habitat Assessment Report
Rock Hill Quarry
East Rockhill Township, Bucks County, Pennsylvania
PFBC SIR# 59461

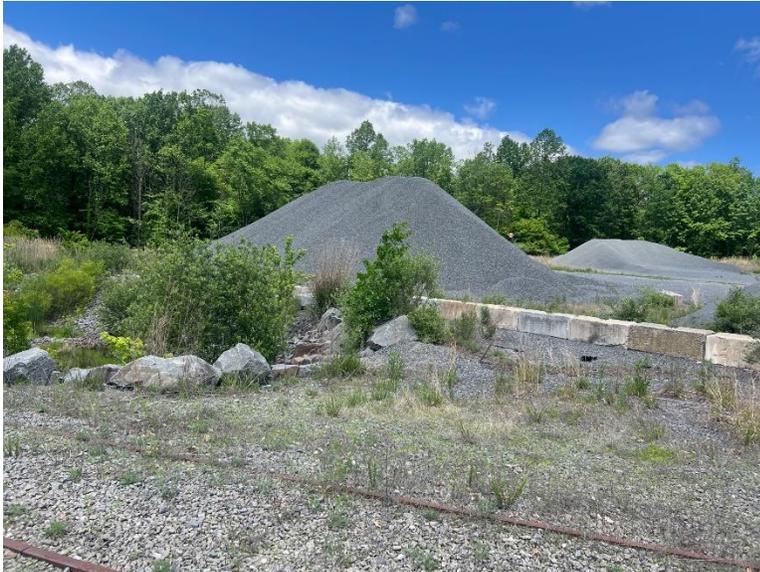
- 1) Upland habitats within the permit area contain potentially suitable Northern Red-bellied Cooter nesting habitat due to the presence of reclaimed meadows and gravel driveways/parking areas.
- 2) No Aquatic habitat within the permit area contains the characteristics necessary for Northern Red-bellied Cooter.
- 3) As a result of the above, no potentially suitable Northern Red-bellied Cooter habitat was found within the subject site.
- 4) Due to the apparent absence of Northern Red-bellied Cooter habitat within the Rock Hill Quarry site, no additional studies related to the species are recommended for the proposed project.

PHOTO 1: Example of onsite potentially suitable Northern Red-bellied Cooter nesting habitat found onsite.

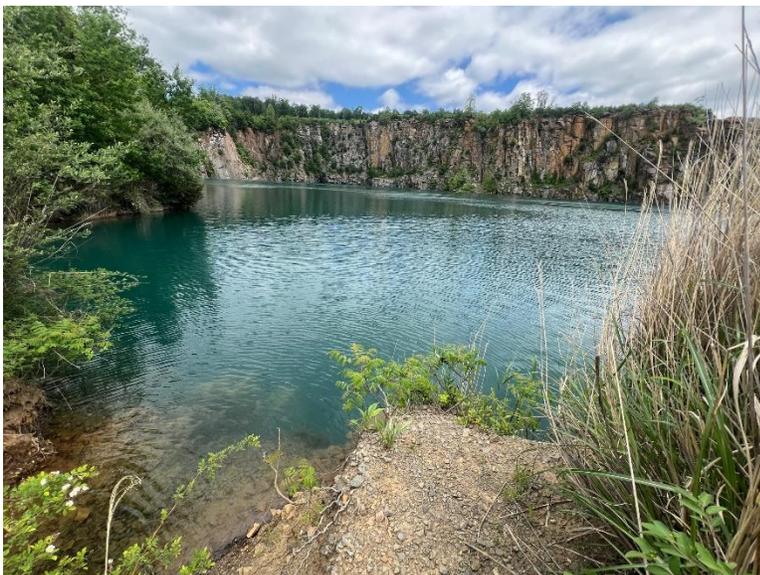
Pond 1 is a large (~20 acres) quarry pit waterbody and largest aquatic feature found within the study area. The inundated quarry pit is quite deep (the bottom is not visible) and depth estimated at greater than 50 feet. Pond 1 is steep-sided, with near vertical highwalls, and the bottom quickly drops off from a narrow, stony, littoral edge. The pond does not contain basking logs or substantial shallow areas. No aquatic vegetation nor submerged aquatic vegetation beds were noted in the pond. Disturbed areas (gravel roads and lots) and reclaimed meadows abut the pond to the west and south.

Despite the presence of adjacent potentially suitable nesting habitat, Pond 1 is not RBC habitat due to the apparent absence of submerged aquatic vegetation, steep banks, and absence of basking habitat.

PHOTO 2: View north of onsite inundated quarry pit (Pond 1). Note the near vertical highwalls, depth, and absence of basking habitat.

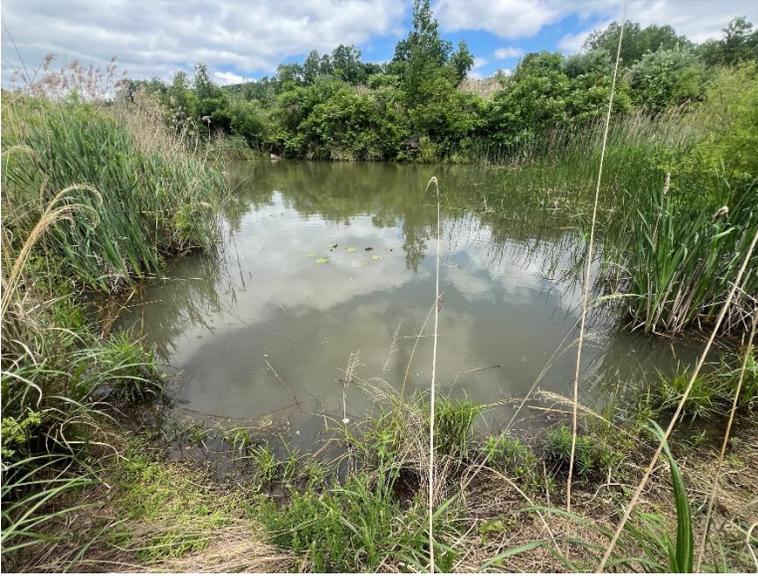
Pond 3 is a small (approximately 0.25-acre) stormwater/pump-water feature in the southwestern portion of the permit area. The depth of the pond is unknown but the eastern portion of the basin appears to be greater than three feet in times of high water. The recently constructed pond basin is ringed in crushed modified stone and contains a stone substrate. The pond consists of several channels and is used for the collection and conveyance of quarry pit discharge during times of mine operation. The western portion of the pond is shallow (less than two feet in depth) with open water choked by giant reed. The eastern portion of Pond 3 contains spatterdock and is enclosed by woody vegetation. Potentially suitable basking habitat is absent. The pond appears to be significantly shaded during the growing season due to the mature trees that grow along its steep banks. Reclaimed meadows and gravel/stone rock fields are to the north and east of the pond. Despite the presence of adjacent potentially suitable nesting habitat, Pond 3 is not potentially suitable RBC habitat due to the presence of a rocky substrate, small size, absence of basking habitat, and recent construction.

PHOTO 3: View north of Pond 3.

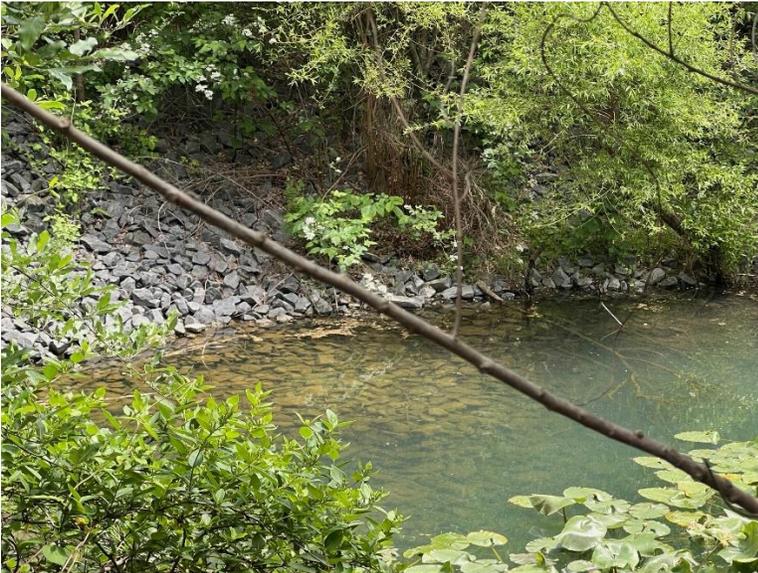
PHOTO 4: View south of Pond 3.

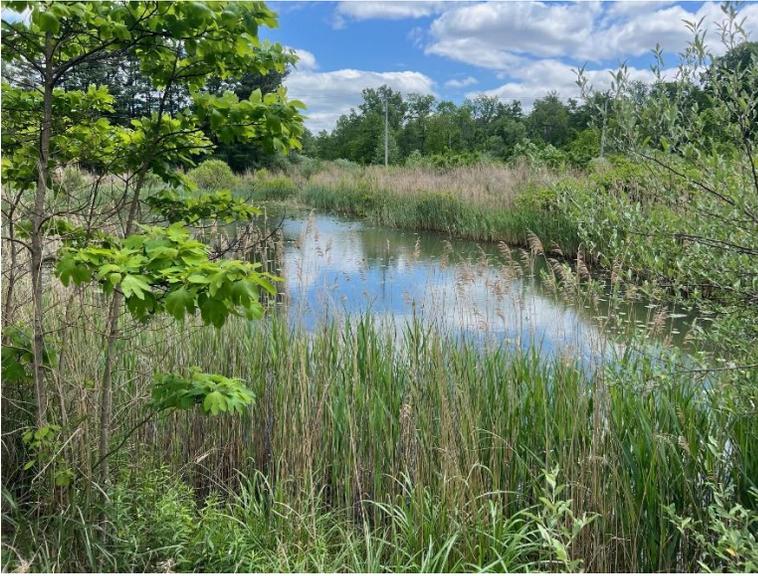
Pond 4 is a small (approximately 0.3-acre) stormwater feature in the western portion of the permit area. The depth of the pond is unknown but appears to be greater than two feet in times of high water. The recently constructed pond basin is ringed in crushed modified stone and contains a stone substrate. Pond 4 contains spatterdock and is enclosed by cattail, giant reed, and willows (*Salix* sp.). Potentially suitable basking habitat is absent. Reclaimed meadows and gravel/stone rock driveways are to the north, east, south, and west of the pond. Despite the presence of adjacent potentially suitable nesting habitat, Pond 4 is not potentially suitable RBC habitat due to the presence of a rocky substrate, small size, absence of basking habitat, and recent construction.

PHOTO 5: View south of Pond 4.

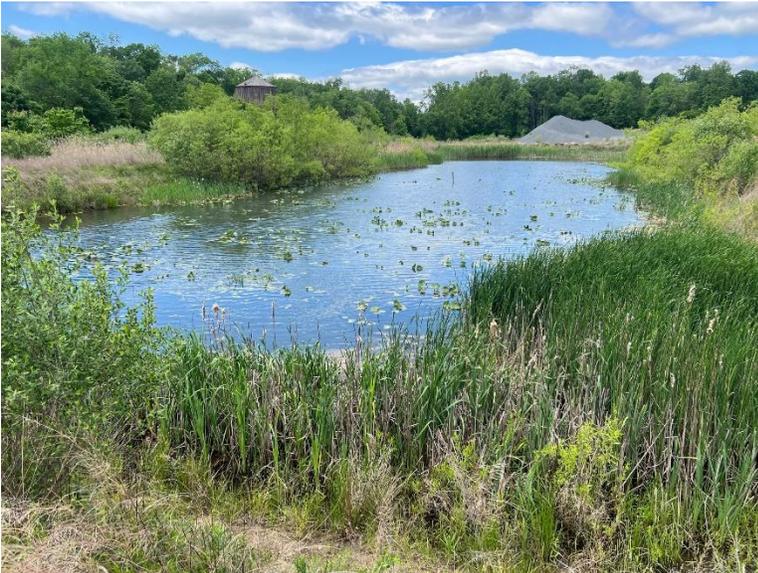
Pond 5 is a small (approximately 0.7-acre) stormwater feature in the western portion of the permit area. The depth of the pond is unknown but appears to be greater than two feet in times of high water. The recently constructed pond basin is ringed in crushed modified stone and contains a stone substrate. Pond 5 contains spatterdock and is enclosed by cattail, giant reed, and willows. Potentially suitable basking habitat is absent. Reclaimed meadows and gravel/stone rock driveways are to the north, east, south, and west of the pond. Despite the presence of adjacent potentially suitable nesting habitat, Pond 5 is not potentially suitable RBC habitat due to the presence of a rocky substrate, small size, absence of basking habitat, and recent construction.

PHOTO 6: View north of Pond 5.

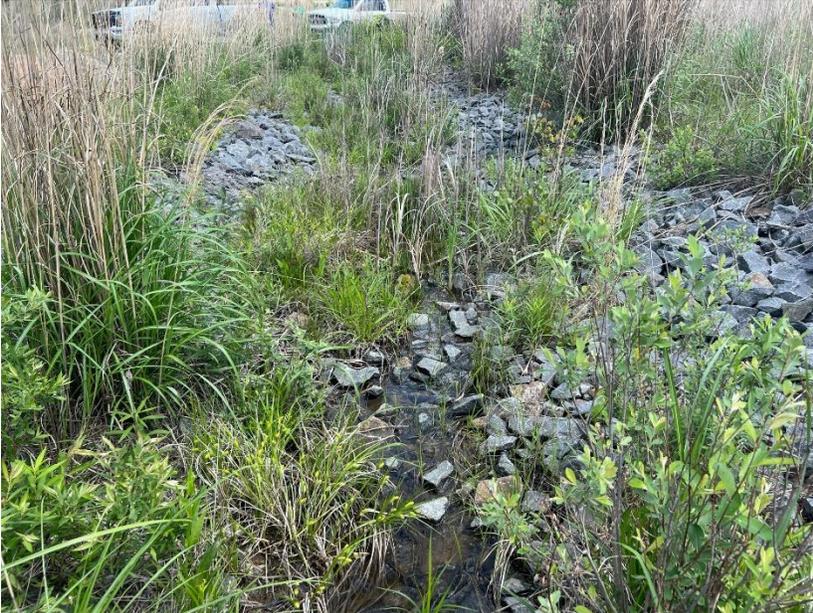
A single, constructed drainage feature exists along the western boundary of the permit area. This drainageway extends for approximately 1,500 feet, beginning as an outflow from stormwater/pump-water basin Pond 3 and was constructed in approximately 2019. The narrow (2 to 4 feet in width) water conveyance is contained within a defined crushed/modified stone channel. The drainageway passes through a series of culverts and pipes as it flows north and offsite, and contained water depths that ranged from three to ten inches. The onsite water-course is not RBC habitat due to its shallow depth, recent construction, and stony channel.

PHOTO 7: View west of onsite drainage feature.
